DESCRIPTION:
Ltr reporting abnormal occurrence on 4-5-74,
regarding cracked studs on Recirculation
Pumps.....

MONTICELLO NUCLEAR GENERATING PLANT
Docket No. 50-263 License No. DPR-22

Cracked Studs on Recirculation Pumps

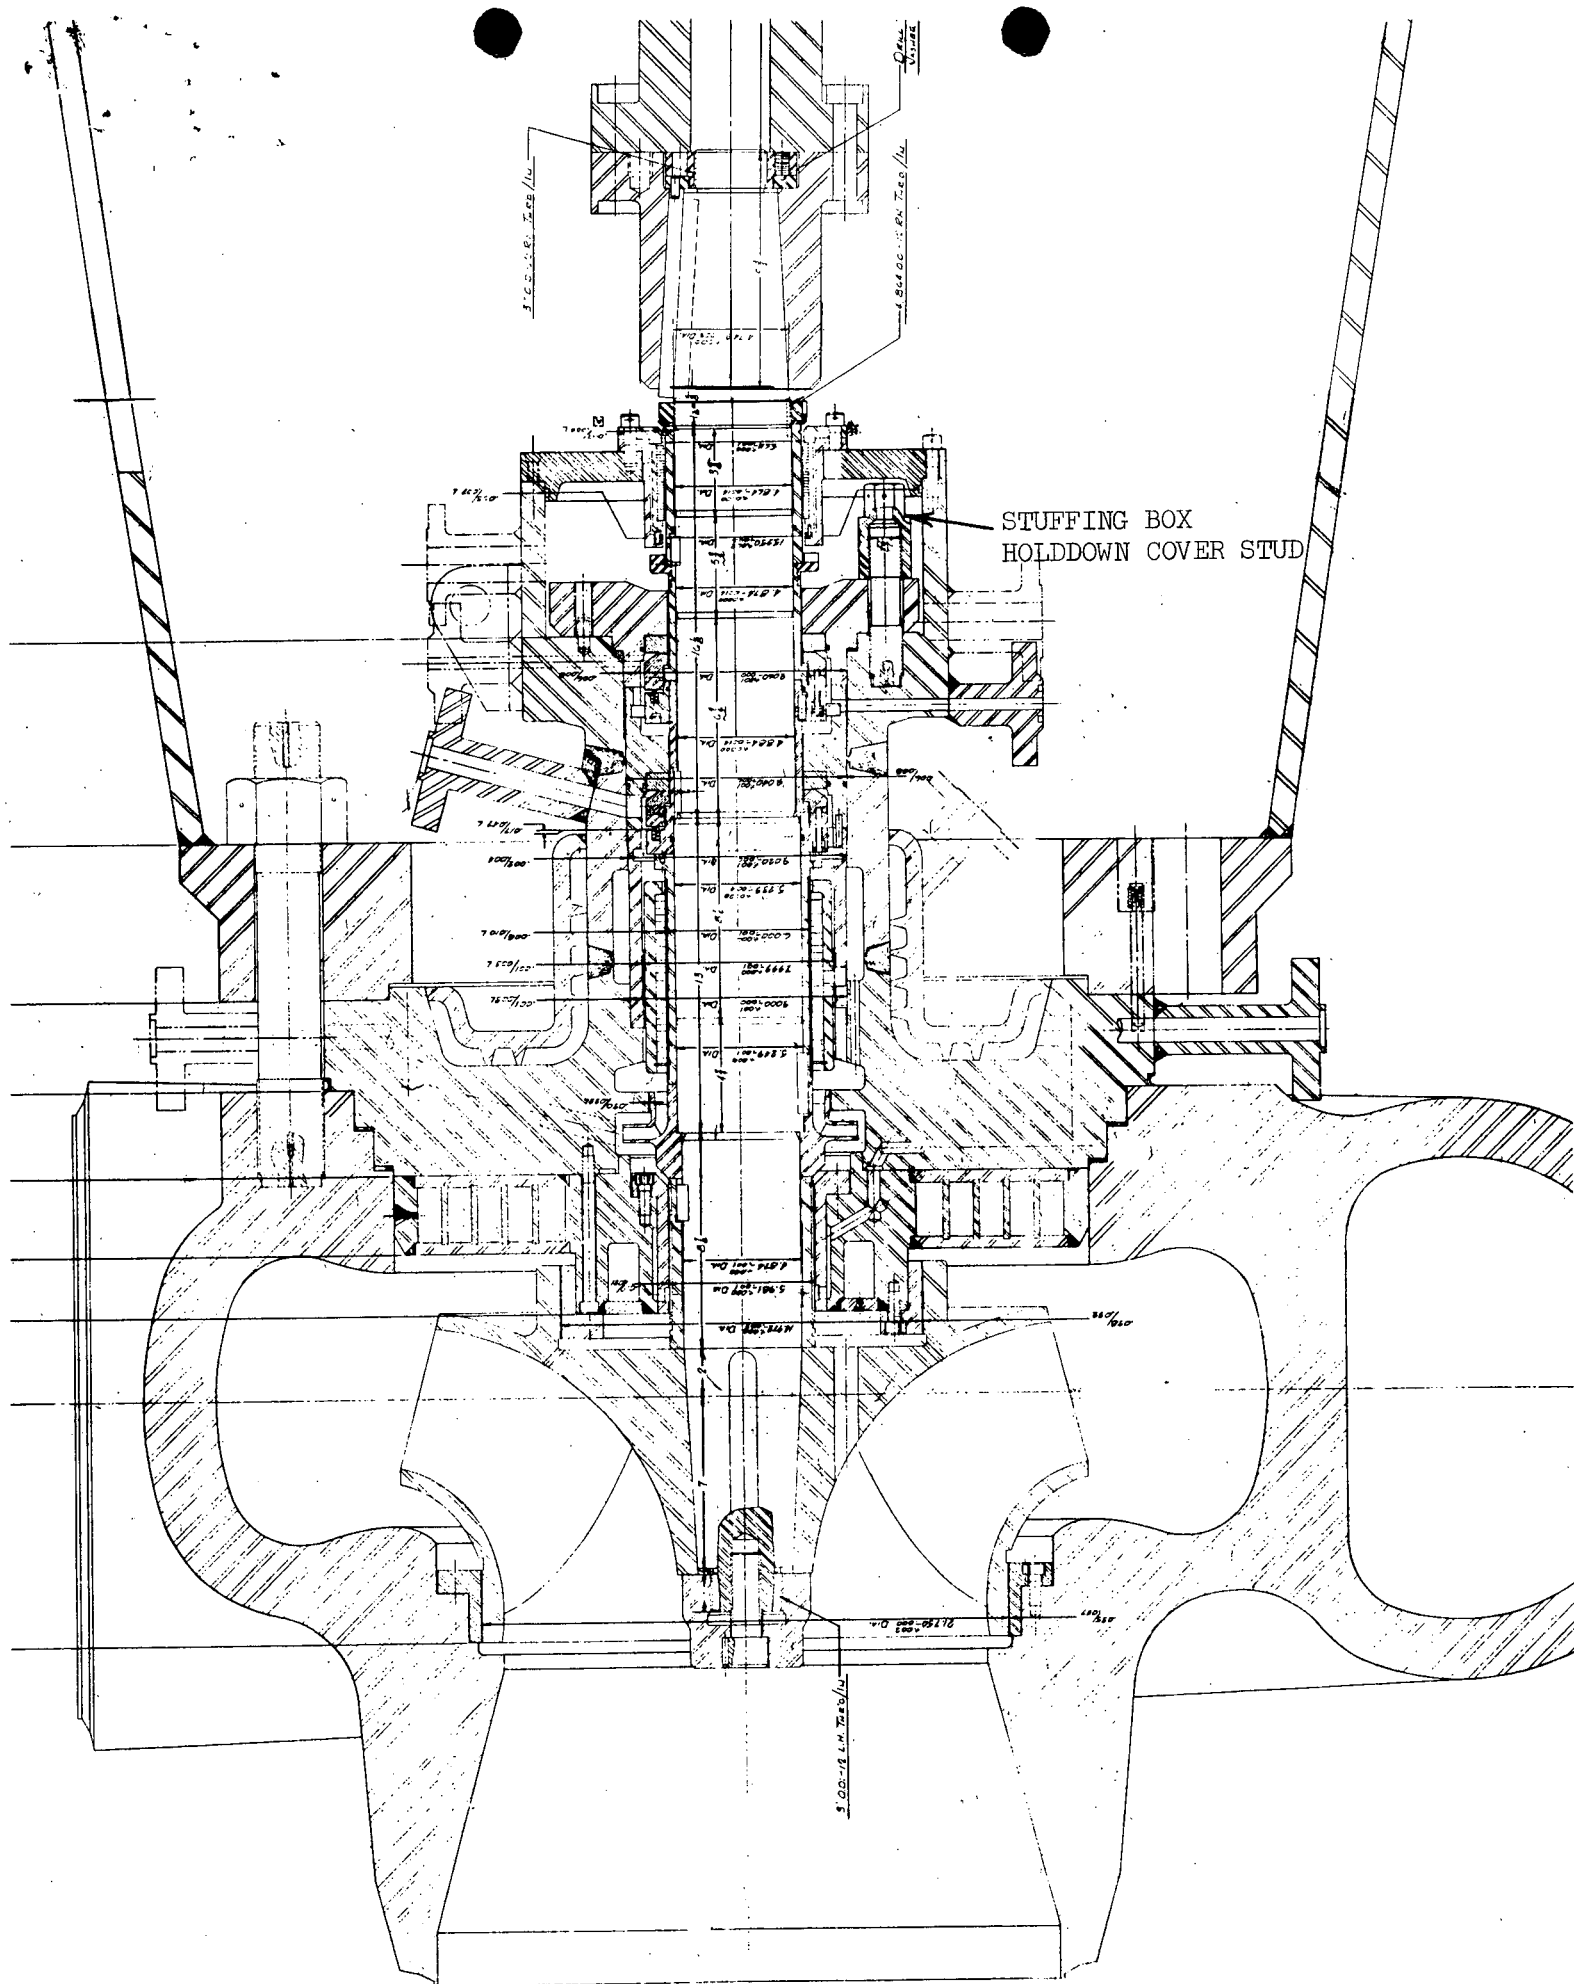
On April 5, 1974, it was discovered that one of the ten stuffing box holddown cover studs on No. 12 recirculation pump had failed (see attached figure). Subsequent ultrasonic examination revealed significant internal defects in all of the remaining studs on No. 12 recirculation pump and in nine of the ten studs on No. 11 recirculation pump.

Complete failure of all the studs on a recirculation pump could result in primary coolant leakage past the pump shaft seal into the drywell. It is noted that the pump is capable of being shutdown and isolated in the event of significant leakage. This is the first time that failure of any recirculation pump stuffing box holddown cover studs has been detected.

Investigation into the cause of the stud failures and possible corrective actions is continuing. Following completion of this investigation, a report on the final resolution of the problem will be submitted.
