February 15, 1972

MONTICELLO NUCLEAR GENERATING PLANT

Docket No. 50-263 License No. DPR-22
Supplementary Report on Damage to Torus Baffles

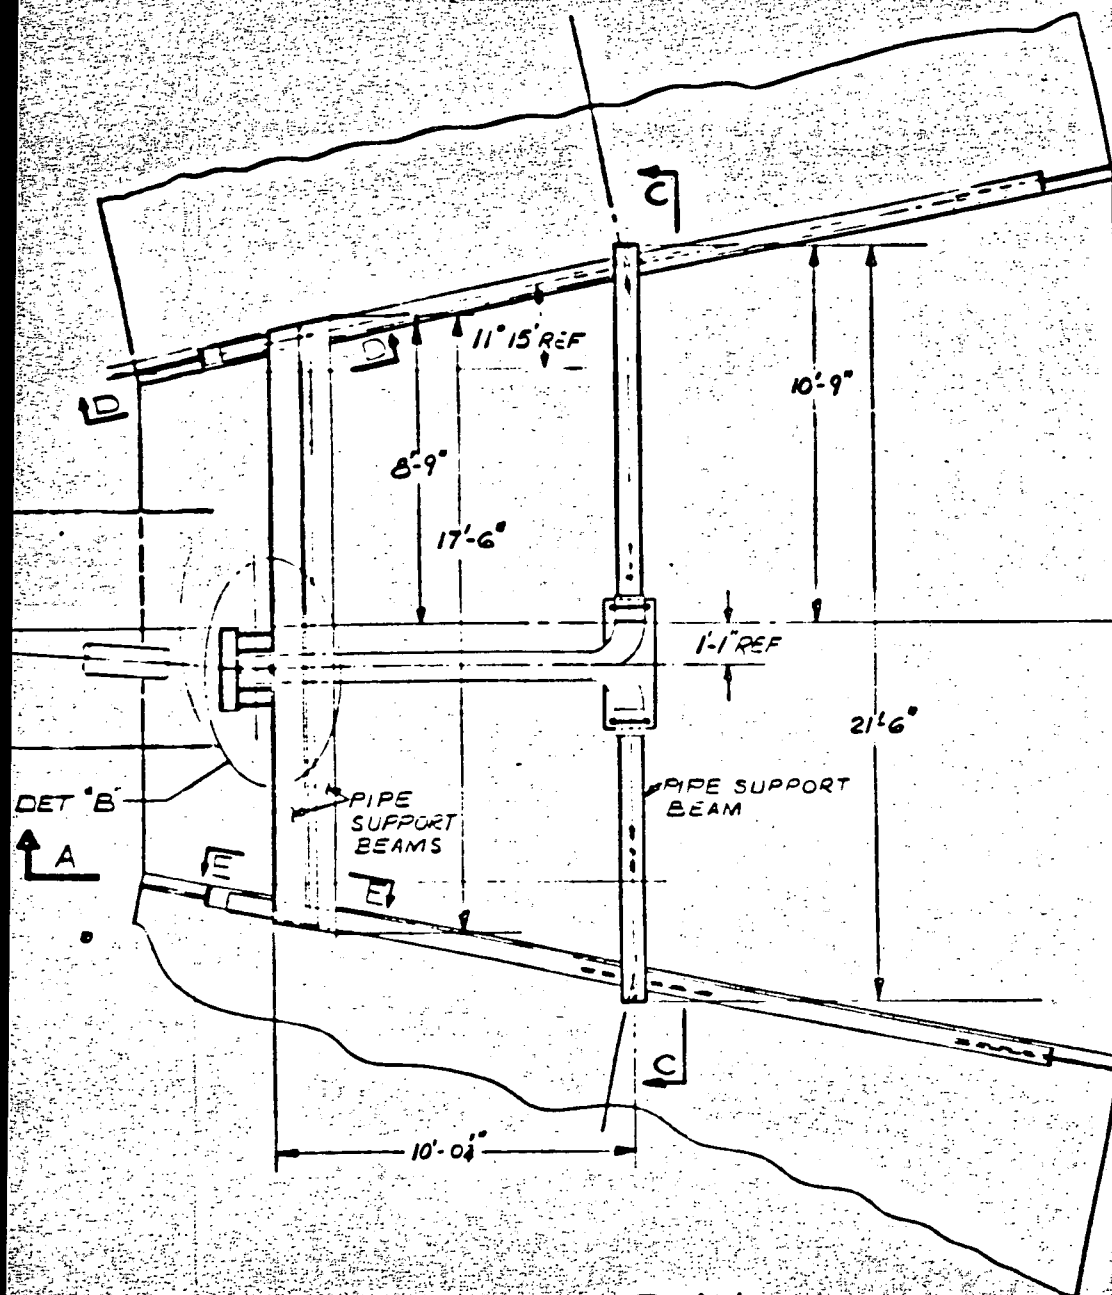
PLAN

Since the last report, all small lines have been restored to their original condition. Likewise, the structural support bracing for the torus catwalk has been repaired. The modifications to the relief valve discharge lines have been completed as described in the previous report. The lines were extended under the torus water level and terminated with a ram's head type tee as shown on the attached sketches.

1. EXTEND THE EXISTING FOUR (4) STEAM RELIEF VALVE DISCHARGE PIPES AS SHOWN
2. USE EXISTING BAFFLE BEAMS FOR PIPE SUPPORT BEAMS.
3. CLEAN AND PAINT ALL UNPAINTED MATERIAL WITH ONE (1) COAT OF 5 MILS OF PHENOLINE 363 IN ACCORDANCE WITH MANUFACTURERS (CARBOLINE CO.) RECOMMENDATIONS.
