MONTICELLO NUCLEAR GENERATING PLANT
Docket No. 50-263 License No. DPR-22

Reporting of Occurrences

Subject: Failure of #11 Standby Gas Treatment System Air Heater Control Circuitry

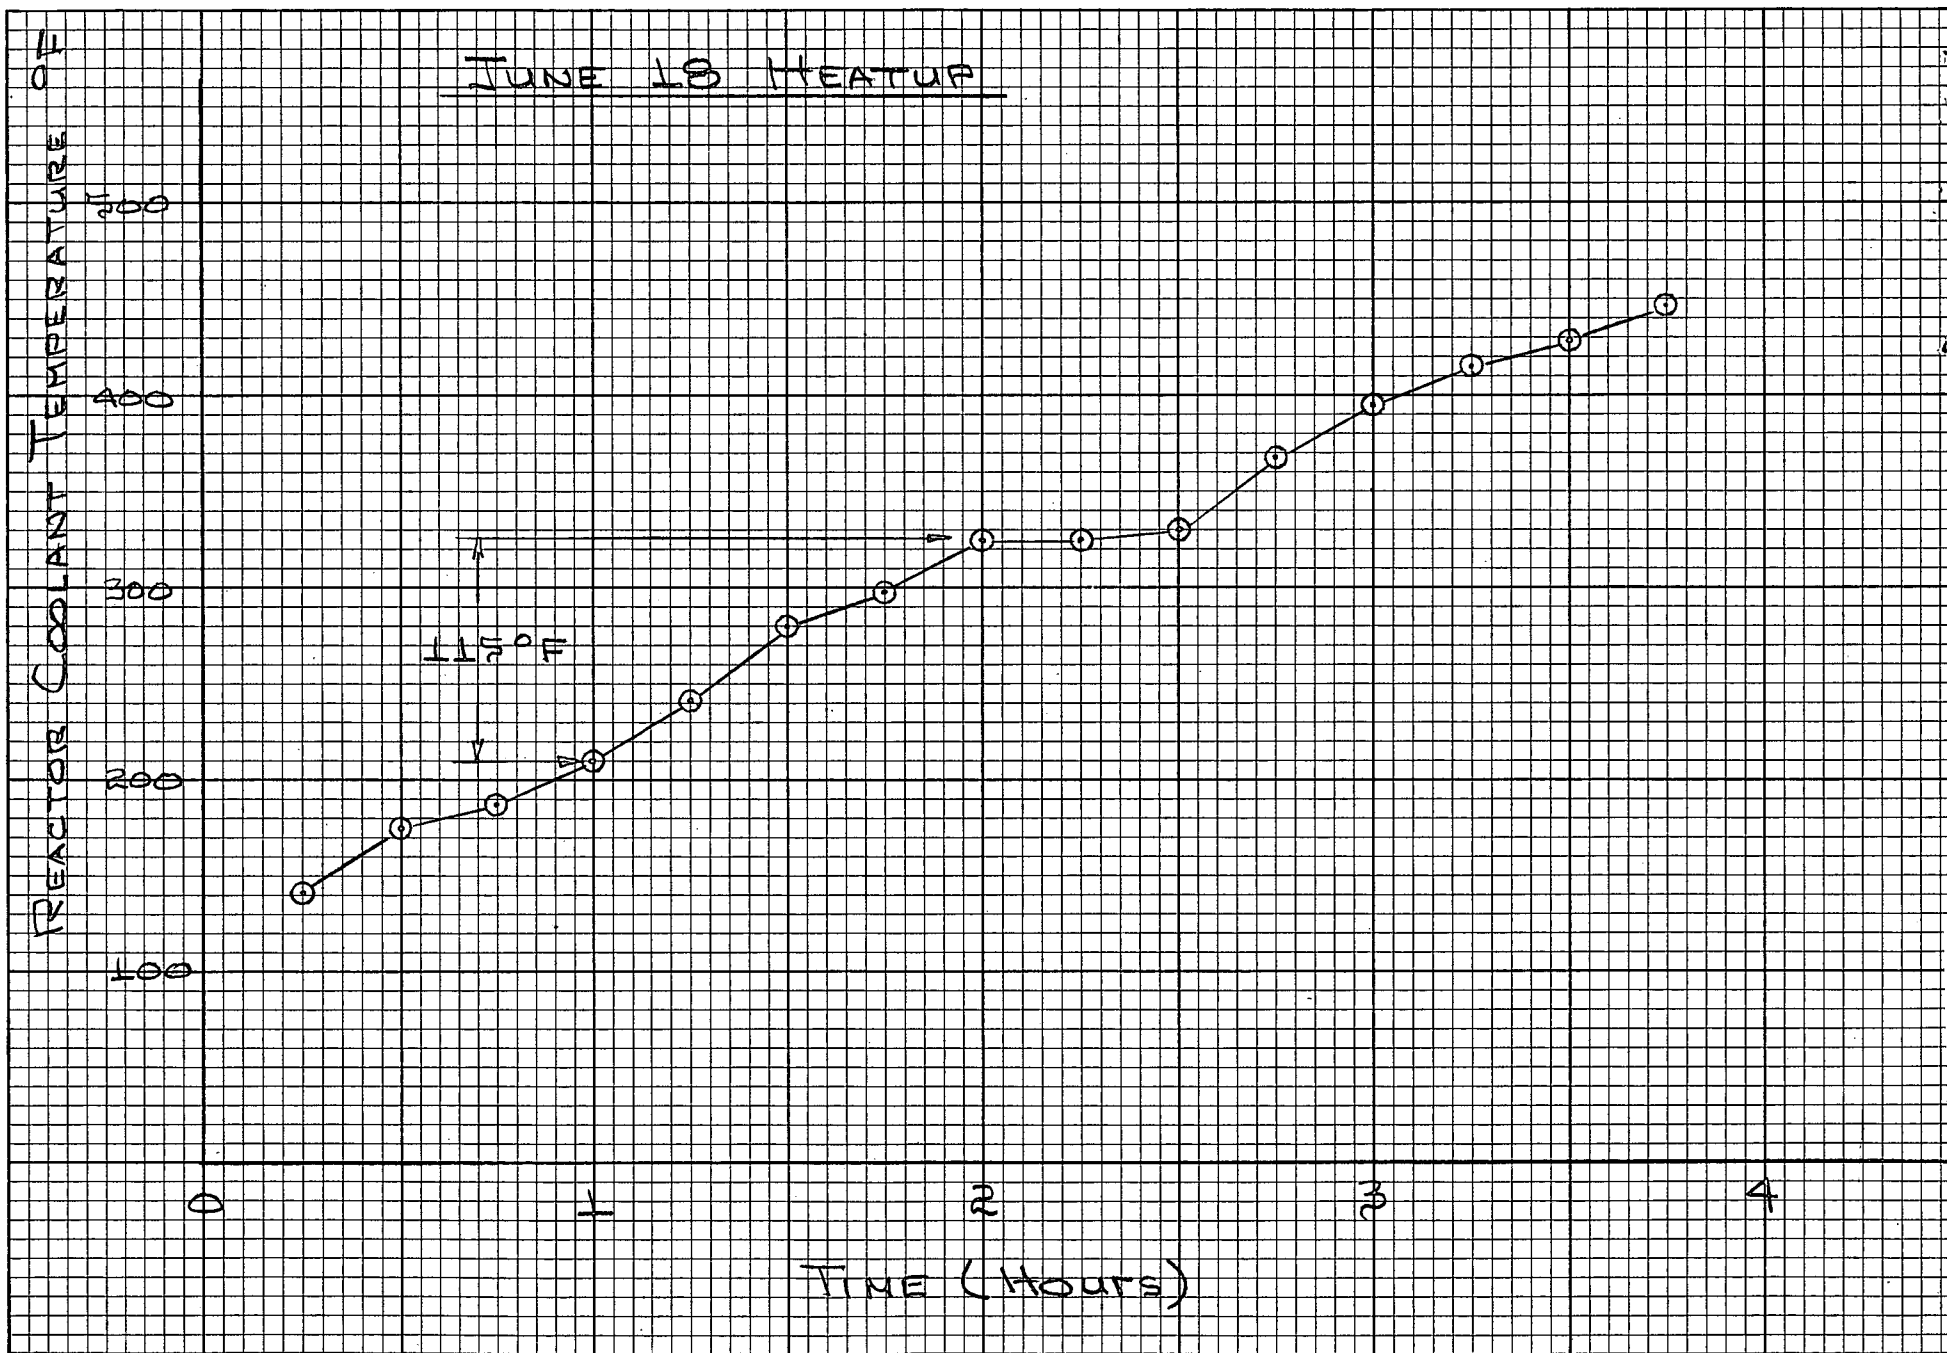
On June 18, 1971, while performing a heatup rate test in conjunction with Startup Test Procedure #9, Reactor Vessel Temperature, the reactor coolant temperature was increased by 115°F (210°F to 325°F) during a one hour period.

A special heatup test was being performed on June 18, 1971 to obtain RPV temperatures during a 90°F to 100°F per hour heatup. The data was being obtained to confirm thermal analysis models. An increase in the reactor coolant temperature of more than 100°F in one hour resulted because personnel directing and performing the test failed to give proper attention to available data.

It has been determined from a review of the test data that the 115°F coolant temperature rise in the one hour period created no unusual stresses on the vessel.

During normal heatup and cooldown operations, reactor coolant temperature changes are controlled at a slower rate than was required for the special heatup test. Although the normal procedures should prevent the temperature from changing more than 100°F in an hour, a memo has been written to the operations personnel stressing that the coolant temperature changes must be watched more closely.

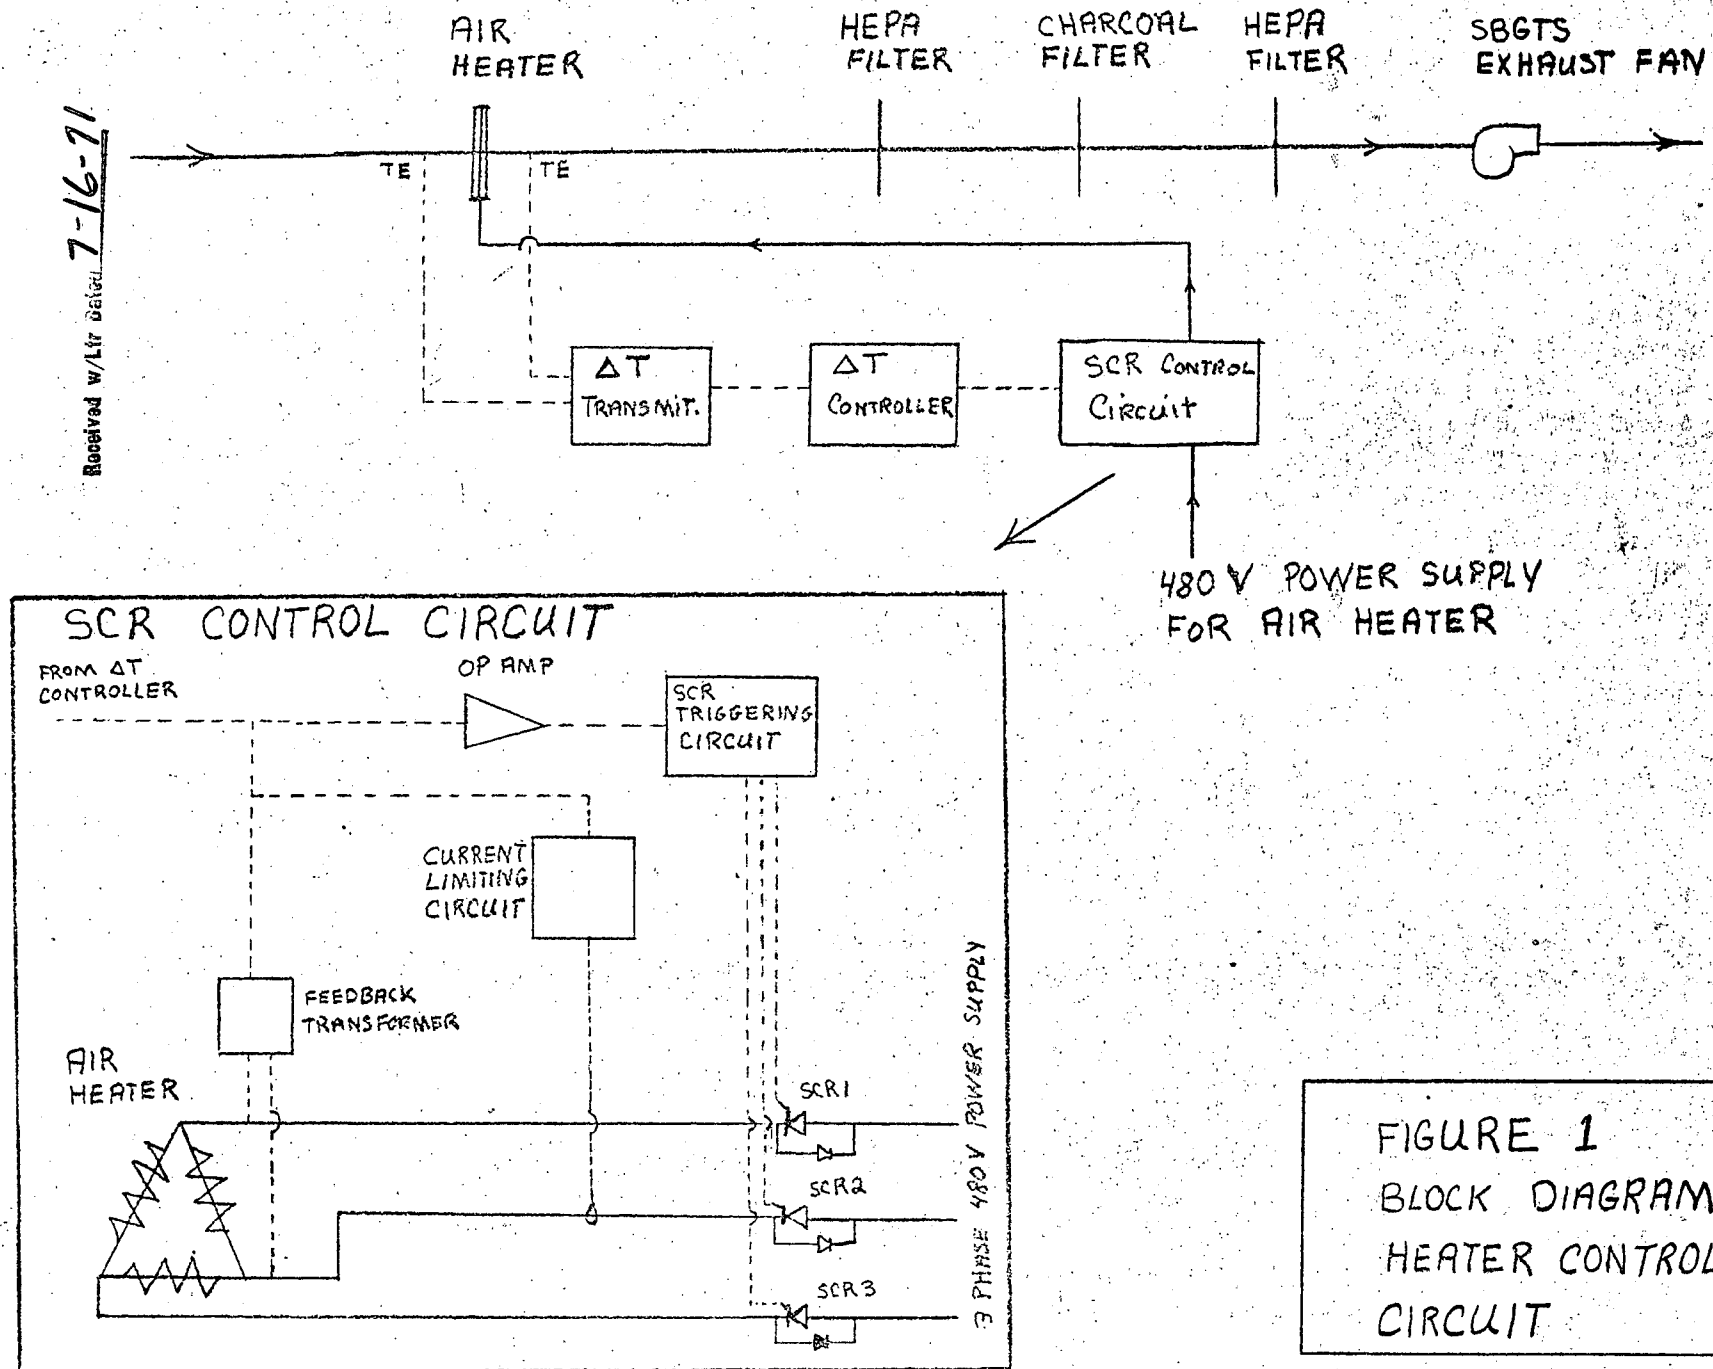
FIGURE 1
BLOCK DIAGRAM OF
HEATER CONTROL
CIRCUIT

Subsequent investigation revealed that a silicon controlled rectifier (SCR #1, shown on attached figure) had developed a leak allowing power to the air heater. The leaking SCR caused overheating of the feedback transformer which in turn damaged the current limiting circuitry and the operational amplifier.

On July 5, 1971, during an operability test of SGTS #11, it was discovered that the differential temperature controller for the air heater would provide only a maximum output signal of 60% even though there was a large deviation from the setpoint. It was also noticed that only a 3°F differential air temperature could be obtained after operation for one-half hour. An examination of the problem revealed that another SCR (SCR #3) had developed a leak causing damage similar to that which occurred on June 19, 1971.

The airheater SCR control circuitry was removed from SGTS #11 and replaced with contactors which energize the electric heaters when the proper minimum flow is detected by an existing flow switch. The system was tested and declared operational on July 9, 1971.

After the July 5th, 1971 occurrence, it was proposed that the entire SGTS #11 air heater control circuit be replaced with contactors which will energize the heaters when minimum SGTS flow is detected. The change to the SGTS was reviewed and approved by the Operations Committee. During the Operations Committee review, it was shown that the SCR control circuit was not necessary and that the contactors would be adequate. Previous testing results show that full heater capacity was required to maintain adequate heating of the incoming gas for the operable range of system flows and that no overheating would occur with full heater capacity at the minimum flow condition. The approved modification to the system was completed on July 9th.
