MONTICELLO NUCLEAR GENERATING PLANT
Docket No. 50-263 License No. DPR-22
Reporting of Operating Occurrence

MONTICELLO NUCLEAR GENERATING PLANT

Unusual Occurrence Report No. 5

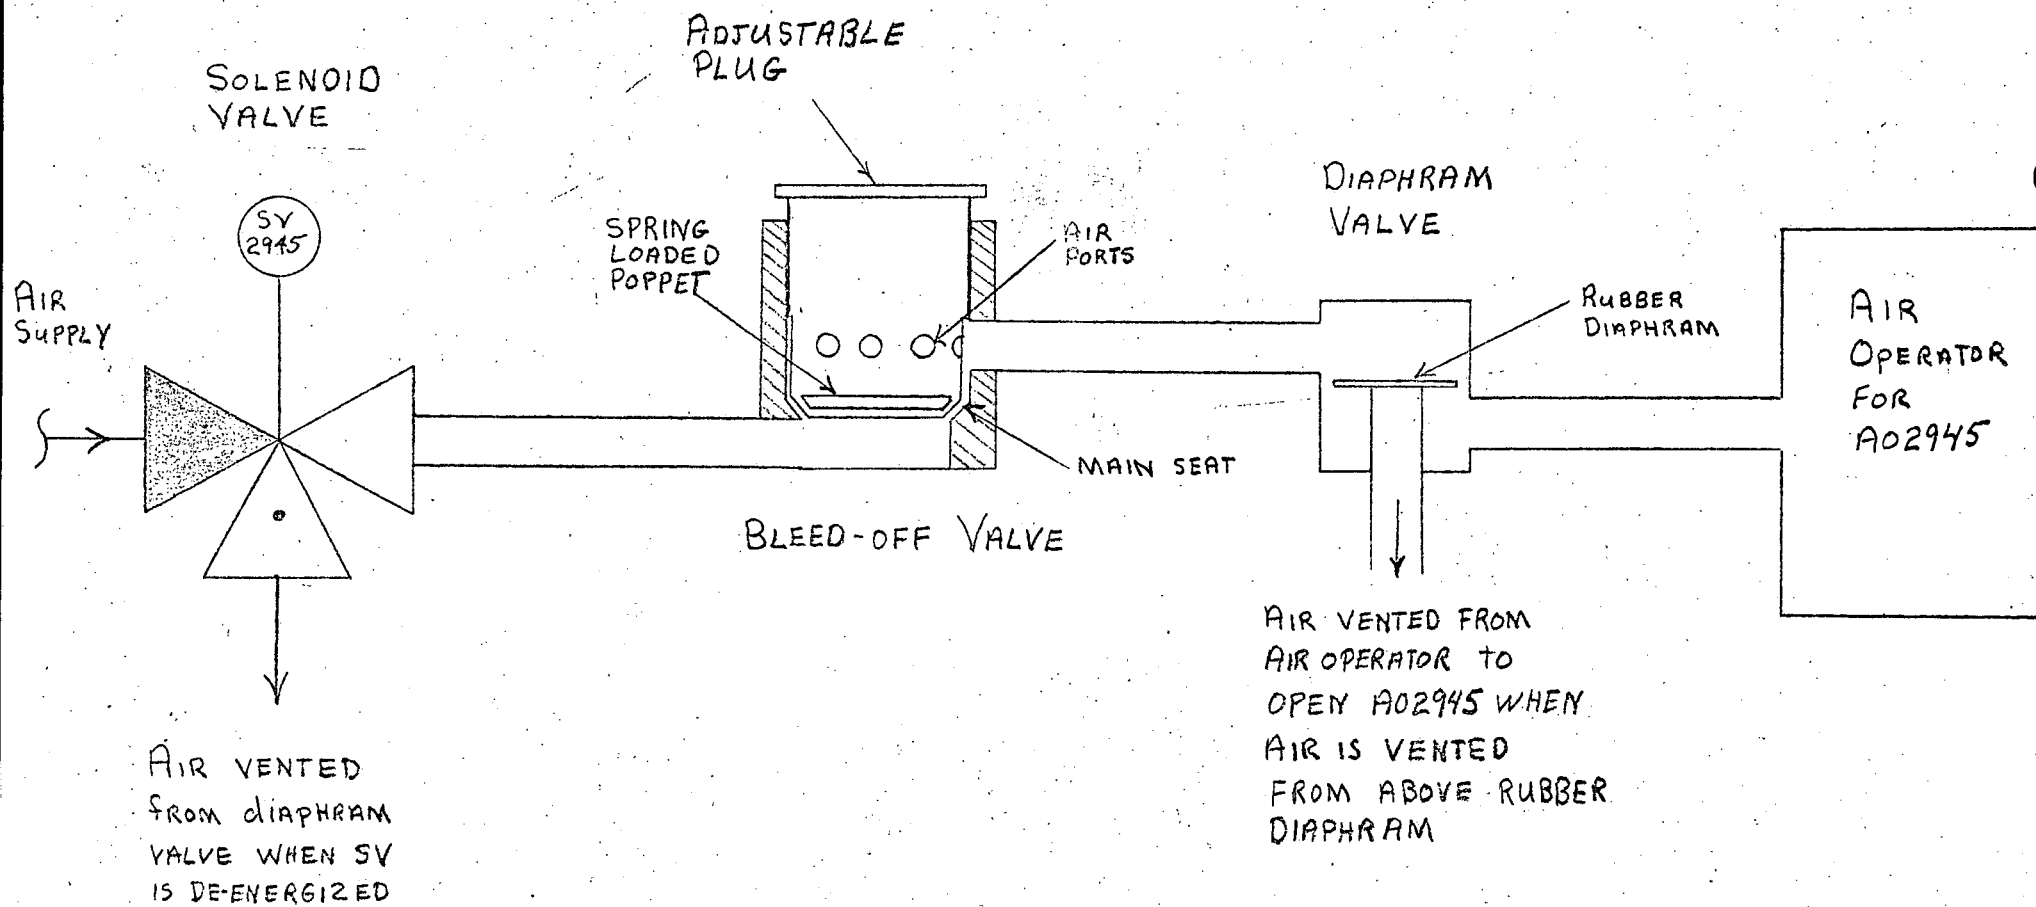
The following brief description of the valve operating mechanisms (refer to attached diagram) will aid in understanding the account and findings of the investigation. When the solenoid valve is energized, air is allowed to pass through the solenoid valve, through the bleed-off valve via the spring loaded poppet and air ports, around the rubber diaphragm of the diaphragm valve and to the air operator, causing the butterfly valve (AO 2945) to close. When the solenoid valve is de-energized, the air supply is interrupted and the air above the rubber diaphragm is vented via the bleed-off valve and the solenoid valve. When air is vented from above the rubber diaphragm, the diaphragm is lifted due to the high pressure below it, allowing the air from the air operator to vent and causing the valve (AO 2945) to open.

It is noted that the air which is vented via the bleed-off valve must do so by passing between the seat of the adjustable plug and the main seat of the valve. The rate of venting is therefore dependent on the setting of the adjustable plug.

Investigation of this occurrence indicated that air operated valve, AO 2945, failed to open due to adjustments made to the bleed-off valve on September 26, 1970. These adjustments were made by Mr. Seedorf under the direction of Mr. Antony in an attempt to quiet AO 2945 which had been excessively noisy when opening. Both SGTS trains were run on September 26th and 27th and they operated properly. It is believed that when the bleed-off valve was adjusted on September 26, the adjustable plug was fully seated. This would normally prevent AO 2945 from opening, however, it is also believed that the teflon tape which was found in the bleed-off valve had prevented the spring loaded poppet from seating, allowing the valve (AO 2945) to open during the operability tests on September 26th and 27th. The teflon tape was apparently blown from the seat of the poppet during operation on September 27th. With the poppet seated and the adjustable plug seated there was no means of venting the air, thus preventing AO 2945 from opening on September 28th. The slowness in opening during subsequent testing is attributed to the valve overtravel condition and the rate of bleed-off.

teflon tape from the bleed-off valve and adjustment of the bleed-off valve to provide for rapid venting. The air operator was also adjusted to prevent overtravel of the butterfly valve. Neolube was applied to the lining of the valve and paint was removed from the valve bushings. The bleed-off valves for AO 2944 (filter train B inlet), AO 2978 (filter train B discharge) and AO 2979 (filter train A discharge) were also disassembled and inspected. A piece of teflon tape was found and removed from the main seat of the bleed-off valve for AO 2978. Neolube was applied to the valve liners and the valves were inspected for overtravel. Overtravel was discovered on AO 2979 and the air operator was adjusted accordingly. The rate of bleed-off for AO 2979 was also increased. All of the valves (AO2944, 2945, 2978 and 2979) were tested and found to operate properly.
