**Subject: June 2011 Inspection Report & Compliance Concerns  
Cameco Resources, Permits 603 & 633**

**PERMITS 603 & 633 INSPECTION REPORT  
JUNE 2011  
DISTRICT 1/LAND QUALITY DIVISION**

**COMPANY:** Cameco Resources Incorporated

**LOCATION:** North of Glenrock, Converse County (Smith-Highland Ranch Uranium Project)

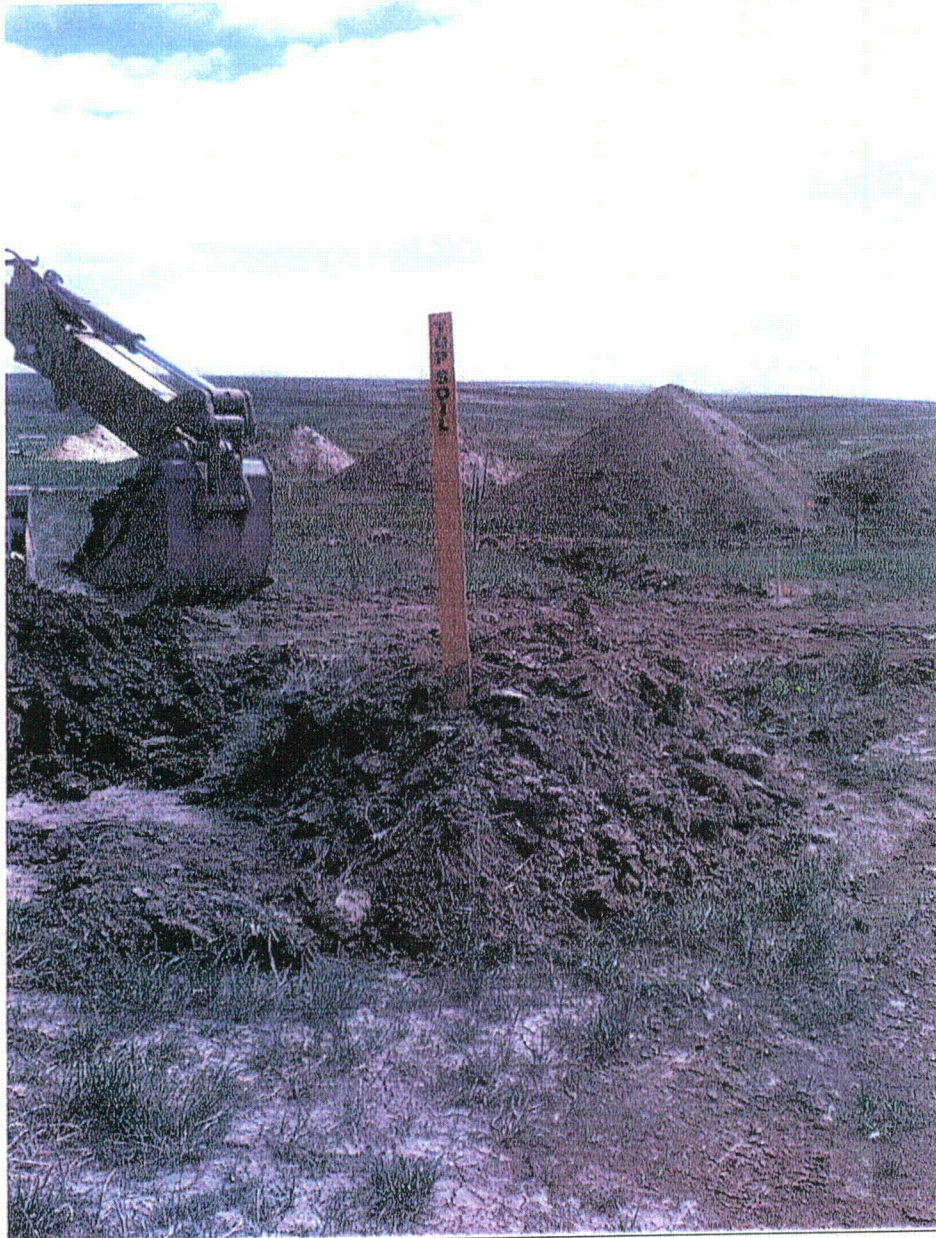
While investigation for abandoned drill holes in the Mine-Unit K North area, numerous deficiencies were observed with erosion and sediment control. A small topsoil pile was noted near hole #3673-19-996 with no sediment control measures (see *Fig. 1*). Steep vertical cuts with no sediment control measures were also encountered in this area (see *Fig. 2*). Sediment was visibly being transported over existing straw wattles (*Fig. 3*) and abandoned silt fence was noted

Figure 1 Unprotected topsoil pile in Mine Unit K North near hole #996

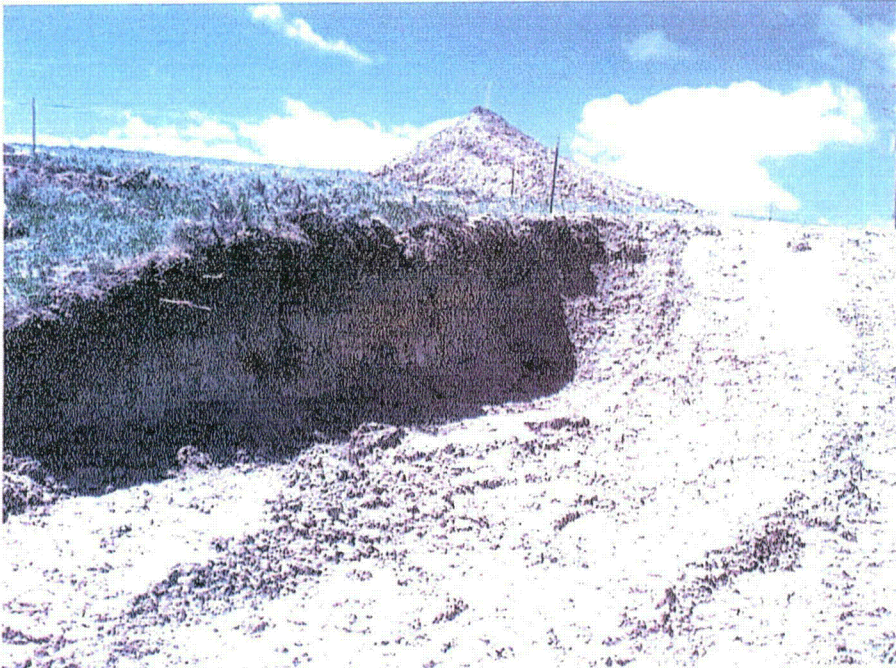
3. Significant deficiency in sediment and erosion control continues to be a very high concern for LQD at the SHRUP mine sites. The lack of sediment control in the Mine Unit K North exploration areas are a repeat violation that LQD has attempted to impress upon the operator as a serious problem on numerous occasions. The inspector encountered instances of sediment washed onto native areas as a result of the mining activities. According the WEQA, § 35-11-415 (b)(viii), "*The operator...shall...prevent, throughout the mining and reclamation operation...the pollution of surface and subsurface waters on the lands affected...*" and according to the Wyoming Land Quality Division Noncoal Rules and Regulations (R&R), Chapter 3, Section 2(c)(i)(A), "*All topsoil or approved surface material shall be removed from all areas to be affected in the permit area prior to these areas being disturbed...*". The disturbance in Mine Unit K North does not include adequate sediment control with significant sediment being deposited on native areas.

Figure 2 Steep cuts with no sediment control in Mine Unit K North

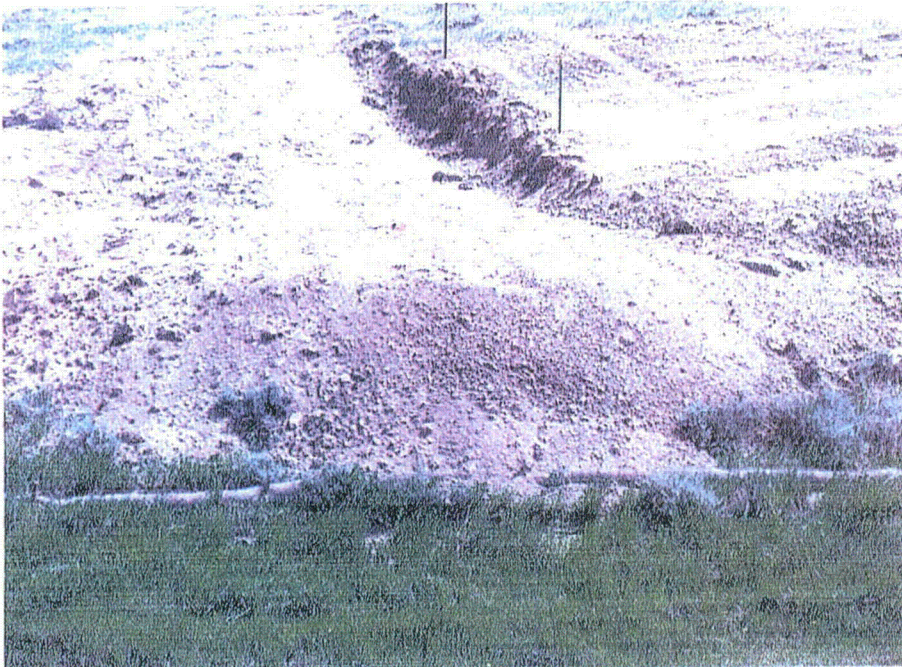
Figure 3 Sediment over-topping straw wattles in Mine Unit K North

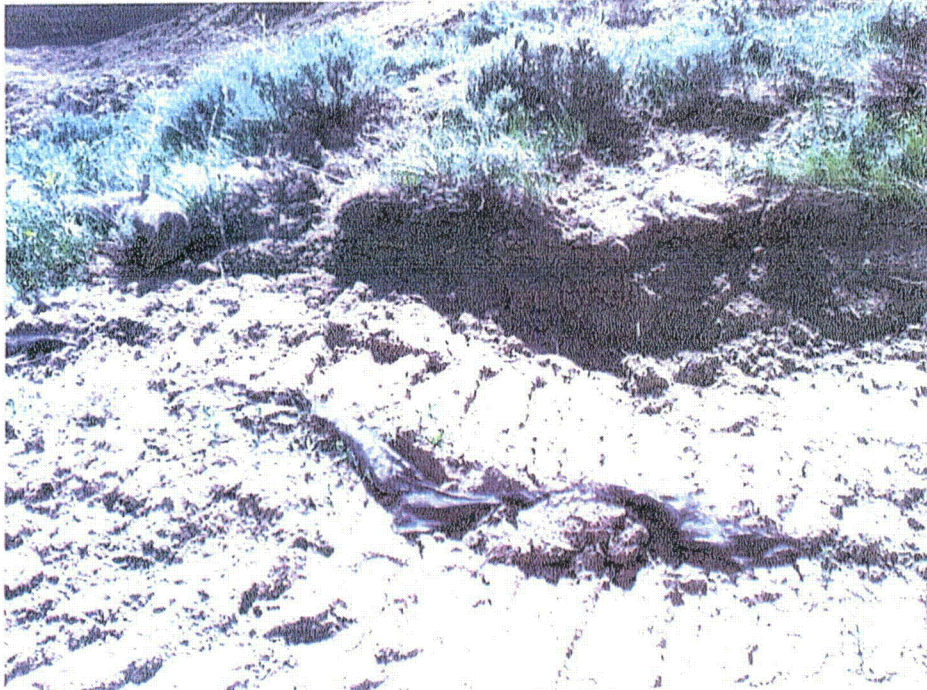
in disrepair (*Fig. 4*). Mine-Unit K North was noted as a very active development area (see *Fig. 5*) and is lacking in adequate erosion and sediment control.

Figure 4 Abandoned silt fence and erosion in Mine Unit K North

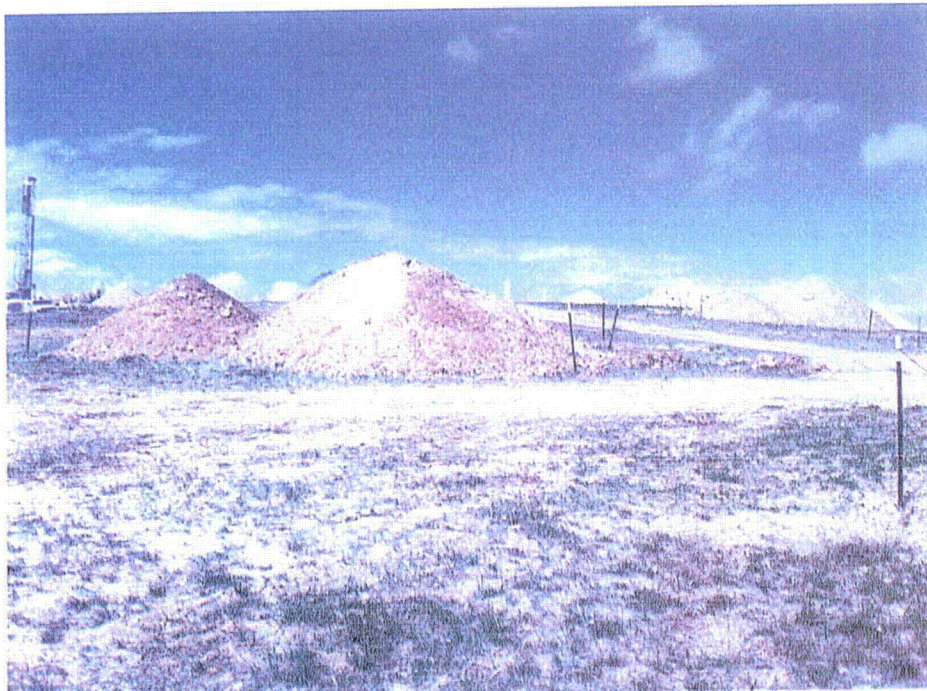
Figure 5 Mine Unit K North Development Activities without downslope erosion control

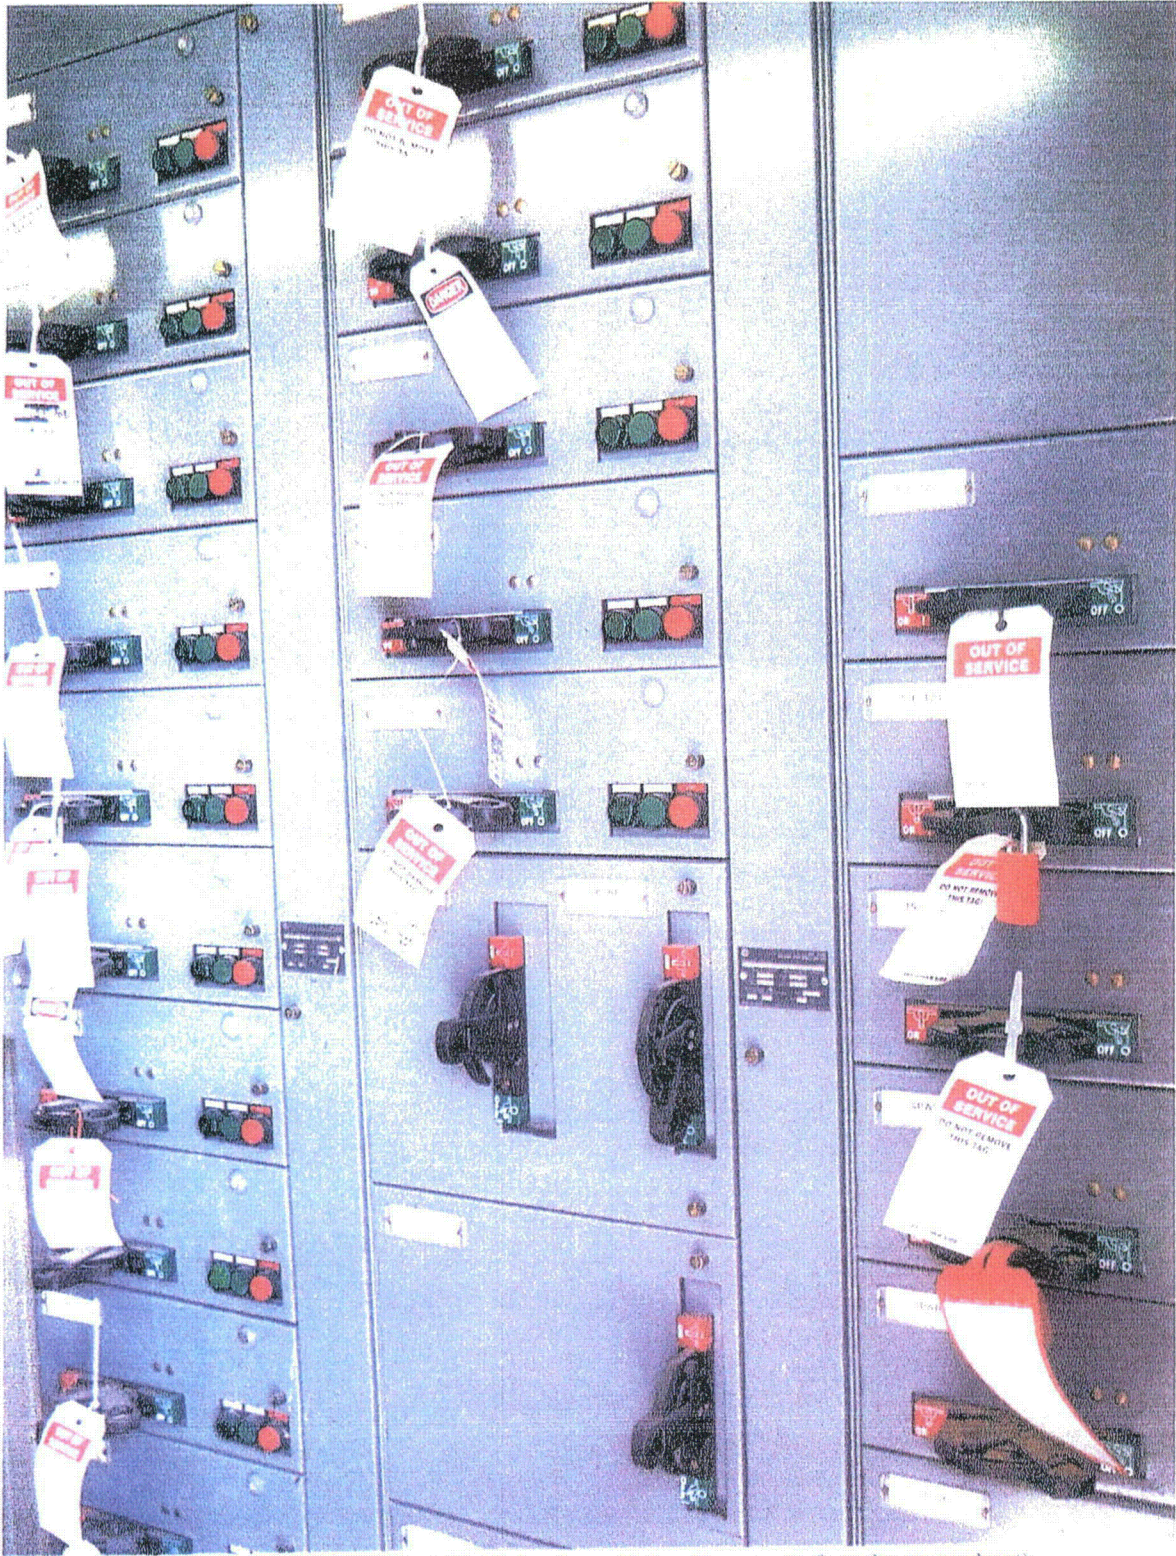
The inspectors noted many wells without caps and open with standing water at depth. Further investigation of the wellfield header houses noted many wells were not in operations as indicated by the tags in the header houses (see *Figs. 15 & 16*). Header houses 15-1, 15-2, 15-3, 15-4, 15-5, and 15-6 were observed with similar findings of few operational wells and low flow rates for production and injection.

- 3673-19-1029
7. MU-15 and MU-H indicate very little production and no evidence of preparing for restoration. The approved permit schedule shows MU-15 beginning groundwater sweep in January 2010. The permit schedule indicates MU-H beginning groundwater sweep in January 2013. Both wellfields have many wells that are not in operations. An inspection of the header houses in each of the wellfields indicates minimal injection or production flows. There is concern that the wellfield reserves have been depleted and have not been moving into restoration. CR will need to provide evidence of sustained production in these wellfields or begin restoration. The LQD may recommend enforcement action for the lack of restoration in these wellfields.

Figure 15 Panel inside a header house in MU-15 showing which wells are out of service (tagged out)

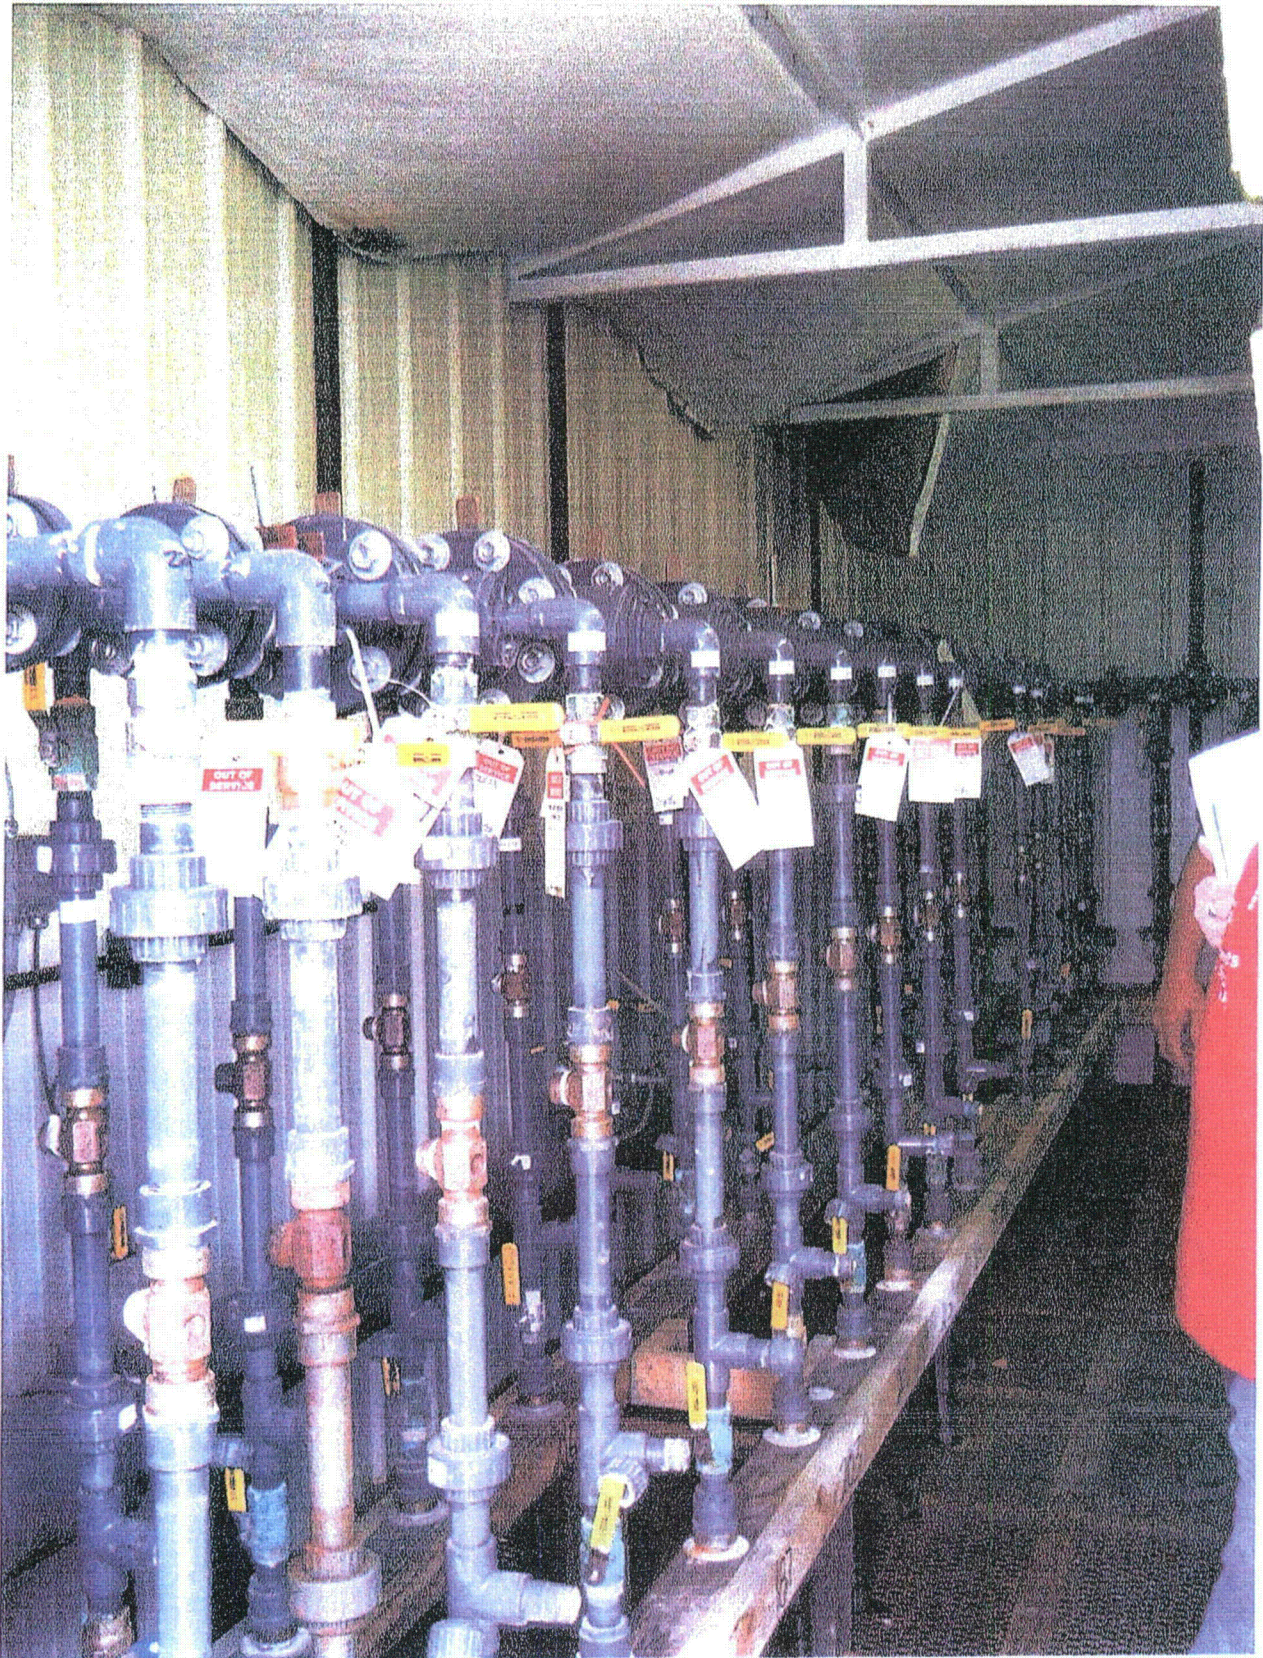
Figure 16 Well pipelines inside header house in MU-15 with many out of service (tagged out)

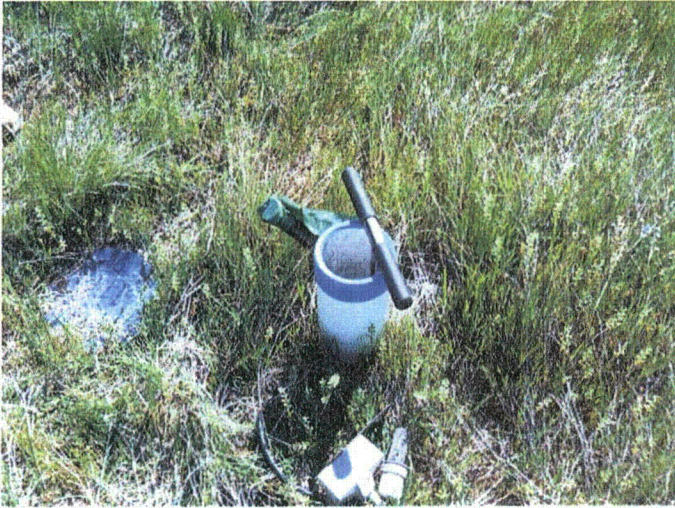
The inspectors noted wells without caps and open with standing water at depth (see *Figs. 17a, 17b and 17c*). Many of these wells did not appear to be operating. Also, the well covers for many of the wells were removed and stacked on the side of the wellfield (see *Fig 18*). Further investigation of the wellfield header houses confirmed that many wells were not in operations as indicated by the tags in the header houses (see *Figs. 19, 20 & 21*). Header houses H-1, H-2, H-3,

Figure 17a Uncapped well in MU-H

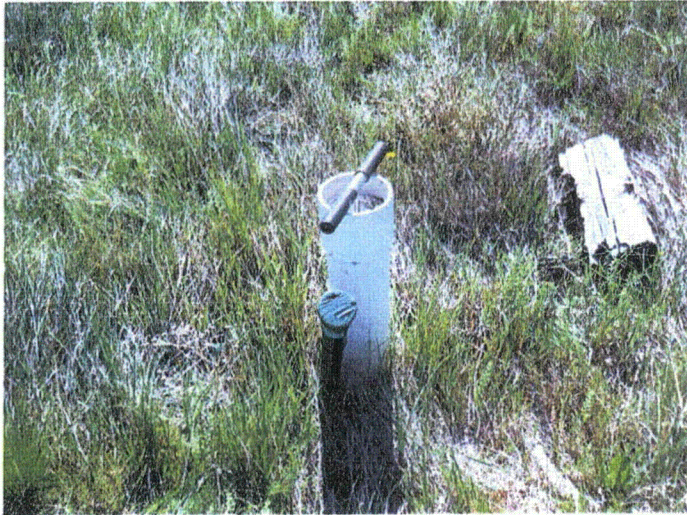
Figure 17b, Uncapped well in MU-H

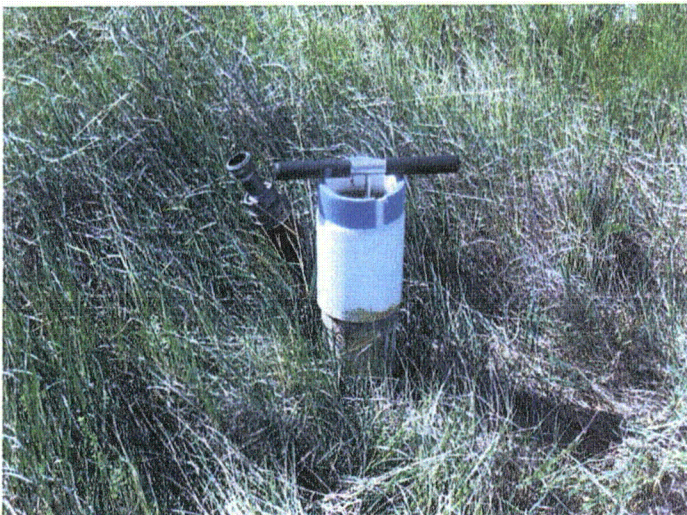
Figure 17c, Uncapped well in MU-H

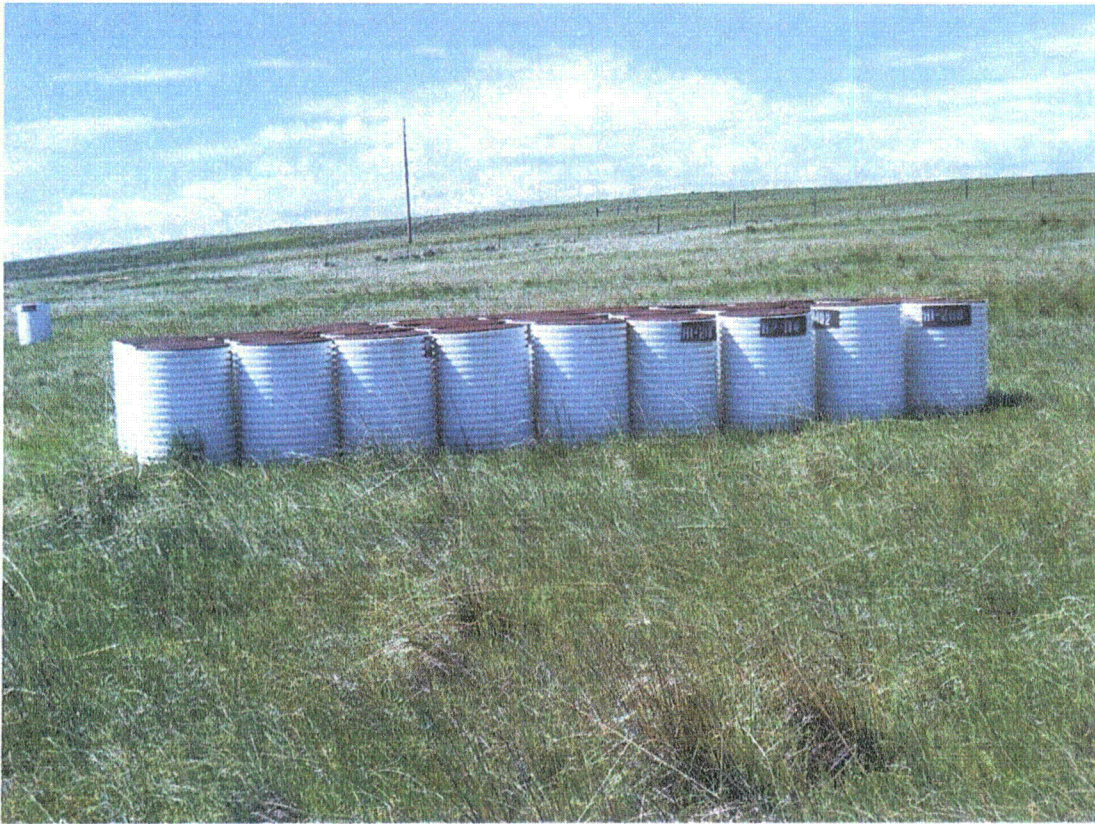
Figure 18 Well covers set along side of wellfield; not over wells

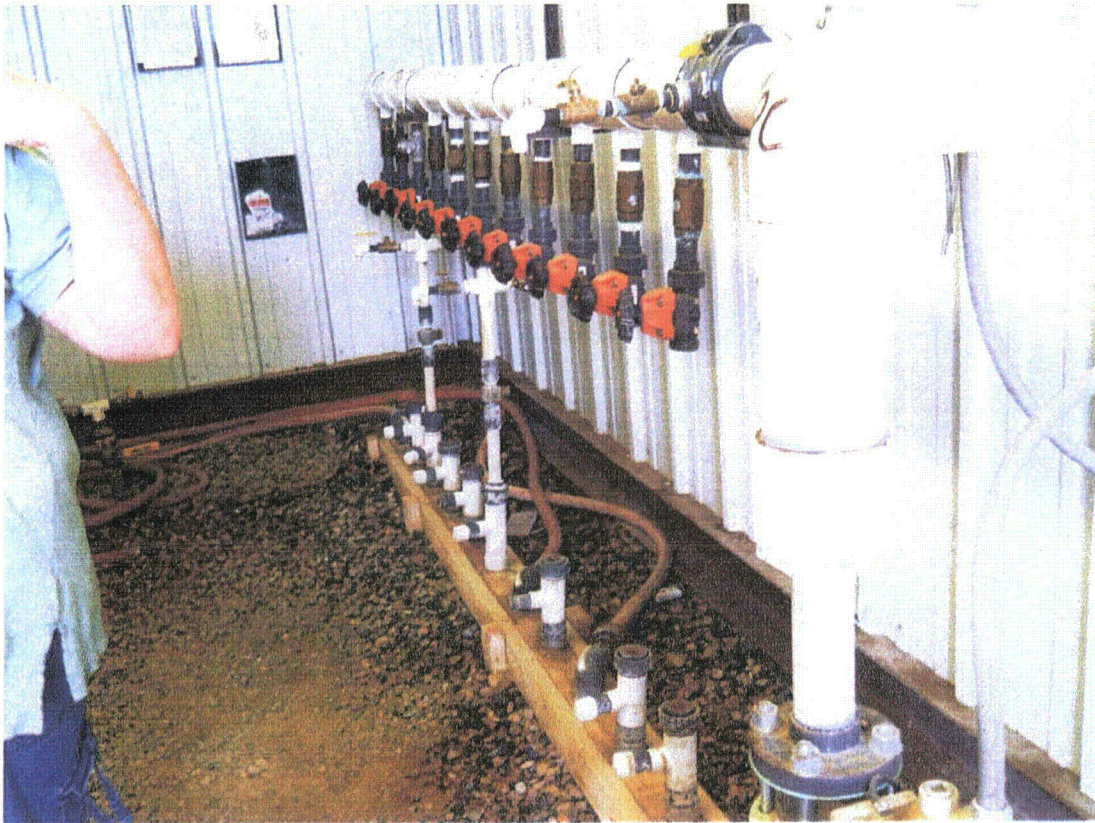
Figure 19 disconnected wells in MU-H header house

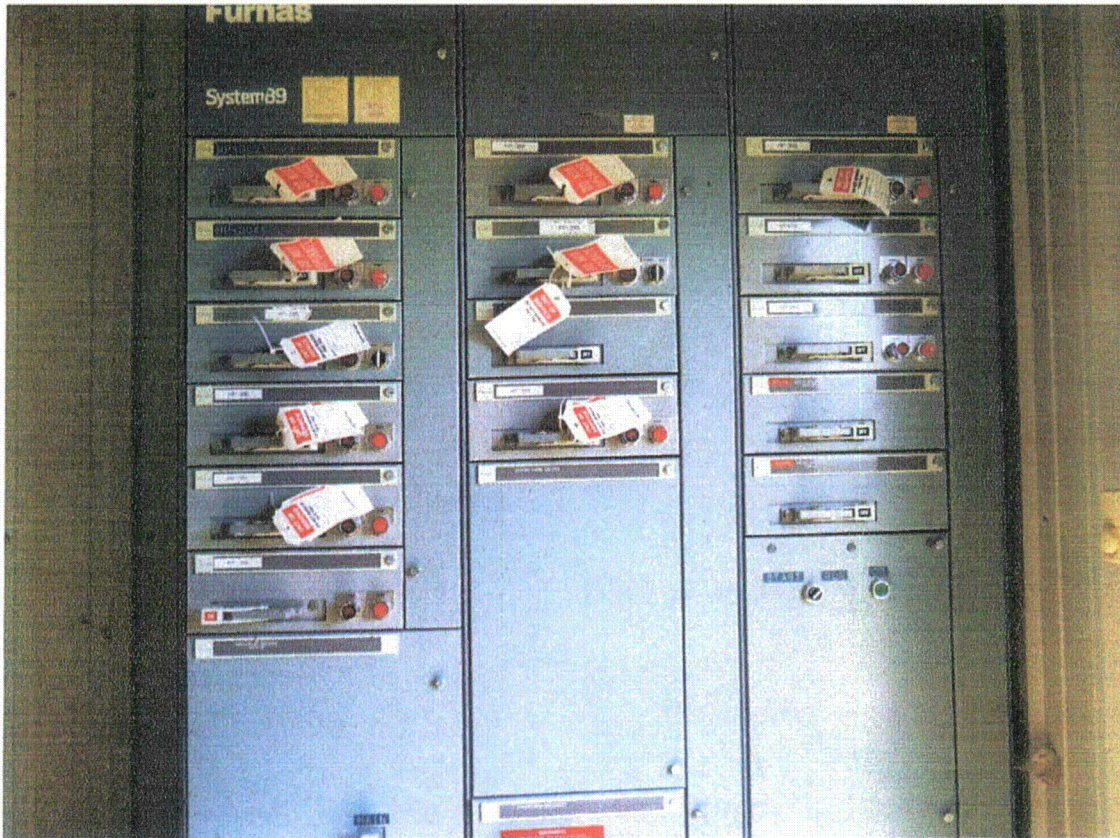
Figure 20 Panel in MU-H header house showing many wells tagged out.

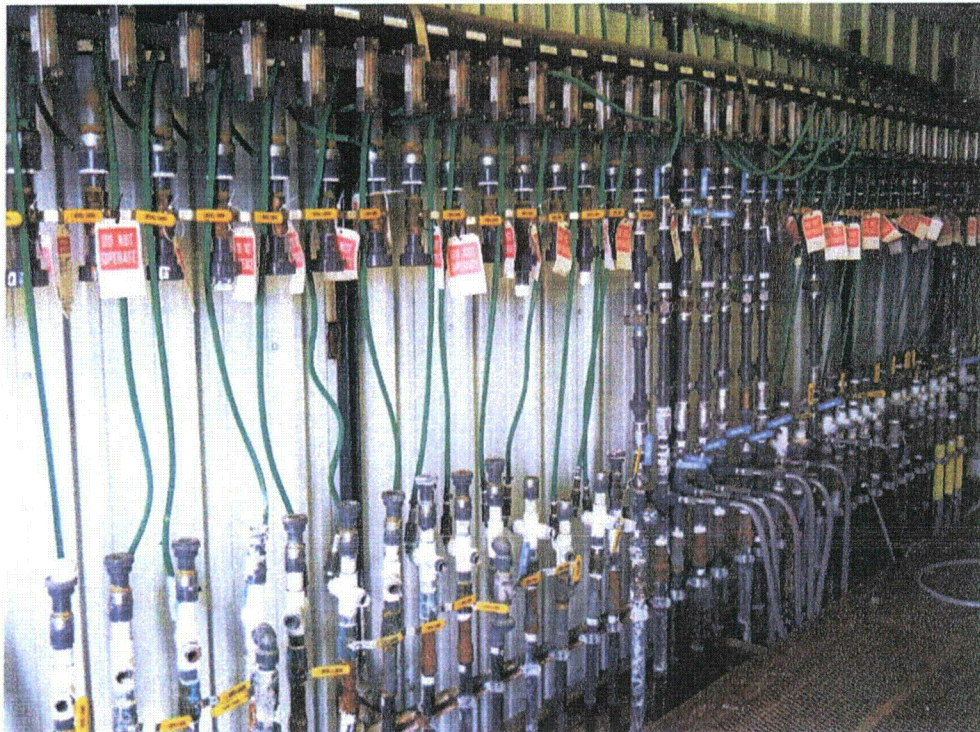
Figure 21 Many wells tagged out in MU-H header house

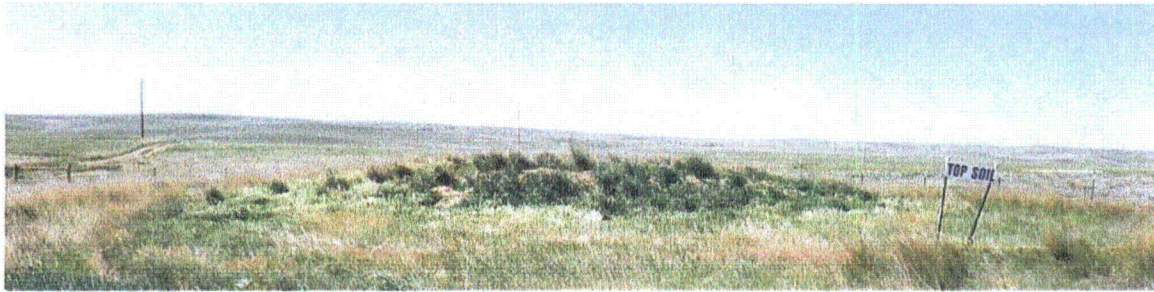
- The condition of some of the topsoil piles in Mine Unit 21 were observed. Two typical topsoil piles were observed. These piles were well vegetated, had a stable containment berm around the pile and were signed (see *Figs. 22 & 23*).
- Various re-seedings and repair areas were also visited. The bell-hole repair in Mine Unit 9 had been re-seeded. It was obvious the newly seeded plants were growing. Another area in Mine Unit 9, a recent re-seeding was also viewed. This area had young grass seedlings coming up in obvious drill seeder rows. Additionally, the K-8 thru K-9 area was viewed. The re-seeding in this area was young but coming along.

Figure 22 Topsoil pile in Mine Unit 21

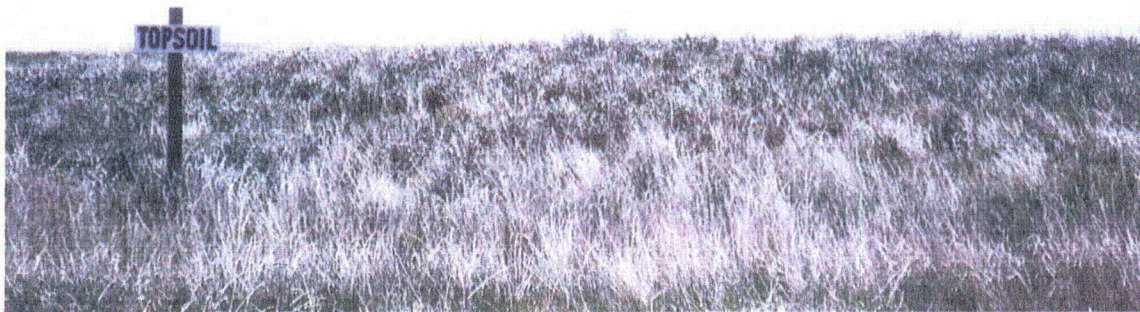
Figure 23 Topsoil pile in Mine Unit 21
