SUBJECT: LER 89-021-01:on 890916,crack on jet pump riser brace due to fatigue.

MONTICELLO NUCLEAR GENERATING PLANT
Docket No. 50-263 License No. DPR-22

Crack on Jet Pump Riser Brace Due to Fatigue

LICENSEE EVENT REPORT (LER)

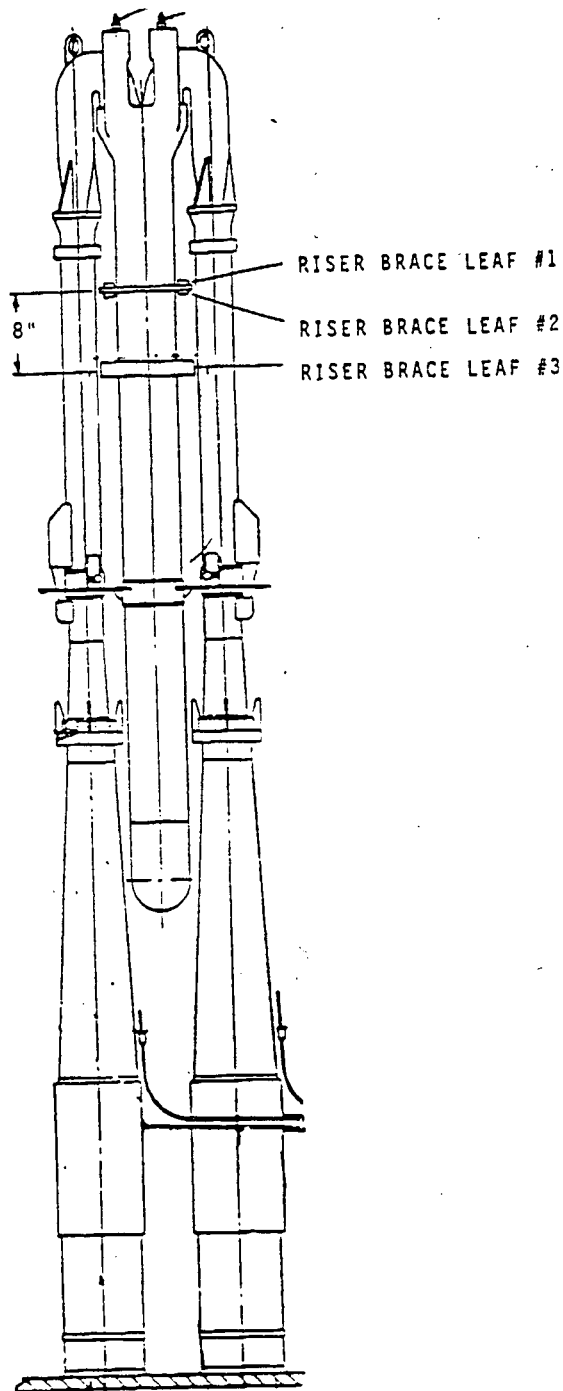
Figure 1. Jet Pump Assembly

The lower riser brace leaf (Leaf #3 in Figure 1) has a calculated natural frequency of 358 Hz, which is well removed from resonant conditions. Therefore resonance is not expected to occur at the lower brace. Evaluation of normal and accident jet pump loading indicates that stresses with only the lower brace in place are within acceptable limits. This shows that the loss of the entire upper brace would not affect the operability of the risers or the associated jet pumps.
