SUBJECT: LER 90-001-01:on 900313,potential emergency filter train sys  
 inoperability due to interaction w/NRE.

MONTICELLO NUCLEAR GENERATING PLANT  
Docket No. 50-263 License No. DPR-22

Supplemental Report - Potential Emergency Filter Train System  
Inoperability Due to Interaction With Non-Safety Related Equipment

TITLE (4) Potential Emergency Filter Train System Inoperability  
Due to Interaction with Non-Safety Related Equipment

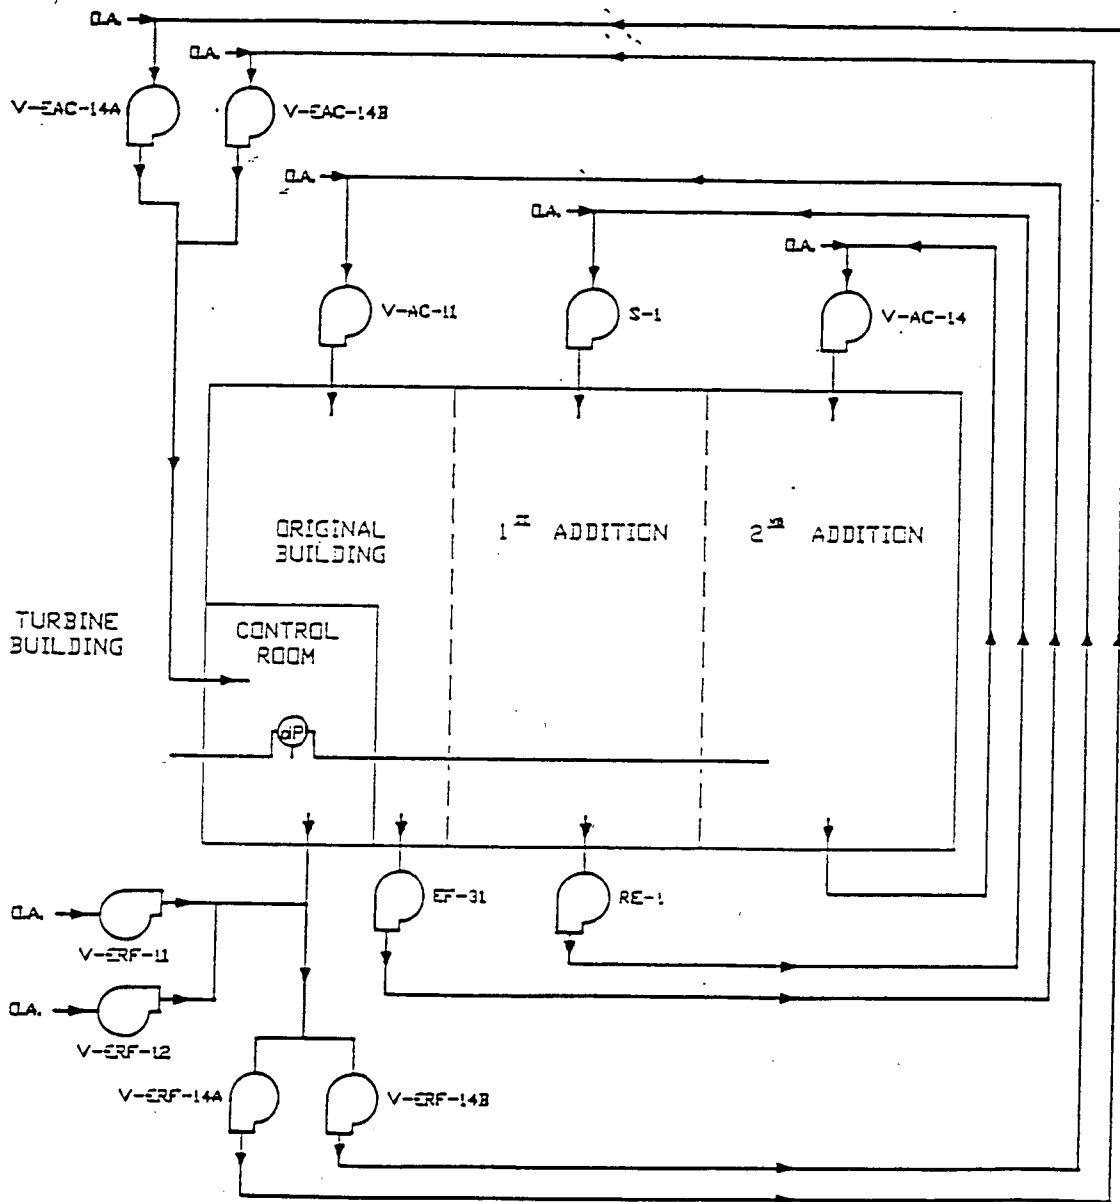
FIGURE 1 SIMPLIFIED ADMINISTRATION BUILDING VENTILATION

On March 30, 1990 during subsequent investigation of the Emergency Filter Train system design, engineers determined that administration building ventilation supply units V-AC-11 and S-1 (see Figure 1, Simplified Administration Building Ventilation system drawing), may not trip in the event of an Emergency Filter Train High Radiation Mode automatic initiation. The trip signal for these ventilation units is initiated by a single Non-Safety Related relay and associated Non-Safety Related switchgear. This is contrary to the design basis for the Emergency Filter Train system which requires all equipment related to Control Room habitability to be single failure proof and Safety Grade. Failure of these ventilation units to trip during a High Radiation event could potentially pressurize the Administration Building and degrade the Emergency Filter Train's ability to maintain a positive differential pressure between the Control Room and the Administration

The Emergency Filter Train was installed in response to the Three Mile Island Action Plan. The system was designed to enhance Control Room habitability following a Loss of Coolant event. During the final stages of the Emergency Filter Train construction, a second addition to the plant Administration Building was constructed (see Figure 1). The potential for the second Administration Building addition's Non-Safety Related ventilation system
