SUBJECT: LER 89-040-01:on 891219,failure to meet secondary  
 containment performance requirements due to design defects.

MONTICELLO NUCLEAR GENERATING PLANT  
Docket No. 50-263 License No. DPR-22

Failure to Meet Secondary Containment Performance  
Requirements Due to Design Deficiencies

## LICENSEE EVENT REPORT (LER)

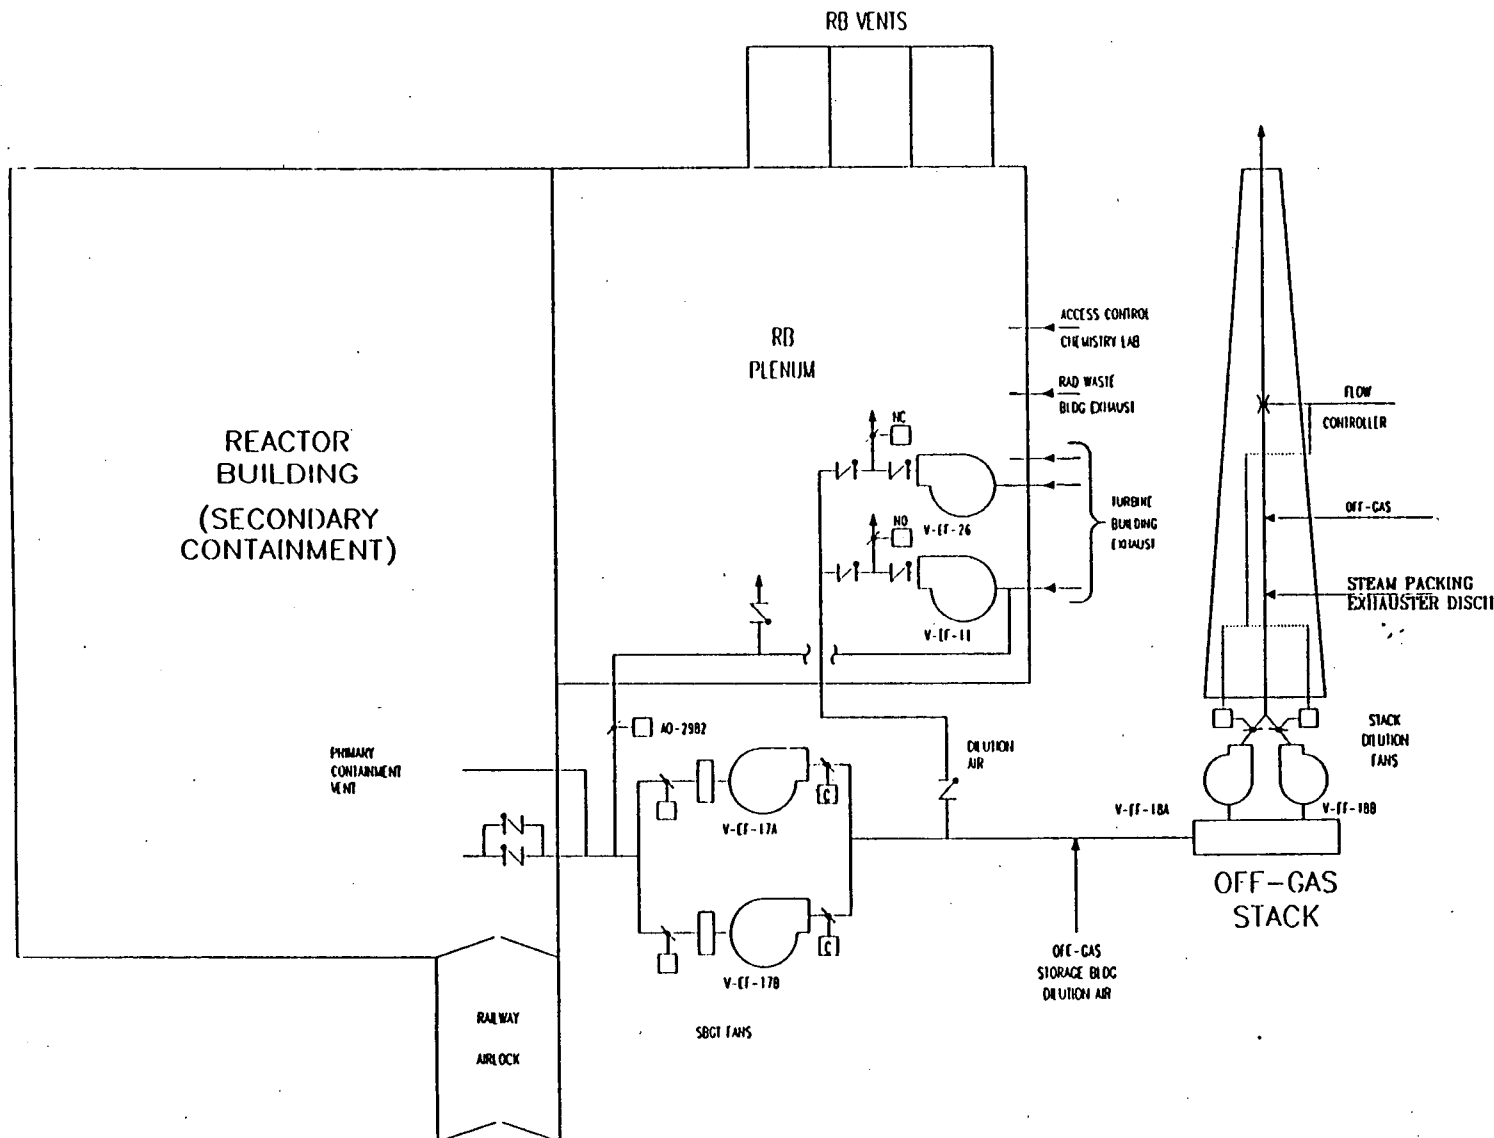
# REACTOR BUILDING VENTILATION SYSTEM

The root cause of this event was design inadequacy. The original design resulted in a condition where normal operation of Non-Safety Related equipment (i.e. Steam Packing Exhauster blowers (K-3A, K-3B) (EIIS Component Code: FAN)) could adversely affect a Safety Related system (i.e. Standby Gas Treatment).

The maximum flow through Standby Gas Treatment that could be achieved during the test was 3500 CFM which produced only a 0.22 to 0.23 inches water vacuum within Secondary Containment. Investigation of the operation of Standby Gas Treatment revealed that, during Secondary Containment isolation conditions with the reactor at power and without a loss of offsite power, Standby Gas Treatment system flow was being limited by flow to the Offgas Stack from the Steam Packing Exhauster discharge (See Figure 1.) Steam Packing Exhauster flow injects into the Offgas Stack after the discharge of the Offgas Dilution Fans (V-EF-18A, V-EF-18B) (EIIS Component Code: FAN) and before the flow sensors (SPS 8000-H1, SPS 8000-H2) (EIIS Component Code: TC) which are used to control the flow through the dilution fans. This causes a reduction in flow through the Dilution Fans and Standby Gas Treatment Fans (V-EF-17A, V-EF-17B) (EIIS Component Code: FAN). This condition may then prevent the achievement of the 0.25 inches water vacuum required within Secondary Containment.

It was determined that a failure of either of two discharge dampers (EIIS Component Code: DMP) for the Turbine Building exhaust fans (V-EF-11 or V-EF-26) (EIIS Component Code: FAN) could lead to higher back pressure in the Standby Gas Treatment discharge line and likewise prevent Standby Gas Treatment from achieving full rated flow. These fans run in parallel to supply 50% of the dilution flow during normal operation. During a Secondary Containment isolation, dampers on the discharge of these fans open to release their discharge to the Reactor Building Plenum Room. However, either of the discharge dampers could stick in a closed position and the respective fan would continue to discharge to the dilution fans. This flow could create a back pressure on the running Standby Gas Treatment fan and limit its flow.

It was also determined that failure of Primary Containment Exhaust to Plenum isolation valve (AO-2982) (EIIIS Component Code: ISV) in the open position during a Secondary Containment Isolation would allow the Standby Gas Treatment fans to draw on the Reactor Building Exhaust Plenum Room instead of the Reactor Building. Therefore, Standby Gas Treatment would not be able to maintain the required vacuum within Secondary Containment.

1. An administrative hold was placed on AO-2982 to secure it in the closed position when Standby Gas Treatment is required to be operable.
2. Operating procedures were revised to require tripping the Turbine Building Exhaust Fans and tripping the Steam Packing Exhauster blowers after an initiation of Standby Gas Treatment and isolation of Secondary Containment which was caused by a radioactive release from within Secondary Containment.
