MONTICELLO NUCLEAR GENERATING PLANT
Docket No. 50-263 License No. DPR-22

Personnel Error Causes 4KV Electrical Fault Resulting
in Automatic Start of Diesel Generator

LICENSEE EVENT REPORT (LER)

Personnel Error Causes 4KV Electrical Fault Resulting in Automatic Start of Diesel Generator

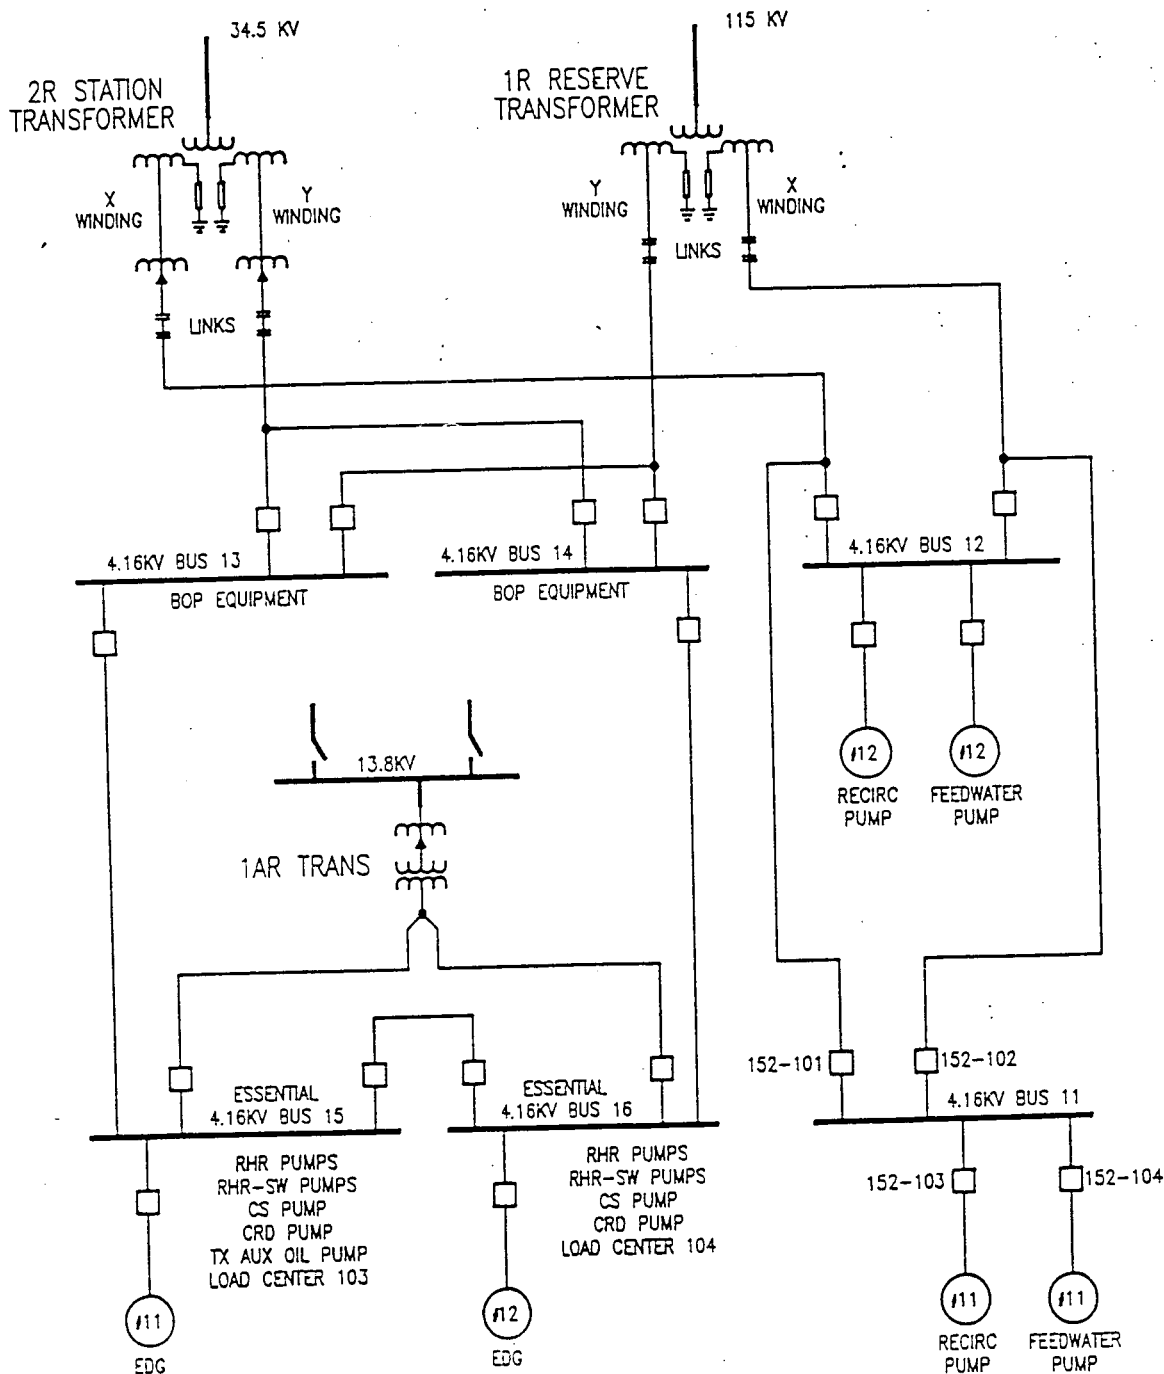
One journeyman technician and one apprentice technician were assigned the task of double testing buses 11, 13 and 15. Bus 11 consists of two source breakers and two load breakers (see attached figure). The two source breakers, 152-101 and 152-102, provide power to the bus from either 2R or 1R Station Transformer respectively. The two load breakers, 152-103 and 152-104, provide power to 11 recirculation pump and 11 feedwater pump respectively. At the time of the event, bus 11 was deenergized with all breakers open and 1R Station Transformer was deenergized. All stabs in breakers 152-102, 152-103 and 152-104 were deenergized. Breaker 152-101 had a set of stabs energized because 2R was energized to supply plant power. The buses were properly isolated and the isolation had been reviewed with the technicians the morning of the event.

The technicians had completed double testing on buses 13 and 15. To double test bus 11, the test equipment had been setup in breaker 152-104 (11 feedwater pump). In each 4160 Volt breaker cubicle there are two sets of stabs. One set of stabs are connected to the bus and the other set are either connected to the load or to the source depending on the function of the breaker. It is a common practice when double testing a bus to check continuity between the stabs of two breaker cubicles to positively determine which stabs are connected to the bus (top or bottom stabs). In doing this continuity check, the technicians mistakenly selected a source breaker cubicle containing energized stabs from 2R Station Transformer. The breaker cubicle 152-101 (2R Source) had a breaker in the cubicle in the disconnect position. The journeyman technician removed the breaker and entered the cubicle to do the continuity check without first checking to ensure the 4160 Volt stabs were deenergized per recommended safety practices.
