MONTICELLO NUCLEAR GENERATING PLANT
Docket No. 50-263 License No. DPR-22

Potential Emergency Filter Train System Inoperability
Due to Interaction with Non-Safety Related Equipment

LICENSEE EVENT REPORT (LER)

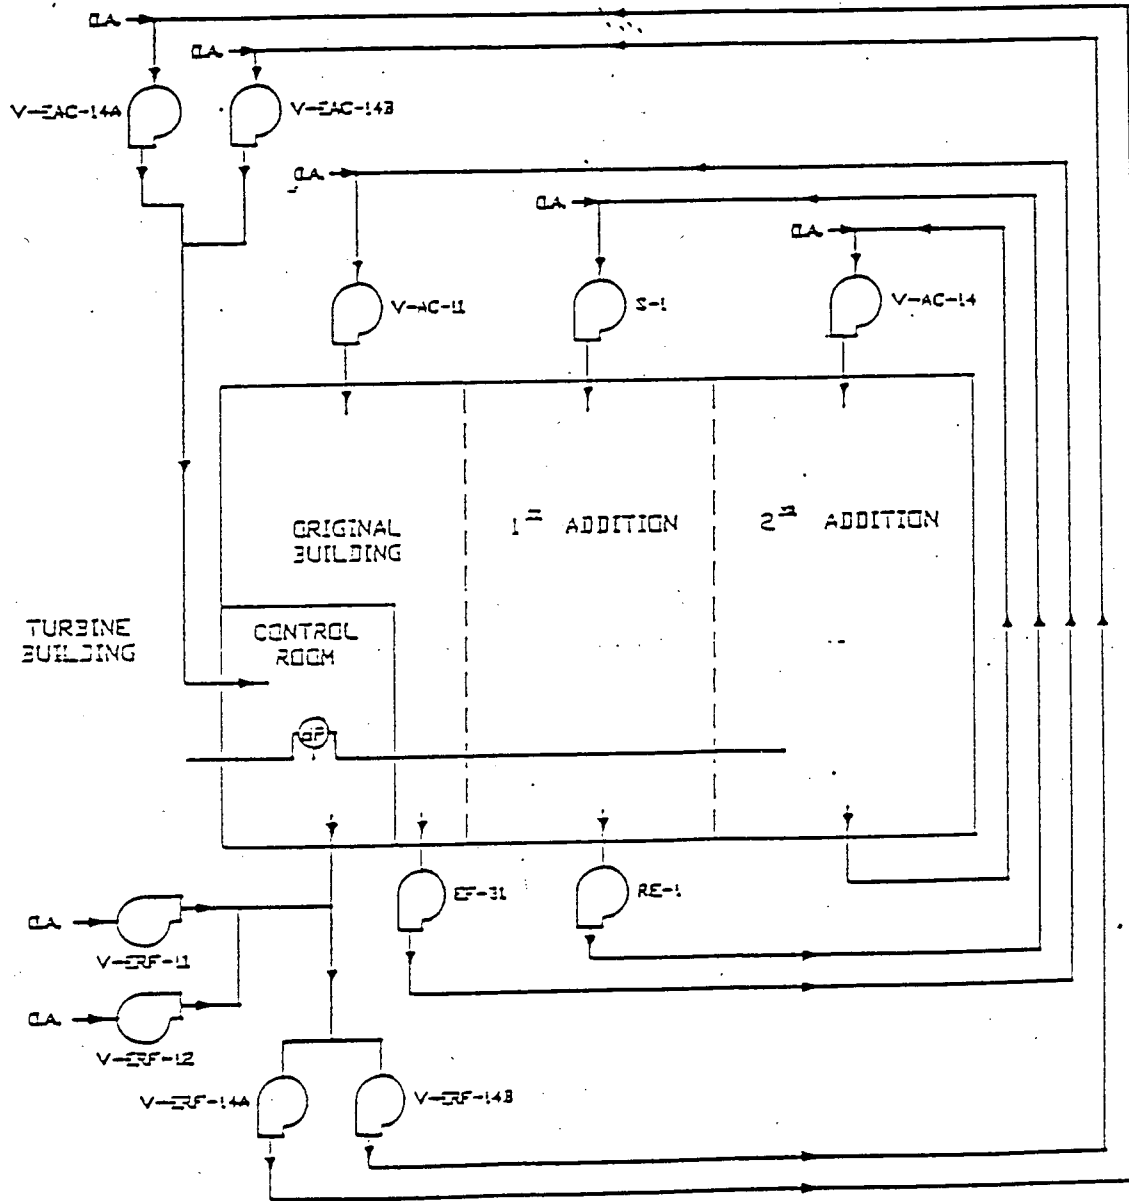
FIGURE 1 SIMPLIFIED ADMINISTRATION BUILDING VENTILATION

On March 30, 1990 during subsequent investigation of the Emergency Filter Train system design, engineers determined that administration building ventilation supply units V-AC-11 and S-1 (see Figure 1, Simplified Administration Building Ventilation system drawing), may not trip in the event of an Emergency Filter Train High Radiation Mode automatic initiation. The signal for these ventilation units is initiated by a single Non-Safety Related relay and associated Non-Safety Related switchgear. This is contrary to the design basis for the Emergency Filter Train system which requires all equipment related to Control Room habitability to be single failure proof and Safety Grade. Failure of these ventilation units to trip during a High Radiation event could potentially pressurize the Administration Building and degrade the Emergency Filter Train's ability to maintain a positive differential pressure between the Control Room and the Administration Building. The ventilation units were immediately tripped and secured to ensure Emergency Filter Train operability.
