SRNL-ESB-2008-00017

Re: Video Survey of Saltstone Vault 4, Cell G

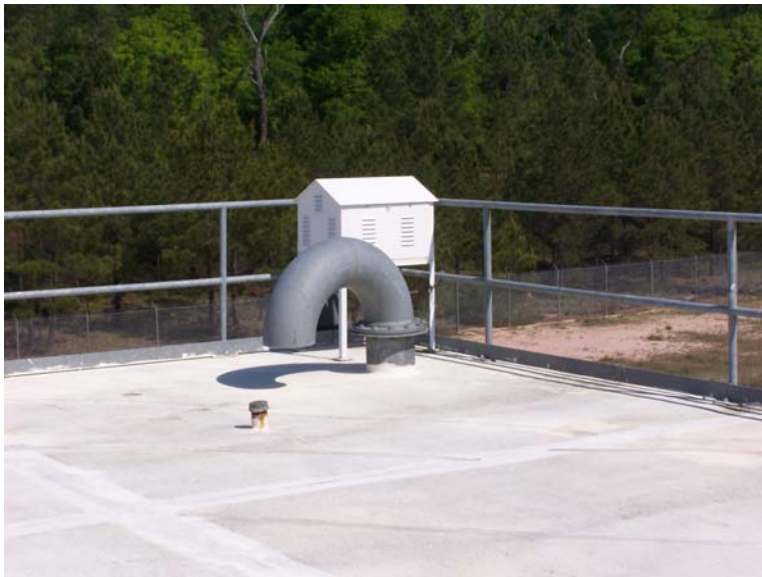
Figure 2. Twelve inch diameter pipe vent located near the north corner of Saltstone Vault #4 Cell G. The pipe elbow was removed to provide an access point for lowering the remote controlled camera.

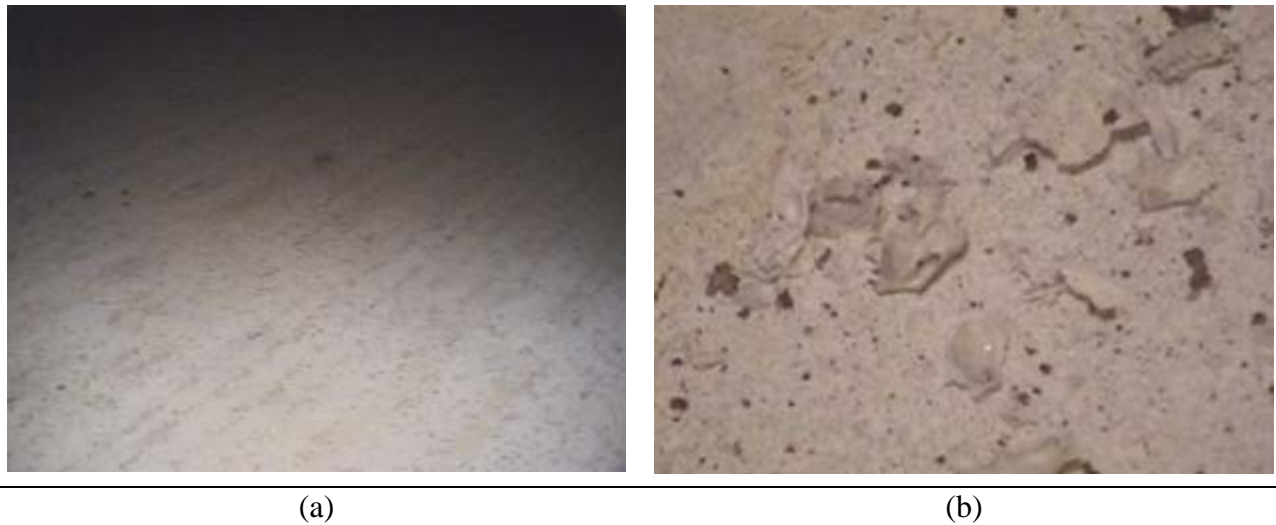
A five minute long video was made of the interior of Vault #4, Cell G. From this video, several still images were captured and are presented in Figures 3 through 5. These images provide a basis to qualitatively assess the surface condition of the saltstone waste including any observed cracking. Figure 3a provides a general view of the saltstone waste surface as seen from the north corner of Cell G. Figure 3b provides a close-up view of the saltstone waste surface. The surface of the saltstone waste appears to be relatively free of large scale cracking. Figure 4a shows a large aperture crack emanating from the north corner of Cell G. This crack propagates out from the corner at approximately a 45 degree angle and appears to extend entirely across the cell. The smaller aperture crack in Figure 4b is oriented perpendicular to the crack in Figure 4a and appears to extend a short distance from the main crack. Figure 5a shows the north corner of Cell G. This image shows that the crack observed in Figure 4a extends to the corner of the cell. The north wall of Cell G is shown in Figure 5b. There is no obvious separation between the vault wall and saltstone associated with shrinkage of the saltstone grout (Figure 5a and b).

Figure 3. General view (a) and close-up view (b) of saltstone waste surface as seen from the north corner of Cell G.

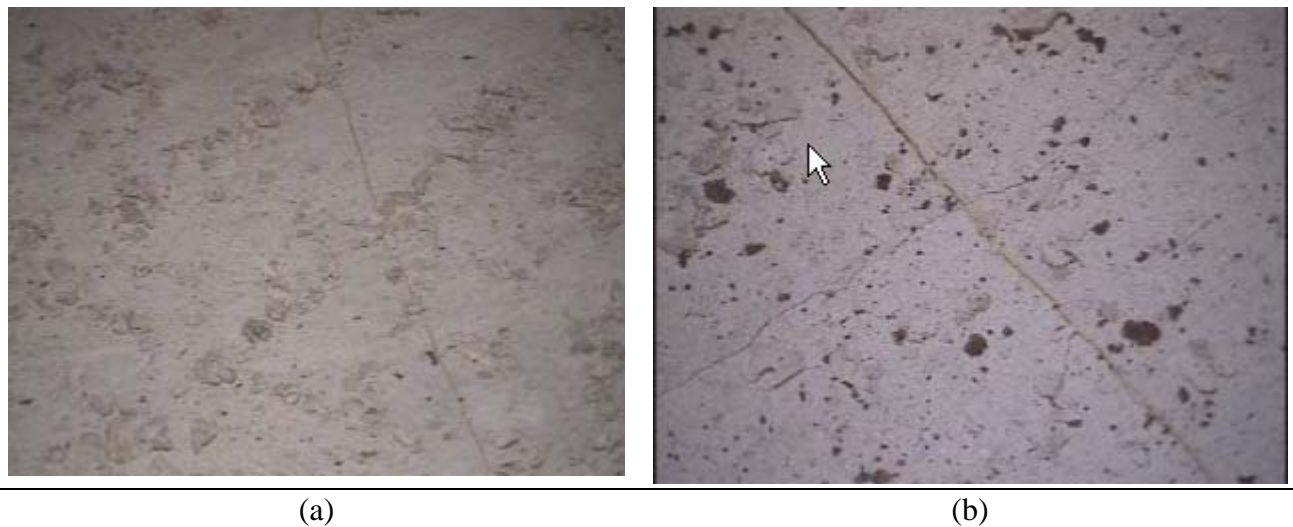
The results of the video survey show that there is some cracking in the saltstone grout, but it is not considered to be extensive. The survey was limited by the zoom capability of the PTZ camera and the view accessible from the north corner of Cell G. It is possible to obtain better quality video and still images over a larger area by using a remote controlled vehicle equipped with a high resolution camera. The surface of the saltstone grout appears to be smooth enough to accommodate a rubber tracked vehicle for this type of survey. Access to the saltstone waste surface could be obtained via an access point similar to the one shown in Figure 6. It should be noted that any vehicle placed on the surface of the saltstone grout would be considered contaminated and would not be released for general non-radioactive use.

Figure 4. Crack in saltstone waste surface emanating from the north corner of Cell G (a) and smaller aperture crack oriented perpendicular to it (b). The larger aperture crack propagates out from the corner at approximately a 45 degree angle and appears to extend entirely across the cell. The smaller aperture crack appears to only extend a short distance from the main crack.

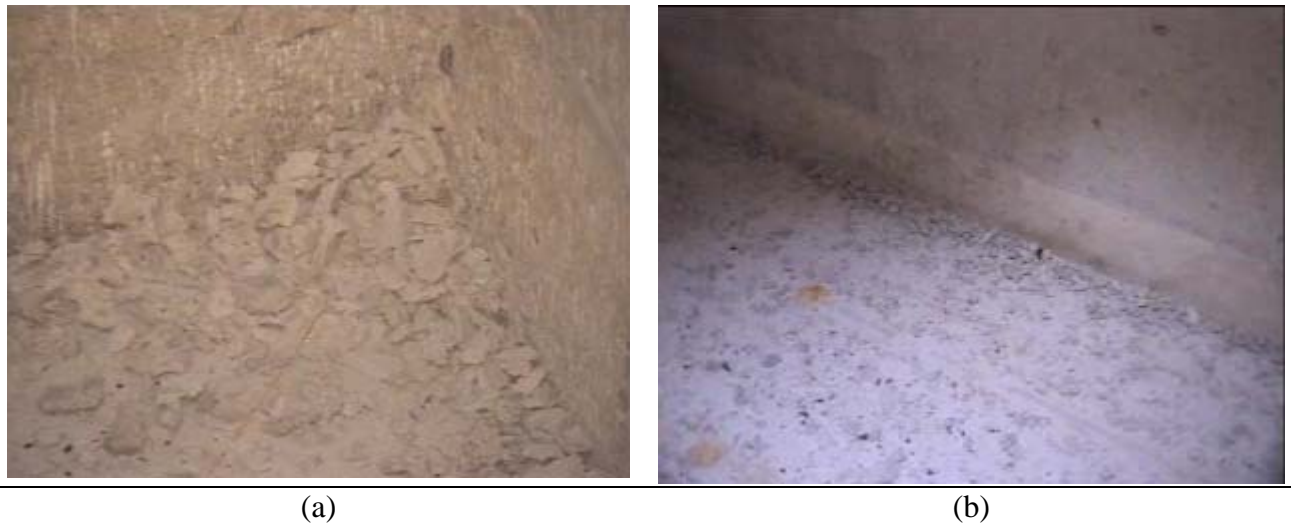
Figure 5. Close-up view of the north corner (a) and east wall of Cell G (b). There appears to be no separation of the saltstone from the vault wall along the edge of the walls in Cell G.

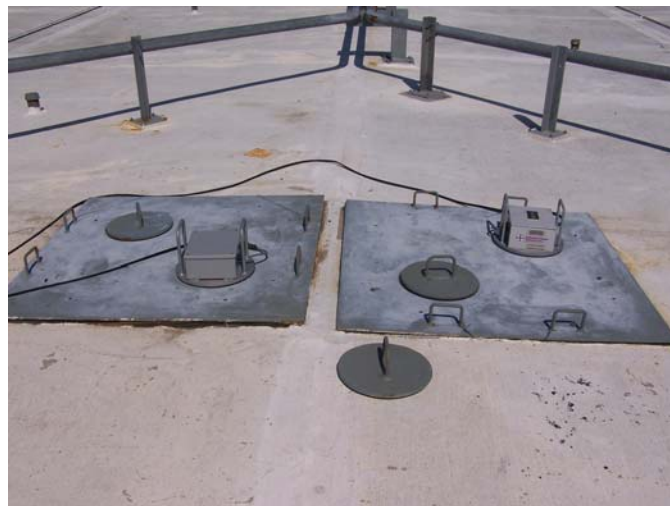
Figure 6. Access ports that could be used to lower a remote controlled vehicle for closer inspection of cracking in the saltstone surface.
