# **Saltstone Disposal Facility Vault 4 Video Inspection Summary**

**July 2011**

Prepared by: Savannah River Remediation LLC  
Closure & Waste Disposal Authority  
Aiken, SC 29808

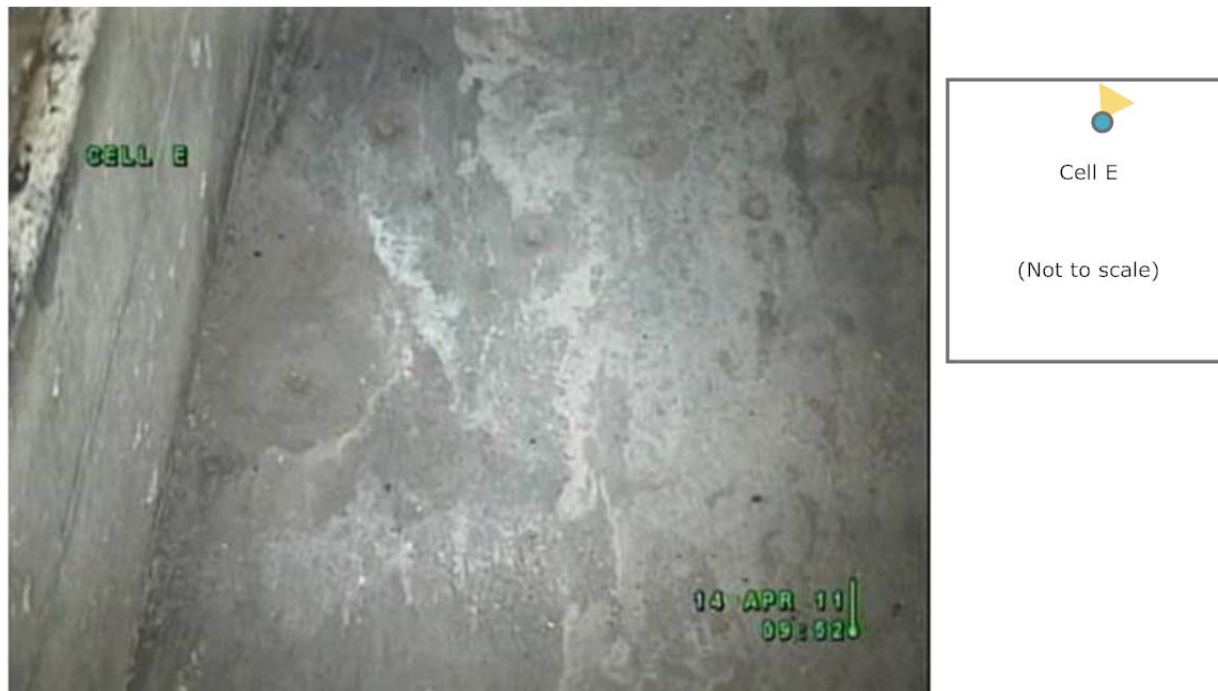
**Figure 3.1-1: Cell E, East Wall Interface**

Shrinkage of the saltstone monolith from the vault walls and columns could provide fast-flow paths for water in the long-term predictions made by the PA. Such shrinkage was not observed in Cells C, D, E, F, G, I, or K. Figure 3.1-1 shows a representative grout-wall interface, in this case one from Cell E.

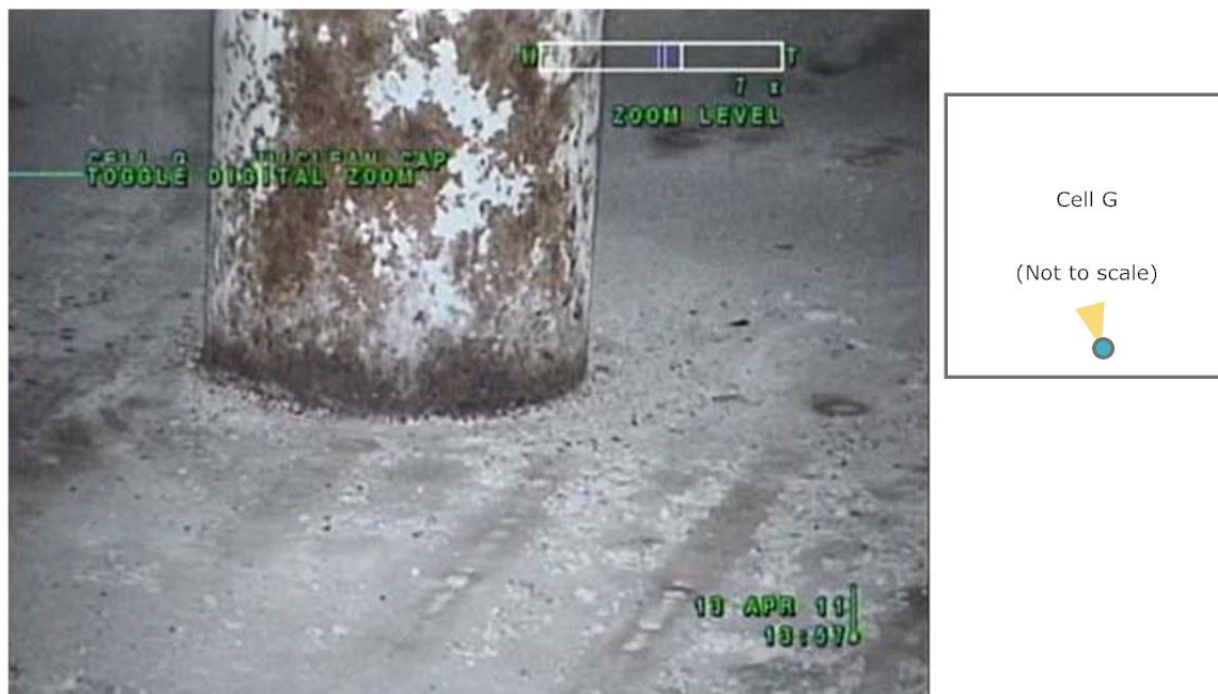
**Figure 3.1-2: Cell G, Column-Grout Interface**

Similar results were seen for the column-grout interfaces, shown in Figure 3.1-2 for a column in Cell G.

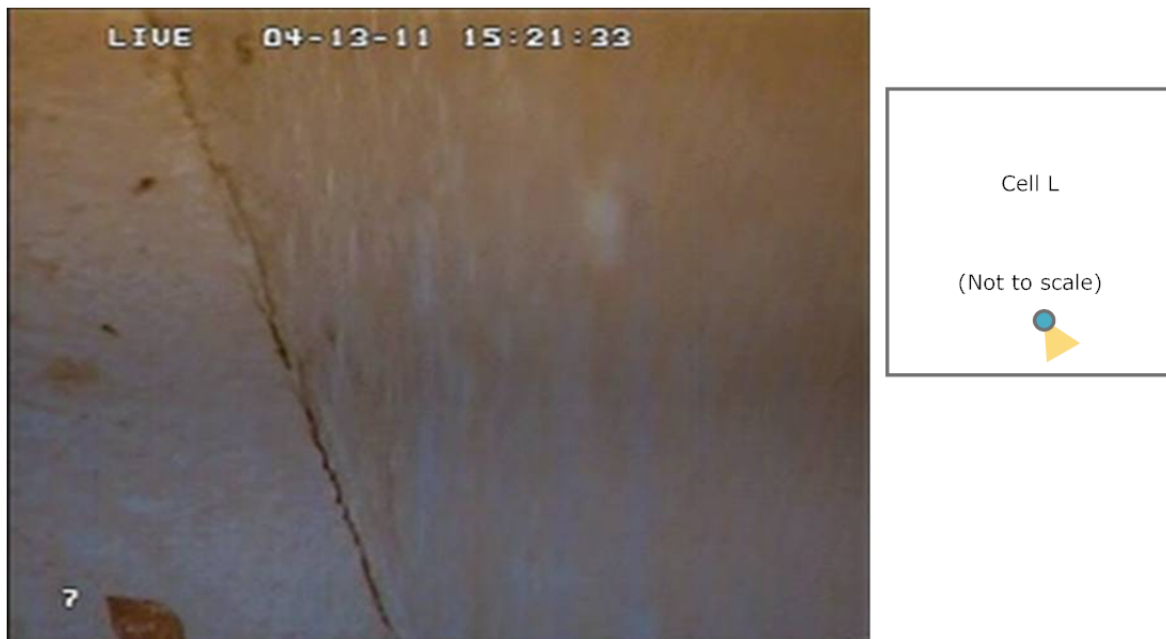
**Figure 3.1-3: Cell L, West Wall Interface**

The only observed instance of shrinkage was in Cell L, which evidenced a small void space between the saltstone monolith and a section of the cell wall. Figure 3.1-3 shows a video still of the observed shrinkage in Cell L. The depth and width of this void space is not known. The observed length of the shrinkage between the wall and grout was approximately 10-feet.

Despite the fact that the surveyed cells evidenced small cracks in the surface, the overall saltstone monolith seems to be intact. The surface cracks observed did not seem to penetrate deeply, some of them only appearing as thin white lines. The shrinkage appearing in Cell L seems to be localized to a single area. The overall grout level seems very even, spreading out well over the entire cell except for the dip in Cell I produced beneath the port where grout was introduced to the cell.

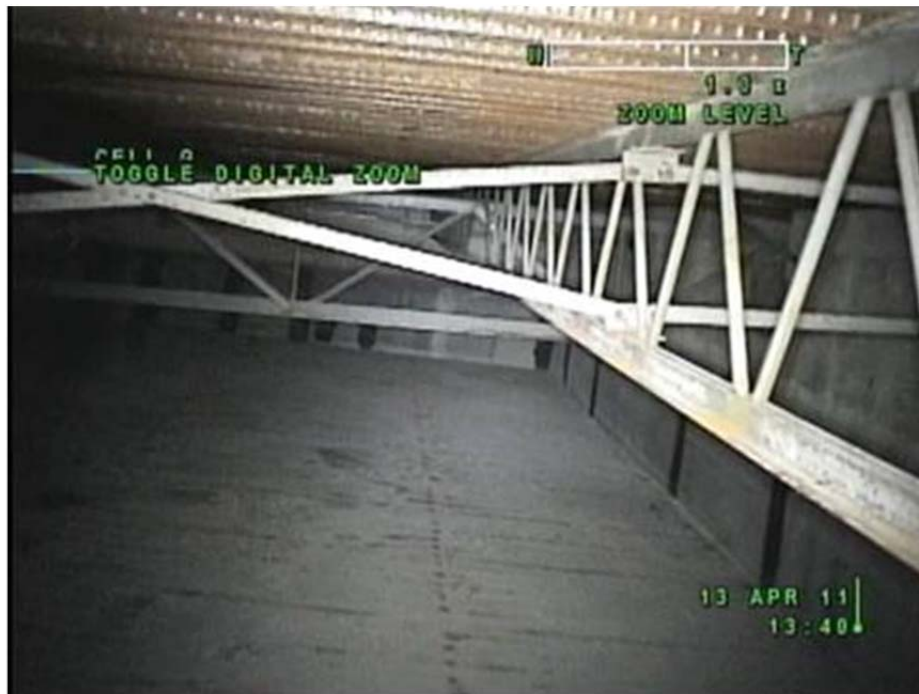
Figure 3.2-1: Cell G, Wide Angle View

Degradation of the saltstone monolith is a matter of importance for PA modeling efforts. Improved understanding of degradation mechanisms, including cracking, provides insights that will inform PA modeling assumptions. This inspection could only inspect for surface cracking. Cells E, F, and G showed no evidence of surface cracking in this inspection. Cell F was the only inspected cell without an operational layer of clean grout covering the saltstone. Figure 3.2-1 shows a wide-angle view of Cell G.

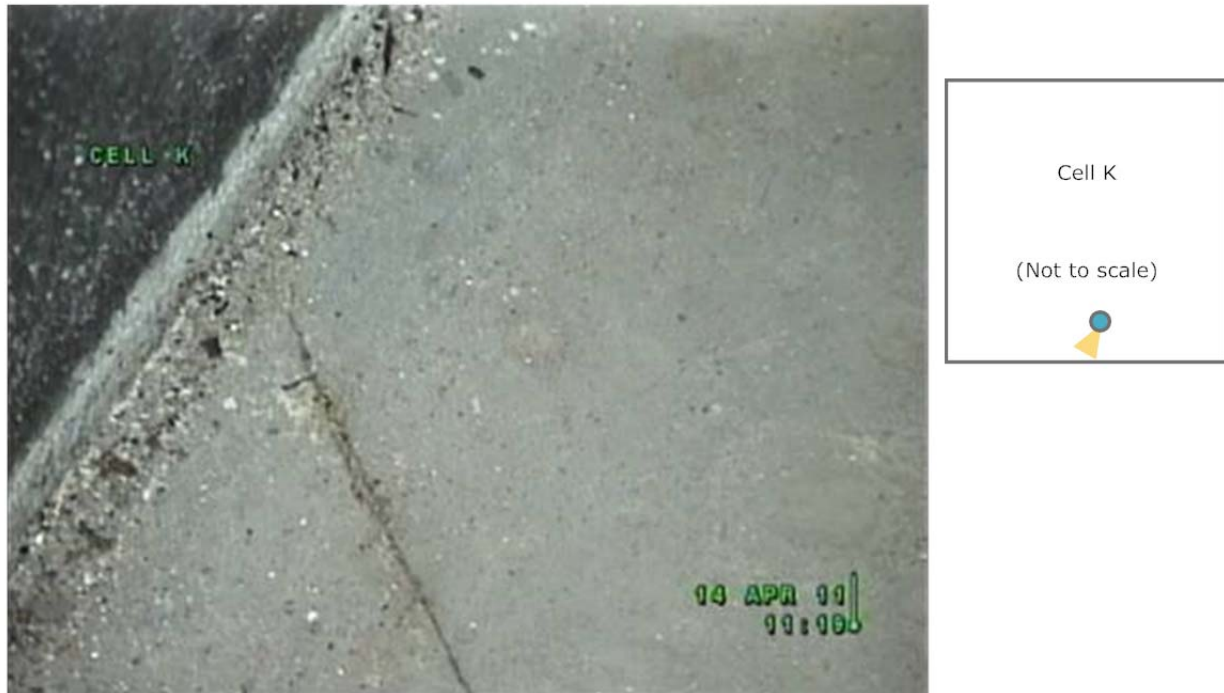
**Figure 3.2-2: Cell K, West Wall Interface**

Cells C, D, I, K, and L all show varying evidence and degrees of surface cracking, with Cell K being the most apparent and Cells C, D, I, and L merely evidencing a few white lines on the surface of the grout. All surface cracks observed were in the operational clean layer of grout covering the saltstone surface. The depth and thickness of these cracks is not known. Figures 3.2-2 through 3.2-4 show the cracks observed in Cell K.

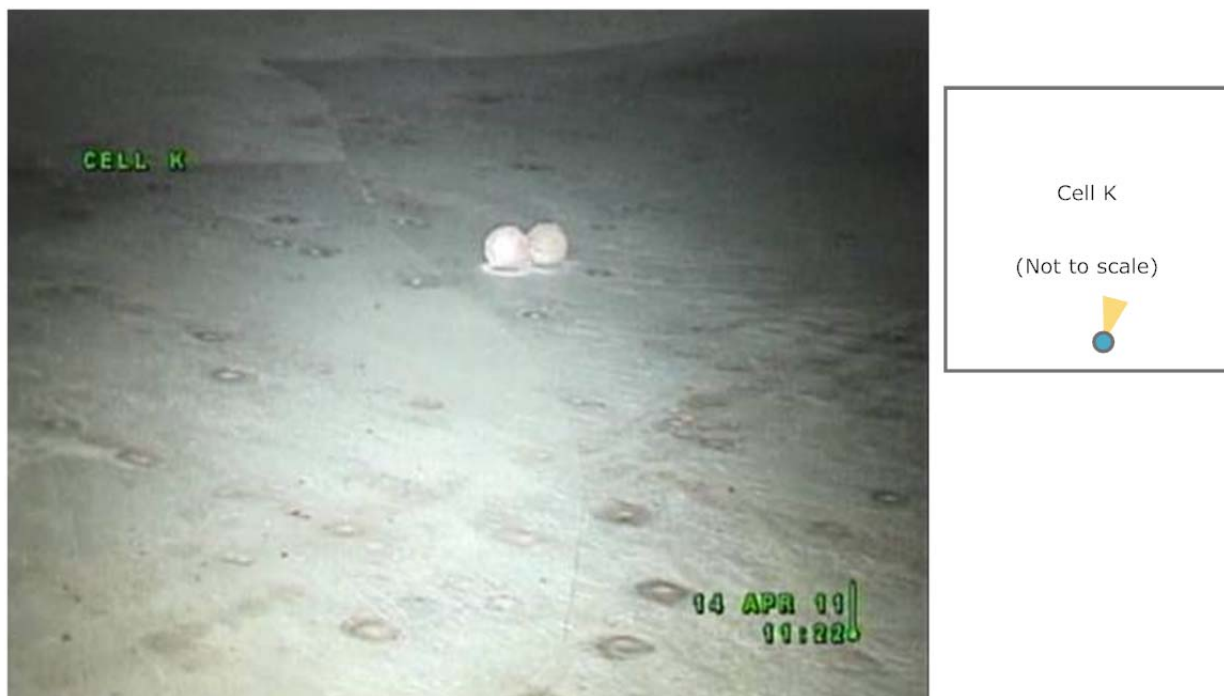
**Figure 3.2-3: Cell K, Grout Surface**

Figure 3.2-3 shows two “pigs” used to remove grout from transfer lines during processing. Each pig is approximately 3 inches in diameter.

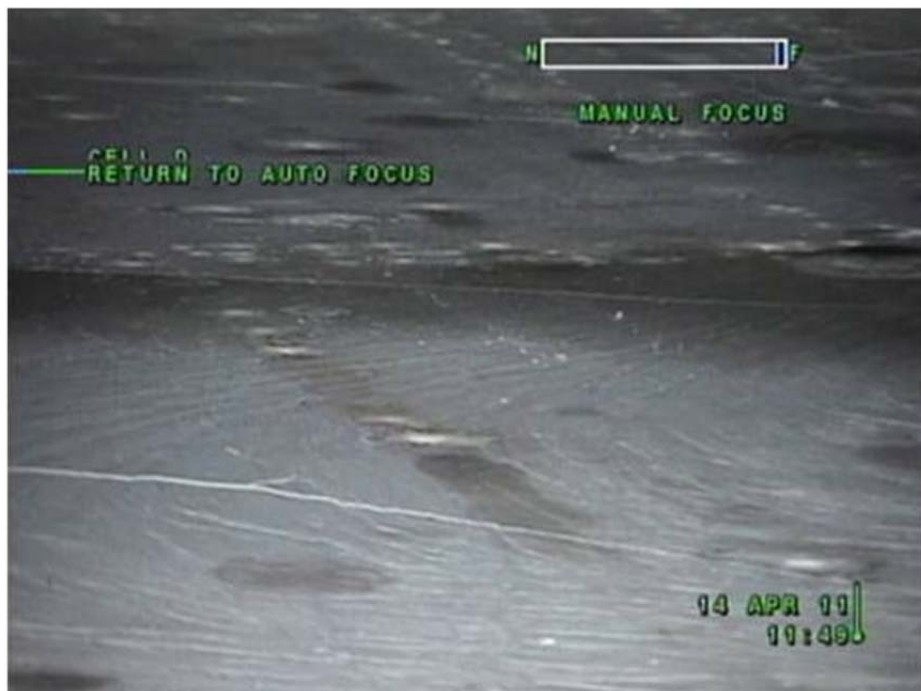
Figure 3.2-5: Cell D, Grout Surface

Cell D also evidenced some minor indications of surface cracking, as shown in Figure 3.2-5. Evidence of surface cracking in Cell D was much less pronounced than observed in Cell K.

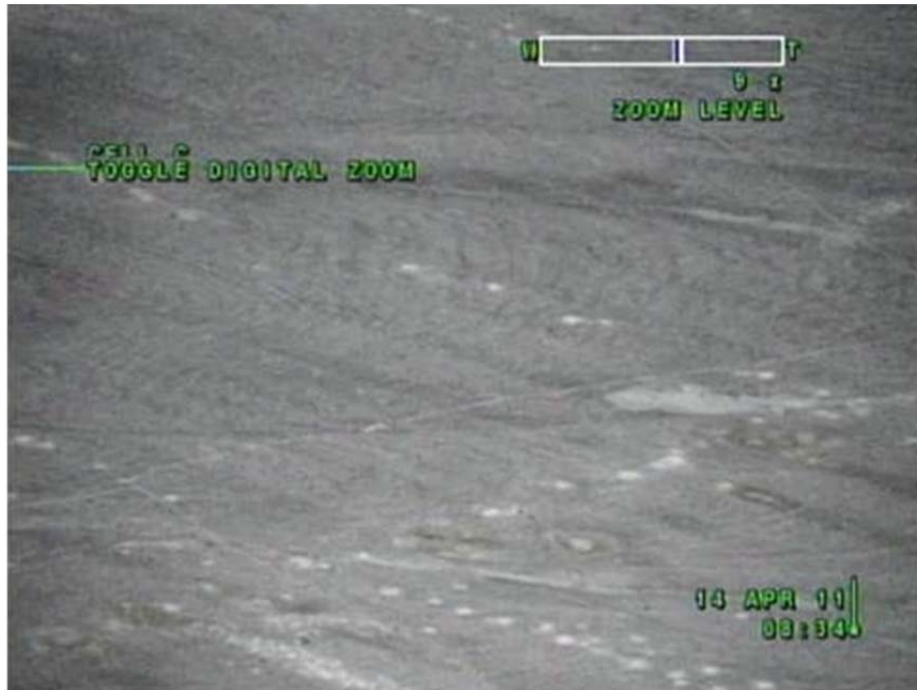
**Figure 3.2-6: Cell C, Grout Surface**

Cells C, I, and L were less conclusive in evidence of surface cracking than Cells D or K. Cells C, I, and L all show thin white lines in the grout, but video limitations such as resolution and focus made precise characterization difficult. Video stills showing this evidence from Cells C, I, and L are shown in Figure 3.2-6 through Figure 3.2-8.

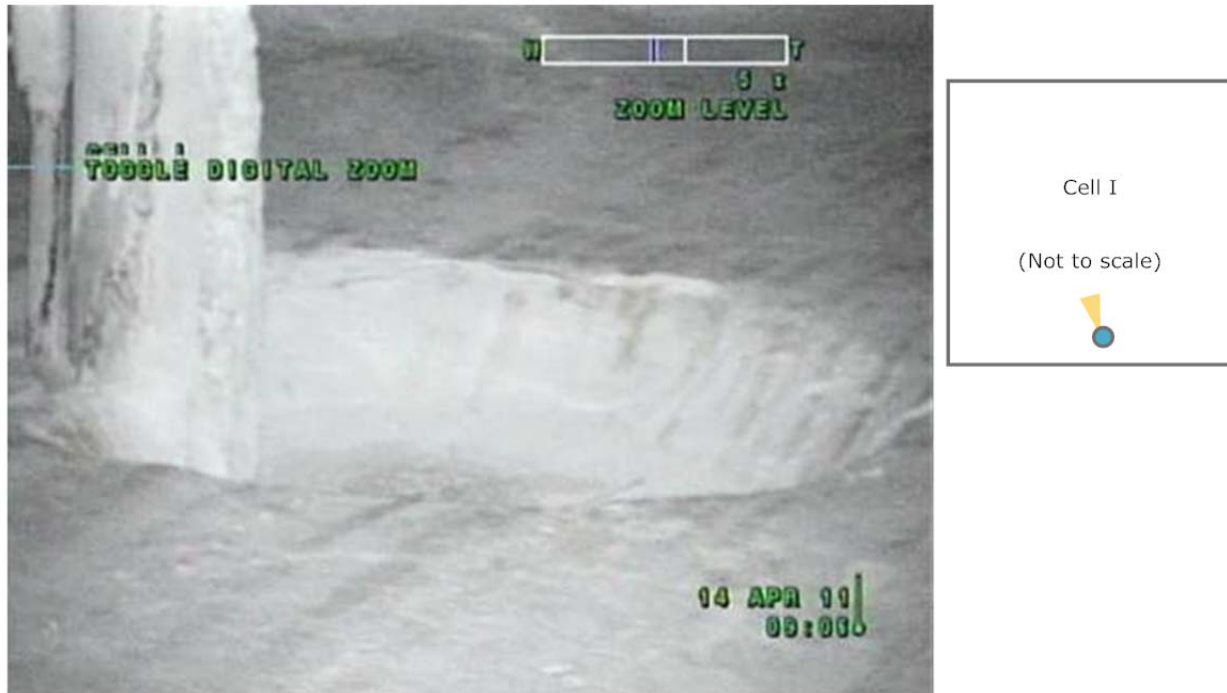
**Figure 3.3-1: Cell I, Grout Surface Variation**

The grout surface was relatively uniform overall. Variations of less than 3 inches in shallow “bumps” and “dips” were common, but only one larger variation was visible. This dip appears in Cell I, and seems to be below the port where the grout was added to the vault, which would account for the level variation. Figure 3.3-1 is a video still from Cell I, showing the dip at the base of a column. The column shown is 10 inches in diameter, which corresponds to an estimated height variation of approximately 10 inches and a diameter of approximately 2.5 feet.

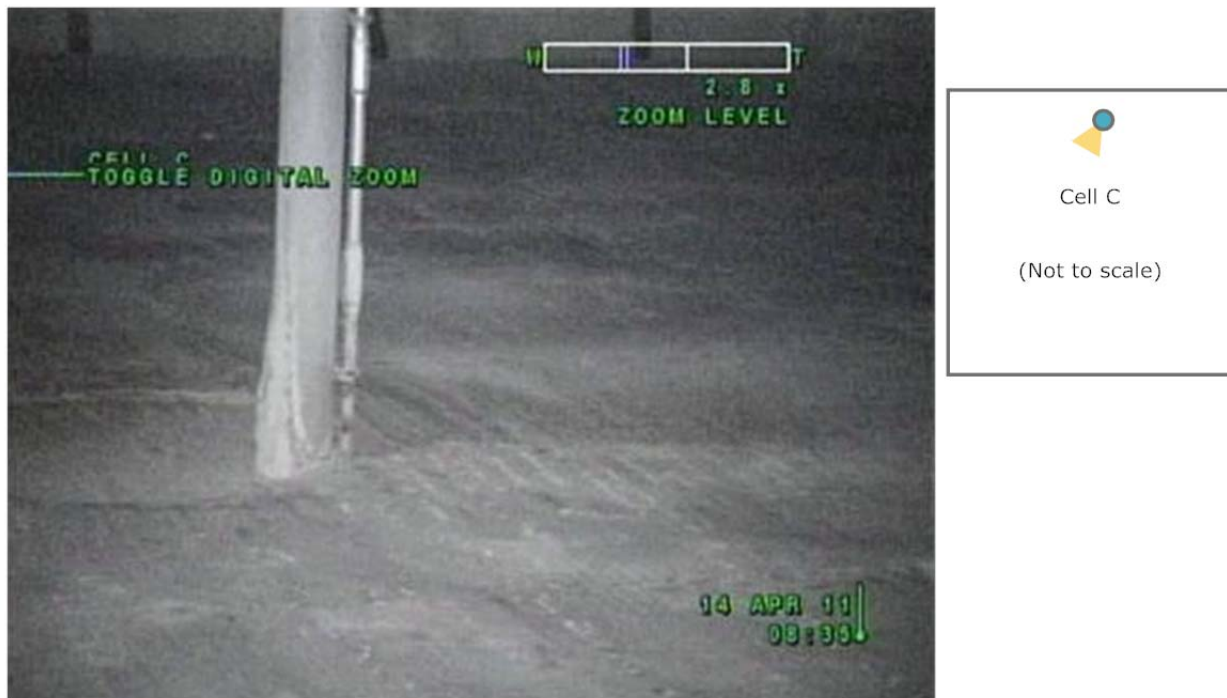
**Figure 3.3-2: Cell C, Grout Surface Level**

Figures 3.3-2 through 3.3-4 show examples of wide-angle views from Cells C, E, and G, which show only minor variation and provide representative examples of the other cells.
