Entergy**CONDITION REPORT****CR-IP2-2009-00666****Originator:** Rohla III, Otto R**Originator Phone:** 5295**Originator Group:** Operations Watch Staff IP2**Operability Required:** Y**Supervisor Name:** Gates, Clifton**Reportability Required:** N**Discovered Date:** 02/15/2009 15:29**Initiated Date:** 02/15/2009 15:35**Condition Description:**

ANALYSIS OF 8" CONDENSATE RETURN LINE FAILURE

Document Number:	0900235.402
Title:	Analysis Of 8"Condensate Return Line Failure
Client:	Entergy– Indian Point Nuclear Station
SI Project Number:	0900235.00

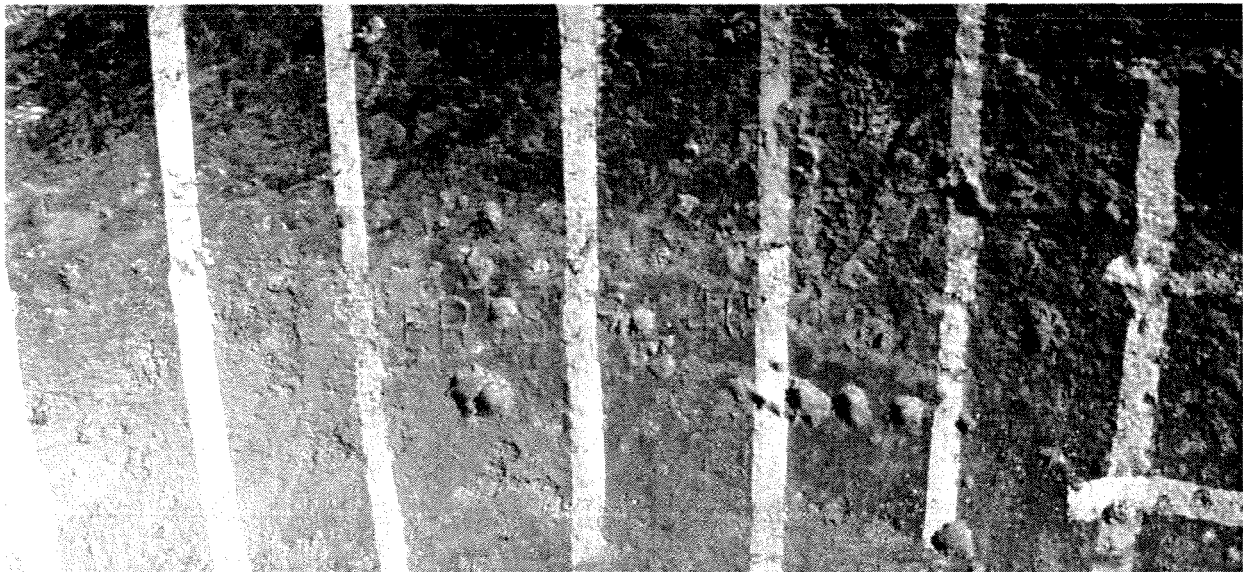
Figure 13 - Manufacturer's stamp marks on the neutral axis of the elbow.
See next figure for detail of the stamp mark after cleaning.

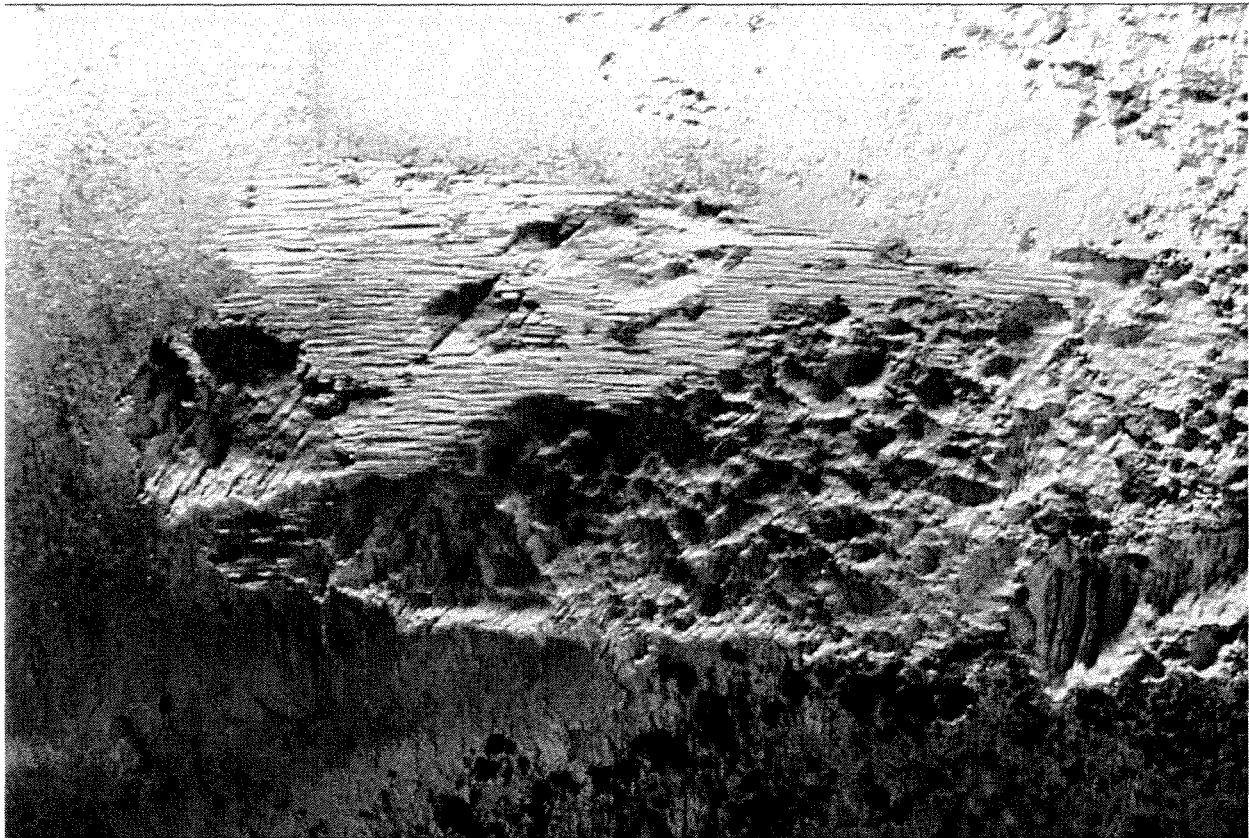
Figure 20 - Area of Area 4, Location 2 after cleaning by glass bead blasting

Note scrape marks. These scrape marks appeared to have discoloration and oxidation comparable to the surrounding uncorroded pipe surface suggesting they may have been formed either during the installation process, or prior to the pipe coating process. If they were formed after coating, the coating would have been damaged and exposed the scraped area to the soil. As a result, the scrape would have been eliminated by subsequent corrosion. The striations are elongated features oriented from lower left to upper right in the round pit at upper left.

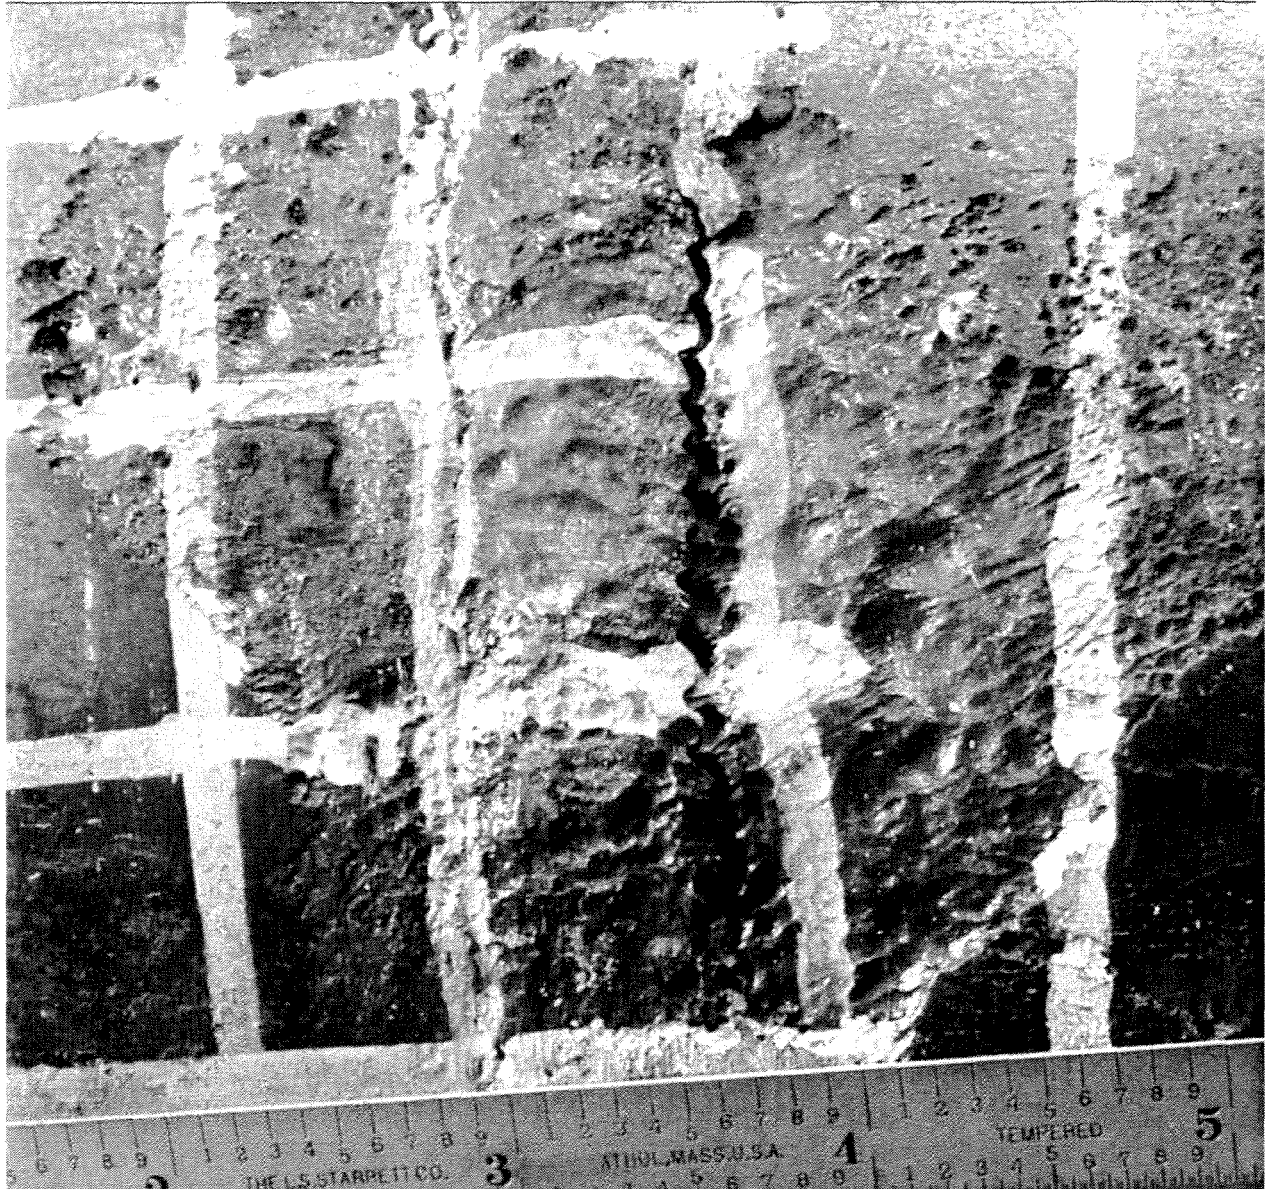
Figure 21 – Detail of corrosion on girth weld in the location designated Area 5.

Note corrosion undercutting the toe of the weld and striations in adjacent corrosion on the elbow. The striations are short linear features oriented about 25 degrees off the longitudinal axis of the pipe and are most visible to the right of the weld

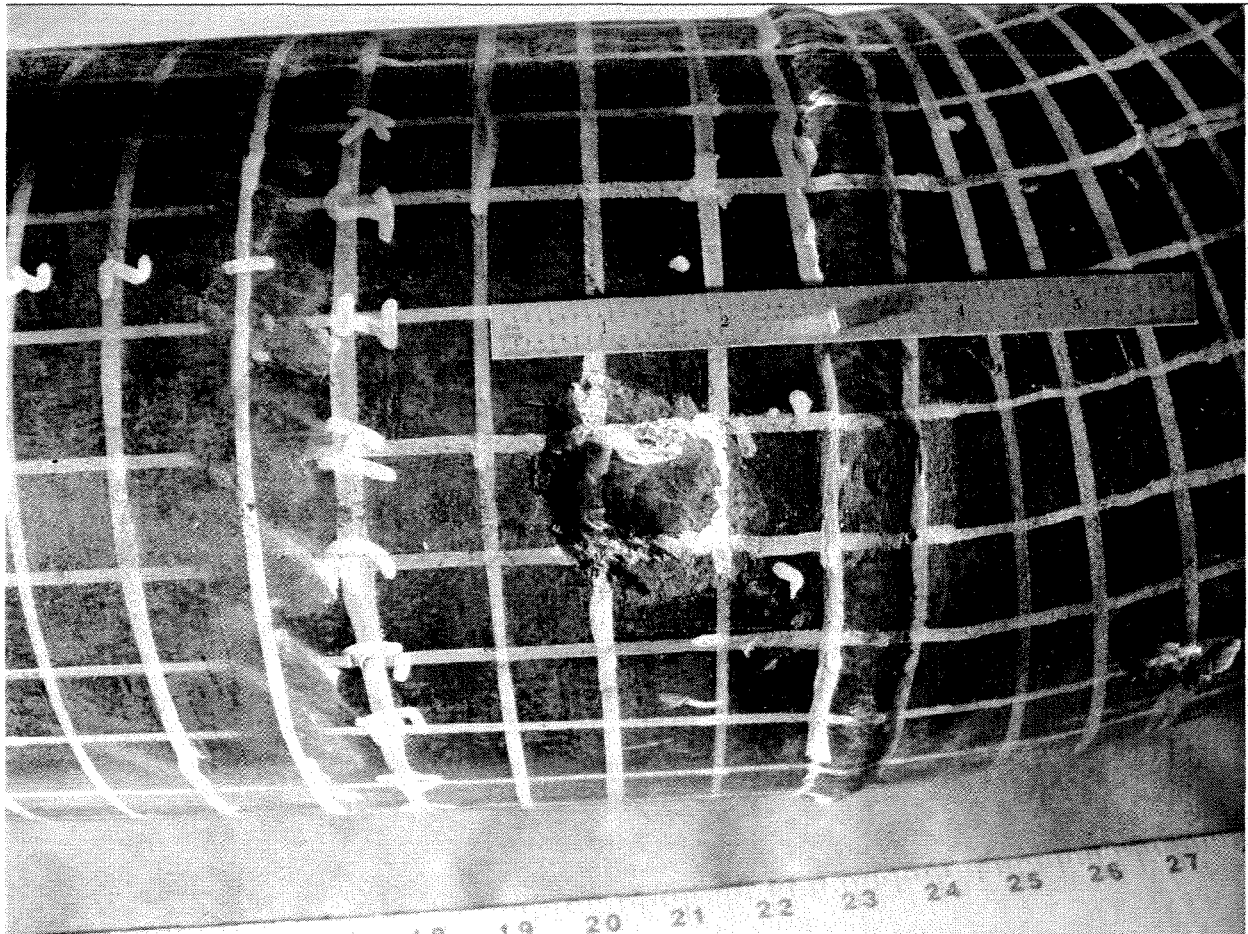
Figure 23 – External corrosion on the pipe (as-received condition), designated Area 6. Note absence of corrosion around this pit.

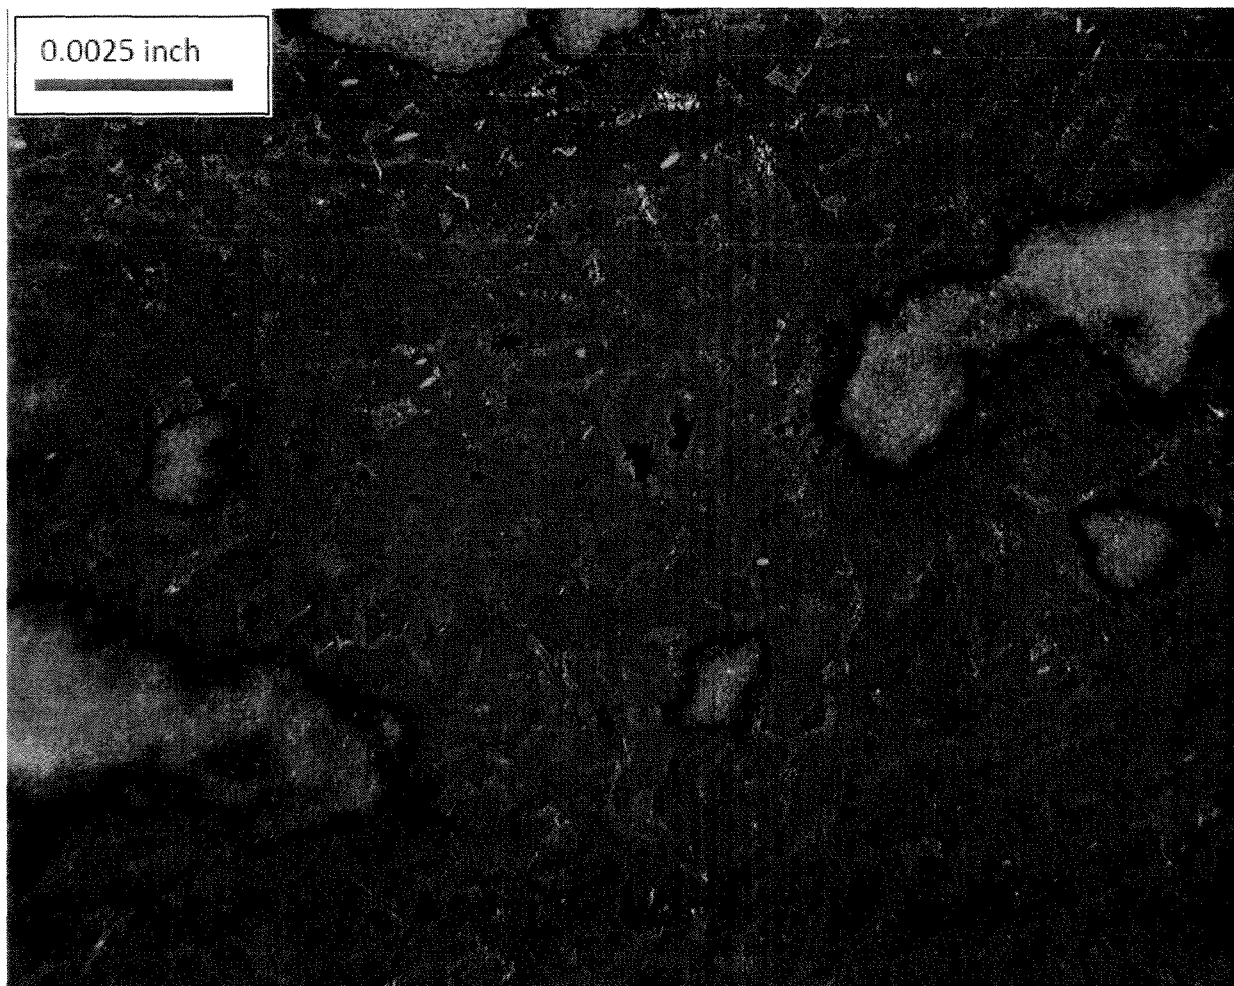
Figure 48- Detail of corrosion product in a pit on the outside of the pipe

The corrosion has preferentially corroded the proeutectoid ferrite and the ferrite lamellae of the pearlite leaving the iron carbide constituent of the pearlite grains uncorroded. The resulting shiny irregular globular-shaped areas replicate in the corrosion product the size and shape of the original pearlite grains. This appearance is typical of iron carbonate corrosion products.
