Project: 0900235.00  
Report: 0900235.402 R0

Subject: **Analysis of 8" Condensate Water Storage Tank Return Line CD-183  
Final report**

**ANALYSIS OF 8" CONDENSATE RETURN LINE FAILURE**

Entergy, Indian Point Nuclear Station

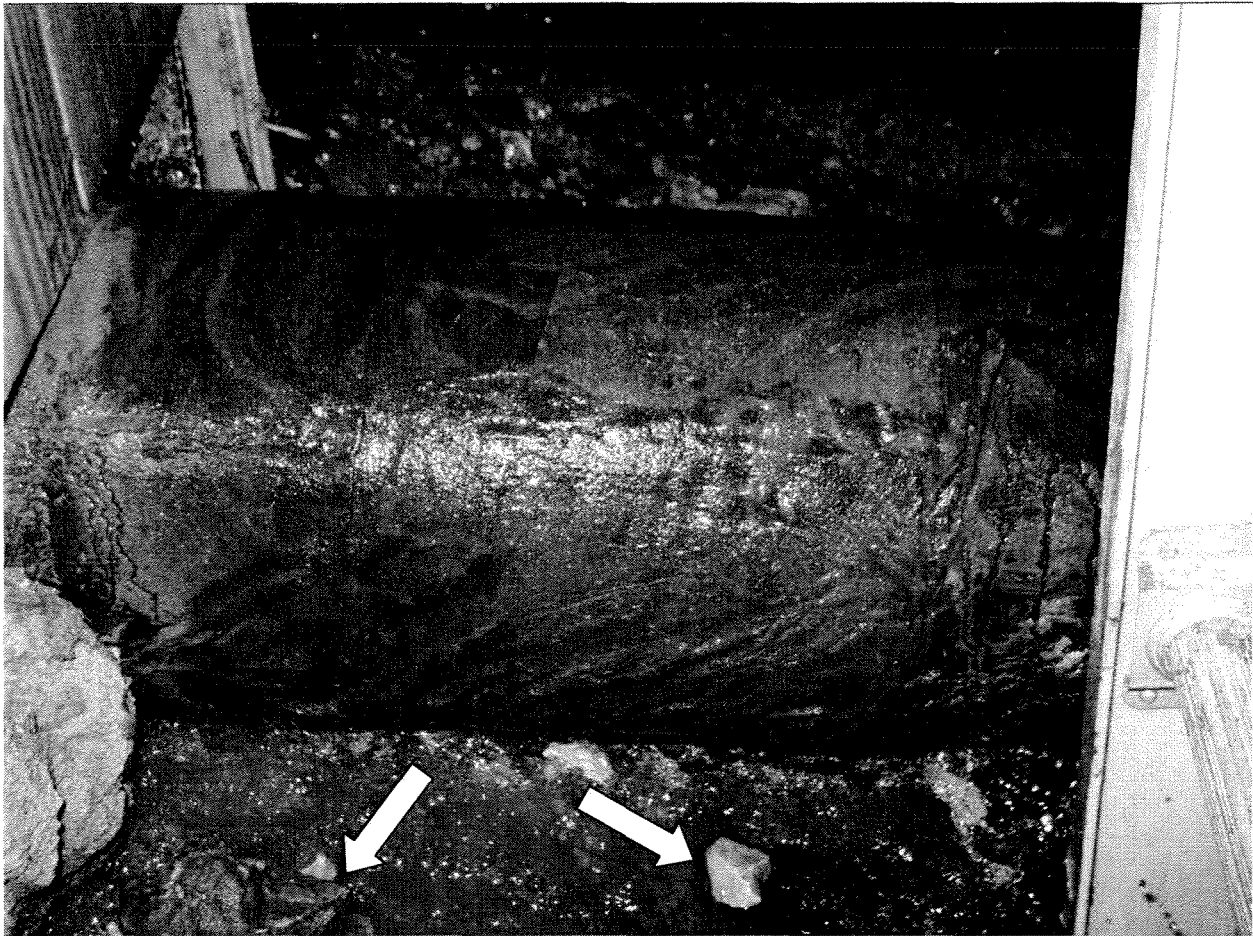
**Figure 1- View of pipe coating as observed in the excavation by Entergy Staff**

This photograph was provided to SI by Entergy staff. It was taken before the pipe sample was removed. Note wrinkling of the coating typical of soil stress. (Soil stress refers to distortion of external pipe coatings of this type. The distortion is typically caused by relative movement of the pipe and soil resulting from pipe expansion and contraction, soil settlement, or other events.) Arrows point to examples of angular rocks in the backfill.

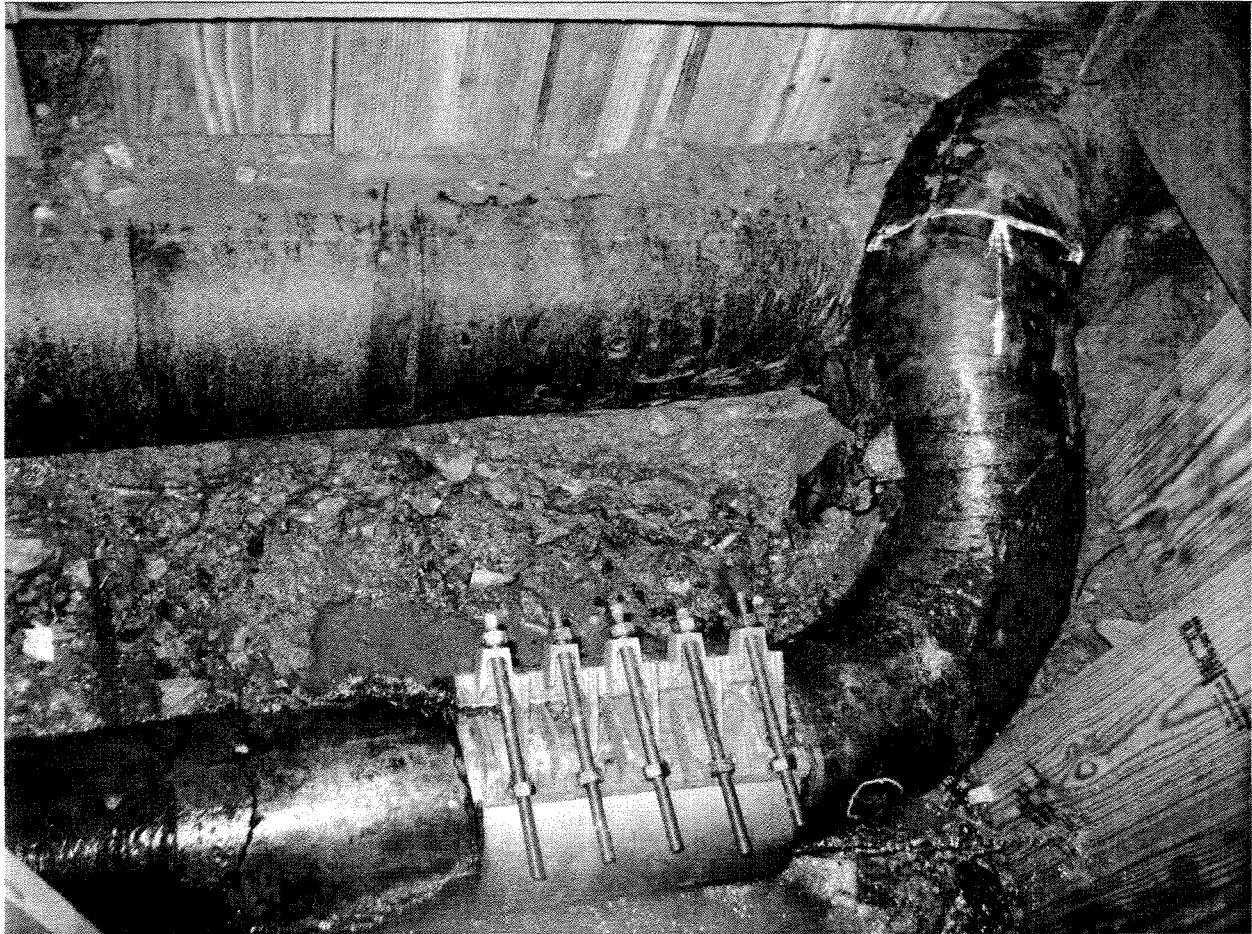
**Figure 2 - Photograph of pipe in the excavation before removal of the pipe sample.**

This photograph was provided to SI by Entergy staff. A leak clamp has been applied to the area of the leak. The white arrow and lines at upper right indicate the limits of coating that was to be removed during the process of replacing the segment of leaking pipe. See next figure for detail of rocks in the backfill to the upper left of the clamp.

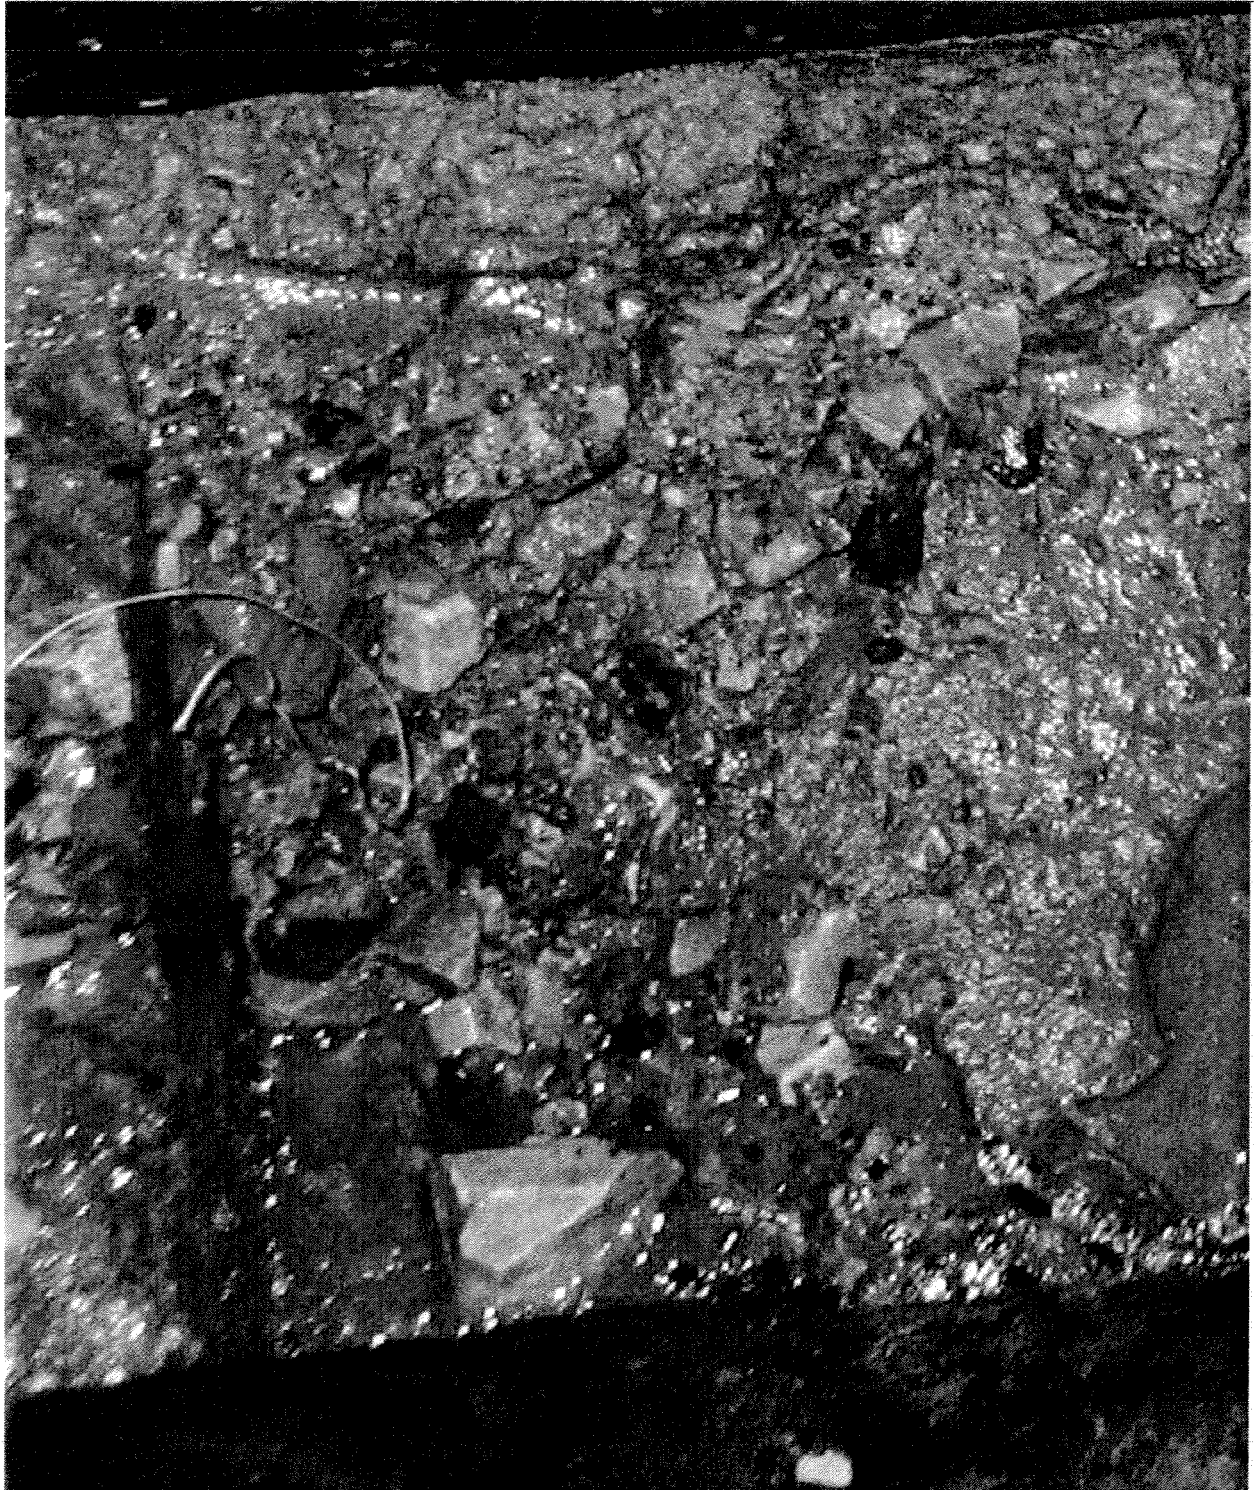
**Figure 3 - Detail of previous figure showing angular rocks in the backfill.**

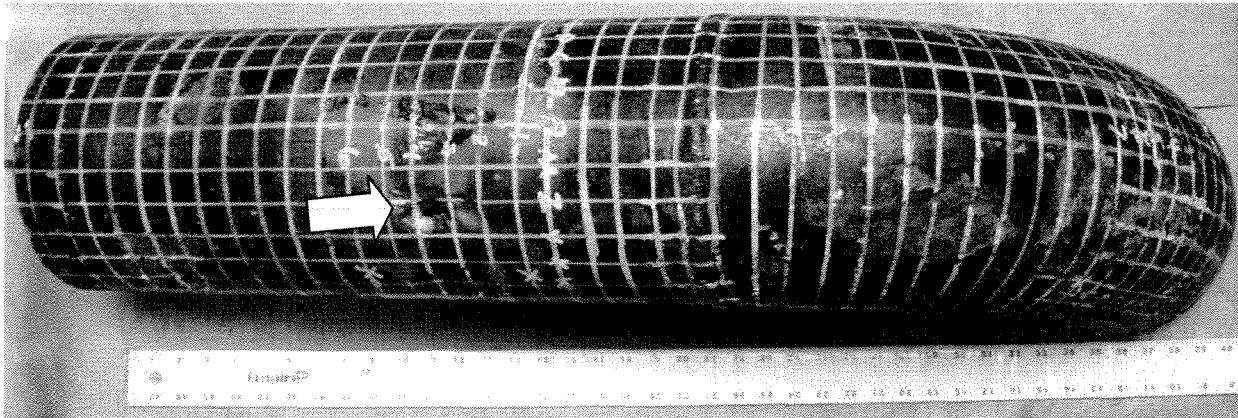
**Figure 9 - Pipe sample, as-received , view 4. Arrow points to location of leak**

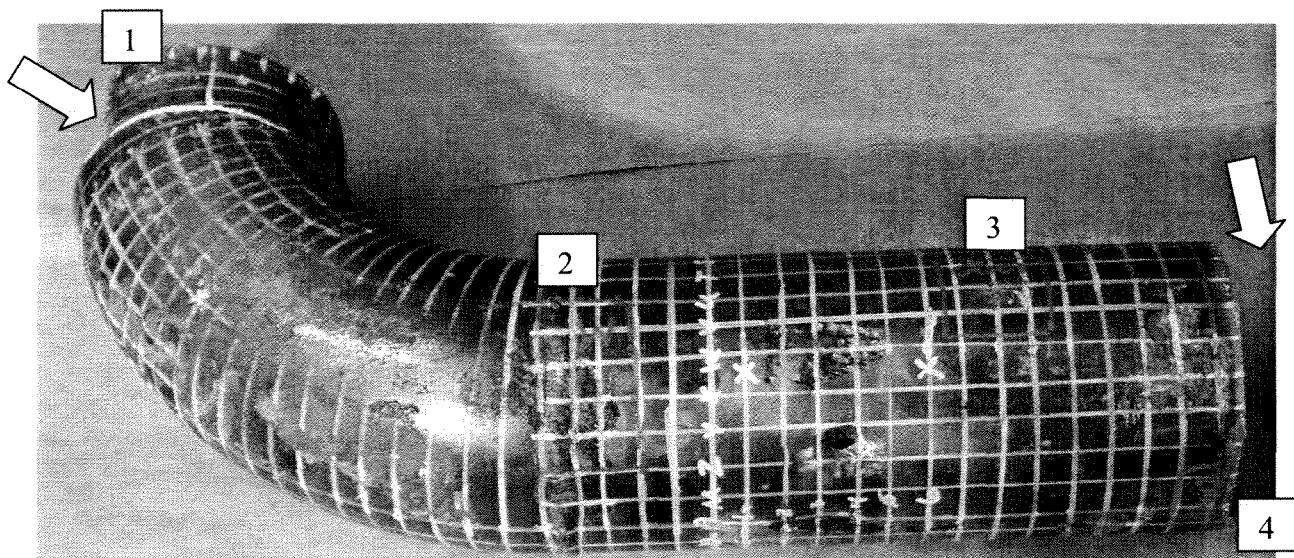
**Figure 10 - Pipe sample marked with red boxes to show locations of samples removed for further analysis**

1. Elbow sample with ID corrosion for metallographic examination,
2. Girth weld sample for metallographic examination,
3. External corrosion pit with internal corrosion on pipe for metallographic examination and EDS analysis of the corrosion product
4. Second sample of pipe for metallographic examination (investigation of possible ERW seam).

Segments at arrows at ends of the sample were previously removed for tensile testing and analysis of steel composition.

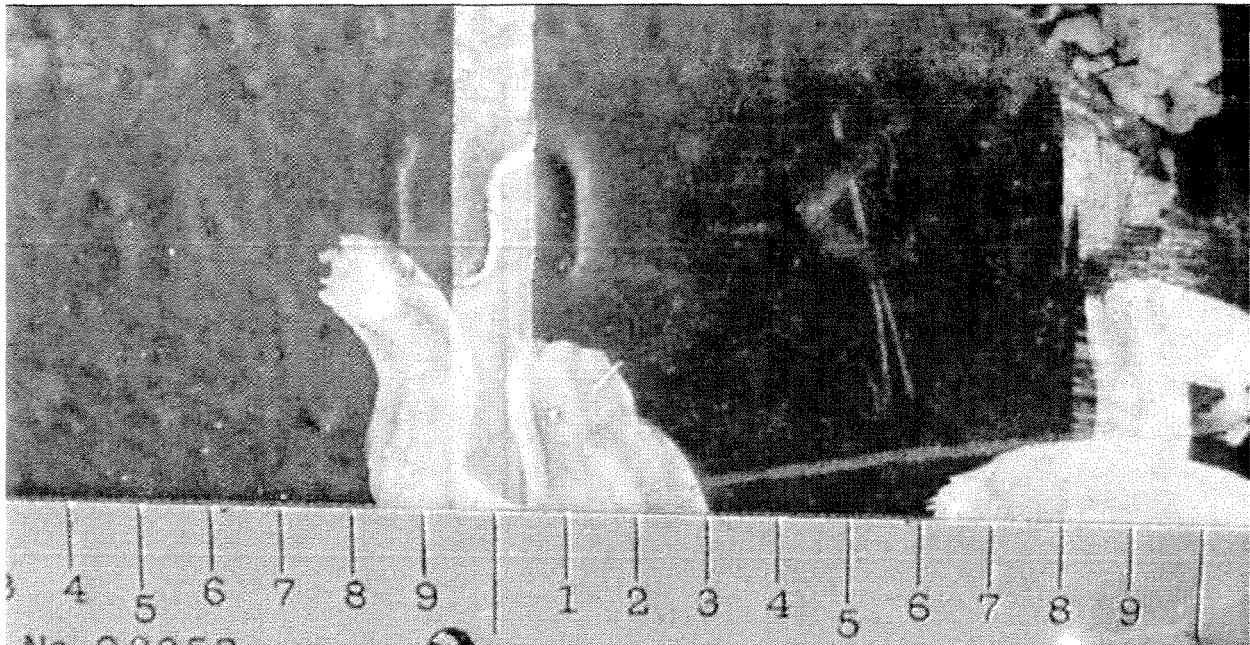
**Figure 11 - "YS" stamp mark on pipe.**

The stamp marks indicate that this pipe is pipe manufactured by Youngstown Steel. At this location the stamps have been partially polished away by erosion from the nearby leak (in this pipe).

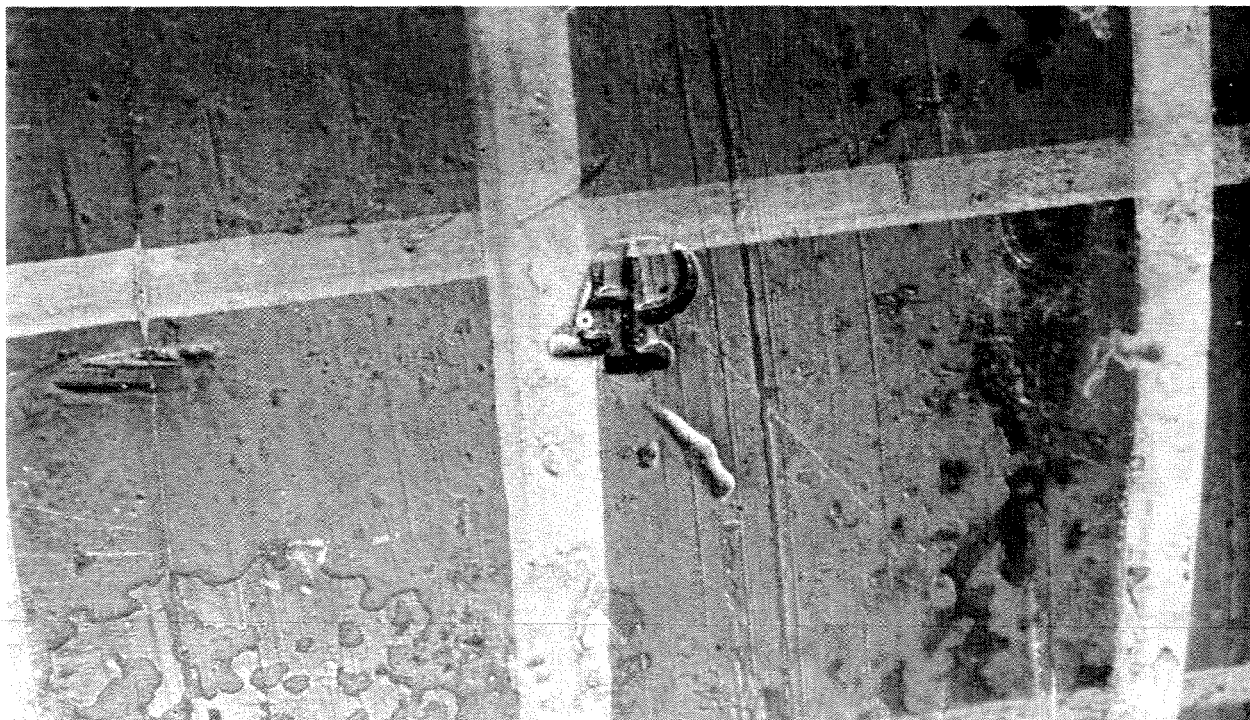
**Figure 12 - API monogram stamp mark on pipe.**

Monogram indicates that pipe met requirements of API specification 5L. It may have also been manufactured to meet ASTM specifications. Grids outlined by white lines are approximately 1" x 1".

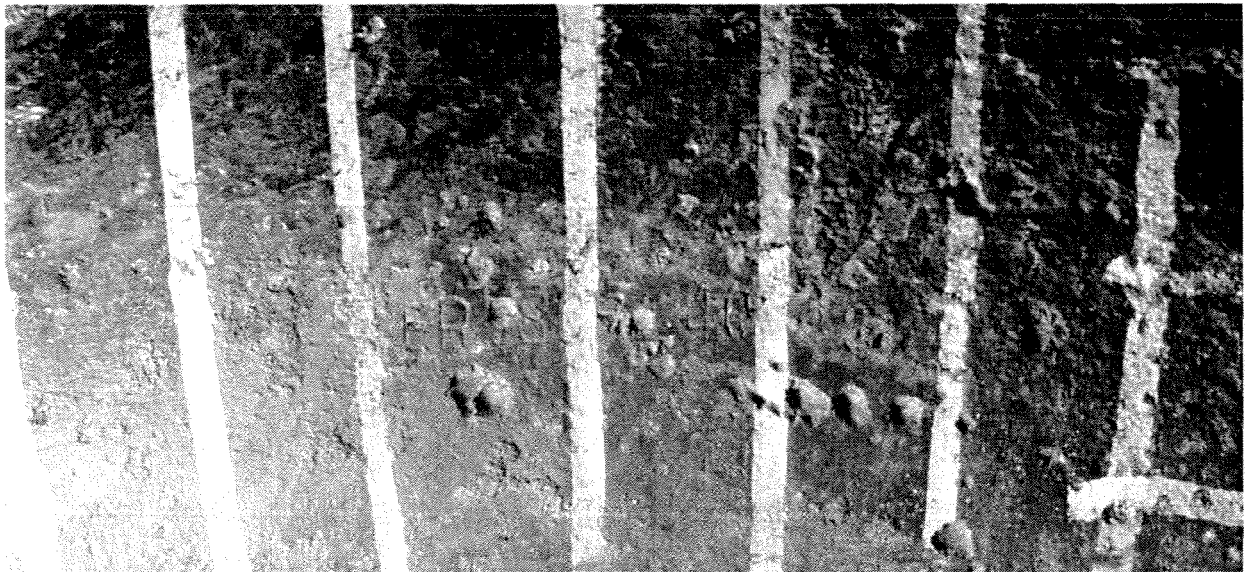
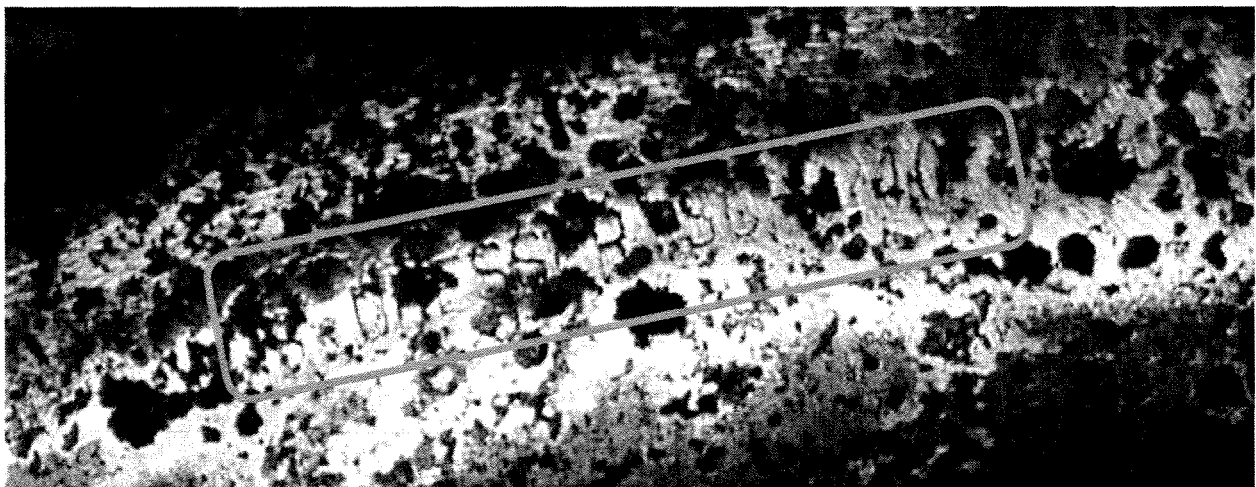
**Figure 13 - Manufacturer's stamp marks on the neutral axis of the elbow.**  
See next figure for detail of the stamp mark after cleaning.

**Figure 14 - Manufacturer's stamp mark after light abrasion with sandpaper.**  
The stamp marks on the neutral axis of the elbow identify it as an 8" schedule 40 fitting manufactured by Dresser. The grade of the fitting is obscured by corrosion.

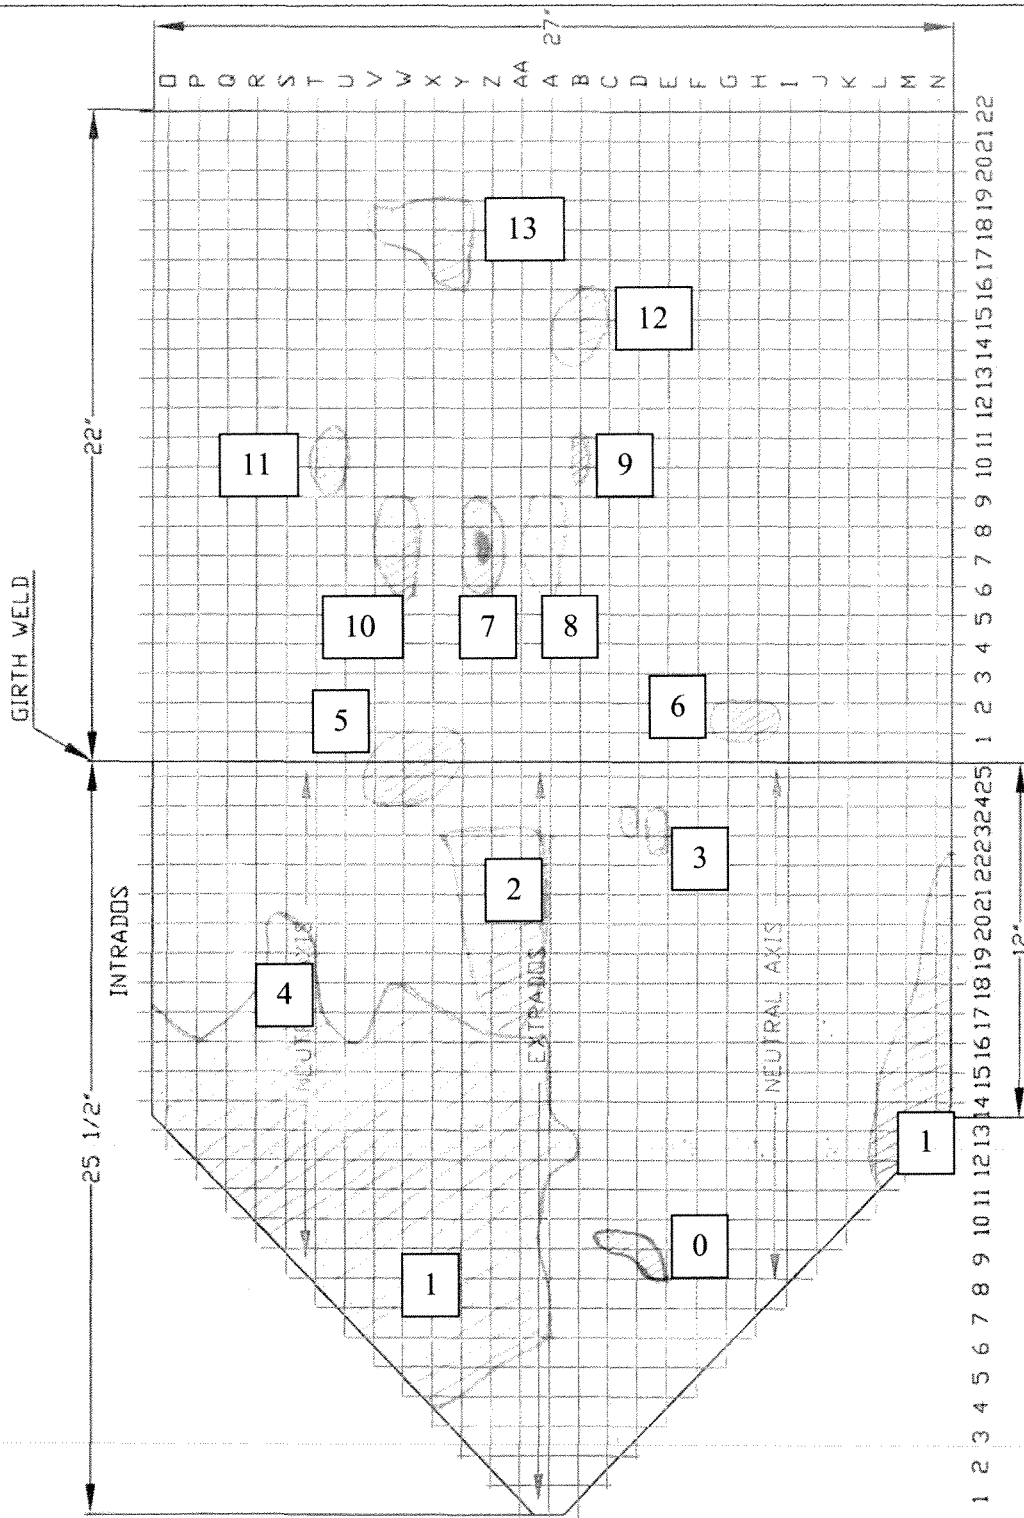
**Figure 15 – Map of external corrosion**

Major areas of corrosion are sketched and numbered. The axial grid lines (marked A, B, C, etc.) are as marked by Entergy. The leak is at location #7. See Table 3 for additional details

Area (see Fig. 15)	Maximum length (inch)	Maximum depth (inch)	Maximum width (inch)	CSA (%) (Note 1)	Related Figures
0	1.7	0.11	2.6	2.3	16
1	9.7	0.20	19	30.2 (note 2)	17, 18
2	7	0.17	3.5	4.7	-
3	1.2	0.09	0.75	0.5	-
4	See Area 1 data, see note 3				19, 20
5	2.8	0.09	3.2	2.3	21, 22, 38-41
6	1.8	0.276	2	4.4	23
7	2.9	Hole (leak)	1.5	3.8	24, 26
8	3.6	0.247	1.4	2.7	24
9	1.8	0.103	0.5	0.4	24, 25
10	3.4	0.184	1.8	2.6	26
11	2.3	See note 4	1.3	NA	27, 28
12	2.4	0.251	2	4.0	-
13	3.2	0.171	3	4.1	29-32

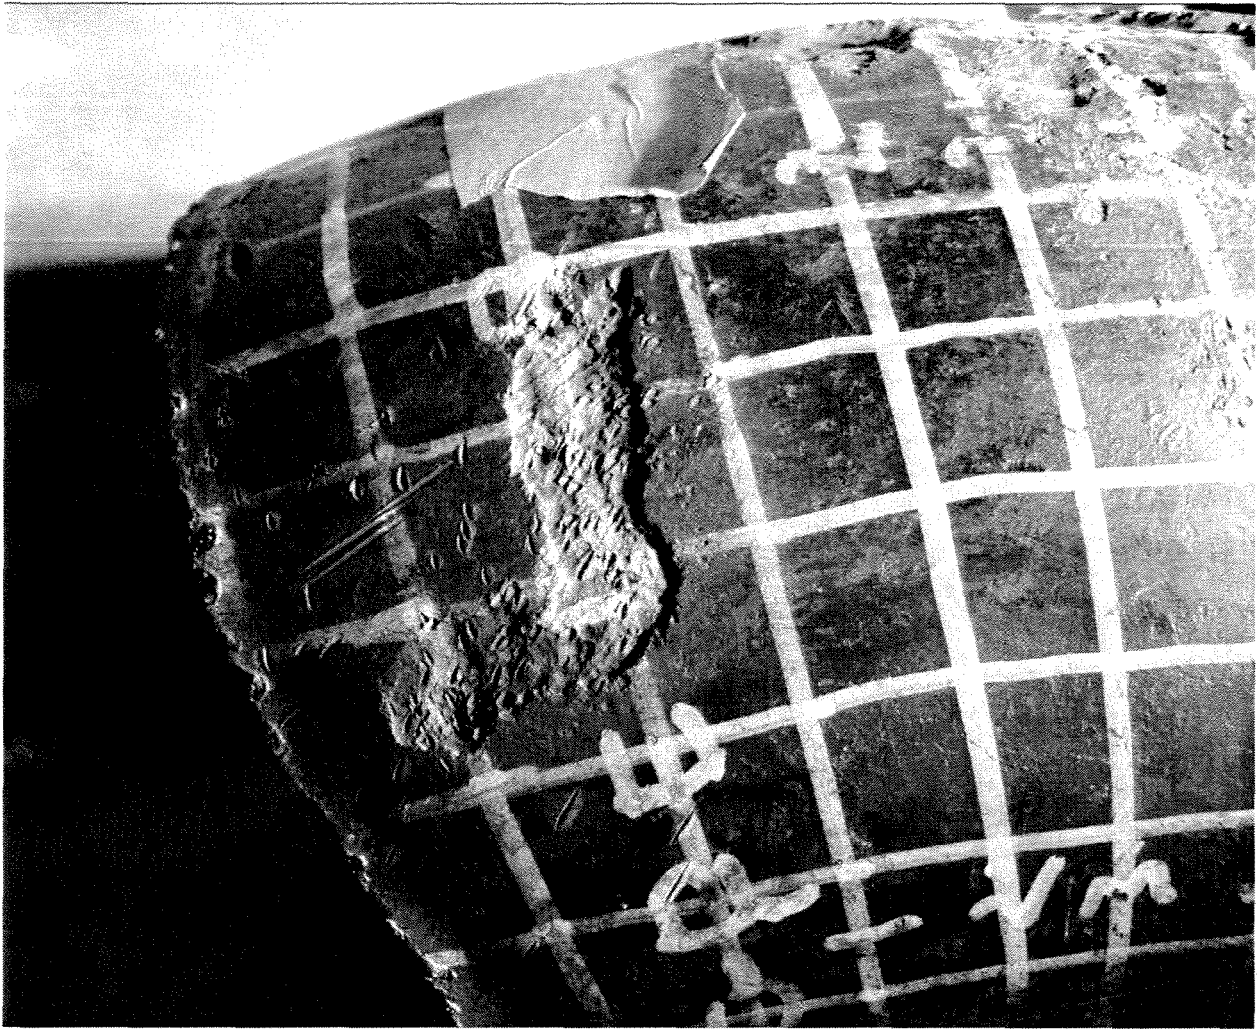
**Figure 16 - External corrosion on elbow (as-received condition) designated Area 0**  
Note the absence of any corrosion surrounding the “L” shaped pit.

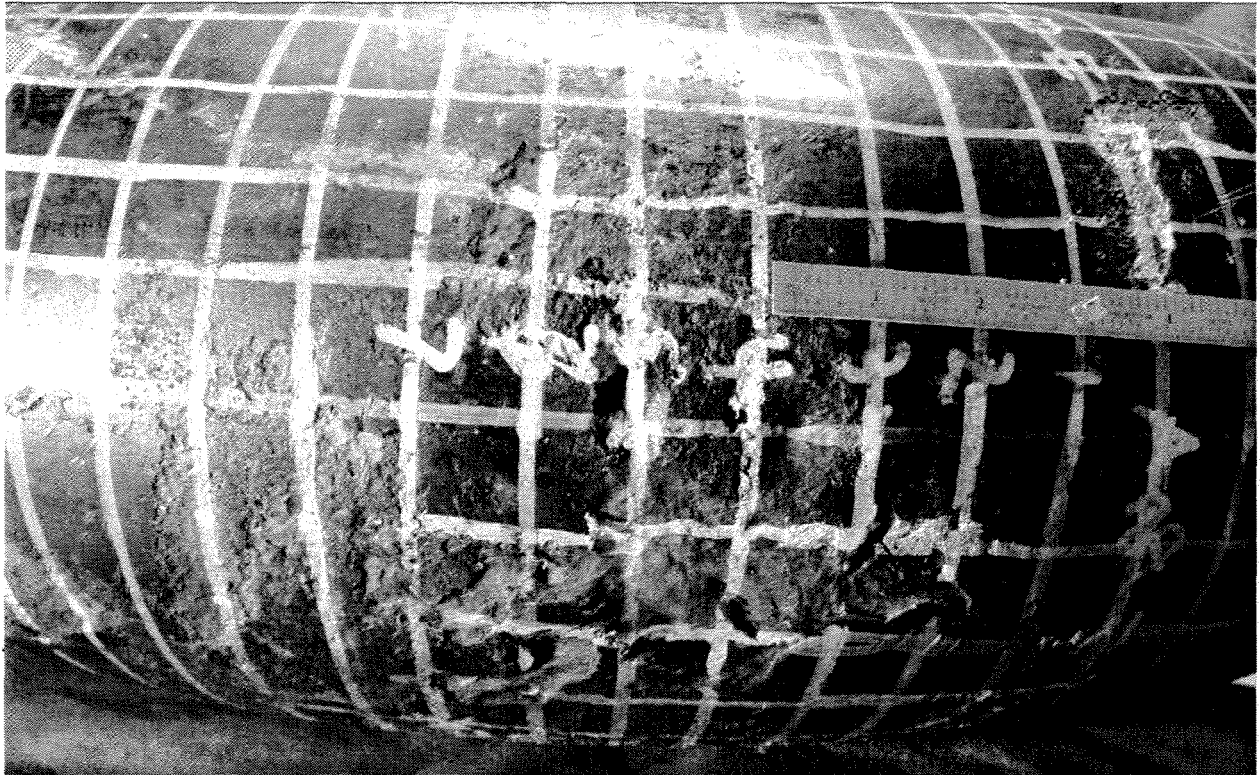
**Figure 17 – External corrosion on the extrados of the elbow, as-received; designated Area 1**

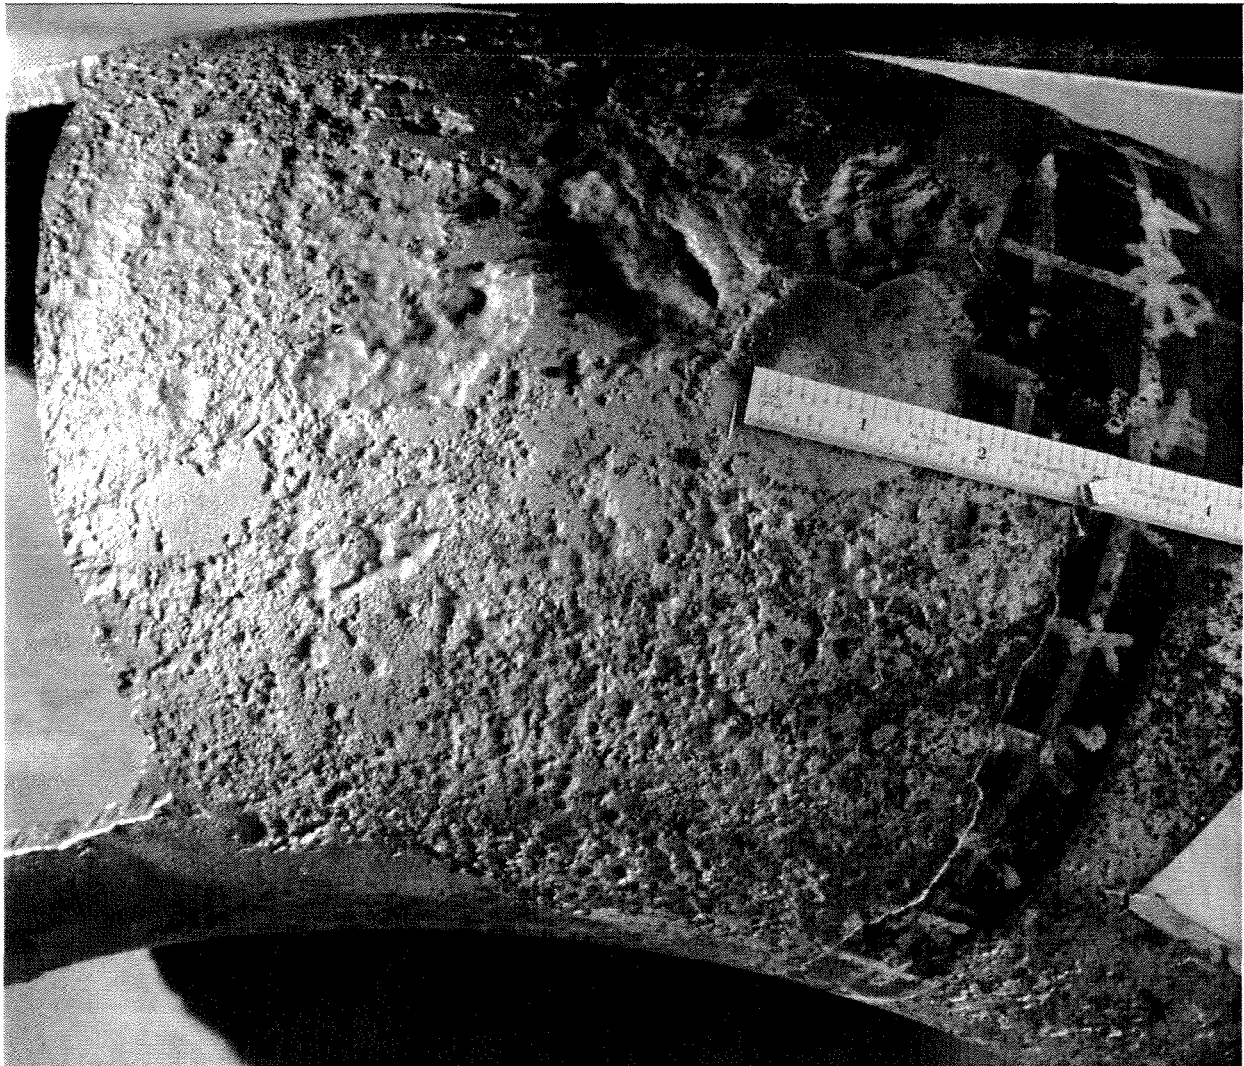
The external corrosion on the elbow was more widespread and included relatively large areas of more generalized corrosion. This corrosion pattern was more characteristic of less effective performance of the external coating, perhaps as a result of the difficulty in producing a good wrap pattern when coating irregular shapes such as elbows and other fittings.

**Figure 18-- Extrados of ell after cleaning, Area 1.**

Note extensive general corrosion compared to the straight pipe. A circumferential band was masked off to prevent loss of the grid line identifications

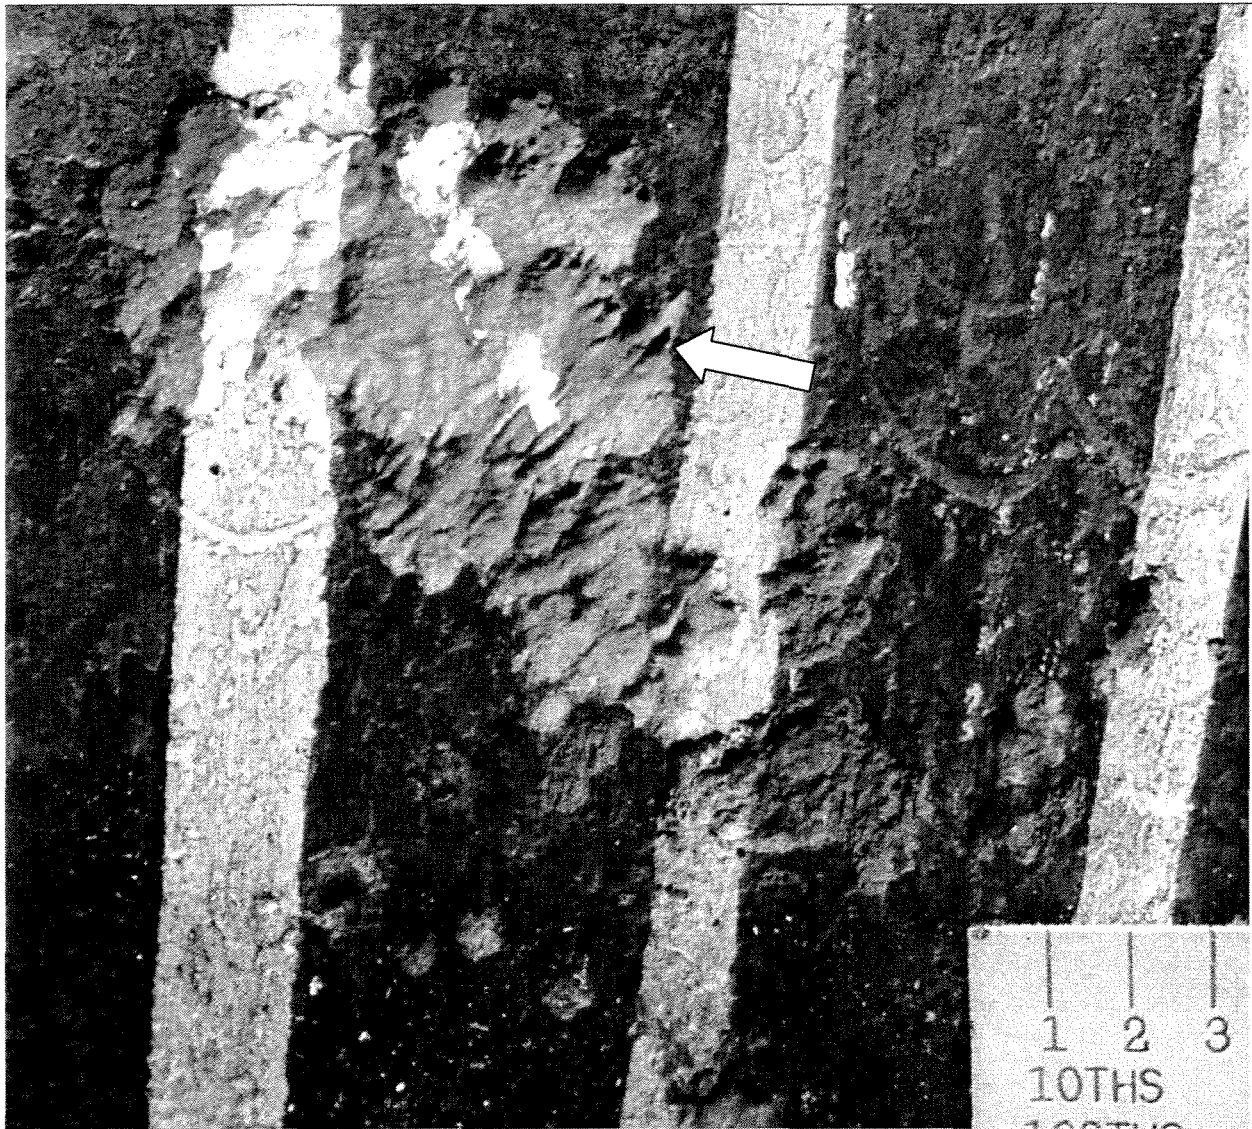
**Figure 19 – Detail of corrosion in Area 4, Location 1**

Note sharp edges of pits and tunnel like features (arrow points to one example of tunneling).

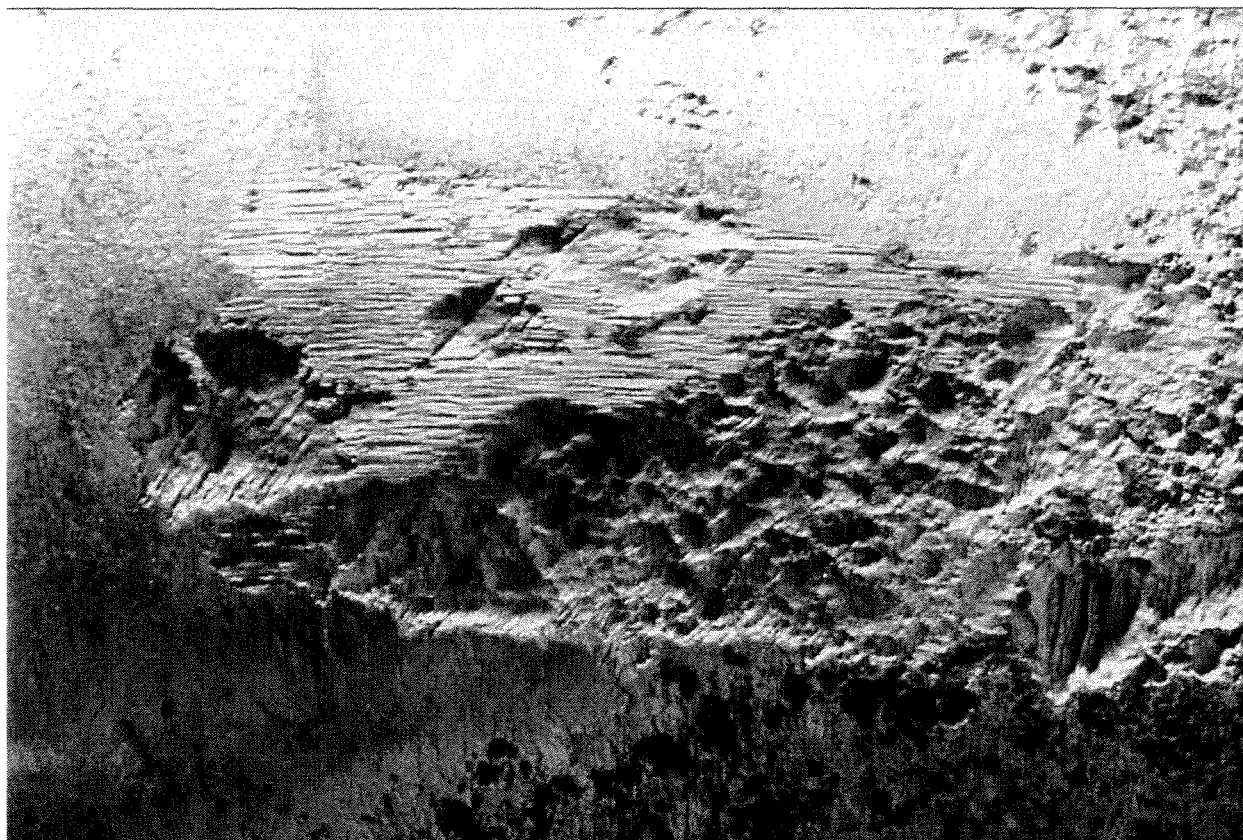
**Figure 20 - Area of Area 4, Location 2 after cleaning by glass bead blasting**

Note scrape marks. These scrape marks appeared to have discoloration and oxidation comparable to the surrounding uncorroded pipe surface suggesting they may have been formed either during the installation process, or prior to the pipe coating process. If they were formed after coating, the coating would have been damaged and exposed the scraped area to the soil. As a result, the scrape would have been eliminated by subsequent corrosion. The striations are elongated features oriented from lower left to upper right in the round pit at upper left.

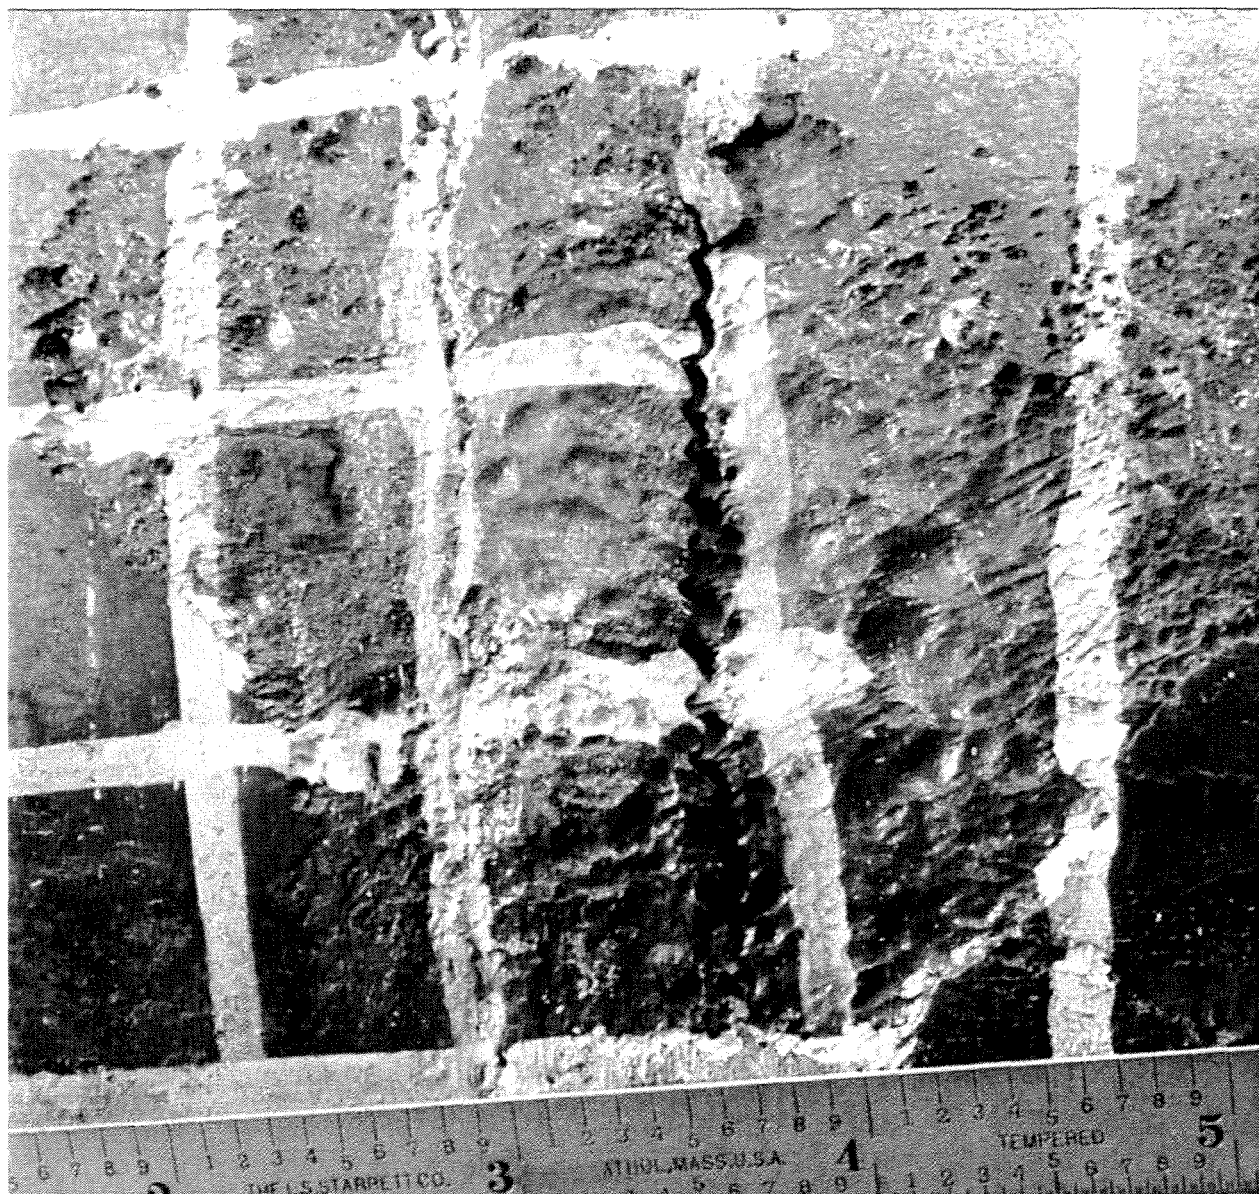
**Figure 21 – Detail of corrosion on girth weld in the location designated Area 5.**

Note corrosion undercutting the toe of the weld and striations in adjacent corrosion on the elbow. The striations are short linear features oriented about 25 degrees off the longitudinal axis of the pipe and are most visible to the right of the weld

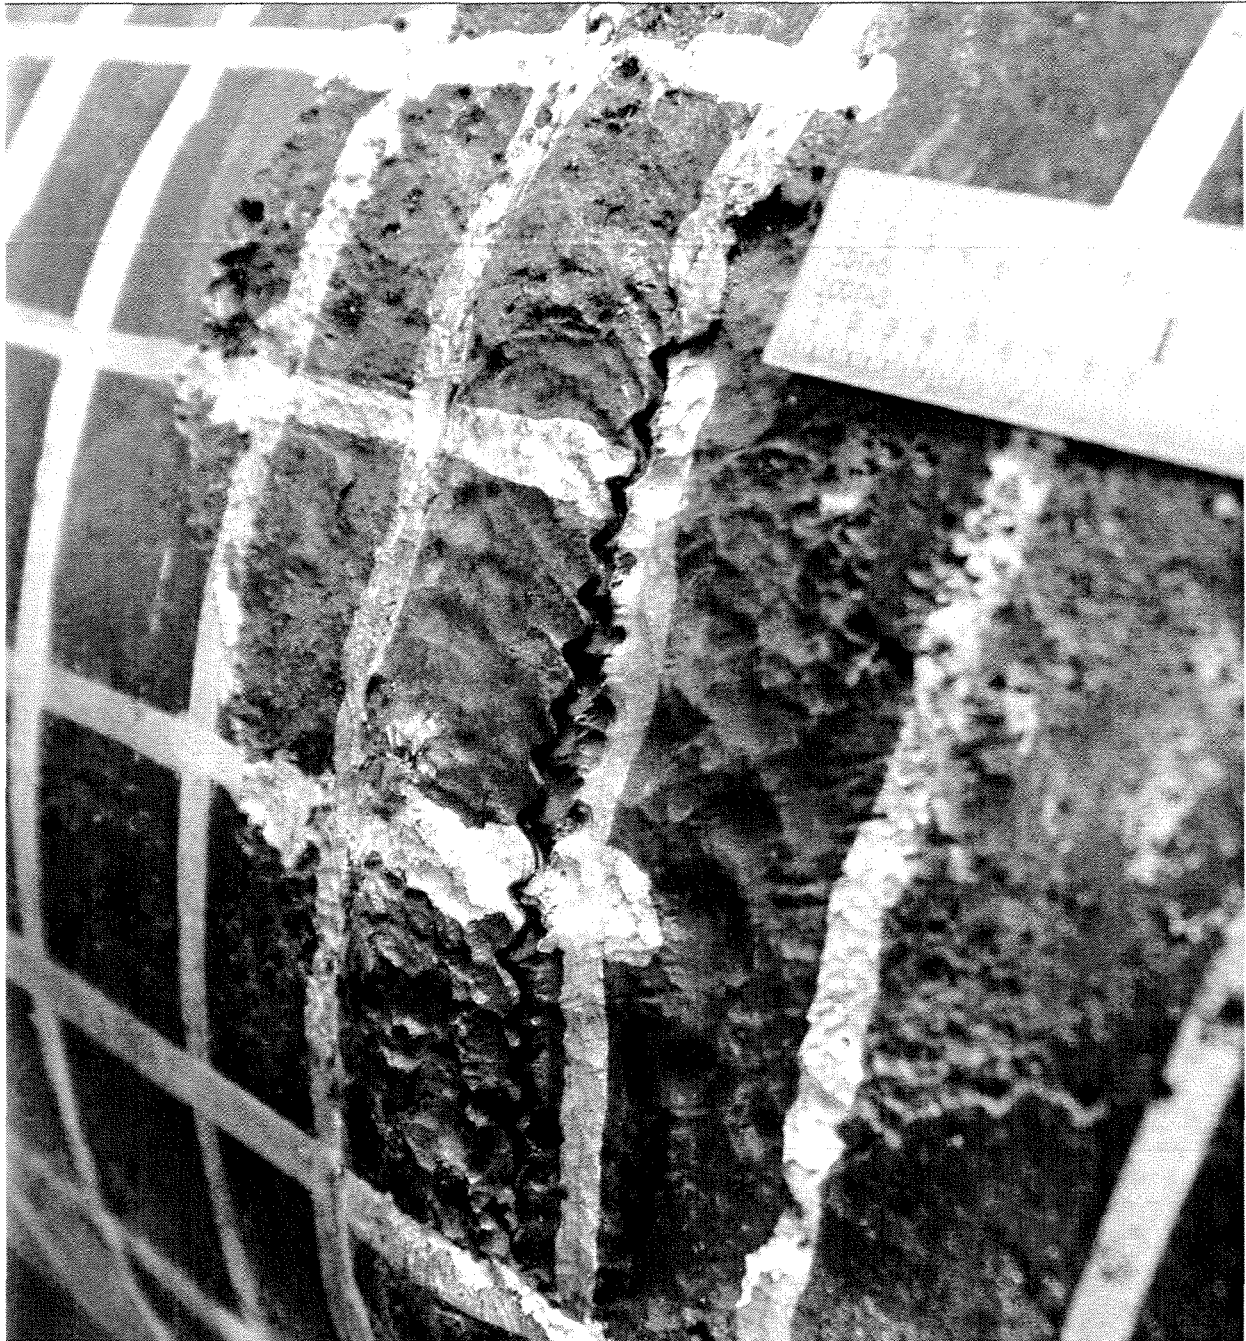
**Figure 22 – Second view showing detail of the corrosion undercutting the toe of the weld**

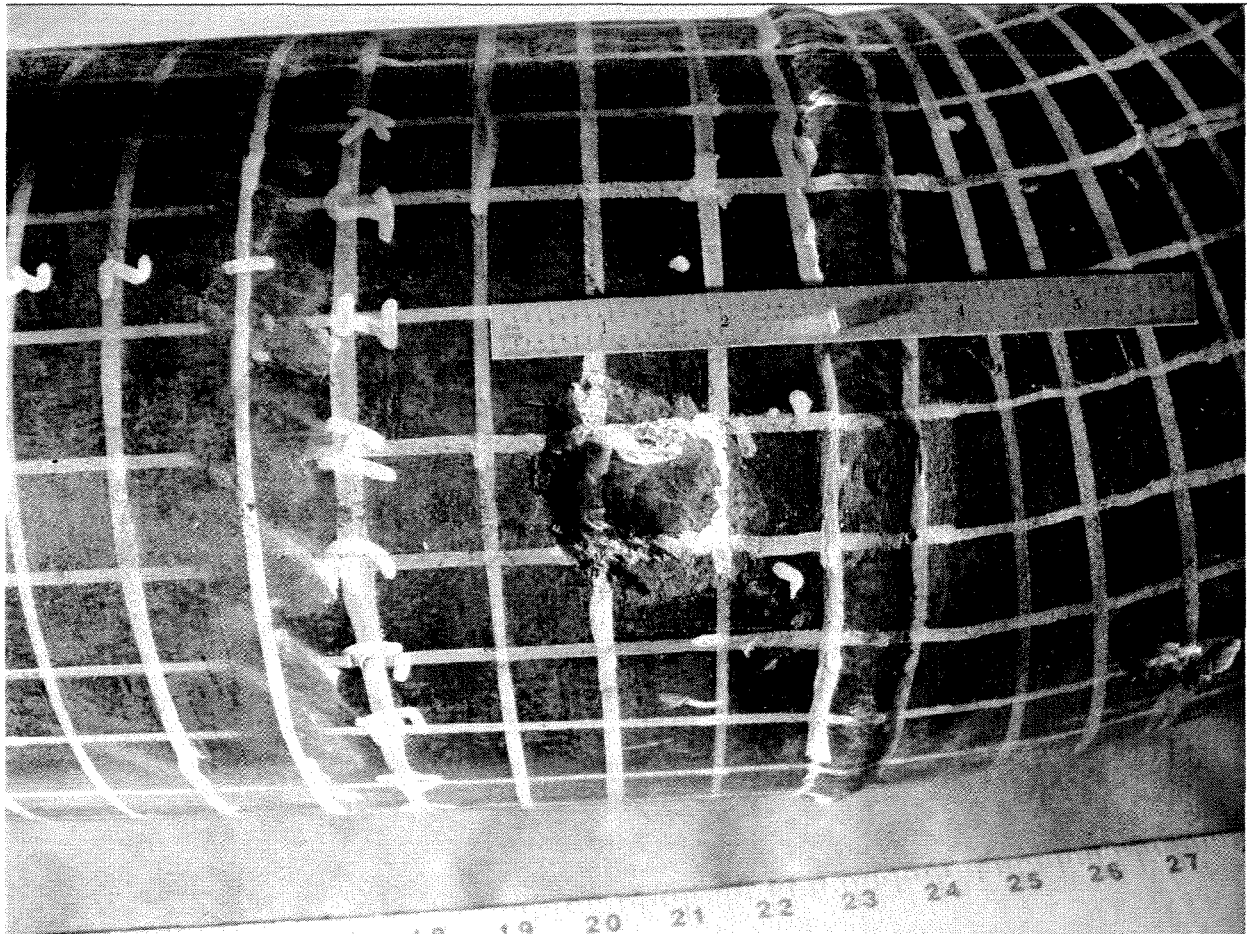
**Figure 23 – External corrosion on the pipe (as-received condition), designated Area 6. Note absence of corrosion around this pit.**
