Project: 0900235.00  
Report: 0900235.402 R0

Subject: **Analysis of 8" Condensate Water Storage Tank Return Line CD-183  
Final report**

**ANALYSIS OF 8" CONDENSATE RETURN LINE FAILURE**

Entergy, Indian Point Nuclear Station

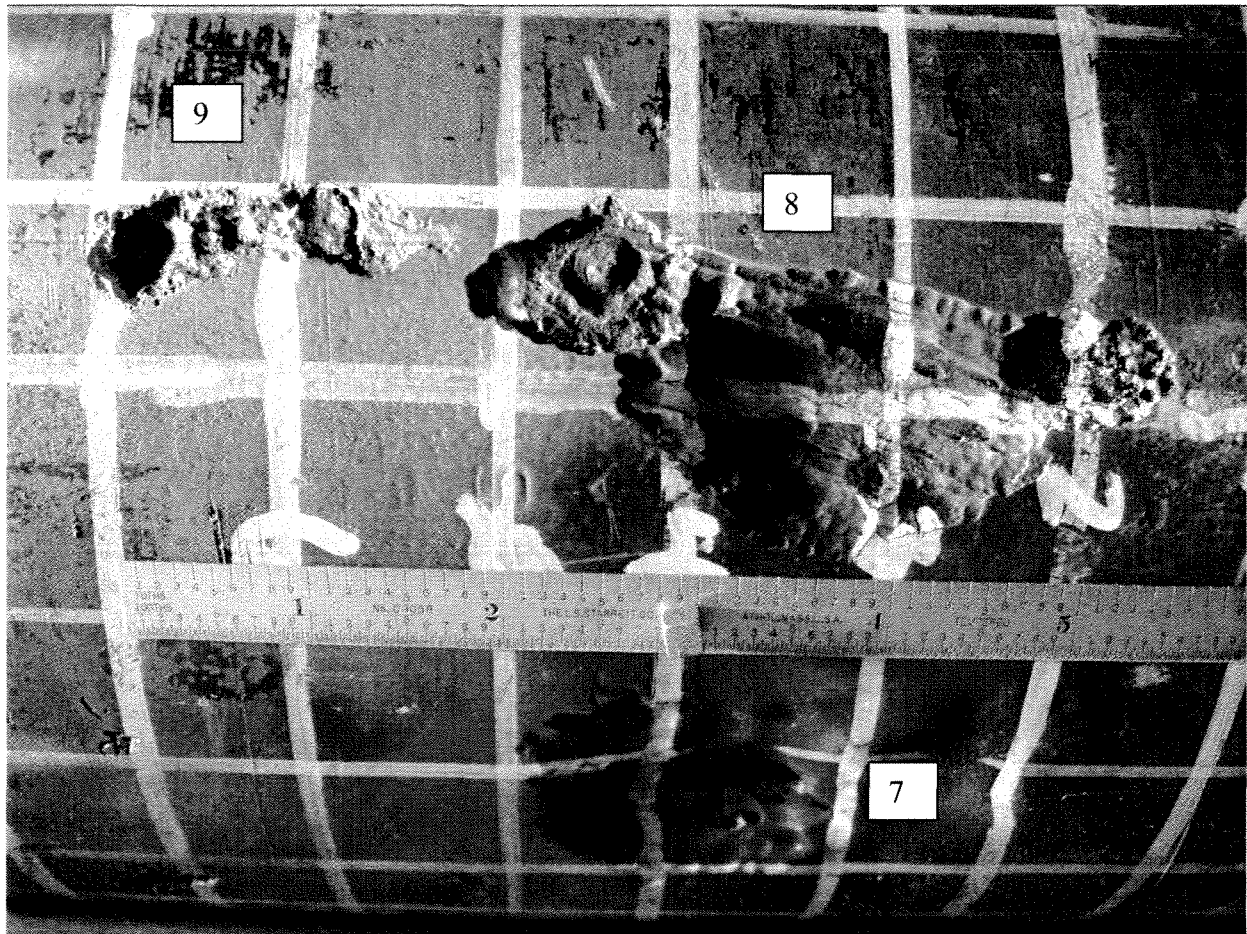
**Figure 24 – Outside surface of pipe (as received) showing leak and two other areas of corrosion in addition to identifying “YS” and “API” stamp marks. Areas designated 7, 8, and 9**

A very subtle feature that appeared to be an ERW seam runs horizontally through the “YS” stamp mark. Youngstown Steel manufactured both seamless pipe and ERW pipe in this size range. Only the seamless pipe could have met the requirements of ASTM A106. Subsequent metallographic examination of the location showed no microstructural evidence of a seam and the seam-like feature may be the remnants of the embossing wheel that produced the “YS” stamp during the manufacturing process of seamless pipe. The area surrounding the leak (Area 7) was eroded and polished as a result of turbulent water in the area of the leak. In comparison, areas of metal loss a few inches or more from the leak (i.e., see areas 8 and 9) have irregular topographies typical of corrosion that has not been modified by erosion.

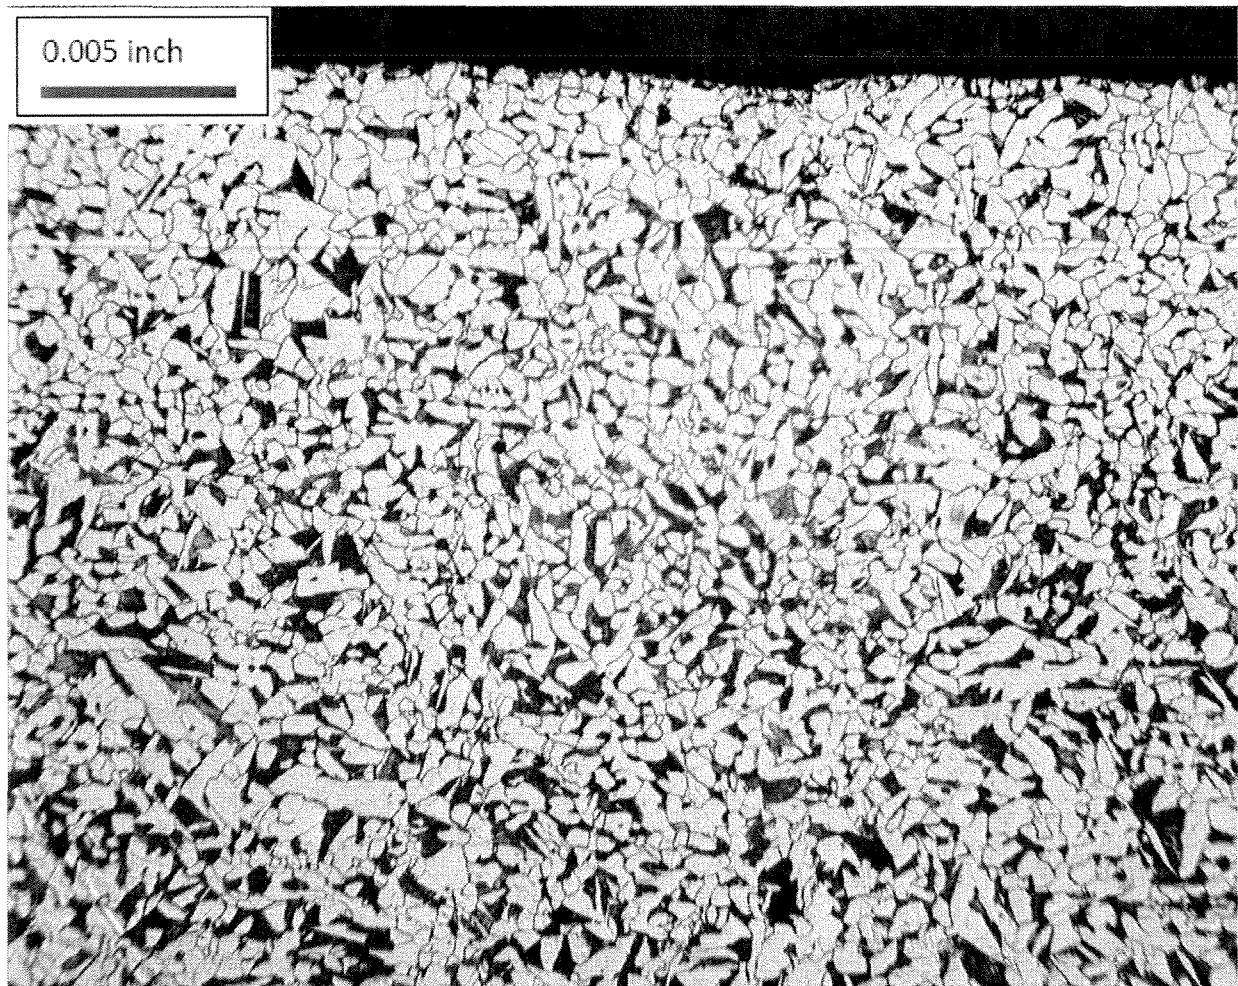
**Figure 46 - Microstructure of pipe at outside surface.**

There is no external corrosion at this location. The outside surface is at the top of the figure.

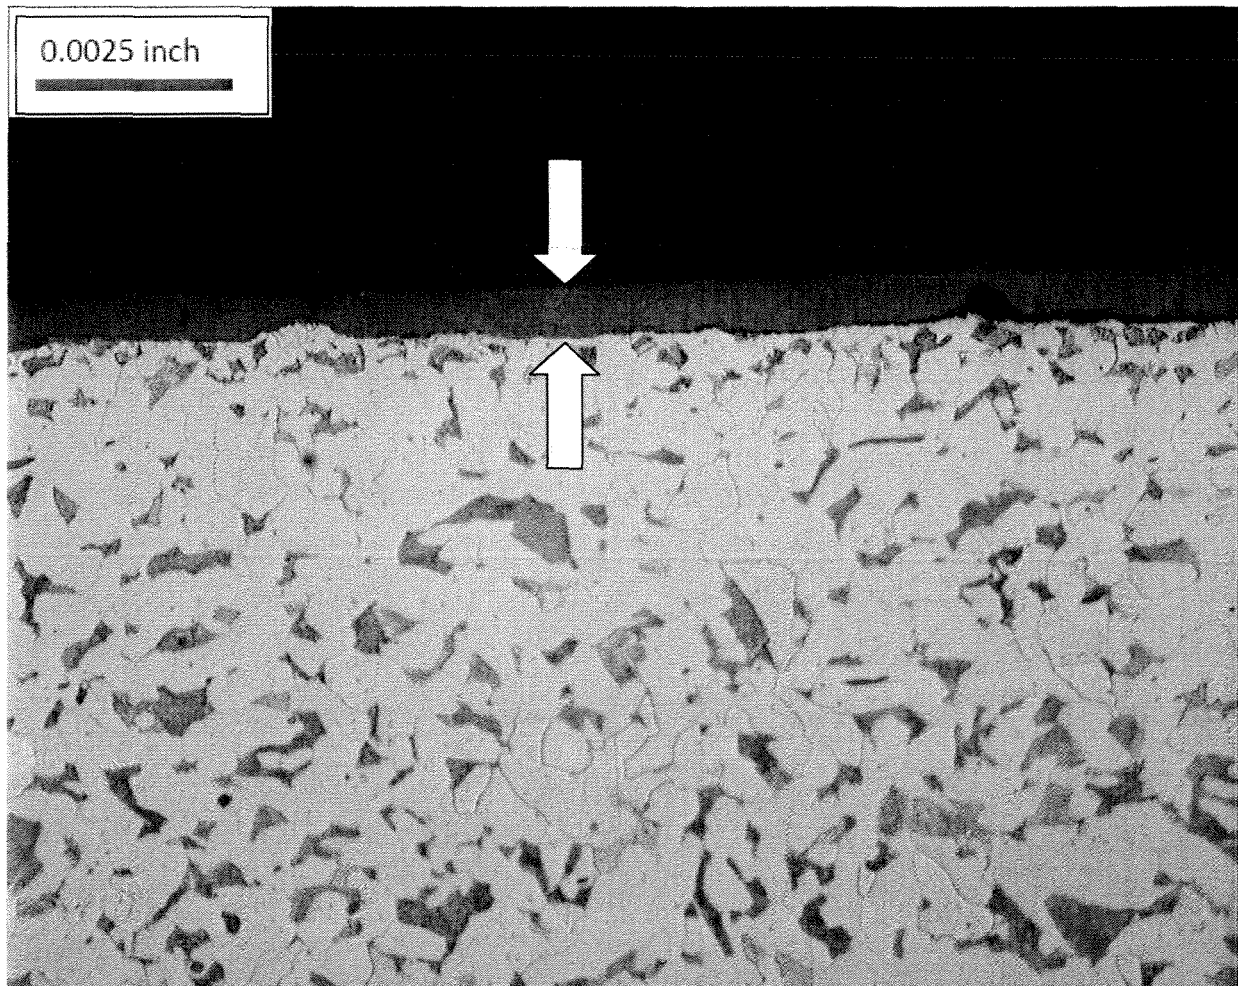
**Figure 47 - Cross section through the pipe immediately adjacent to an external corrosion pit showing intact mill scale (between arrows)**

The presence of intact mill scale indicates that there was no corrosion on this surface and that there was no surface preparation prior to external coating. A small amount of decarburization of the surface is present, as expected for this type of steel product.

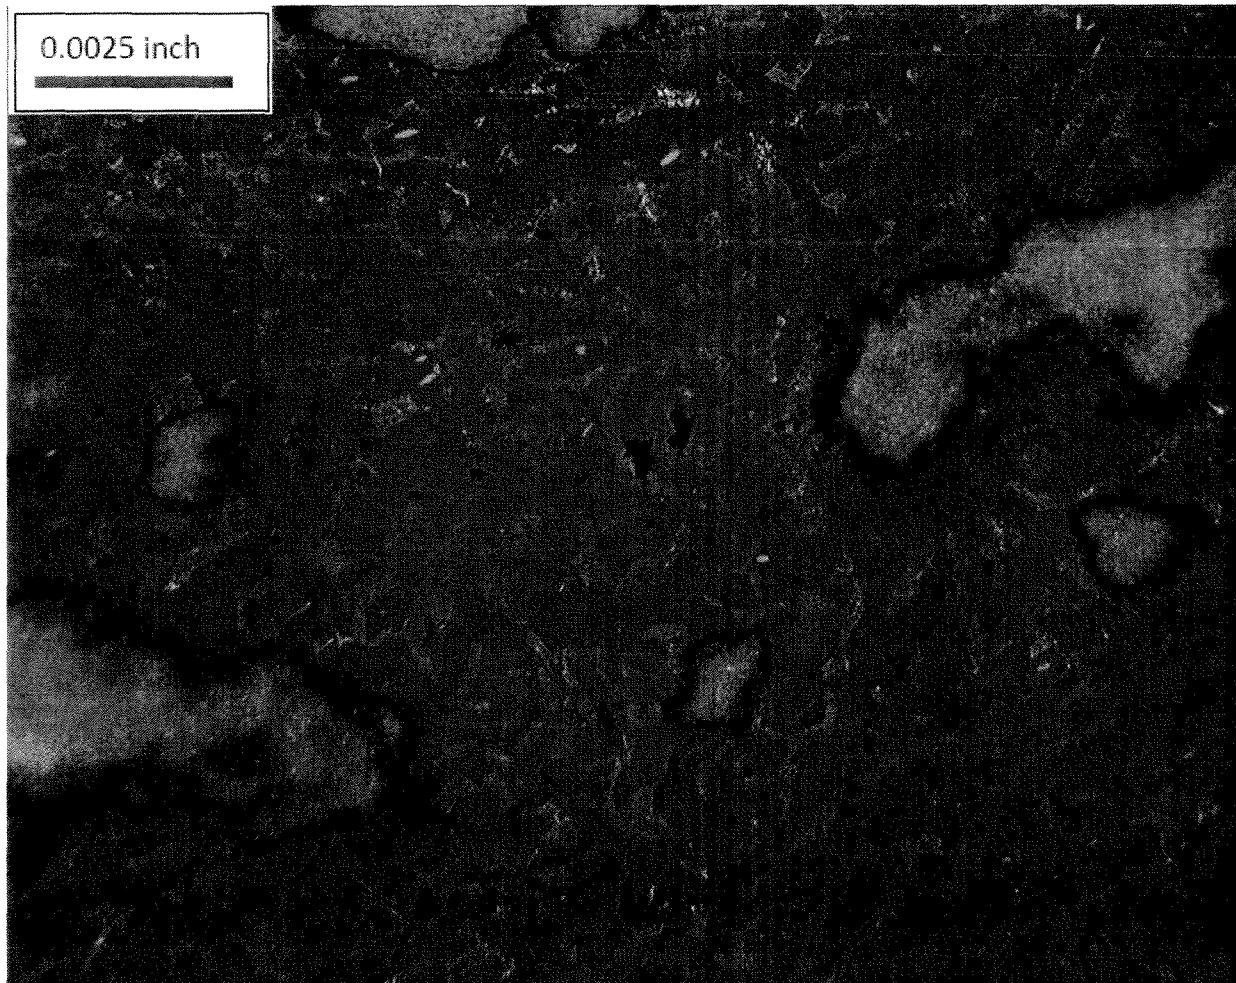
**Figure 48- Detail of corrosion product in a pit on the outside of the pipe**

The corrosion has preferentially corroded the proeutectoid ferrite and the ferrite lamellae of the pearlite leaving the iron carbide constituent of the pearlite grains uncorroded. The resulting shiny irregular globular-shaped areas replicate in the corrosion product the size and shape of the original pearlite grains. This appearance is typical of iron carbonate corrosion products.
