Entergy Operations, Indian Point Energy Center

Root Cause Analysis Report

CST Underground Recirc Line Leak

CR-IP2-2009-00666

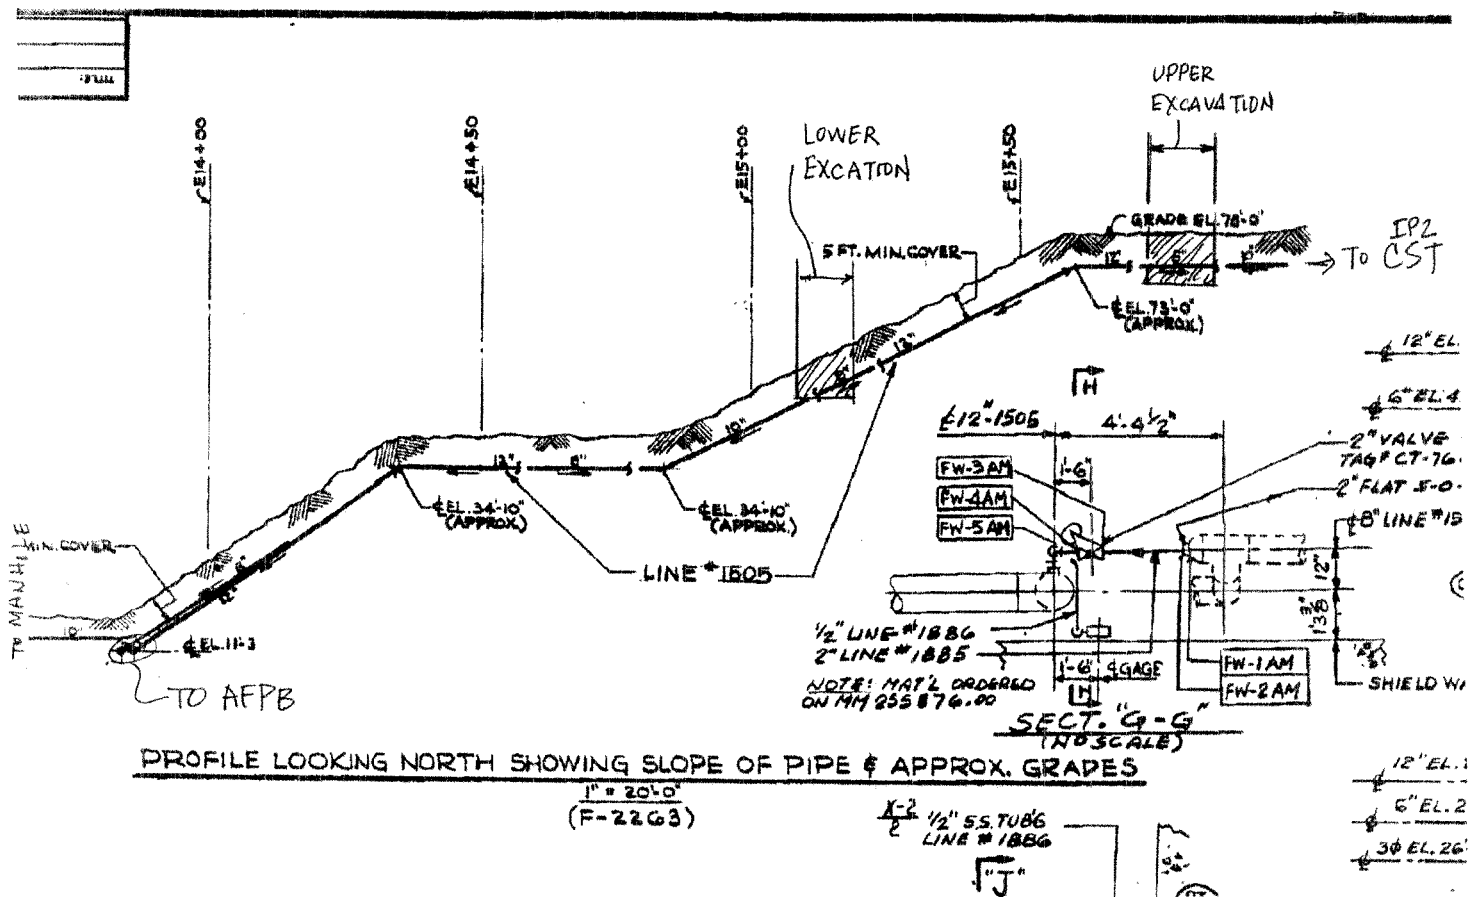
8" LINE 1509

The visual inspection of these pipes at the lower excavation revealed that they were in generally good condition, with the coating intact and in acceptable condition. A minor coating repair was required at one location on 8" Line 1509 and the 10" overflow line required repair at the top portion of the pipe at the crests of the corrugations, possibly indicative of coating damage during the digging. Based on the results of these pipe visual inspections (at the upper and lower holes), and the coating repairs performed, there was no evidence of any significant pipe degradation that would warrant the re-inspection of these pipes at the same locations. Future inspection of these lines will be performed at different location(s) along their length. The scheduling of the future inspections will be controlled under the IPEC Buried Pipe Program. Specifically for the CST lines, CA-5 of CR IP2-2008-04754 reads, "Given the results of the leak in the AFP Building, determine if the scope and/or frequency of future buried condensate lines should be modified. This should cover both IP2 and IP3." See elevation drawing on the next page.

Completed assessments of these lines determined these lines to be of HIGH impact (two lines are safety related), MEDIUM corrosion risk and HIGH inspection priority. The HIGH inspection priority results from the safety function performed by Lines 1505 and 1509. The pipe material, soil resistivity and site condition factors result in these lines being of medium corrosion risk. Accordingly, with the initial inspection of these lines performed in October/November 2008, re-inspection of these lines is required within eight years, or by September 2016.
