Edwin I. Hatch Nuclear Plant - Unit 1
HNP-ISI-ALT-14, Version 2.0
Temporary Non-Code Repair of Plant Service Water Piping

**Edwin I. Hatch Nuclear Plant – Unit 1
HNP-ISI-ALT-14, Version 2.0
Temporary Non-Code Repair of Plant Service Water Piping**

**Alternative HNP-ISI-ALT-14, Version 2.0
Temporary Non-Code Repair of Plant Service Water Piping**

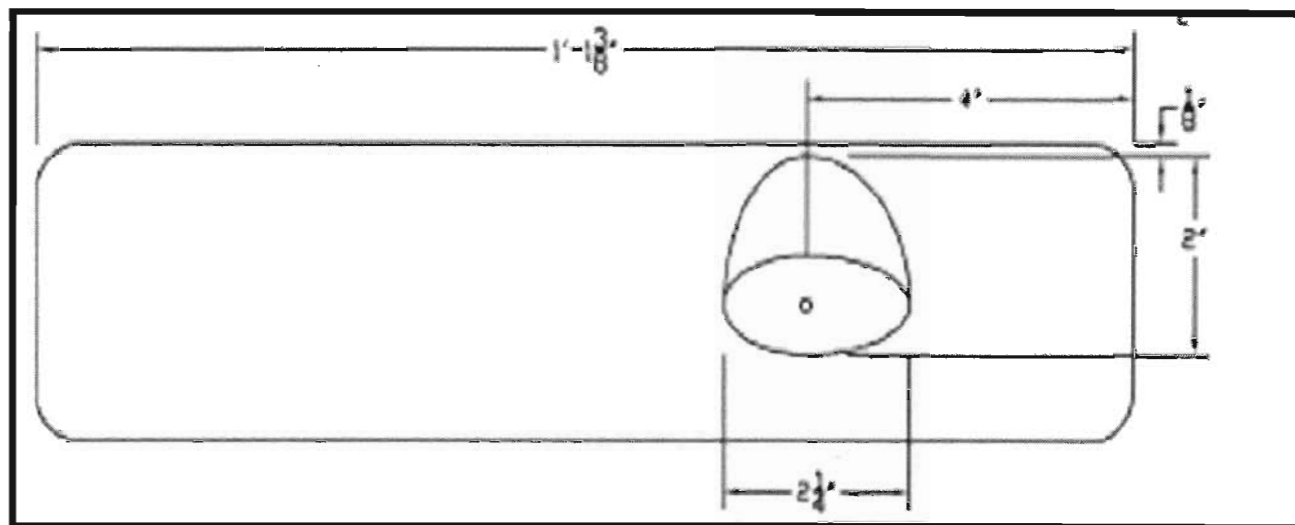
Sketch 1 from Figure 4 – Measured Details for Plate #2

This location is at the 7 o'clock position looking south. The size of this plate was based on inputs from the UT measurements taken as requested by the SNC Corporate Stress Group (ref. Figure 3). The UT examiner was asked to find where the wall thickness measured at least 0.200-inches and at least 0.300-inches away from each leaking location in four directions. The examiner was able to get seven UT readings; however, a measurement could not be obtained for the ultrasonic point for the 0.200-inch location at the "upper" side for Location #2 because of ID surface irregularities. After finalization of Version

Several repair/replacement activities were evaluated and it is proposed that the addition of two contoured plates to the affected sections of piping by means of welding be made to isolate the leaks (see Figure 4). This option allows the welding on the two attachments to be located in an area with minimal degradation, ensuring a structurally sound load path while minimizing the risk of "burn-through" and increased leakage. The design will also ensure that the configuration of the repair will allow continued wall thickness monitoring of the region by ultrasonic examination to ensure that future degradation will not adversely impact the structural capability of the repaired section.

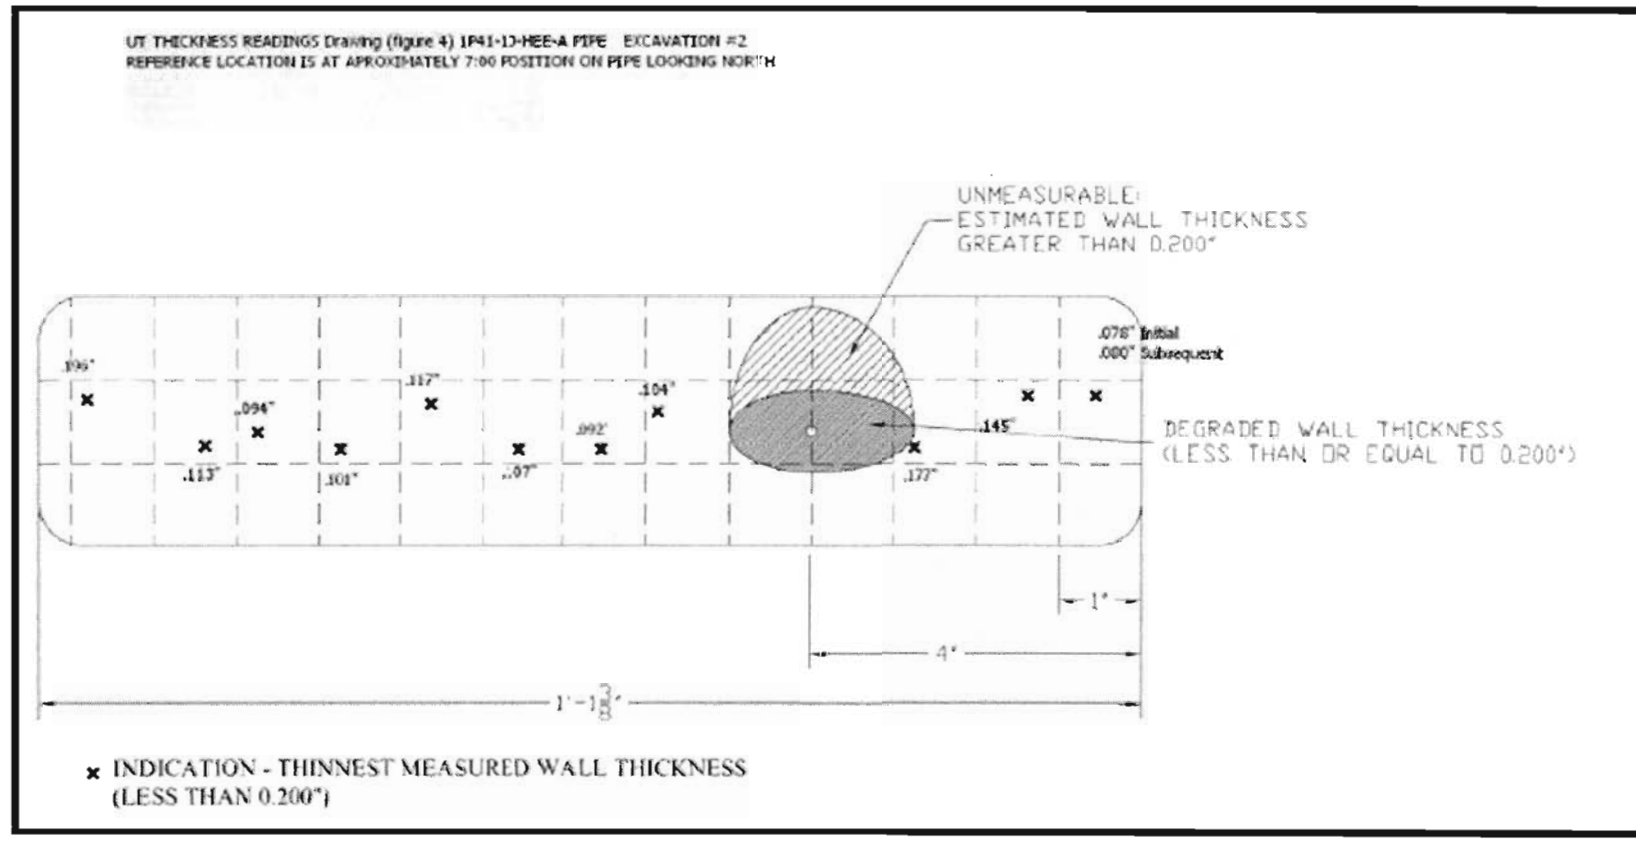
Sketch 2 from Figure 4 – Best Estimate Details for Plate #2

As noted above, ID surface irregularities limited the UT thickness measurements. Although this cannot be confirmed, SNC is of the opinion that a better representation of the thickness at Location #2 is depicted in the enclosed Sketch 2.
