PNP 2012-001

January 31, 2012

SUBJECT: Licensee Event Report 2011-004-01, Turbine-Driven Auxiliary
Feedwater Pump Inoperable in Excess of Technical Specification
Requirements Due to Unexpected Trip

Palisades Nuclear Plant
Docket 50-255
License No. DPR-20

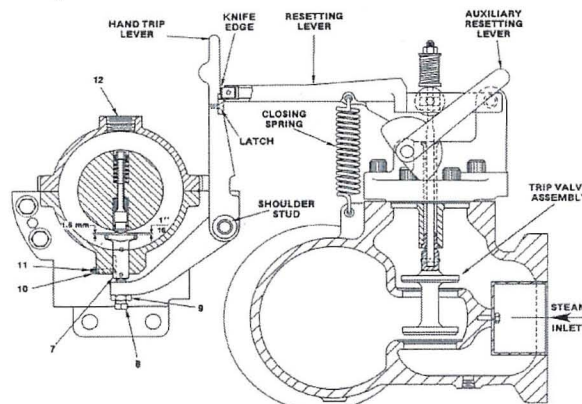
On May 10, 2011, during TS surveillance test, RO-97, "AFW Automatic Initiation Test," P-8B, tripped due to the unexpected actuation of the mechanical overspeed trip linkage allowing the trip valve assembly to isolate steam flow to the turbine-driver. An examination revealed that the knife-edge of the trip resetting lever had disengaged from the hand trip lever latch area allowing the trip valve assembly to isolate steam flow to the turbine-driver.

The initial causal evaluation determined supplemental contract employees had inappropriately applied grease to knife-edge area on the mechanical overspeed trip linkage during maintenance activities performed in the October 2010 refueling outage. Based on the information available at that time, the greasing of the knife-edge on the mechanical overspeed trip linkage was considered to be the sole cause of the P-8B trip.

Subsequent discussions with the turbine vendor revealed other possible causes for the trip could have existed. Greasing of the knife-edge area may not have been the only cause. To address the actual impact of the greased knife-edge condition, Entergy Nuclear Operations, Inc. (ENO) contracted an independent engineering firm to perform a force analysis on the overspeed trip mechanism components. The preliminary force analysis results showed that the greasing of the knife-edge area on the mechanical overspeed trip linkage alone would not have caused the trip.

The root cause evaluation did not identify any single physical cause for the pump trip. Several potential physical causes were identified. The evaluation concluded that preparation for, and execution of, the P-8B turbine overhaul during October 2010 refueling outage did not maintain the turbine and turbine governor in a manner that ensured overspeed trip reliability.

The conclusion of the independent engineering firm's formal force analysis remained the same. Greasing of the knife-edge area on the mechanical overspeed trip linkage alone, could not have caused the overspeed trip.

On May 11, 2011, the grease was removed from the mechanical overspeed trip linkage, the mechanical overspeed trip linkage was reset, and TS surveillance test, RO-97, was completed satisfactorily. On May 12, 2011, after satisfactory completion of TS surveillance test, QO-21, P-8B was returned to operable status. During the October 2011 maintenance outage, all the identified potential physical causes for the overspeed trip were addressed to ensure overspeed trip reliability.

Planned corrective actions include a revision to the applicable maintenance procedure to incorporate vendor recommendations, process enhancements in the identification of critical maintenance activities and ensuring appropriate oversight of supplemental workers performing critical maintenance activities.
