**GE Hitachi Nuclear Energy**

February 01, 2012  
MFN 12-006 R0

**Subject: Part 21 60-Day Interim Report Notification:  
Failure of CRD Collet Retainer Tube/Outer Tube Weld**

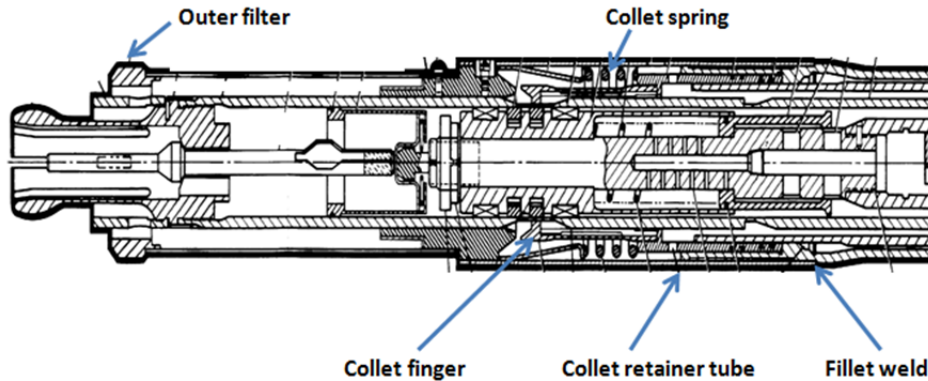
The recent refurbishment of a CRD G003 CTF assembly revealed a 360 degree failure around the collet retainer tube weld which was also completely separated, with a 0.15” displacement of the collet housing from the outer tube. This is the first occurrence of this type failure on any CTF assembly observed by GEH. It is noted that the CRD continued to perform normally, including scram, while in service.

The fillet weld design in question is applicable to all 919D258G002 and G003 Cylinder, Tube and Flange assemblies since the collet retainer tube material, part configuration and fillet weld design are the same for both groups. This fillet weld is located on the Outer Tube Assembly and is part of the Cylinder, Tube and Flange (CTF) assembly of the CRD mechanism.

The G003 CTF containing the failed fillet weld was removed from service in 2011. The collet retainer tube displacement was observed to be 0.15 inches. In addition to this observed displacement, two other dimensions provide an upper bound to the potential movement of the collet retainer tube:

Although not confirmed, preliminary indication suggests that the weld failure may be attributed to the lack of weld penetration and fusion to the base materials.

GEH recommends normal CRD surveillance testing in accordance with the plants' Technical Specification Surveillance Requirements. A failure of this fillet weld resulting in separation and full displacement of the collet retainer tube and affecting the operation of the CRD would be identified during the surveillance testing.

GEH recommends that all sites continue to perform scheduled maintenance on CRD assemblies and perform dye penetrant inspections of this weld area as previously described in GE SIL139 supplement 6.
