PART 21 REPORT - FOREIGN MATERIAL FOUND IN EMERGENCY DIESEL GENERATOR HIGH PRESSURE FUEL HOSE

Report No. 10CFR21-0104

COMPONENT: NPPD fuel hose 2-01H-050-003

SYSTEM: Emergency Diesel Generator

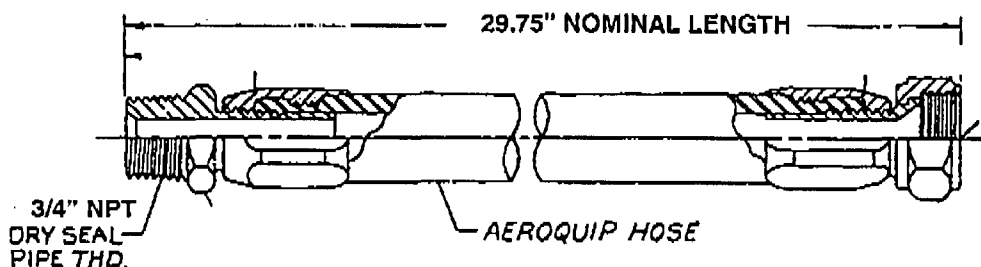
FIGURE 1
FUEL HOSE #2-01H-050-003

The foreign material found during inspection of the returned hose assembly was determined to be very small pieces of the elastomer tube internal to the hose. It appears these pieces were introduced during assembly of the end fittings onto the hose during fabrication of the hose assembly.

This hose is used in the fuel oil supply piping on the KSV diesel engine; it is located in the piping between the engine fuel filter and the fuel injector pumps (see Figure 1 and 2) and is unique to the NPPD-Cooper Station engines.

Hoses remaining in customer inventory should be inspected to verify they are free of foreign material prior to installation. Any hoses previously installed on the EDG are not suspect as operability has been confirmed via functional testing.

To prevent recurrence of this issue, the dedication report for the hose assembly has been revised to include a requirement to solvent flush each hose prior to shipment. Filtered solvent will be pumped through the hose for a minimum of 5 minutes. After flushing, nitrogen will be blown through the hose to remove excess flushing fluid and a detailed visual inspection will be performed to ensure there are no visible contaminants immediately prior to installation of the hose end caps. This flushing requirement was already included in the dedication reports for other critical application hose assemblies so this notification is being limited to this part number only.

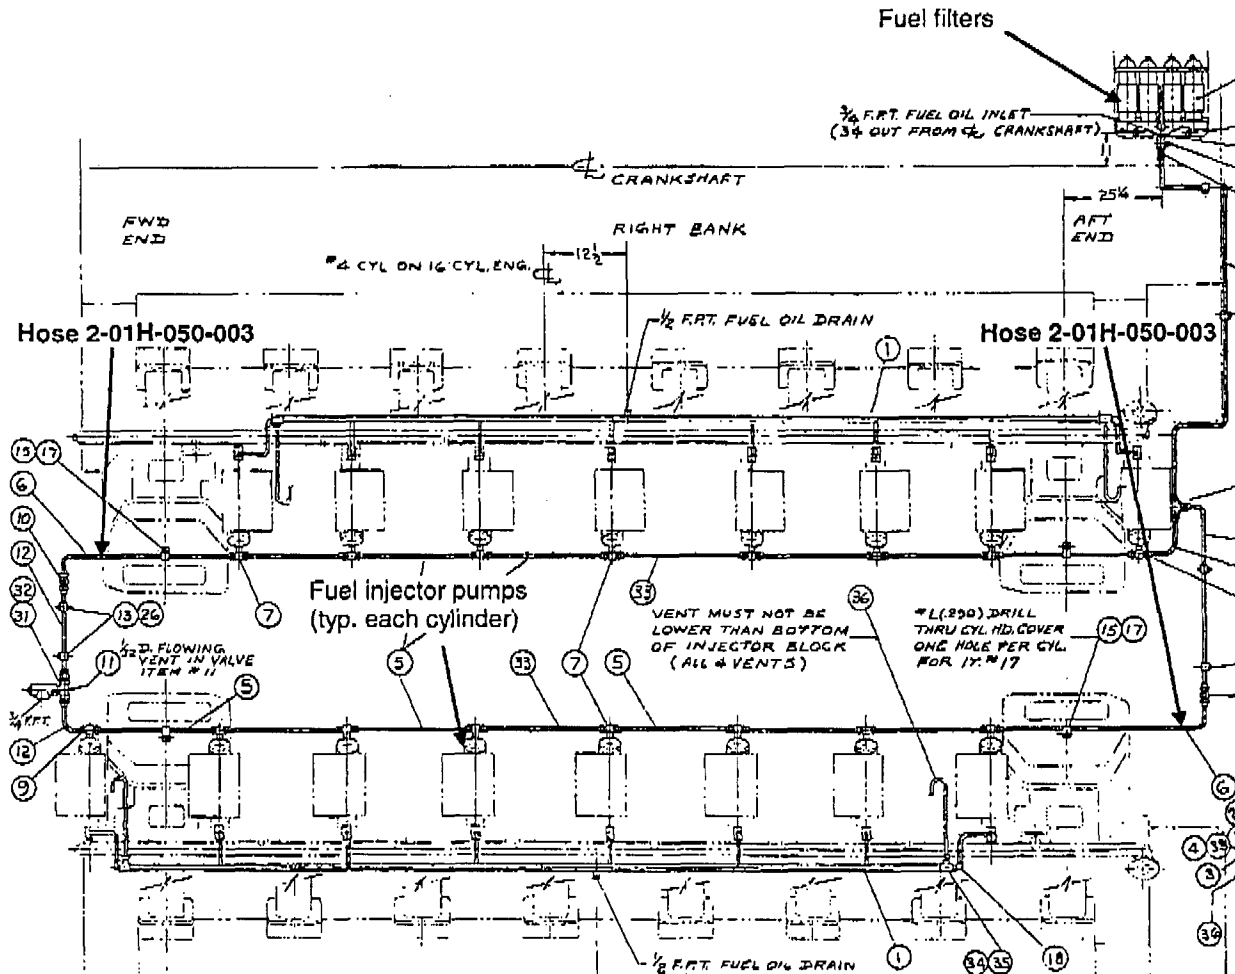
FIGURE 2
LOCATIONS OF FUEL HOSE #2-01H-050-003

The hose, P/N 2-01H-050-003, is located after the engine fuel filter and before the fuel injection pumps. Foreign material within this hose could migrate to the fuel injection pumps. The entrance of foreign material could impact operability of one or more fuel injection pumps and therefore affect fuel delivery to one or more engine cylinders. This could impact the load carrying capability of the diesel engine or possibly complete engine shutdown. Either scenario has the potential to prevent the emergency diesel generator from performing its safety related function.
