**VIRGINIA ELECTRIC AND POWER COMPANY (DOMINION)**  
**NORTH ANNA POWER STATION UNIT 1**  
**STEAM GENERATOR TUBE INSPECTION REPORT**

**NORTH ANNA UNIT 1  
180-DAY NRC REPORT REGARDING STEAM GENERATOR TUBE INSPECTION  
PER TECHNICAL SPECIFICATION 5.6.7**

## FALL 2011 - NORTH ANNA UNIT 1 STEAM GENERATOR INSPECTIONS

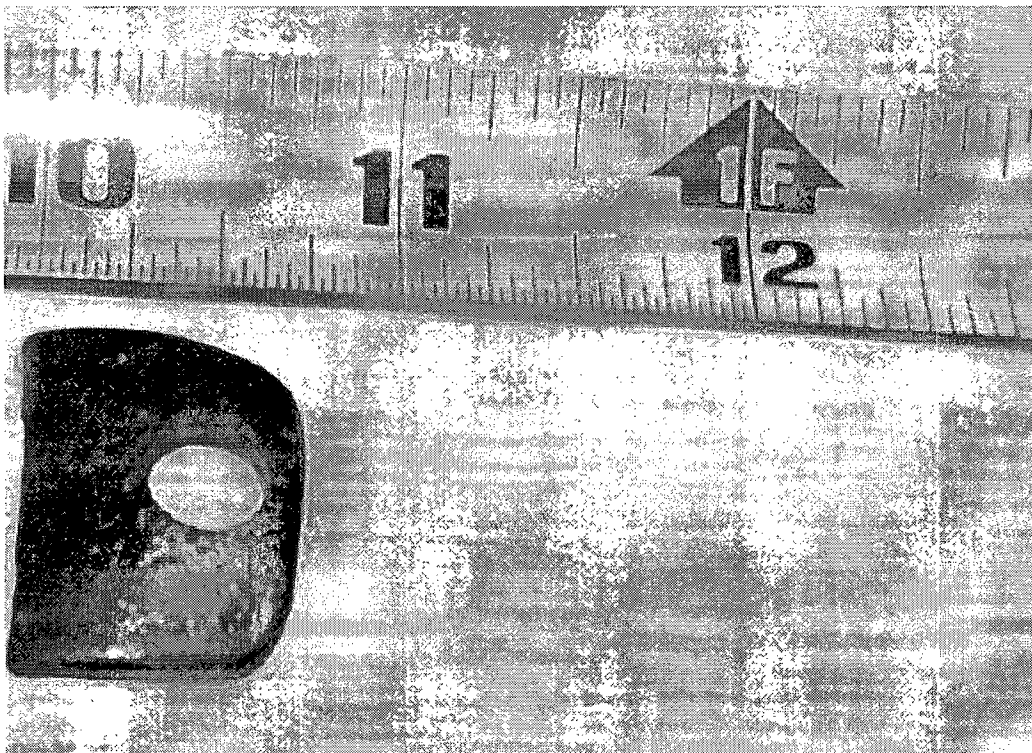
**Figure 1 – SG A Primary Side Foreign Object**

Two foreign objects were identified within the hot leg channel head of SG "A." One object was found to be protruding slightly from tube SGA R29C21. This object was removed from the tube (Figure 1). Post-removal, full length bobbin probe examination, and +Point probe examination of the full tubesheet depth confirmed that the foreign object caused no tube degradation. The second object was identified lying on the bottom of the hot leg channel head bowl and was successfully removed (Figure 2). Both objects appear to have originated from the same part (Figure 3) – possibly a conduit / pipe support clamp – and are 300 series stainless steel. A visual examination of the tubesheet revealed no evidence of tube end or cladding damage.
