NRC Lessons Learned - External Events

Rebecca Karas
Office of New Reactors
U.S. Nuclear Regulatory Commission
February 8, 2012

Experience with North Anna Power Station Restart after 23-8-2011 Virginia Earthquake

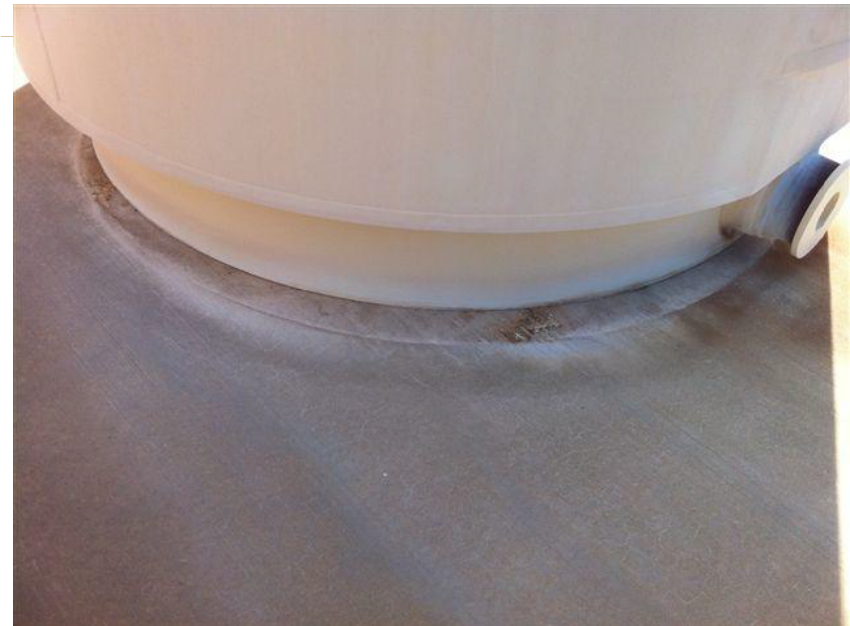
Dry Cask Storage

25 of 27 TransNuclear
vertical casks moved
between 1 and 4 ½ inches

NUHOMS horizontal
modules had small gaps and
corners cracked

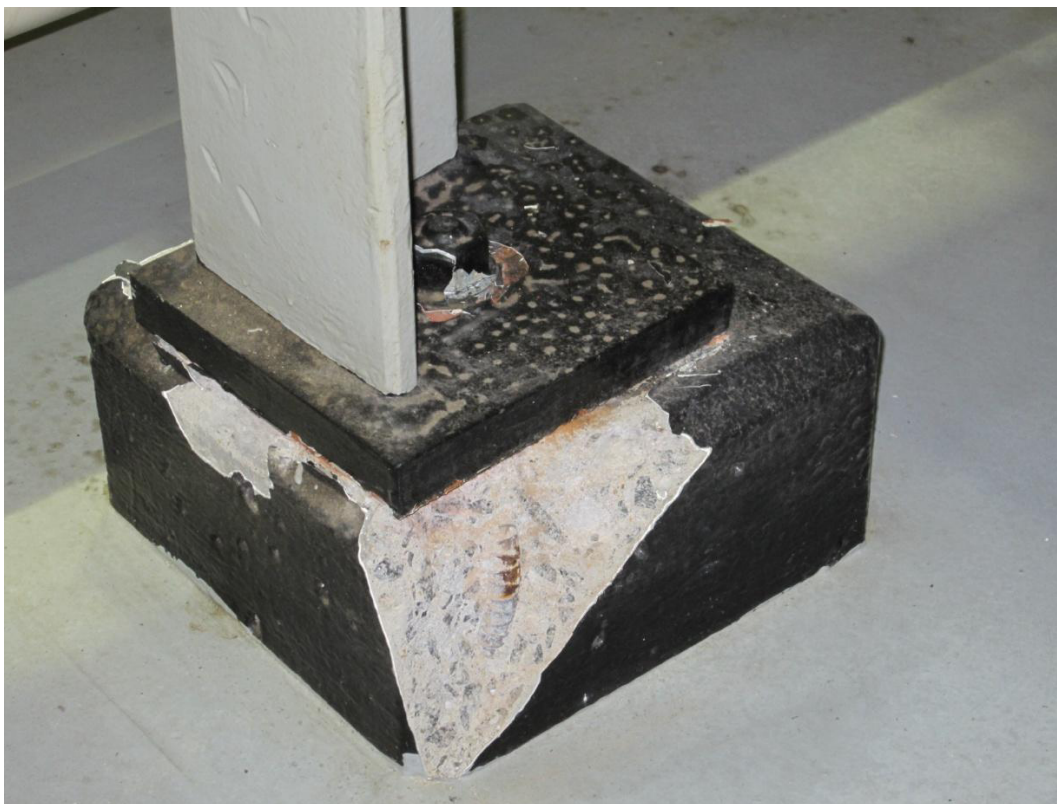
U2 Turbine Building

Powdex
Demineralizer
Tanks Base
Pedestal (non-
safety related)

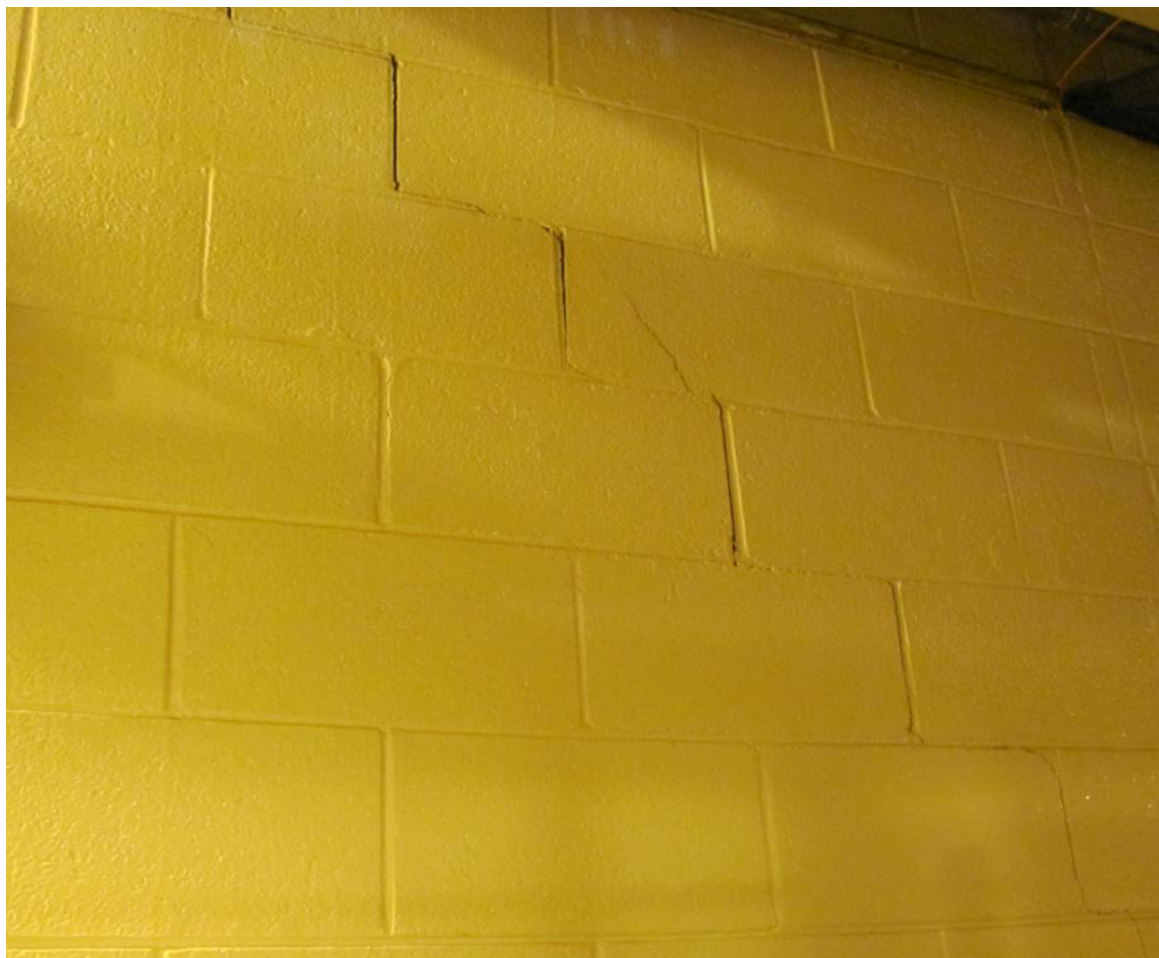
Turbine Building Hallway

Crack In
Unreinforced
Non–Safety
Related
Block
Wall

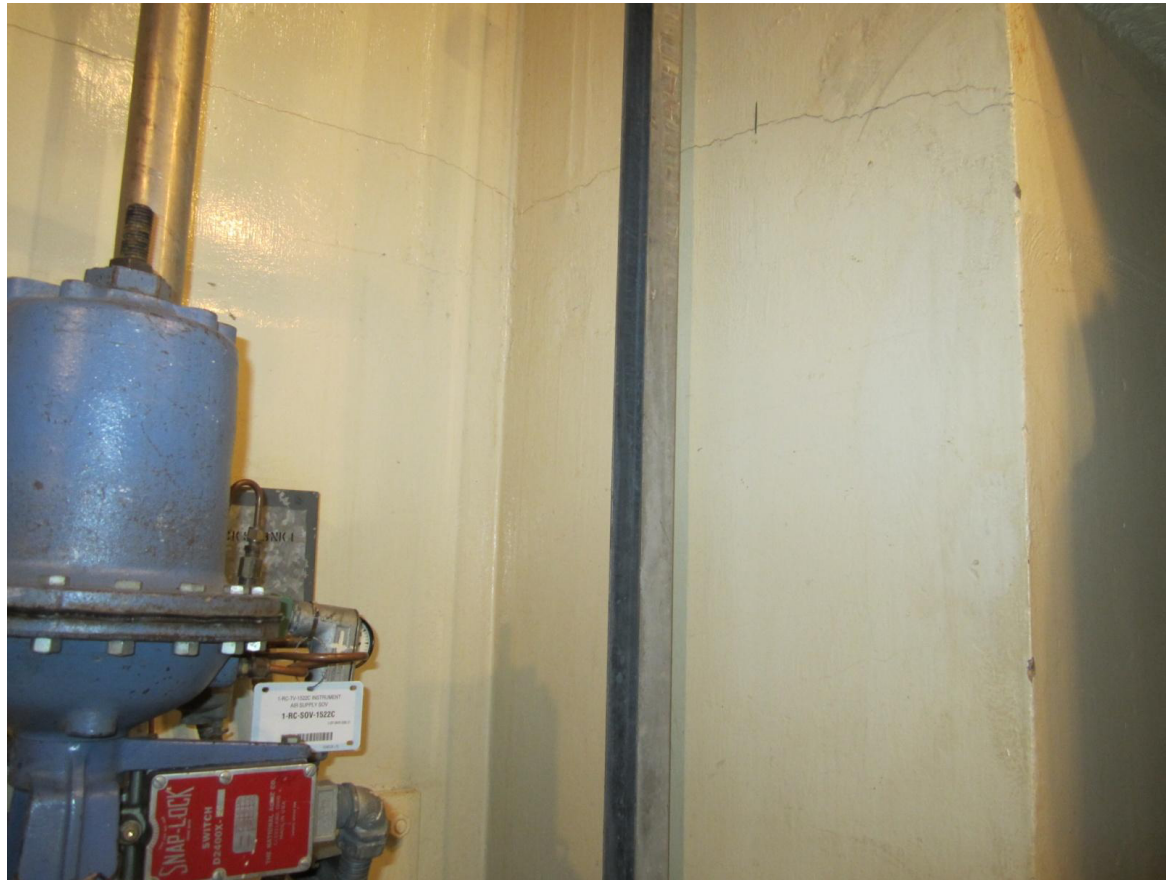
Unit 1 Containment

Surface Crack In Interior Containment Wall

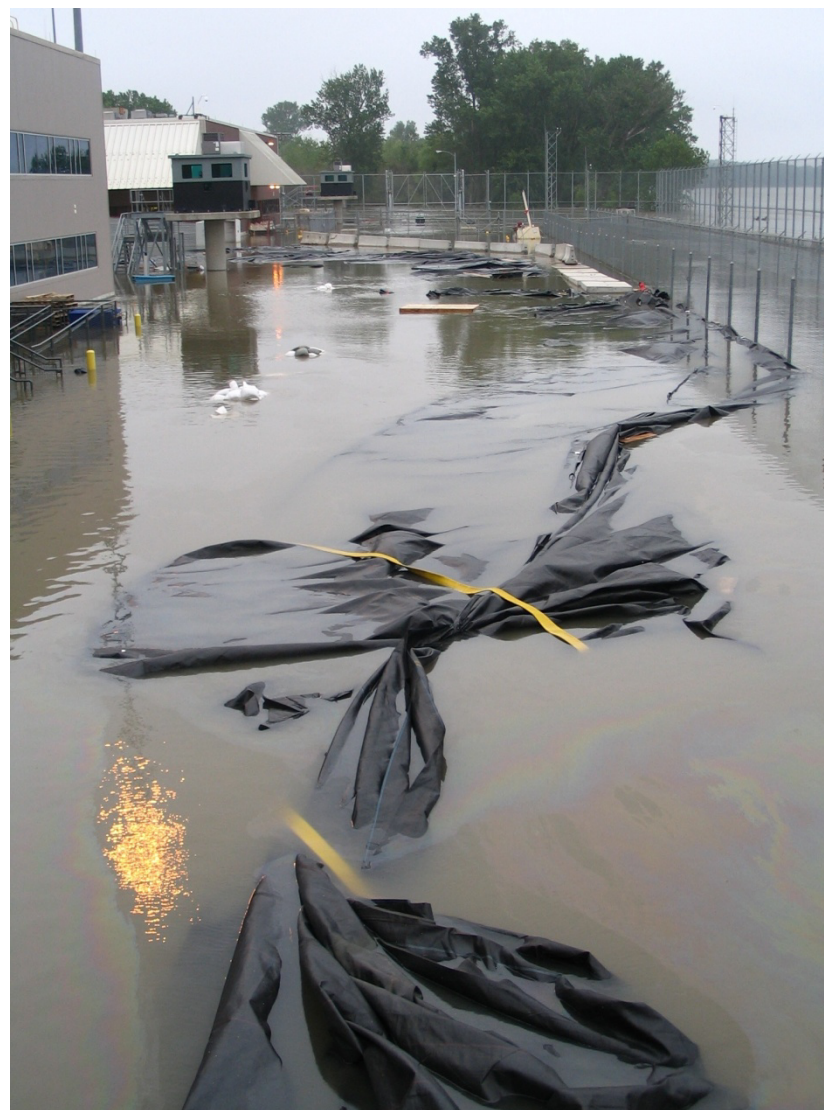
Failure of Aquadam

- On June 25, 2011, the river level at Fort Calhoun peaked at 1006 feet and 10 inches.
- On June 26, 2011, a small front-end loader ran into the Aquadam puncturing it
- Failure threatened the normal transformers and caused plant operators to disconnect from offsite power
- The NRC entered monitoring mode of emergency response

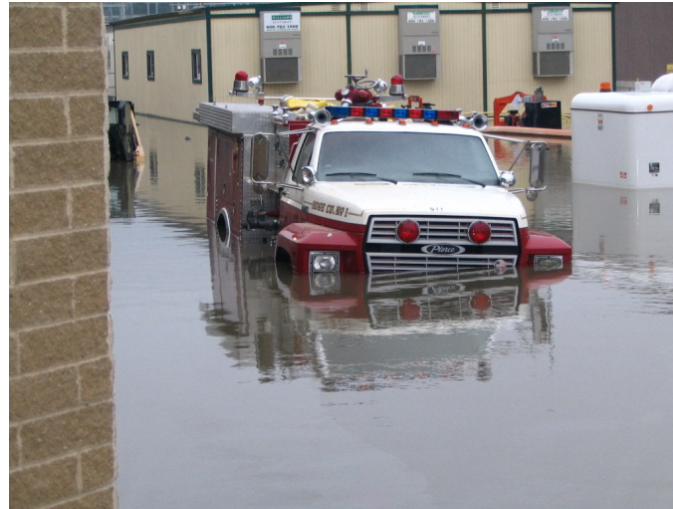
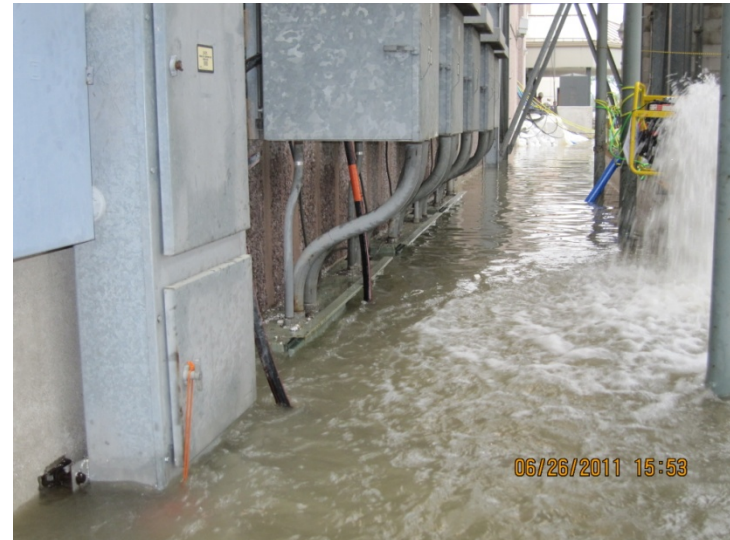
Failure of Aquadam

- The licensee's pumper truck for backup cooling water was partially submerged
- Actions by plant workers kept water out of the normal transformers
- Water entering a manhole quickly made it's way to the intake structure and threatened the raw water pumps
