From: Wiebe, Joel
Sent: Friday, February 10, 2012 11:13 AM
To: Joseph Bauer
Cc: David Gullott; Zimmerman, Jacob
Subject: Operating Experience to be sent to Quad Cities and Dresden Stations
Attachments: EN 7624 Byron 2.pdf; Beaver Valley LER.PDF; Fitz LER.PDF; NMP LER.PDF; EN 7636 Byron.pdf

SUBJECT:
Beaver Valley Power Station, Unit No. 1
Docket No. 50-334, License No. DPR-66
LER 2007-002-00

1. FACILITY NAME Beaver Valley Power Station Unit Number 1				2. DOCKET NUMBER 05000334		3. PAGE 1 of 7		
4. TITLE Undetected Loss of 138 kV 'A' Phase to System Station Service Transformer Leads to Condition Prohibited by Plant Technical Specification

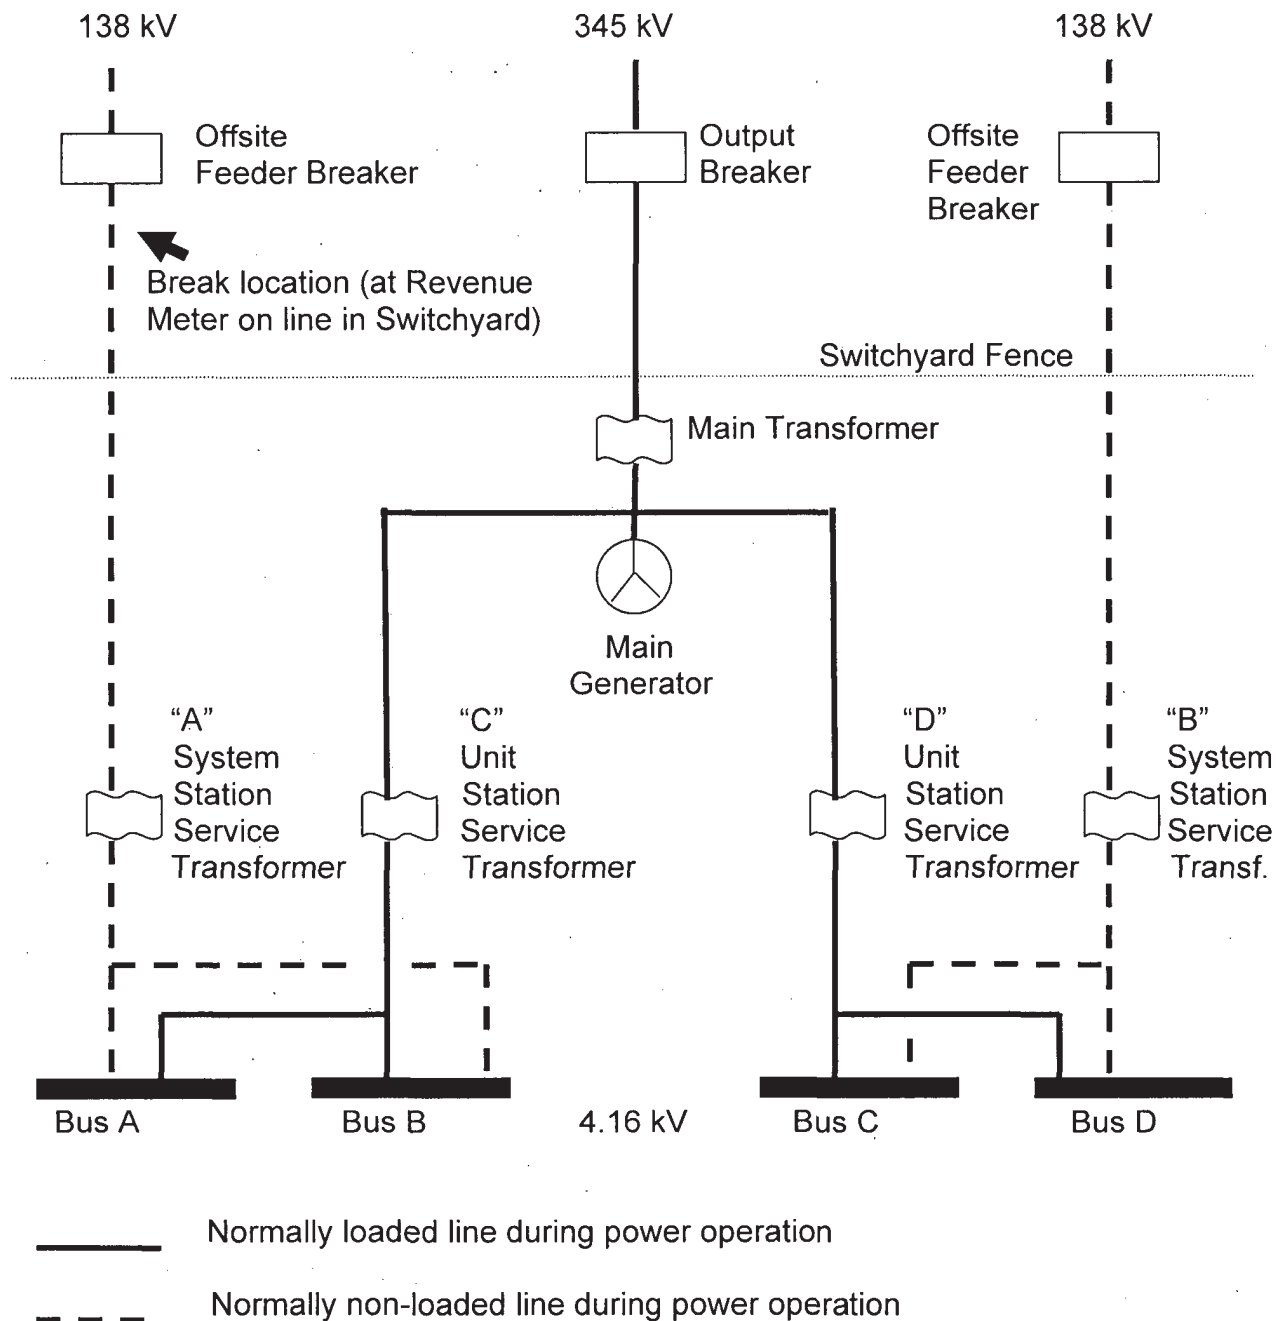
Simplified Unit Electrical Distribution Drawing

During a non-routine walkdown of the offsite switchyard on 11/27/2007, a site construction supervisor discovered that the 'A' phase conductor on a Beaver Valley Power Station Unit No. 1 (BVPS-1) three-phase 138 kV power line had broken off in the switchyard. This break occurred between the offsite feeder breaker (OCB-92-FDS) and the line running onsite to the 'A' train System Station Service Transformer (SSST) located inside the site security fence. The switchyard walkdown was being performed to investigate line voltage differences. The terminal broke on the switchyard side of a Revenue Metering Current Transformer/Voltage Transformer (CTVT), which was installed in 2006 to track the station's power usage through this line. During normal station power operation, there is no appreciable current going through this 138 kV line as the station busses (loads) are normally powered from the unit generator. [See simplified power sketch on page 7.]

On 11/27/2007, the line side high voltage terminal to the "A" phase revenue metering CTVT was found to be failed resulting in an open circuit. This failure de-energized one of the three offsite transformer primary phases ('A' phase) going to the 'A' Train BVPS-1 SSST. Computer information indicated that this phase was lost on 11/01/2007. This failure made the 'A' train SSST inoperable and thus, one of the two BVPS-1 safety related offsite circuits inoperable.
