THE UNIVERSITY OF TEXAS AT AUSTIN

*Nuclear Engineering Teaching Laboratory · <http://www.me.utexas.edu/~nuclear/index.php/netl>
1 University Station, R9000 · Austin, Texas · 78712 · (512) 232-5370 · Fax (512) 471-4589*

Subject: Docket 50-602, License no. R-129 Licensee Event Report 47625 Followup
Report

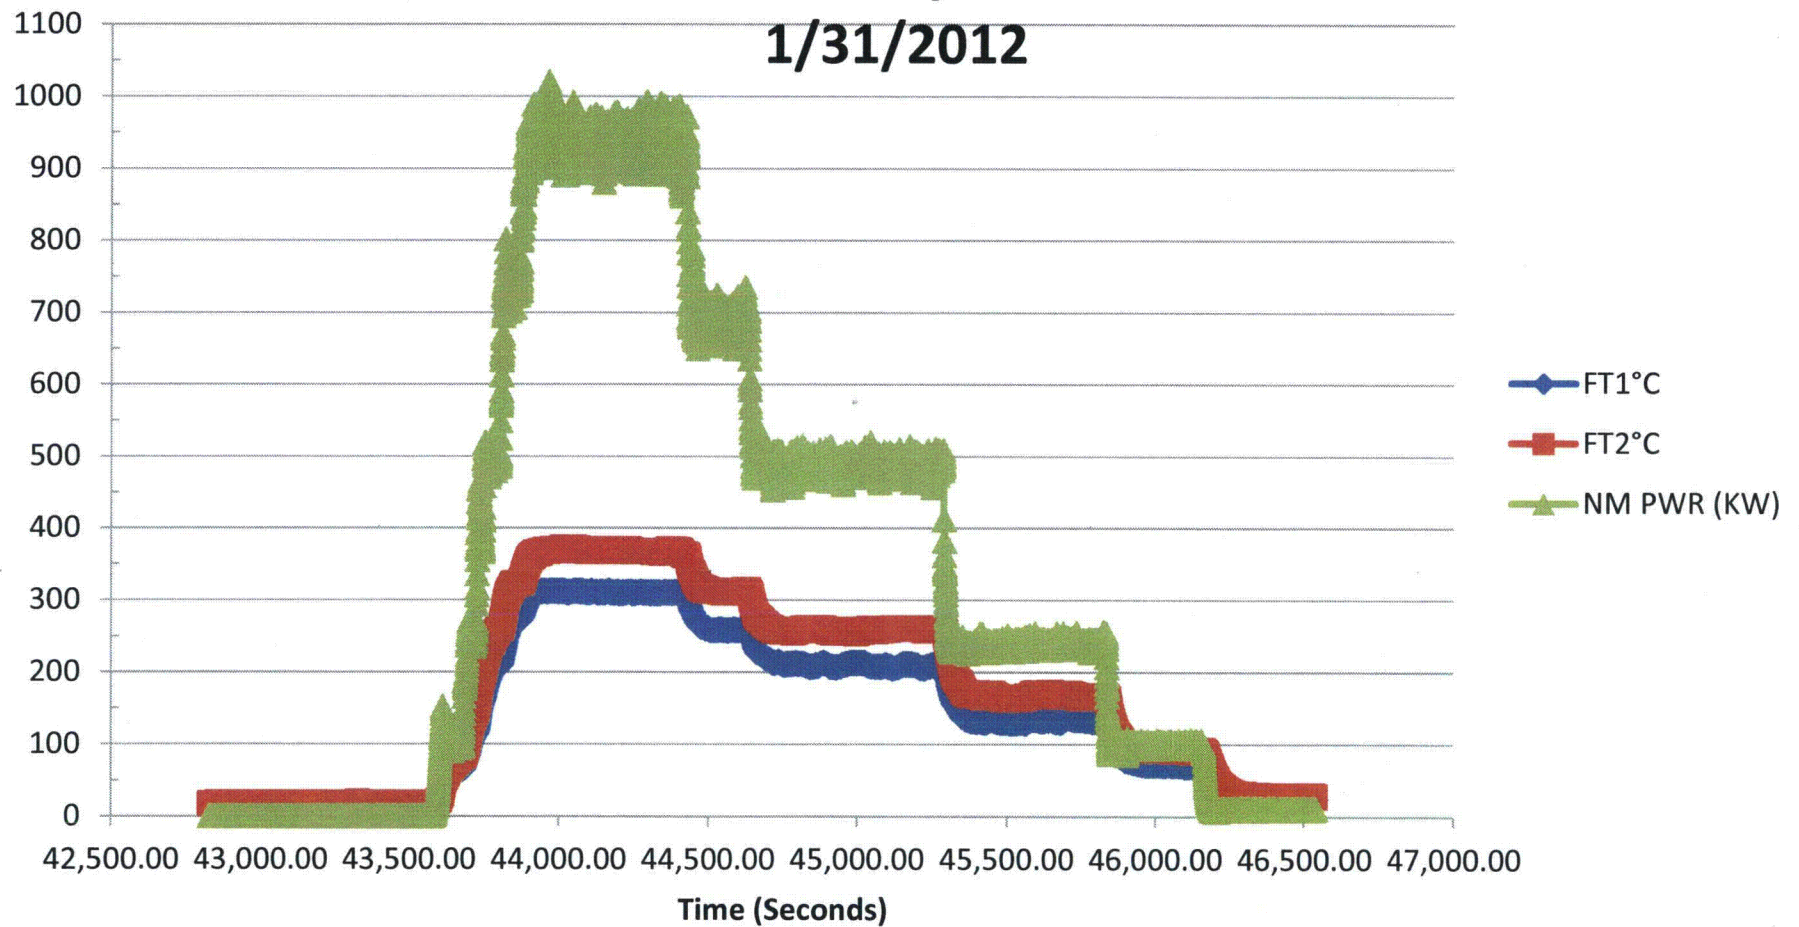
Pwr & FT vs Time with repaired TC

Resistance checks were completed on January 31, 2012. Testing indicated the short circuit was resolved. The thermocouple is considered restored to service, pending routine calibration checks conducted in accordance with approved operating/maintenance procedures.
