Subject: 10CFR21 Reporting of Defects and Non-Compliance -  
Engine Systems, Inc. Report No. 10CFR21-0104, Rev. 0

NPPD Fuel Hose, P/N 2-01H-050-003

Report No. **10CFR21-0104**

COMPONENT: NPPD fuel hose 2-01H-050-003

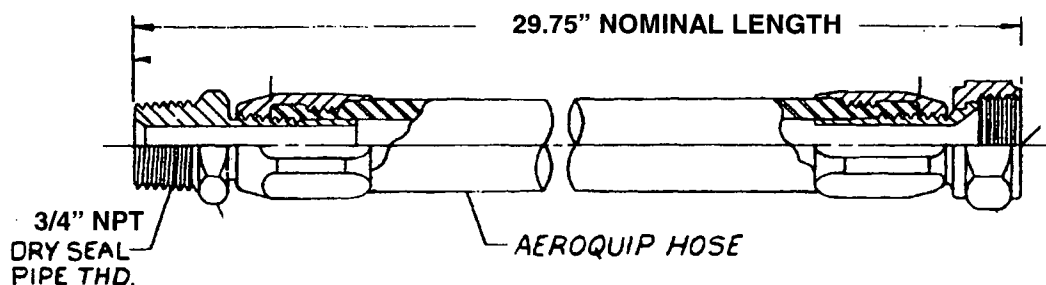
**FIGURE 1**  
**FUEL HOSE #2-01H-050-003**

The foreign material found during inspection of the returned hose assembly was determined to be very small pieces of the elastomer tube internal to the hose. It appears these pieces were introduced during assembly of the end fittings onto the hose during fabrication of the hose assembly.

Hoses remaining in customer inventory should be inspected to verify they are free of foreign material prior to installation. Any hoses previously installed on the EDG are not suspect as operability has been confirmed via functional testing.

To prevent recurrence of this issue, the dedication report for the hose assembly has been revised to include a requirement to solvent flush each hose prior to shipment. Filtered solvent will be pumped through the hose for a minimum of 5 minutes. After flushing, nitrogen will be blown through the hose to remove excess flushing fluid and a detailed visual inspection will be performed to ensure there are no visible contaminants immediately prior to installation of the hose end caps. This flushing requirement was already included in the dedication reports for other critical application hose assemblies so this notification is being limited to this part number only.

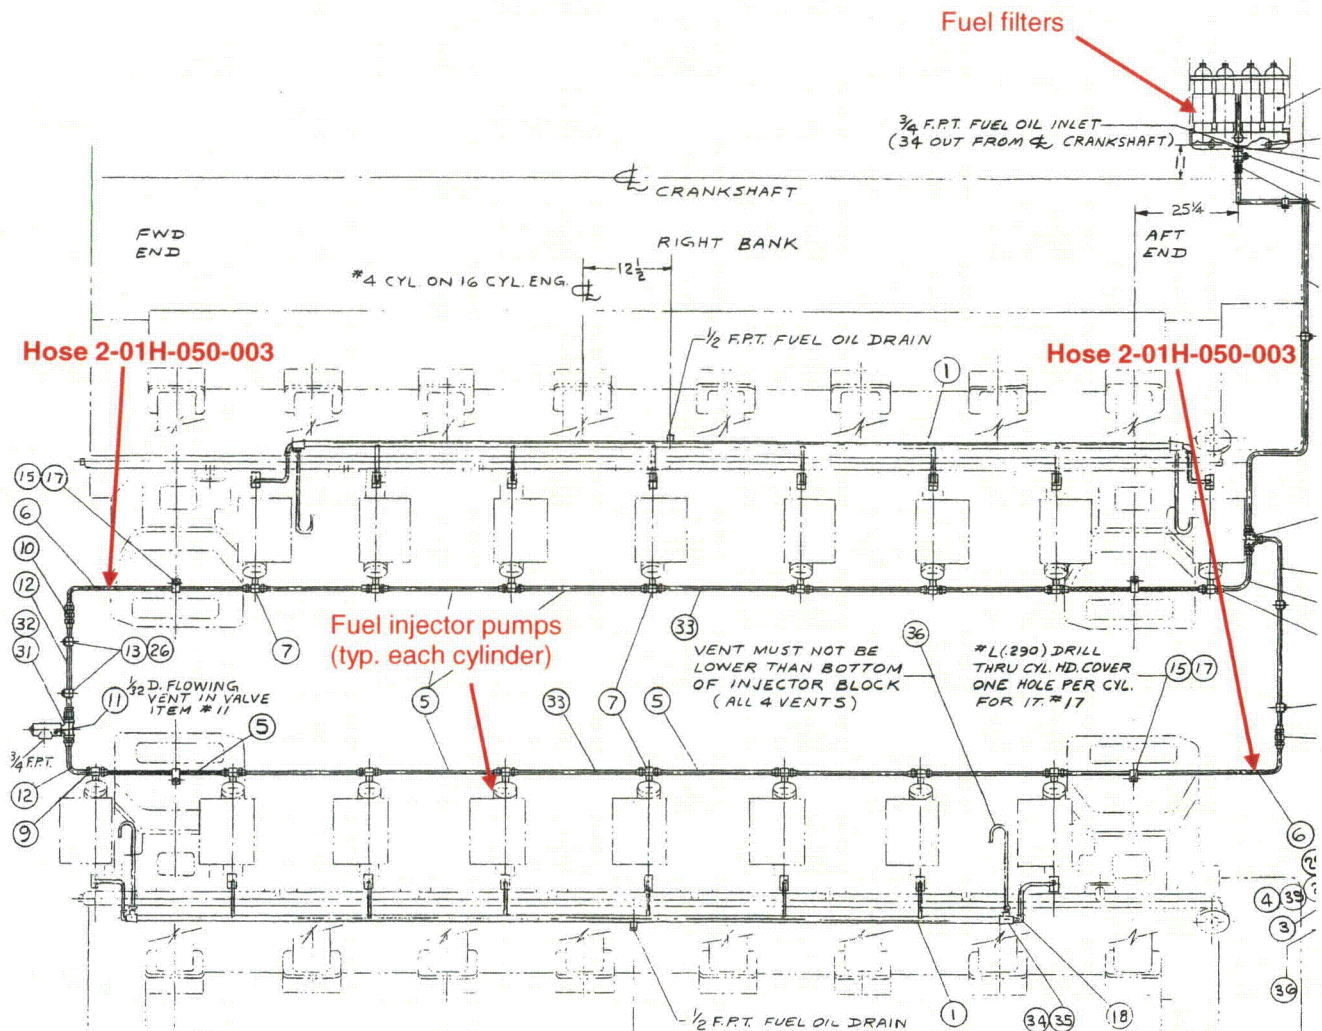
**FIGURE 2**  
**LOCATIONS OF FUEL HOSE #2-01H-050-003**

The hose, P/N 2-01H-050-003, is located after the engine fuel filter and before the fuel injection pumps. Foreign material within this hose could migrate to the fuel injection pumps. The entrance of foreign material could impact operability of one or more fuel injection pumps and therefore affect fuel delivery to one or more engine cylinders. This could impact the load carrying capability of the diesel engine or possibly complete engine shutdown. Either scenario has the potential to prevent the emergency diesel generator from performing its safety related function.

This hose is used in the fuel oil supply piping on the KSV diesel engine; it is located in the piping between the engine fuel filter and the fuel injector pumps (see Figure 1 and 2) and is unique to the NPPD-Cooper Station engines.
