**Subject: January 2012 Inspection Report
Cameco Resources, Permits 603 & 633**

**PERMITS 603 & 633 INSPECTION REPORT
JANUARY 2011
DISTRICT 1/LAND QUALITY DIVISION**

COMPANY: Cameco Resources, Incorporated

LOCATION: North of Glenrock, Converse County (Smith-Highland Ranch Uranium Project)

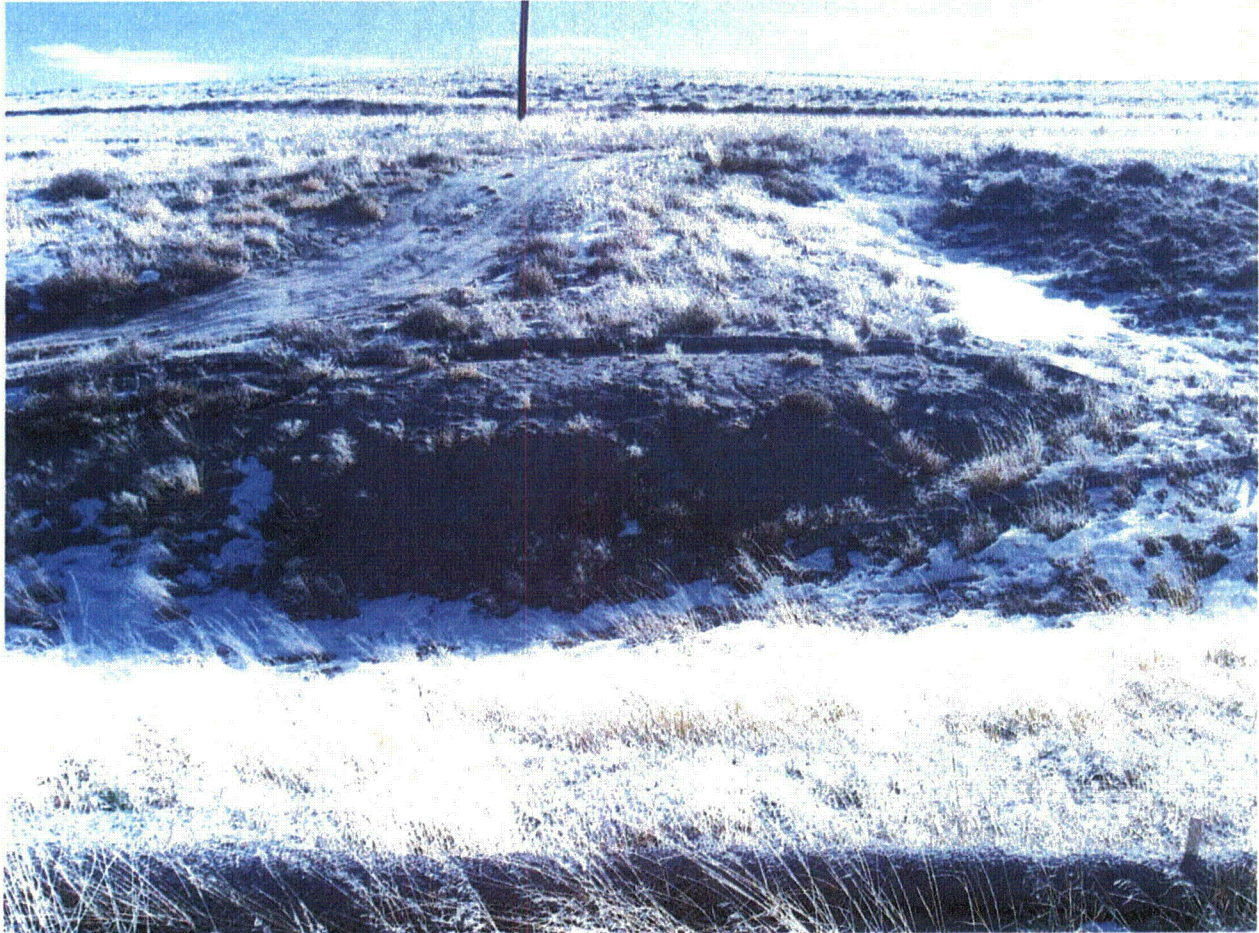
- slopes of drainage are stable with waddles functioning; few sandy exposed areas on south slope could use additional revegetation (**Figure 1**)

- 2 The drainage slopes in MU-9 appear stable and straw waddles have been utilized to protect revegetation. There are barren areas particularly along the south slopes that will likely erode further if additional prevention is not provided such as slope reduction and vegetation. LQD will continue to monitor the drainage for control of sediment into the flow path of the drainage.

Figure 1 South slope of drainage in MU-9; straw waddles used to control sedimentation; steep slope without vegetation likely to continue to erode

There are no compliance items that require immediate action. As mentioned during the inspection, CR should continue to monitor sediment in the drainage in MU-9, particularly on steep slopes without vegetation. It was noted that CR has improved topsoil protection and sediment control practices as well as minimizing the disturbance footprint in new wellfield development areas. This effort is recognized and greatly appreciated.

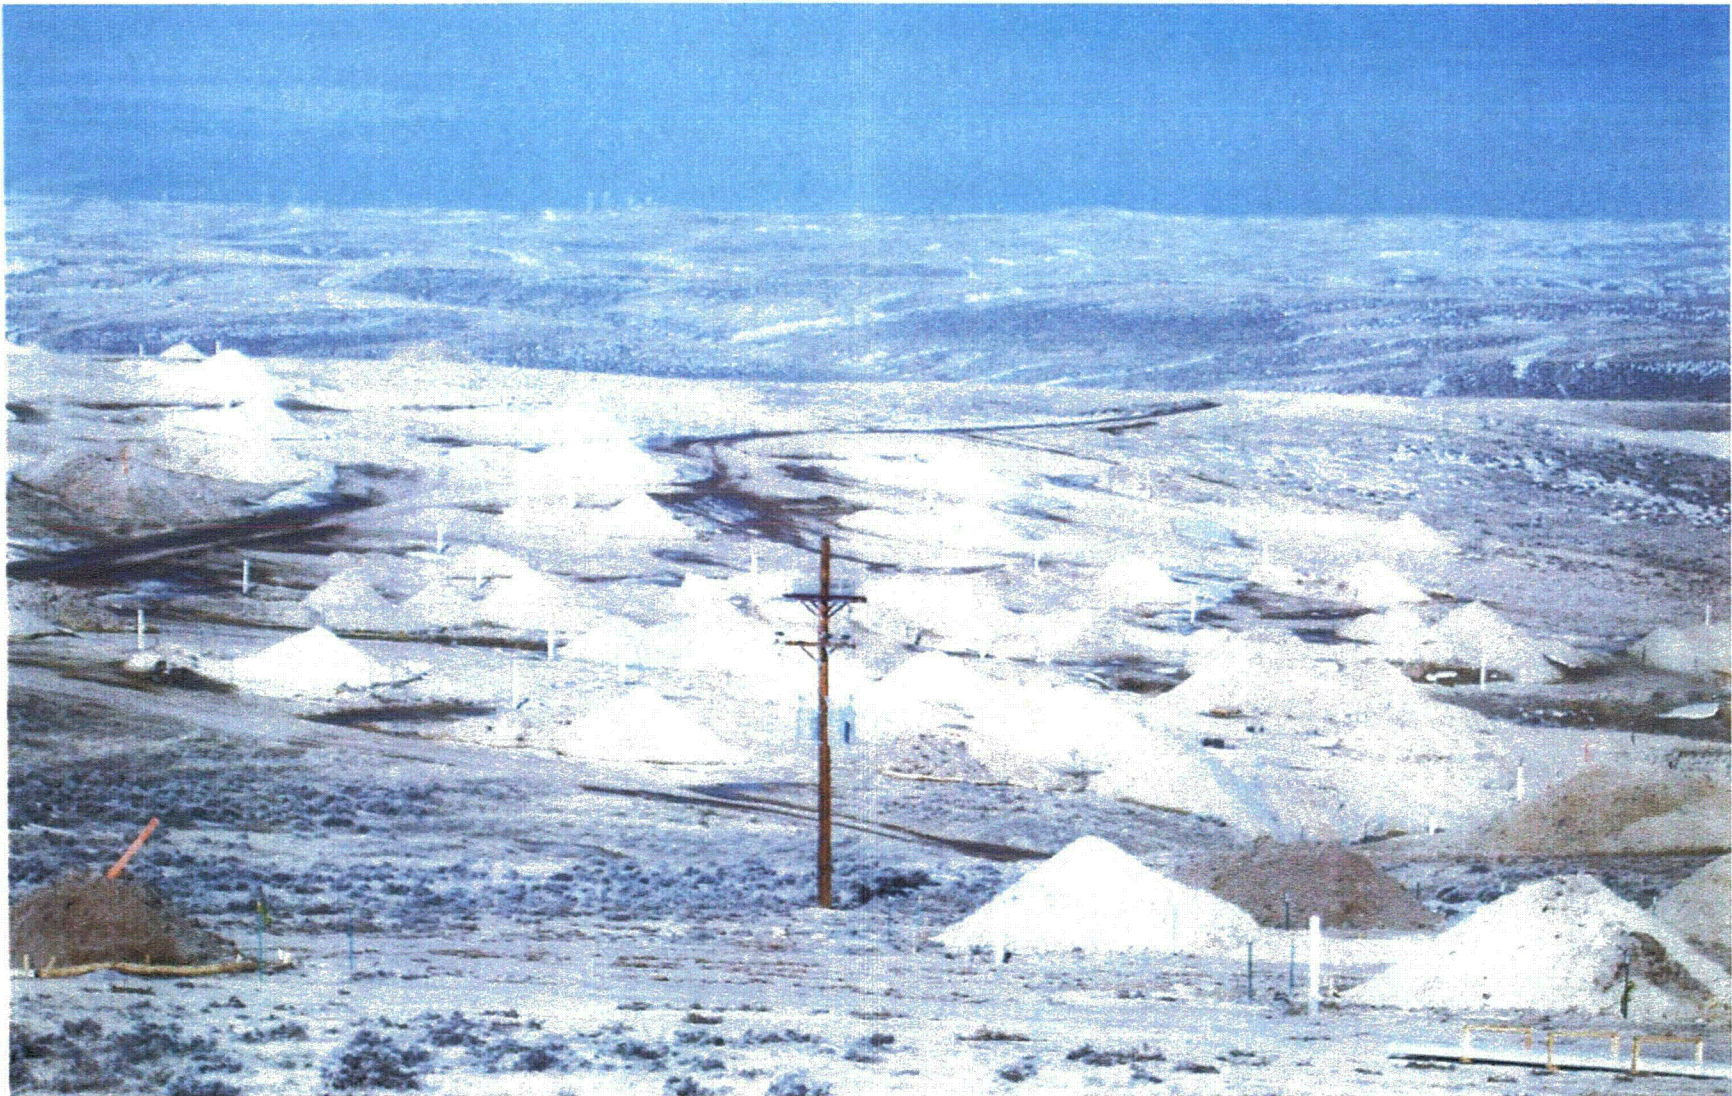
- waiting on pump test approval from LQD;
- wellfield development in progress; topsoil salvage and protection was exceptional with straw waddles at the base of the piles and piles placed away from the activity at the well; drill traffic appeared to be staying on designated pathways with notable undisturbed areas to enhance the revegetation during wellfield reclamation (**Figure 2 & 3**)

Figure 2 MU-10 wellfield development; topsoil stockpiles placed away from drilling activities and clearly marked, routes for vehicle use are clear, areas without disturbance can be identified, sediment control placed around stockpiles
