A Summary of Aging Effects and Their Management in Reactor Spent Fuel Pools, Refueling Cavities, Tori, and Safety-Related Concrete Structures

The Oak Ridge National Laboratory conducted an independent review of operating experience at U.S. commercial nuclear power plants regarding spent fuel pool and reactor cavity leakage, boiling-water reactor Mark I containment torus corrosion and cracking, and aging degradation of safety-related concrete structures. The review was restricted to information in publicly available sources, including license renewal applications submitted by the licensees and safety evaluation reports prepared by the staff. Information compiled for spent fuel pool and reactor refueling cavity leakage focused on the cause and extent of leakage, the effects of borated water on materials, the effects on concrete and steel degradation, corrective actions, and the effects of material degradation on load-carrying capacity. The review of boiling-water reactor Mark I containment information involved identification of the causes of torus corrosion and cracking, the locations of corrosion and cracking, and engineering evaluations and acceptance criteria. The review of opera

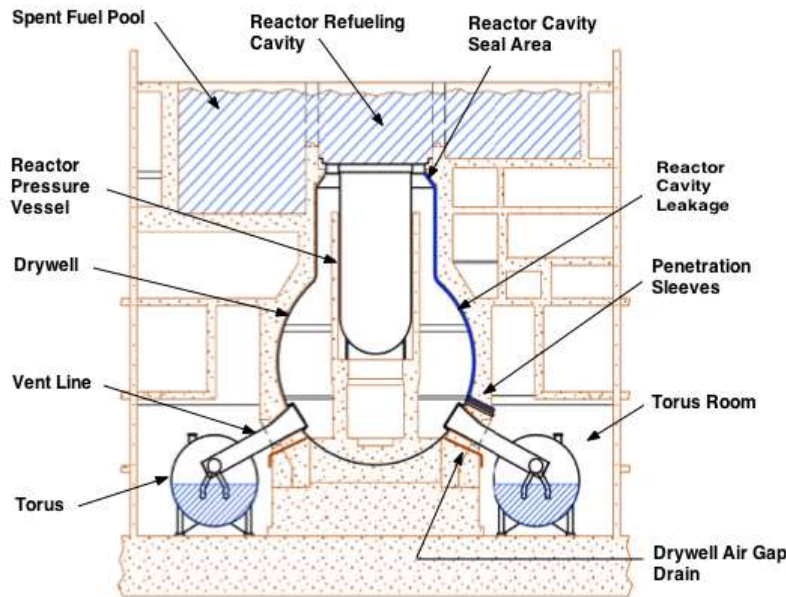
Figure 6-1 Cross section of BWR MK I showing location of reactor refueling cavity, spent fuel pool, and torus as well as one leakage path that has been observed

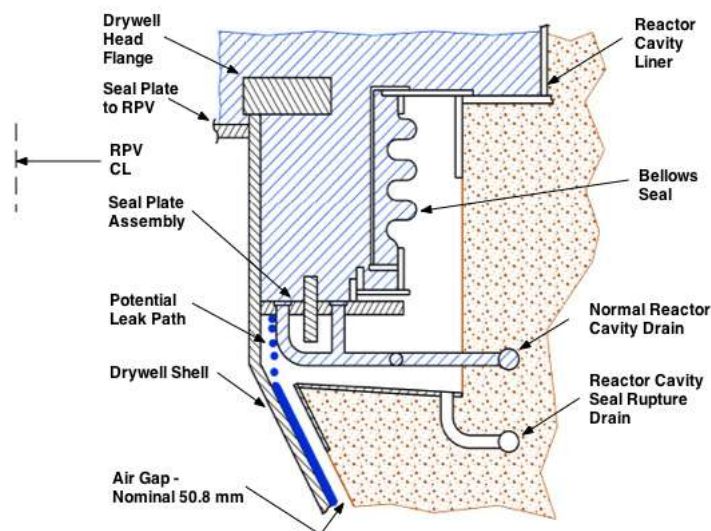
Figure 6-2 Detail of drywell—reactor cavity seal area and identification of potential leakage path

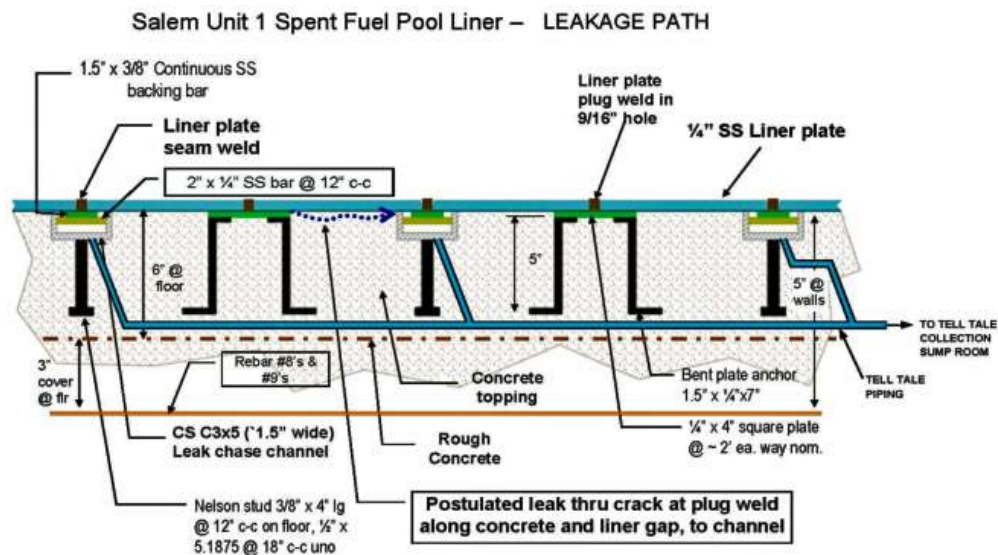
Figure 6-4 Cross section of a leak chase system for a PWR plant and a postulated path for leakage occurrence

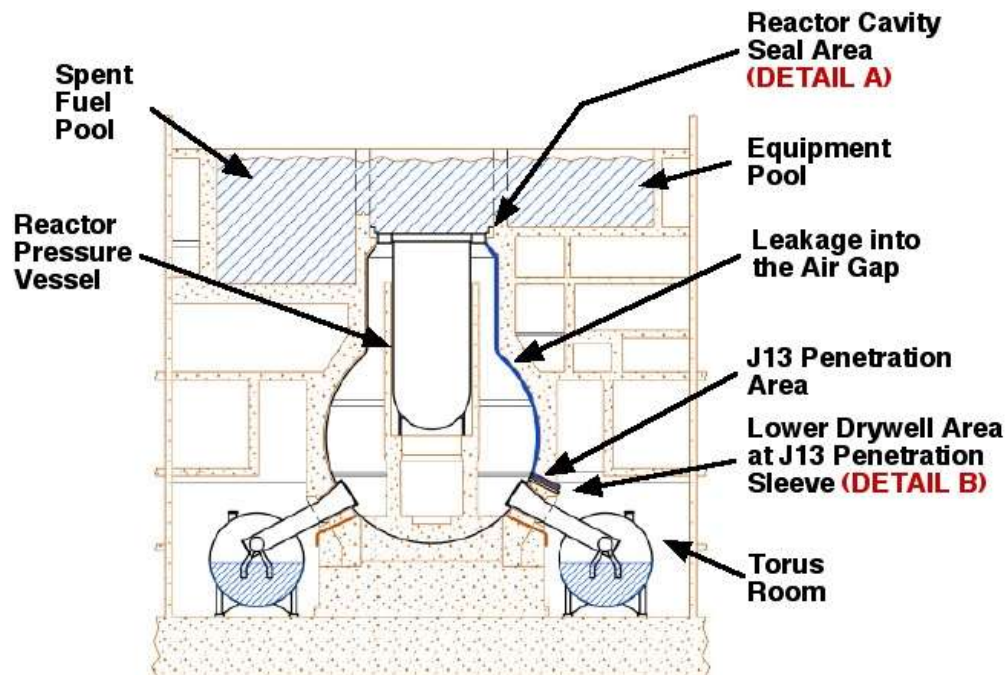
Figure A.2-2 Locations of reactor cavity seal and J13 penetration areas

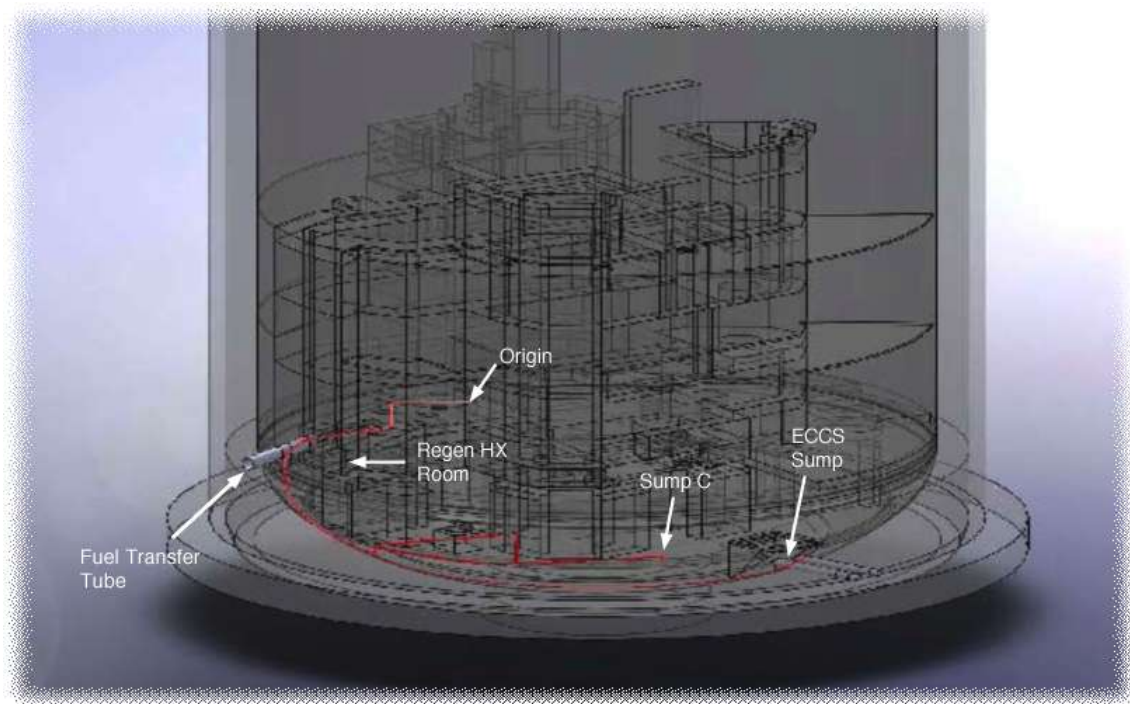
Figure A.6-1 Potential leakage paths for refueling cavity water

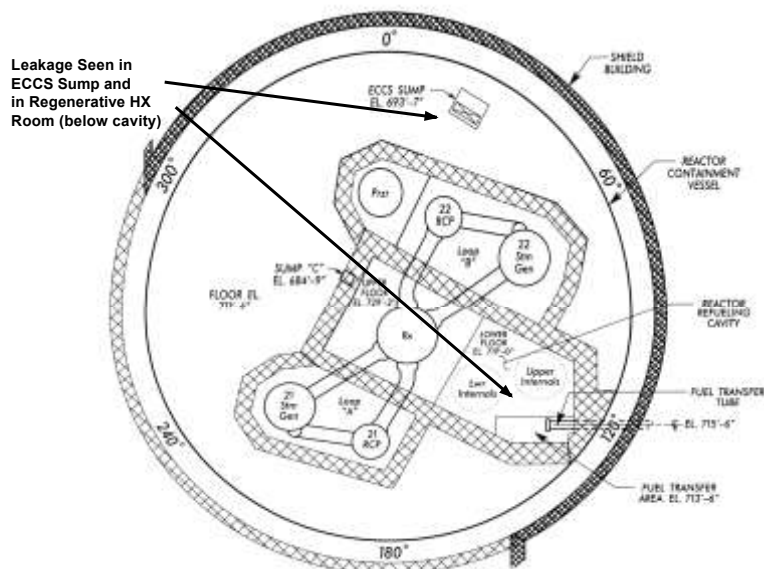
Figure A.6-2 Locations of observed leakage of refueling cavity water

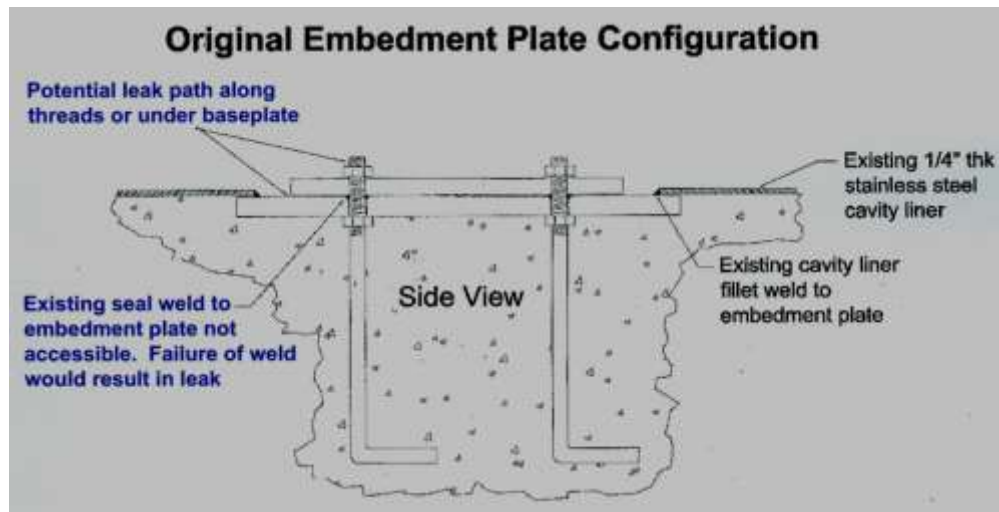
Figure A.6-3 Cross section of original embedment plate configuration showing potential leakage paths

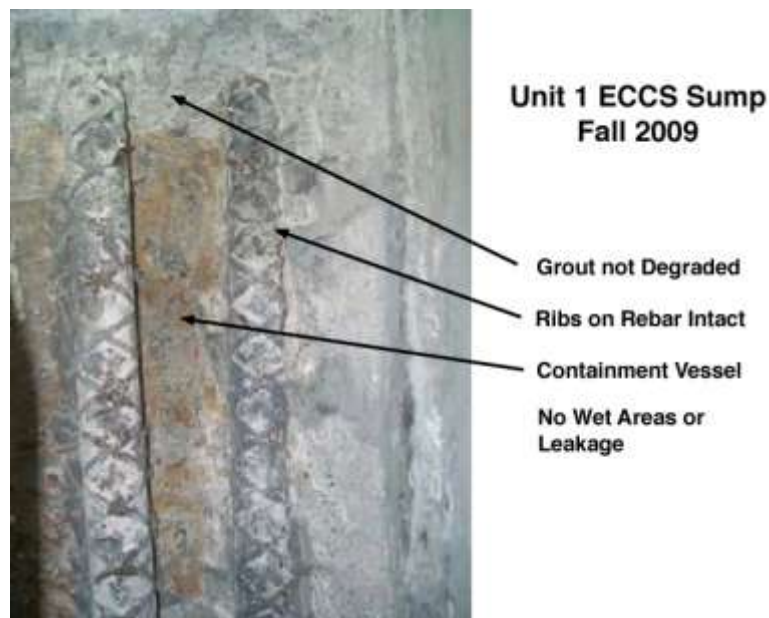
Figure A.6-5 Condition of containment shell, grout, and concrete steel reinforcement in Unit 1 ECCS after grout removal

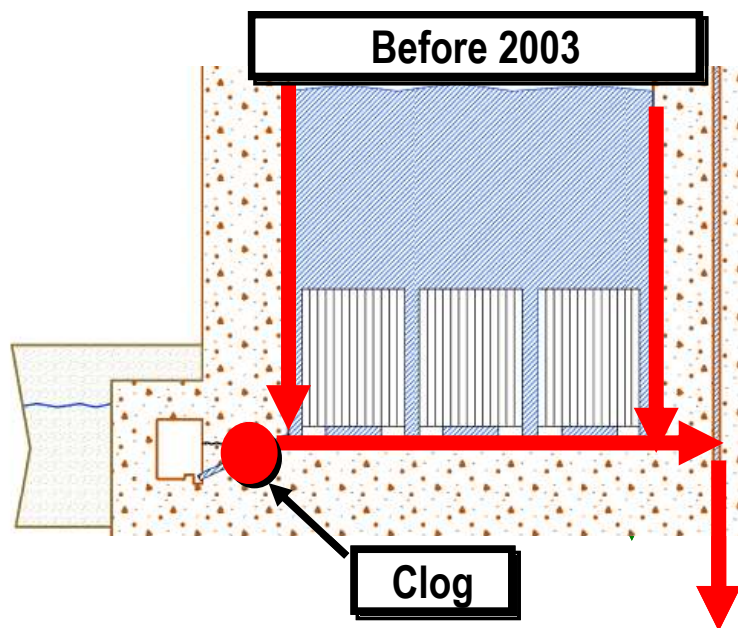
Figure B.9-1 Spent fuel pool leakage path for Salem Unit 1 before 2003

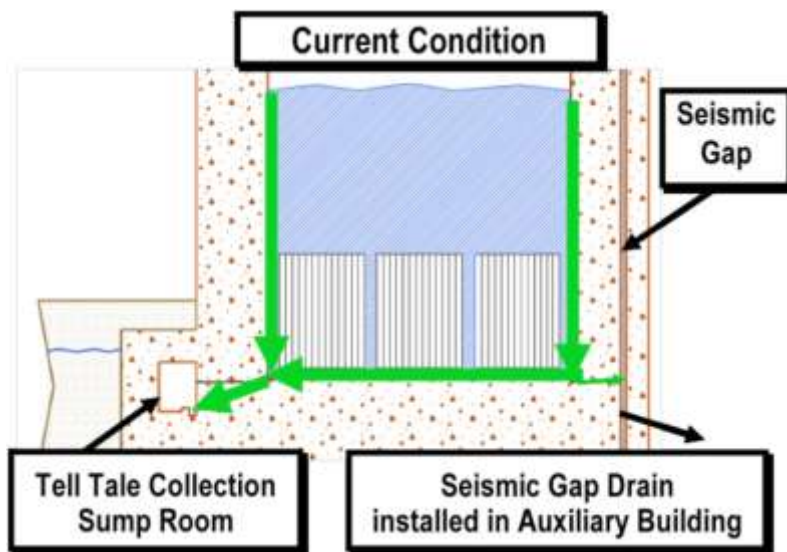
Figure B.9-2 Current spent fuel pool leakage path for Salem Unit 1

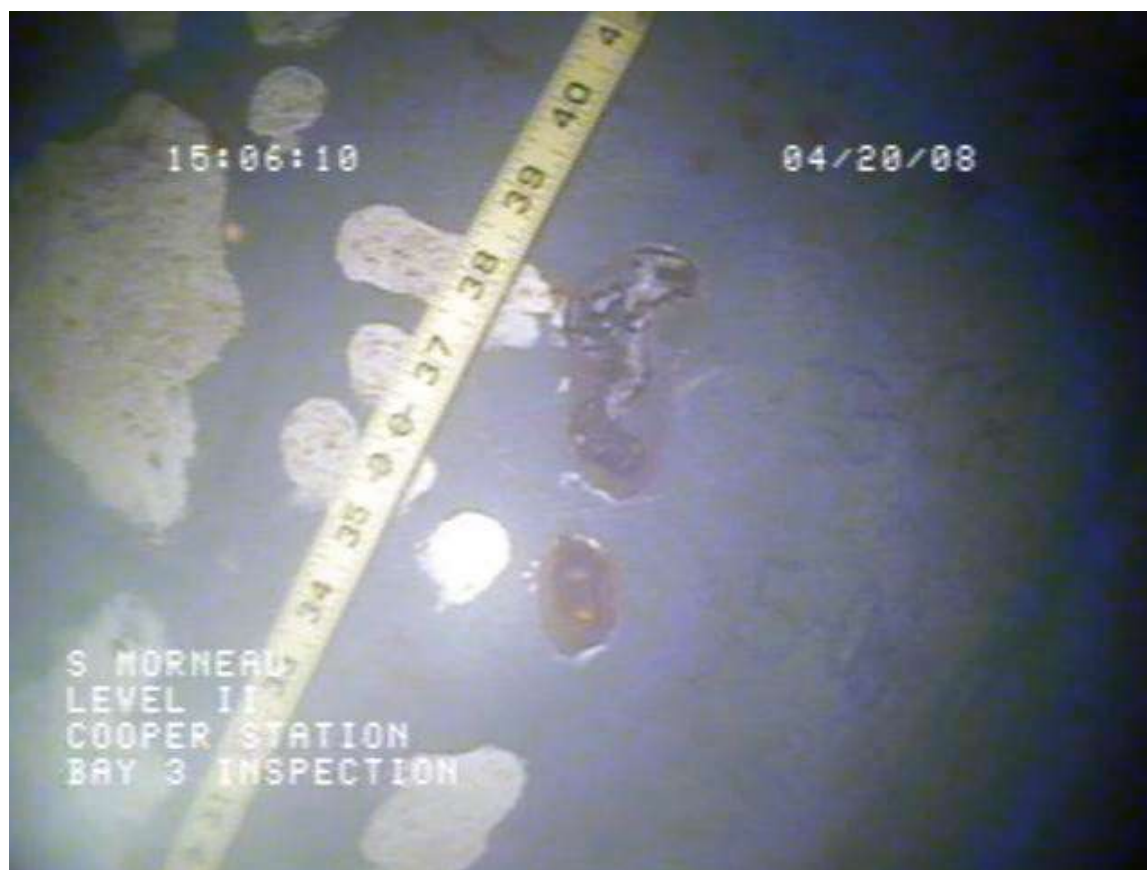
Figure C.1-1 Example of pitting corrosion in torus
