SUBJECT: **R.E. Ginna Nuclear Power Plant**
Docket No. 50-244

**Response to Request for Additional Information RE: The 2011 Steam Generator
Tube Inspections – R.E. Ginna Nuclear Power Plant**

**Response to Request for Additional Information Regarding the 2011 Steam
Generator Inspection Report**

**R.E. Ginna Nuclear Power Plant, LLC
February 15, 2012**

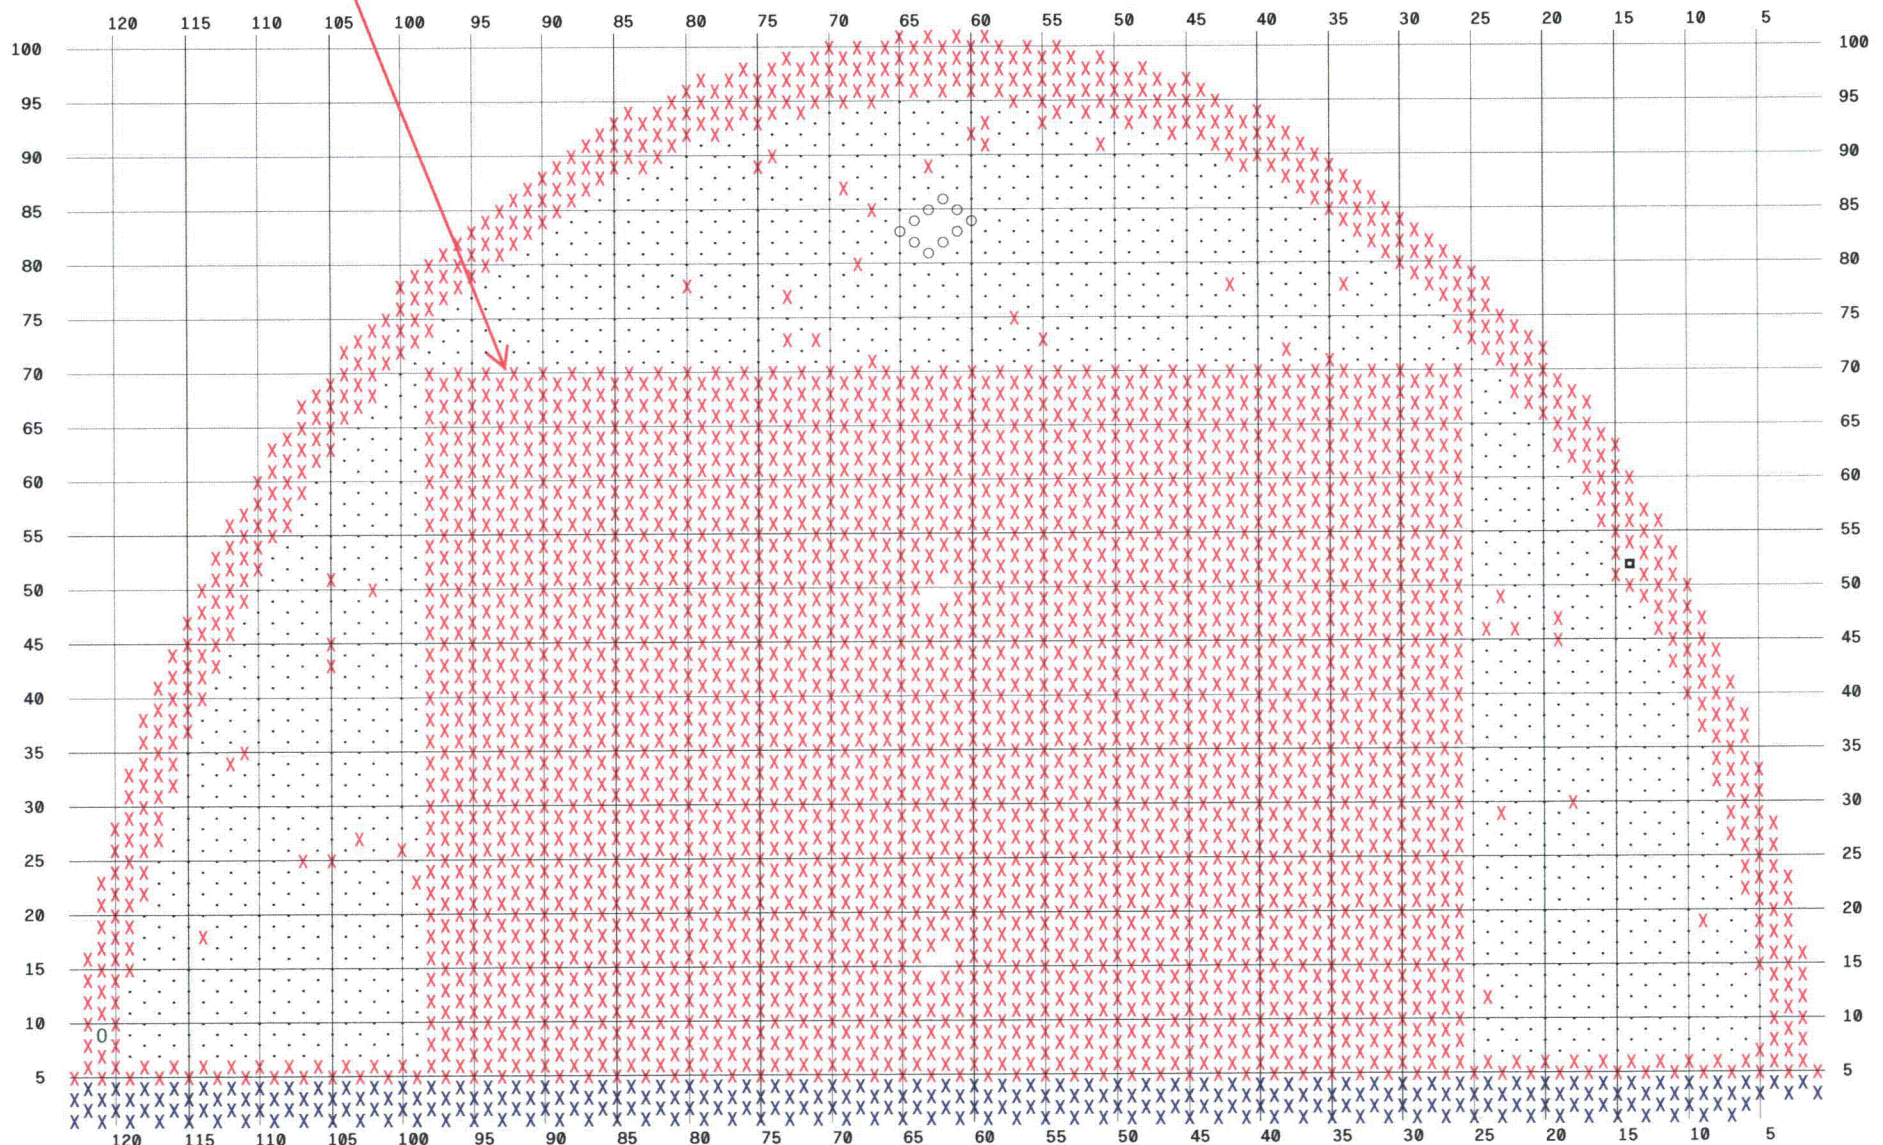
Ginna Steam Generator A Tubesheet Map

The tubesheet map, Attachment 3, shows the examination area. The central box area is a large portion of the examination area, and was selected to bound the denting extent of condition.
