**Joint Regulatory/Pre-Decisional  
Enforcement Conference**

**Technical Support Center Habitability**

**Florida Power & Light Company**

**February 21, 2012**

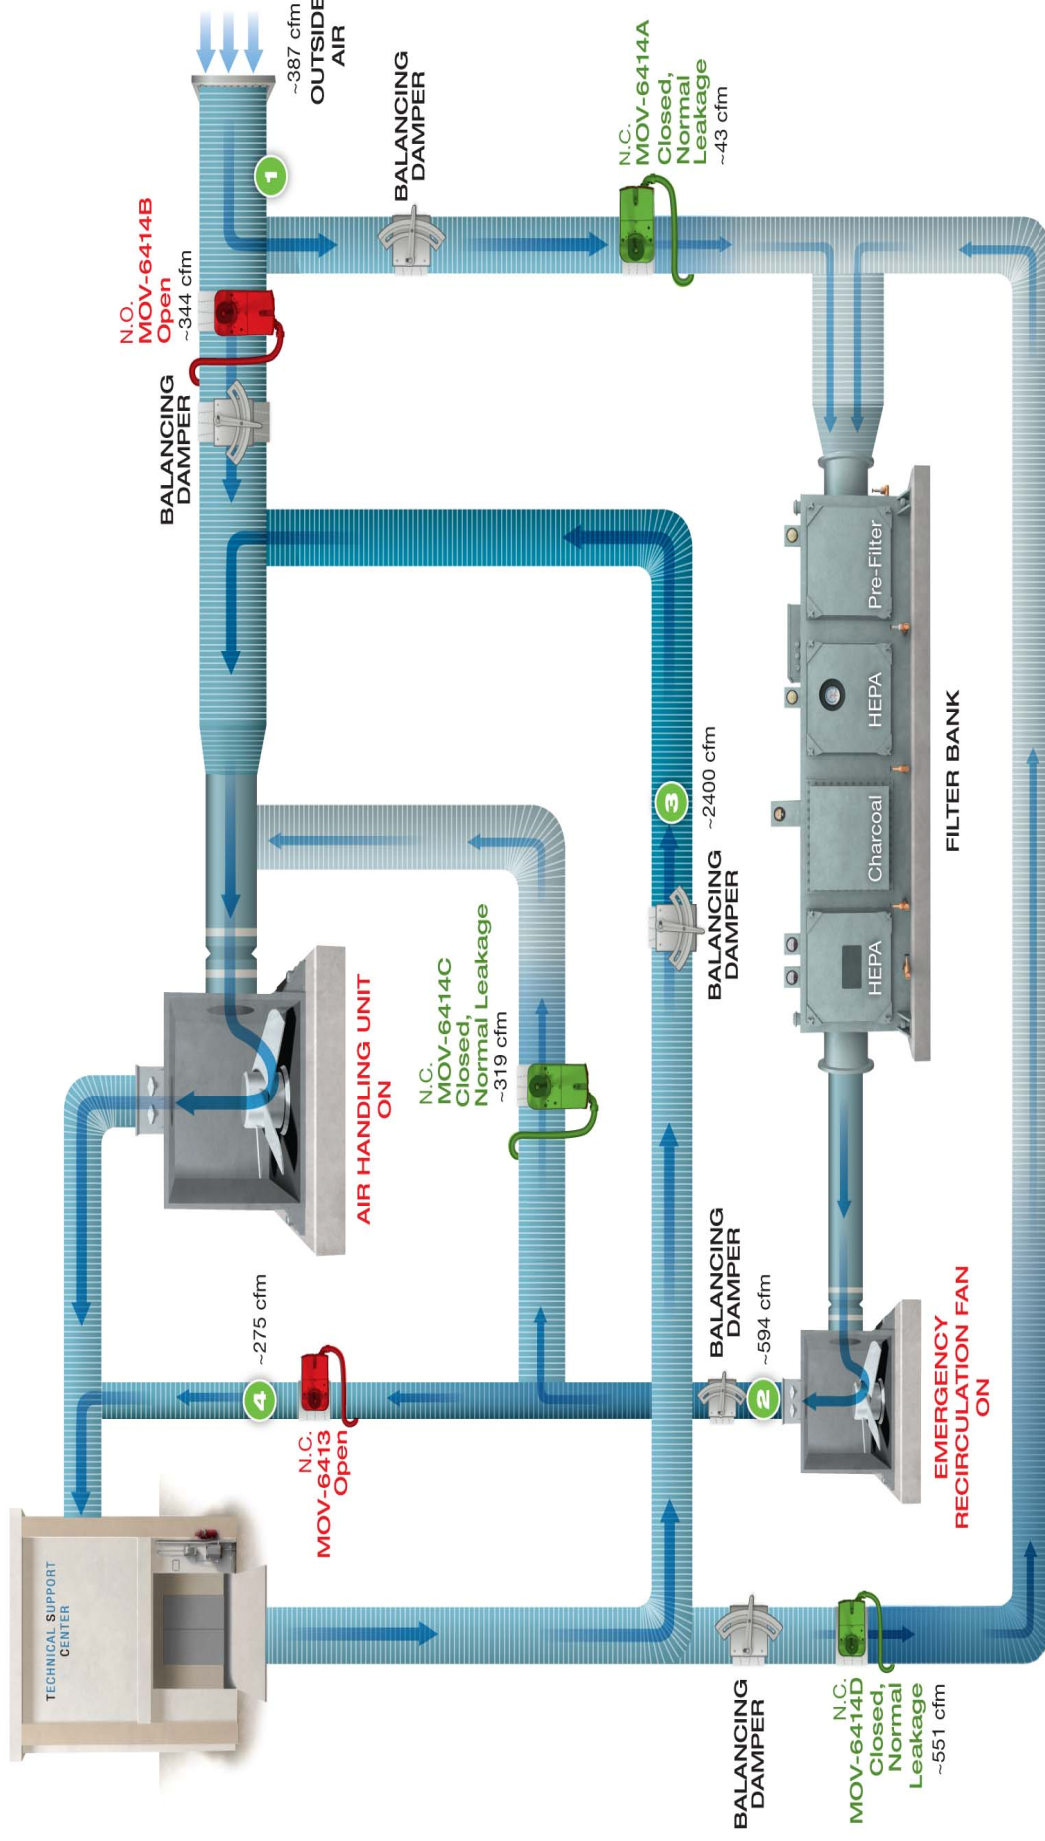
SCENARIO 3: Emergency Operation Breaker Open (18-day period)

# 18 Day Event Configuration

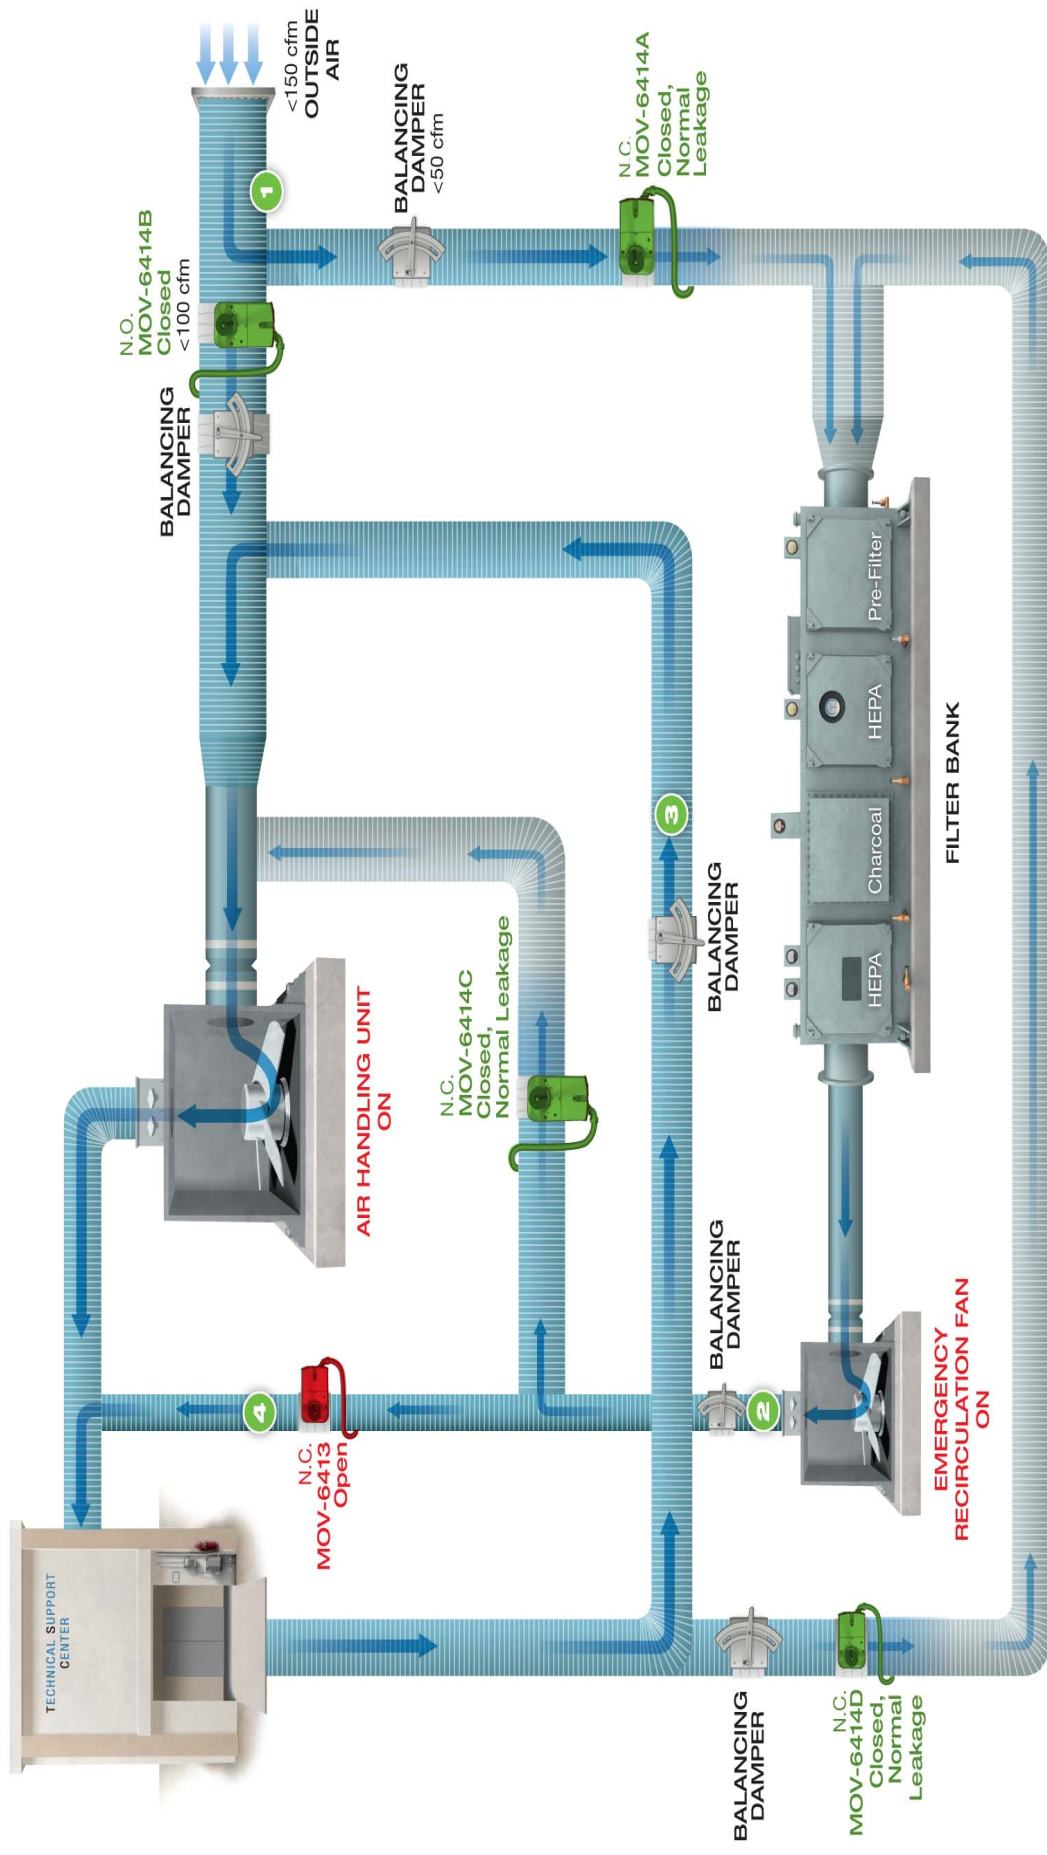
SCENARIO 4: Emergency Operation Breaker Open & MOV-6414B Frozen Shut (7-month period)

# 7 Month Event Configuration

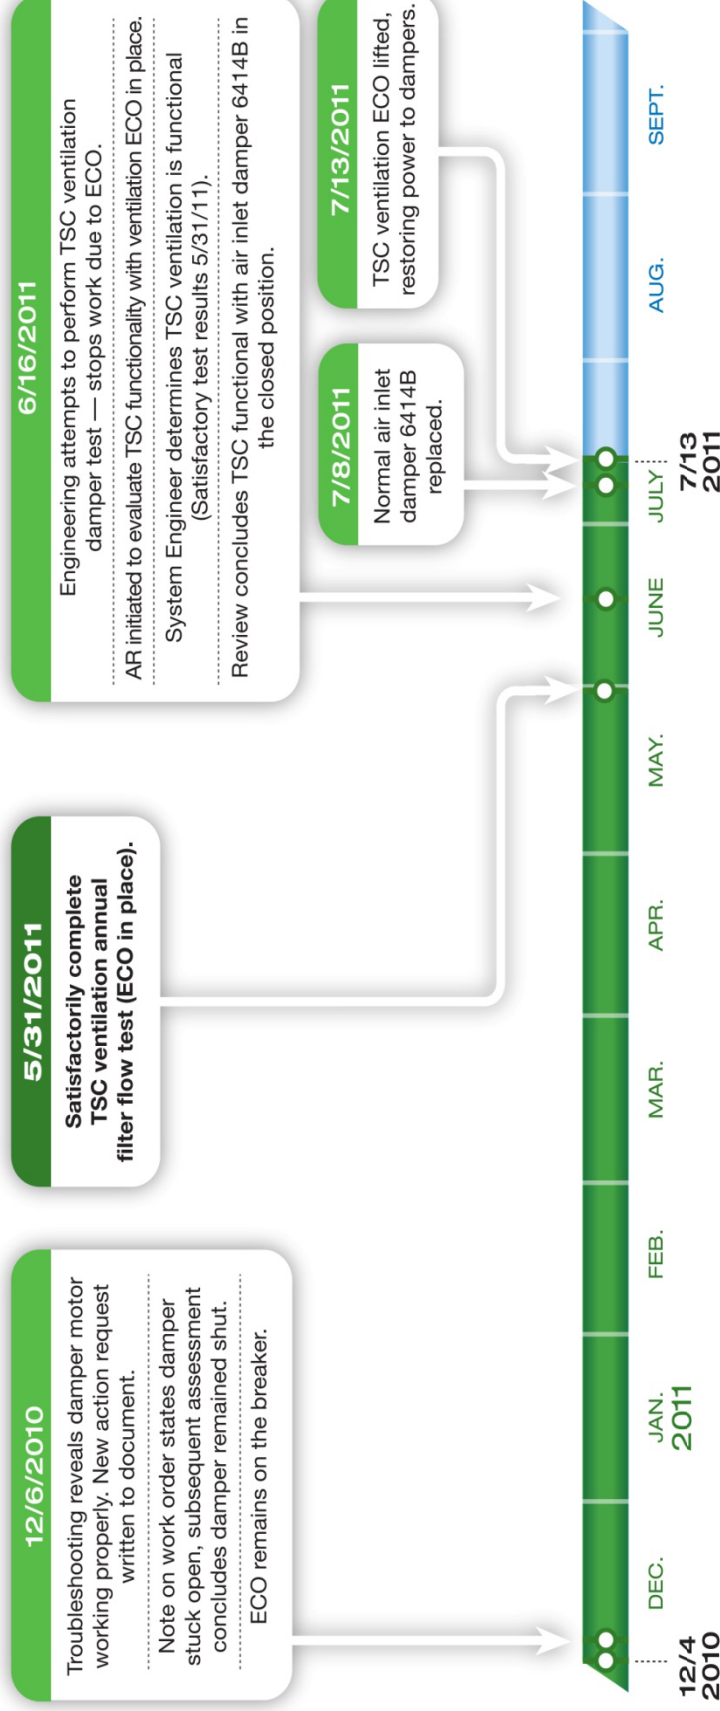
7 Month Period: 12/4/2010 to 7/13/2011

**The force of the recirculation fan is sufficient to provide adequate air flow through the TSC filter bank even though damper actuators were de-energized.**

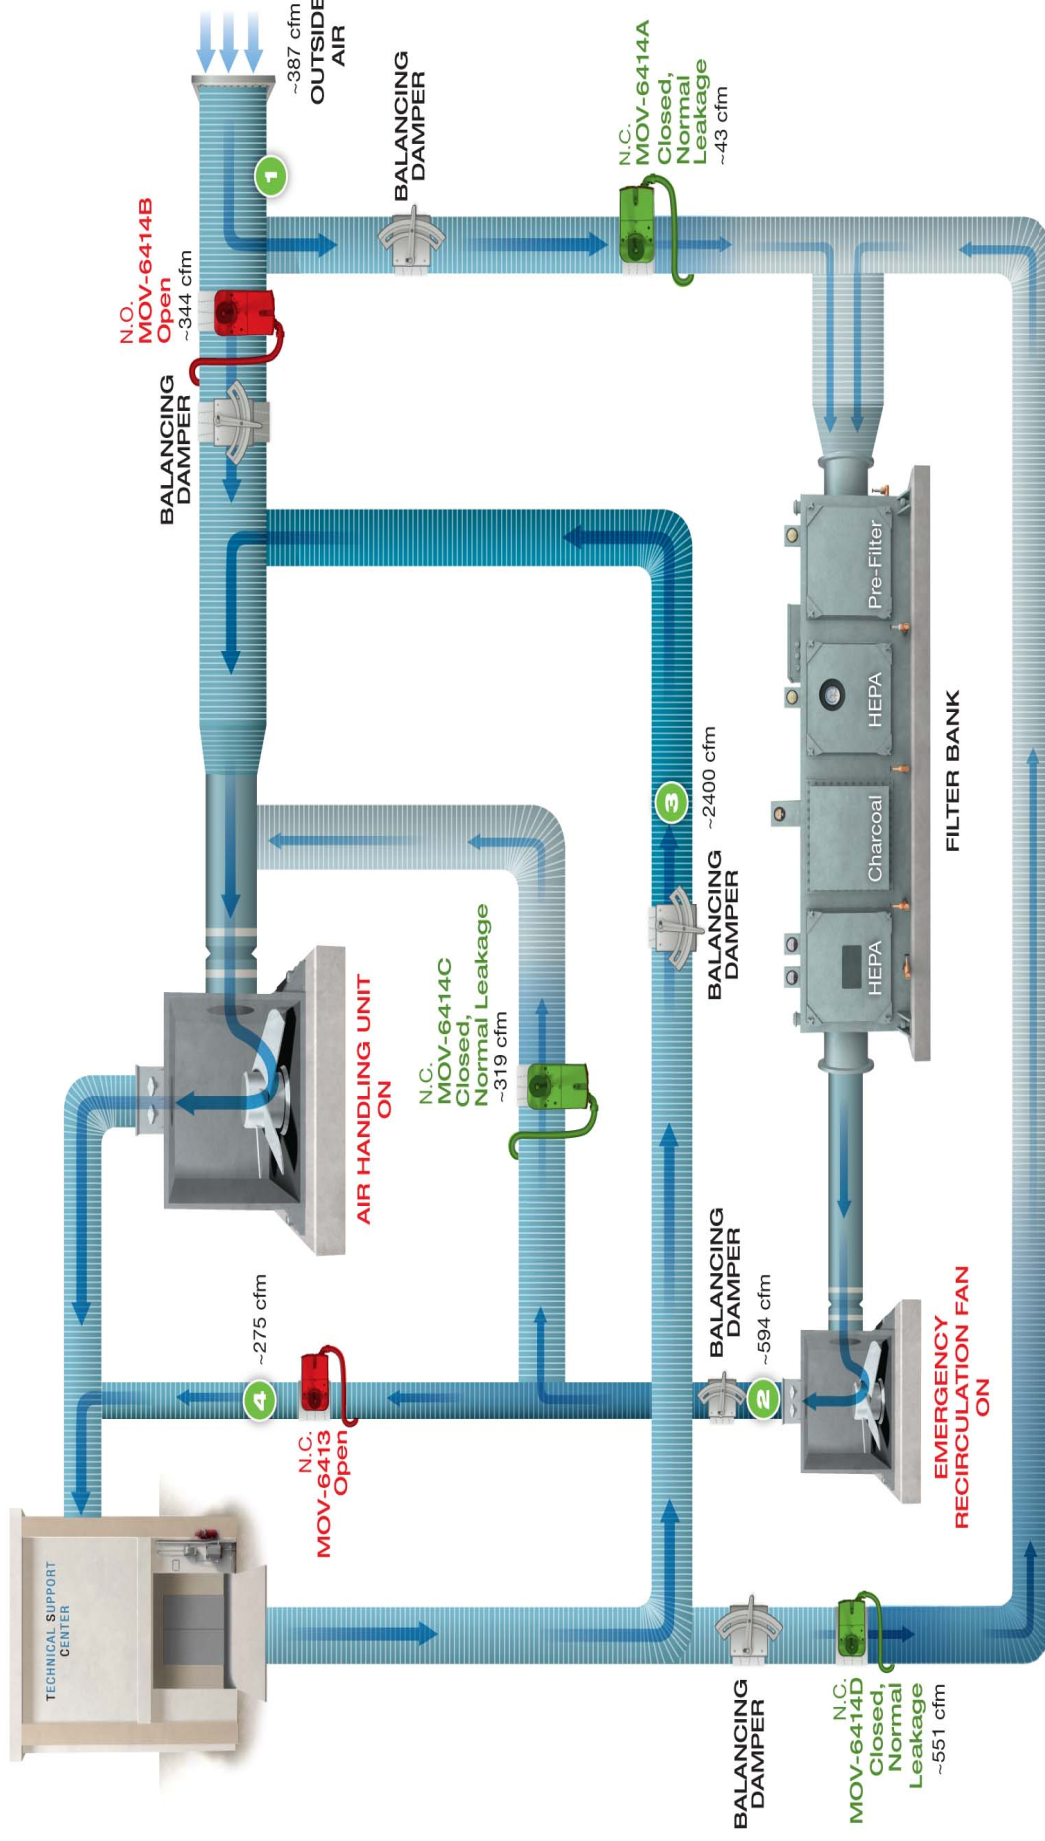
SCENARIO 3: Emergency Operation Breaker Open (18-day period)

- Normal Air Inlet Damper 6414B – Assumed to be **open**.
- Accident Scenario – Design basis Unit 3 large-break LOCA (bounding analysis).
- Meteorological Data – Design basis X/Q meteorological dispersion factors.
  - Approved by License Amendments 244 and 240.
  - *Earlier analysis used 10/11-specific met data.*
- Source Term – Design basis source term at current licensed power level.
- Containment Leakage – Unit 3 worst case containment leakage (0.12%/day).
  - *Earlier analysis used actual Unit 3 containment leakage (0.082%/day)*
  - Bounds worst leakage in 40 years of operation for either Unit.
  - Bounds future acceptance criteria for ILRT at post-EPU conditions.
- ECCS Leakage – UFSAR design leakage.
  - Greater than double the actual measured ECCS leakage.
- Filtration – *Earlier 10/11 analysis assumed no filtration.*

**Bounding inputs are used for unfiltered air in-leakage, meteorological data and containment leakage.**
