ENGINE SYSTEMS, INC.

Subject: 10CFR21 Reporting of Defects and Non-Compliance -
Engine Systems, Inc. Report No. 10CFR21-0105, Rev. 1

Subcover Assembly, P/N 1A-7846

10CFR21 REPORTING OF DEFECTS AND NON-COMPLIANCE

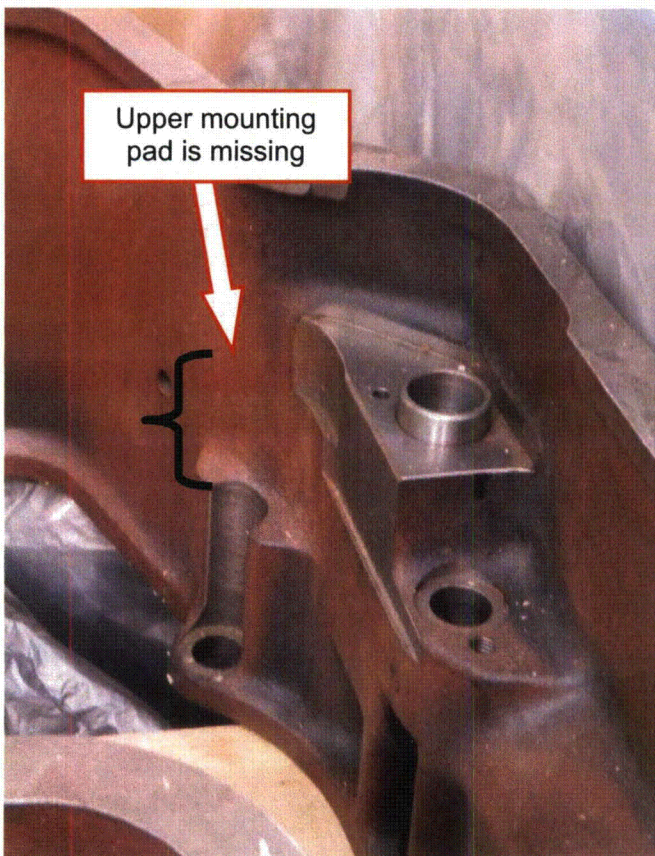
Engine Systems Inc. (ESI) began a 10CFR21 evaluation on 12/20/11 upon notification of an issue with four subcover assemblies at Perry Nuclear Plant. It was reported that Perry was performing a maintenance activity whereby they were replacing four cylinder head subcover assemblies on their Enterprise diesel engine. During installation, it was noted that qty 2 of the 11 bolt holes were missing an upper mounting pad. This was visually apparent once the customer attempted to install the bolts, which have a 6" length. The two areas missing the upper landing pad did not have an area for the underside of the bolt head to rest upon. See photos 1 and 2 below showing an incorrect vs. correct subcover.

**Photo 1: Subcover Returned by Perry
(Incorrect)**

Lack of the mounting pads alone will not result in a failure, however if a customer attempts to install the subcover without recognizing the missing material, there is the possibility that two of the eleven hold down bolts will provide no clamping function. This may result in loosening of the subcover mounting which could allow the cover to separate from the cylinder head.

Customers may elect to justify use of a shorter bolt to facilitate installation of in-stock covers. Otherwise it is ESI's recommendation that customers return the subcovers for replacement.

The root cause analysis determined that the cause of this issue was that the pattern for the casting is missing the portions that would ultimately form this upper mounting pad. In addition, the machining drawing was unclear in showing these locations. As a result, ESI's inspections did not specifically check for these locations and the non-conforming subcovers were shipped to the customer.

The pattern is now being corrected to ensure the presence of the upper mounting pads. Also, ESI's dedication report is being revised to add specific checks to inspect for the presence of these pads. This will be completed prior to any future shipments of this item.

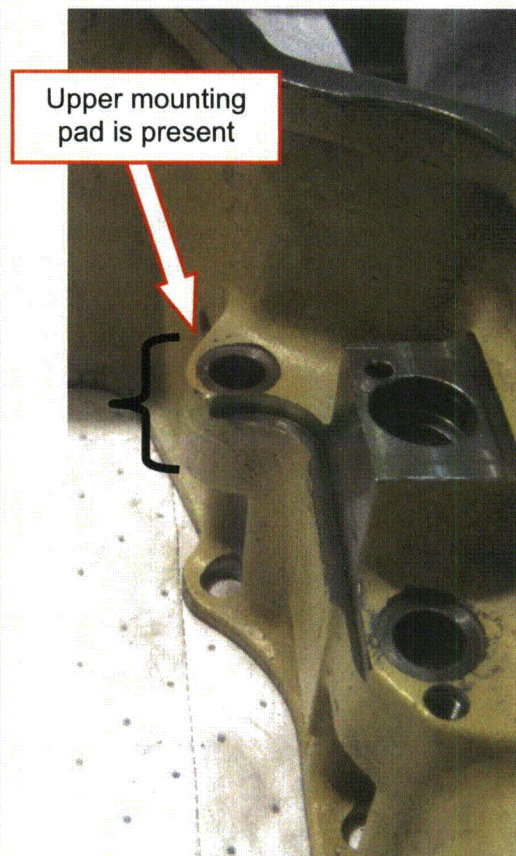
**Photo 2: Previously Installed Subcover
(Correct)**

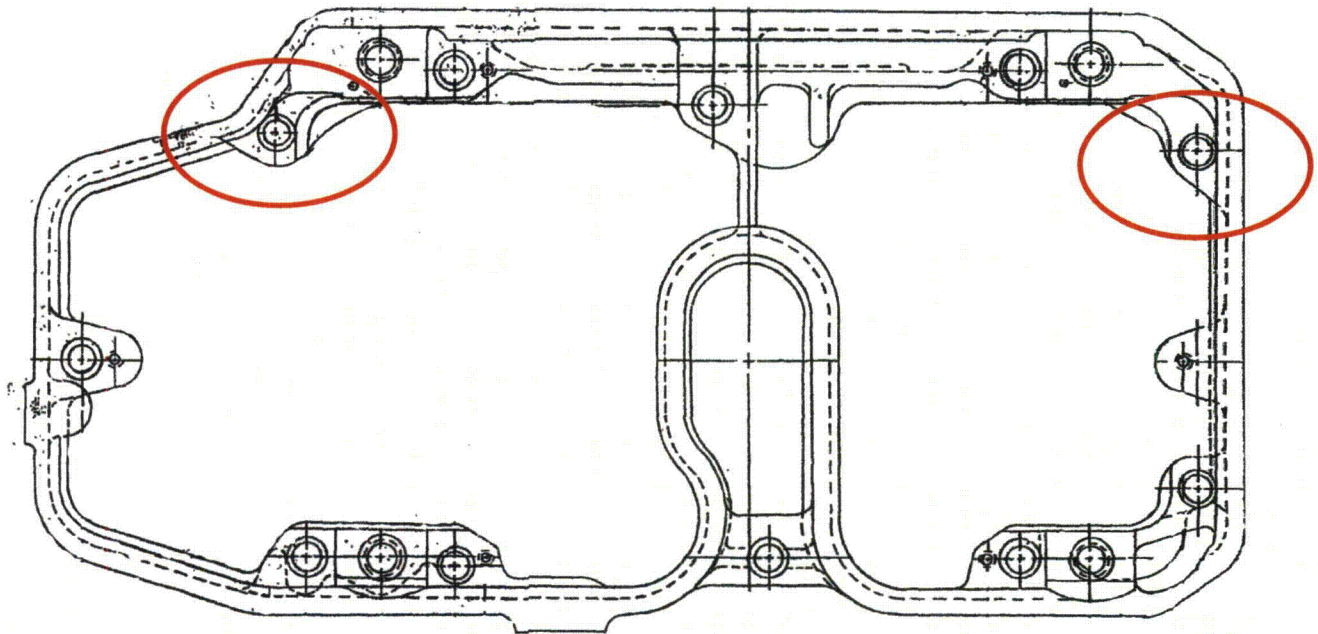
Figure 1 and photo 3 below show the positions within the subcover where the pads are missing.

Figure 1: Overhead View of Subcover

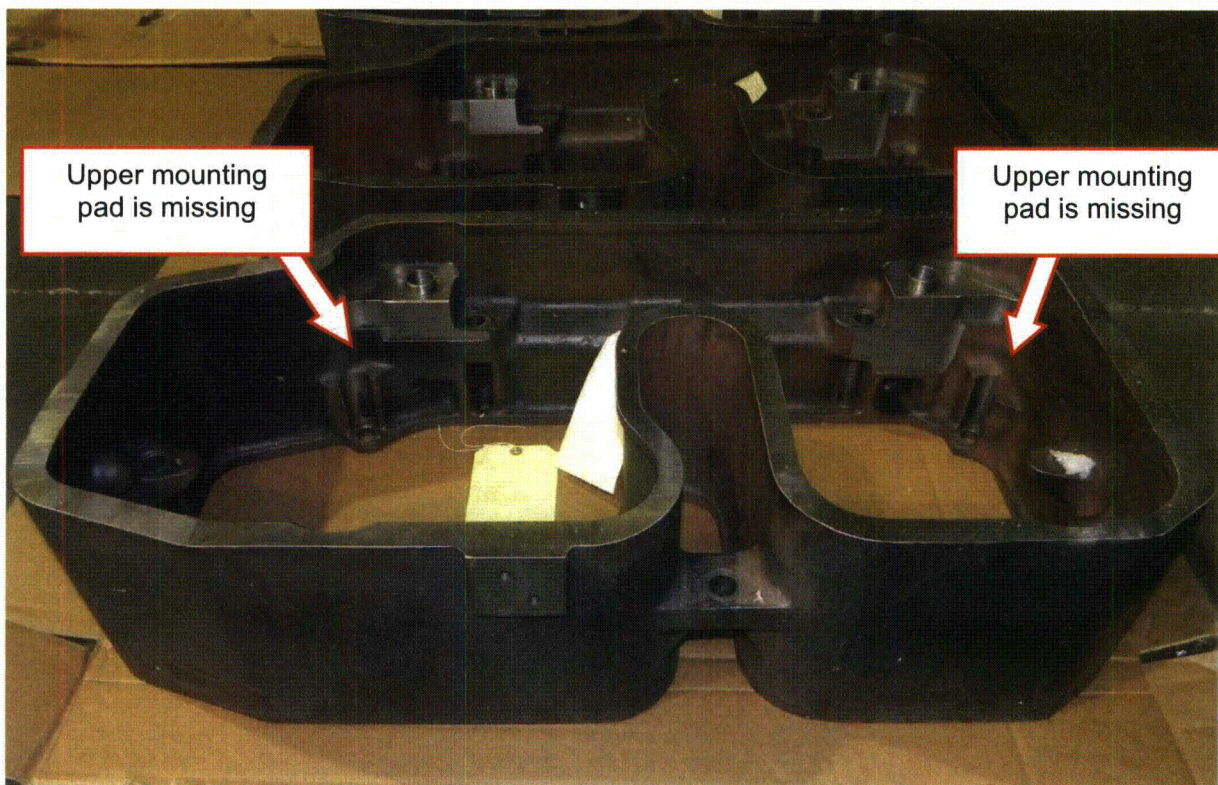
Photo 3: Locations of Missing Landing Pads
