**SUBJECT: BYRON UNIT 2 - NRC SPECIAL INSPECTION TEAM (SIT)
REPORT 05000455/2012008**

The special inspection reviewed the circumstances surrounding the January 30, 2012, electrical insulator failure in the Byron switchyard that resulted in a Unit 2 automatic reactor trip and Notice of Unusual Event emergency declaration.

Report No.: 05000455/2012008

Facility: Byron Station, Unit 2

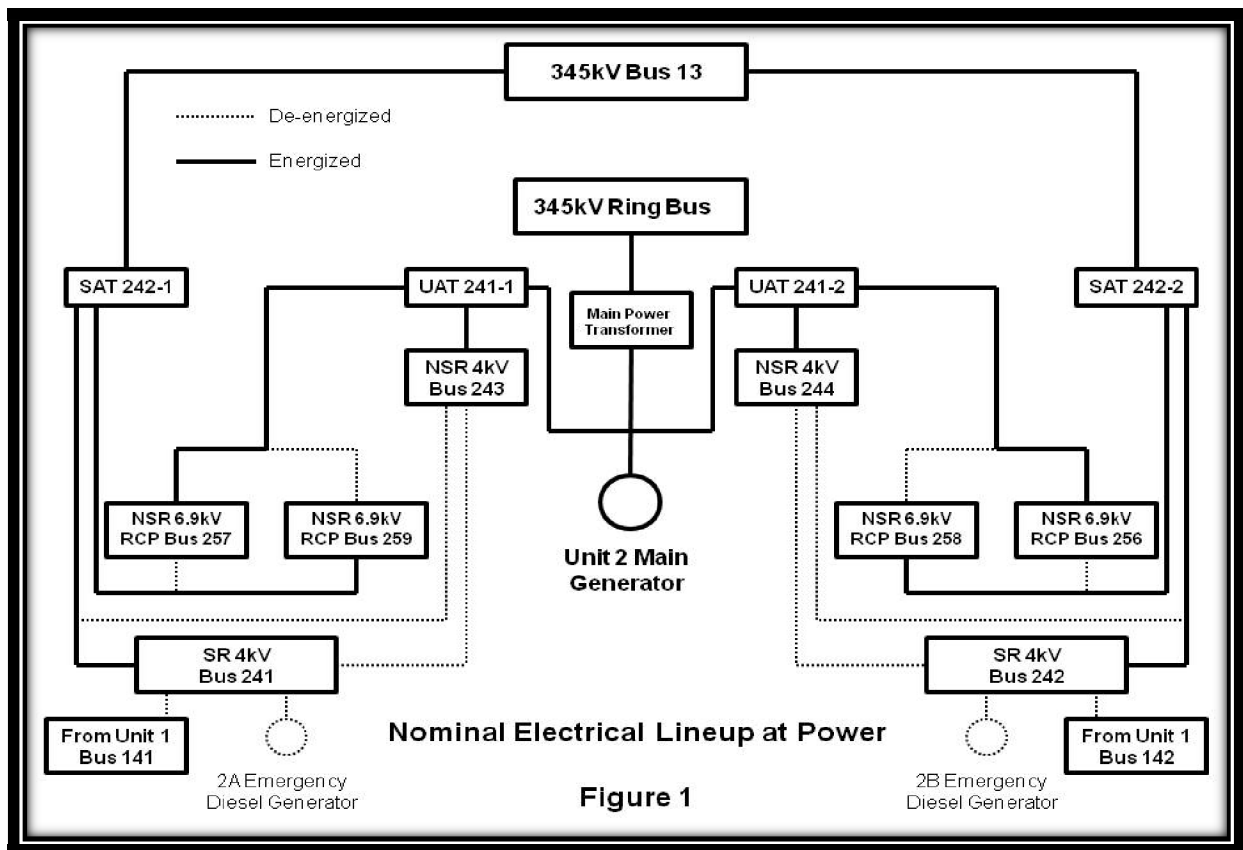
The first offsite preferred power source is from 345kV Bus 13 to Unit 2 SATs 242-1 and 242-2. These SATs then supply NSR power to two RCPs through 6.9kV Bus 258 and Bus 259. The remaining RCP buses (Bus 256 and Bus 257) are powered from UATs 241-1 and 241-2. In addition to the 6.9kV buses, the Unit 2 SATs also supply power to SR Bus 241 and Bus 242.

The second offsite preferred power source is from 345kV Bus 6 through Unit 1 SATs 142-1 and 142-2 and through Unit 1 ESF Bus 141 and Bus 142 utilizing Unit 1 and Unit 2 cross-tie breakers.

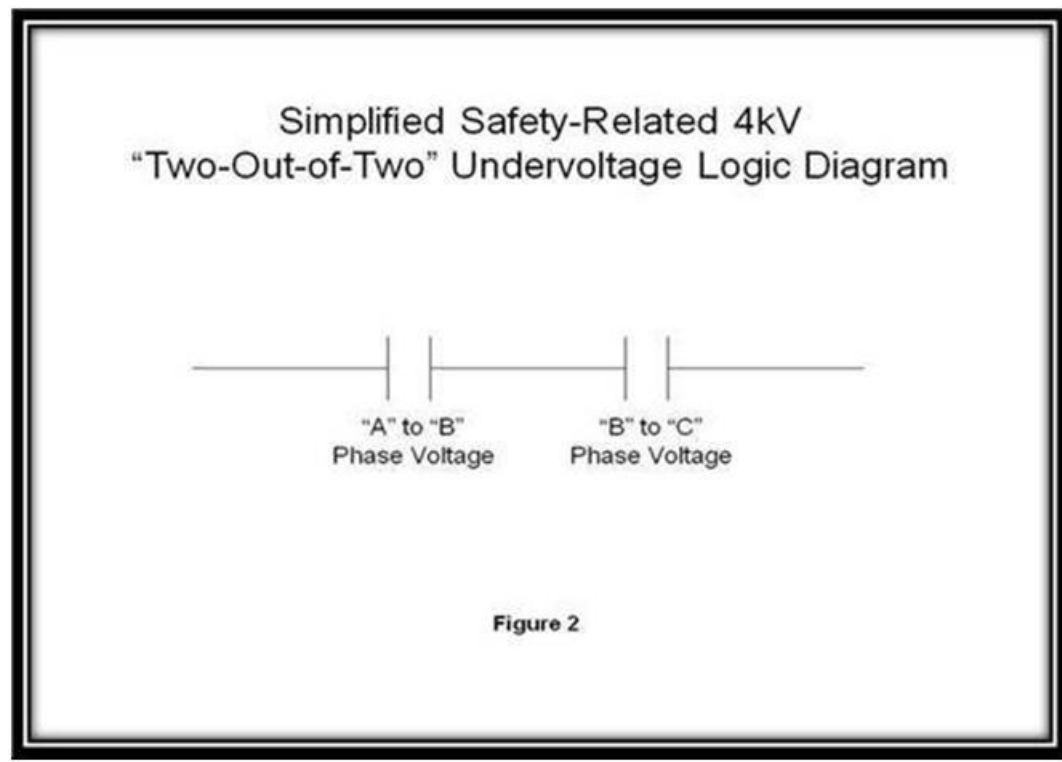
Description of Unit 2 SR 4kV Bus 241 and Bus 242 Undervoltage Protection Scheme (Figure 2)

The Unit 2 undervoltage protection scheme for SR Bus 241 and Bus 242 is based on a two-out-of-two coincidence logic. Voltage sensing devices monitor Bus 241 and Bus 242 phase-to-phase differential voltage between the “A” and “B” phases (A-B phase voltage differential) and the “B” and “C” phases (B-C phase voltage differential). Because the undervoltage protection scheme utilizes contacts that are in series, an undervoltage trip signal is processed only if the voltage sensing device detects a differential voltage of less than 2730 Volts alternating current (Vac) for **both** the A-B and B-C phases. If only the “A” phase or “C” phase voltage is lost, then only one of two undervoltage contacts close, the undervoltage protection logic is not satisfied, and an undervoltage trip signal is not processed. The degraded voltage protection logic is of a similar design. The circuitry for receiving a Bus 241 and Bus 242 undervoltage or degraded voltage alarm in the main control room utilizes the same logic.

However, because the ESF undervoltage and degraded voltage protection schemes were comprised of two contacts in series that monitored differential voltages between the A-B and B-C phases, upon the loss of only the "A" or "C" phase, only one protective relay is actuated and therefore does not satisfy the coincidence logic necessary to initiate an undervoltage or degraded voltage protection signal.

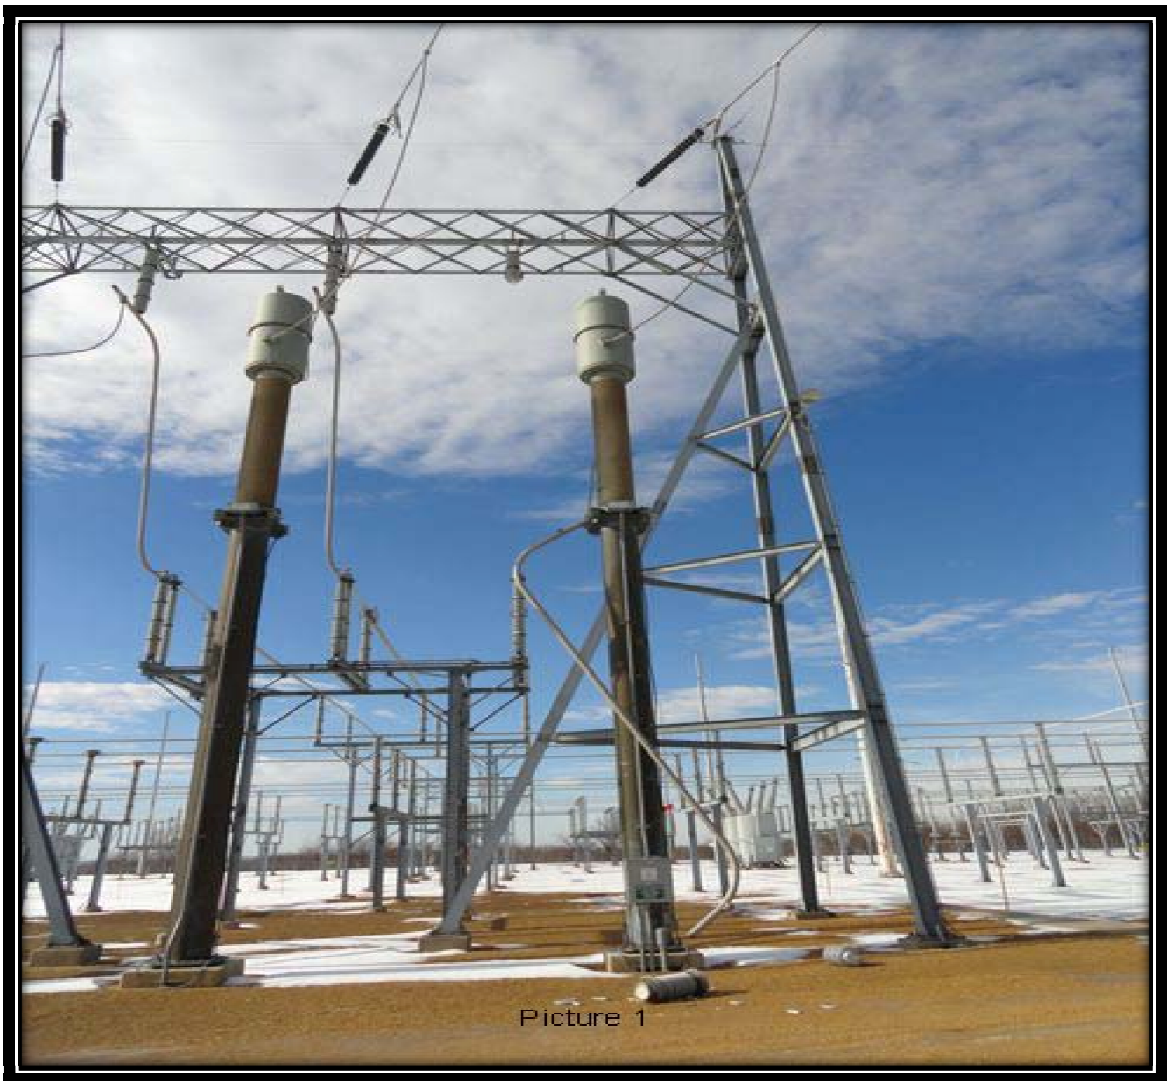
On January 30, 2012, at 10:01 a.m., Byron Unit 2 automatically tripped from full power due to an undervoltage condition on 6.9kV Bus 258 and Bus 259 that supply power to two of the four RCPs. The undervoltage condition was caused when the “C” phase insulator stack for the Unit 2 SAT revenue metering unit broke and part of the insulator fell to the ground (Picture 1).

The inspectors determined that the loss of the incoming 345kV "C" phase to the Unit 2 SATs was caused by an open "C" phase conductor. The conductor opened when an insulator stack that provided vertical support to the "C" phase conductor failed.

As part of the licensee's immediate corrective actions, the failed insulator was replaced and the SATs were assessed for damage. In addition, the licensee implemented a number of compensatory actions to raise awareness of the design vulnerability and to provide additional annunciator response instructions for the control room operators. These compensatory actions included the following:
