Response to NRC Bulletin No. 87-01  
"Thinning of Pipe Walls in Nuclear Power Plants"

Consolidated Edison Company of New York, Inc.  
Indian Point Unit No. 2  
Docket No. 50-247  
September 11, 1987

Metallurgical Analysis Summary Report

Sample Description: 6 inch spool piece between the level control valve (LCV-1103) and the isolation valve from Feedwater Heater No. 26C to the Heater Drain Tank.

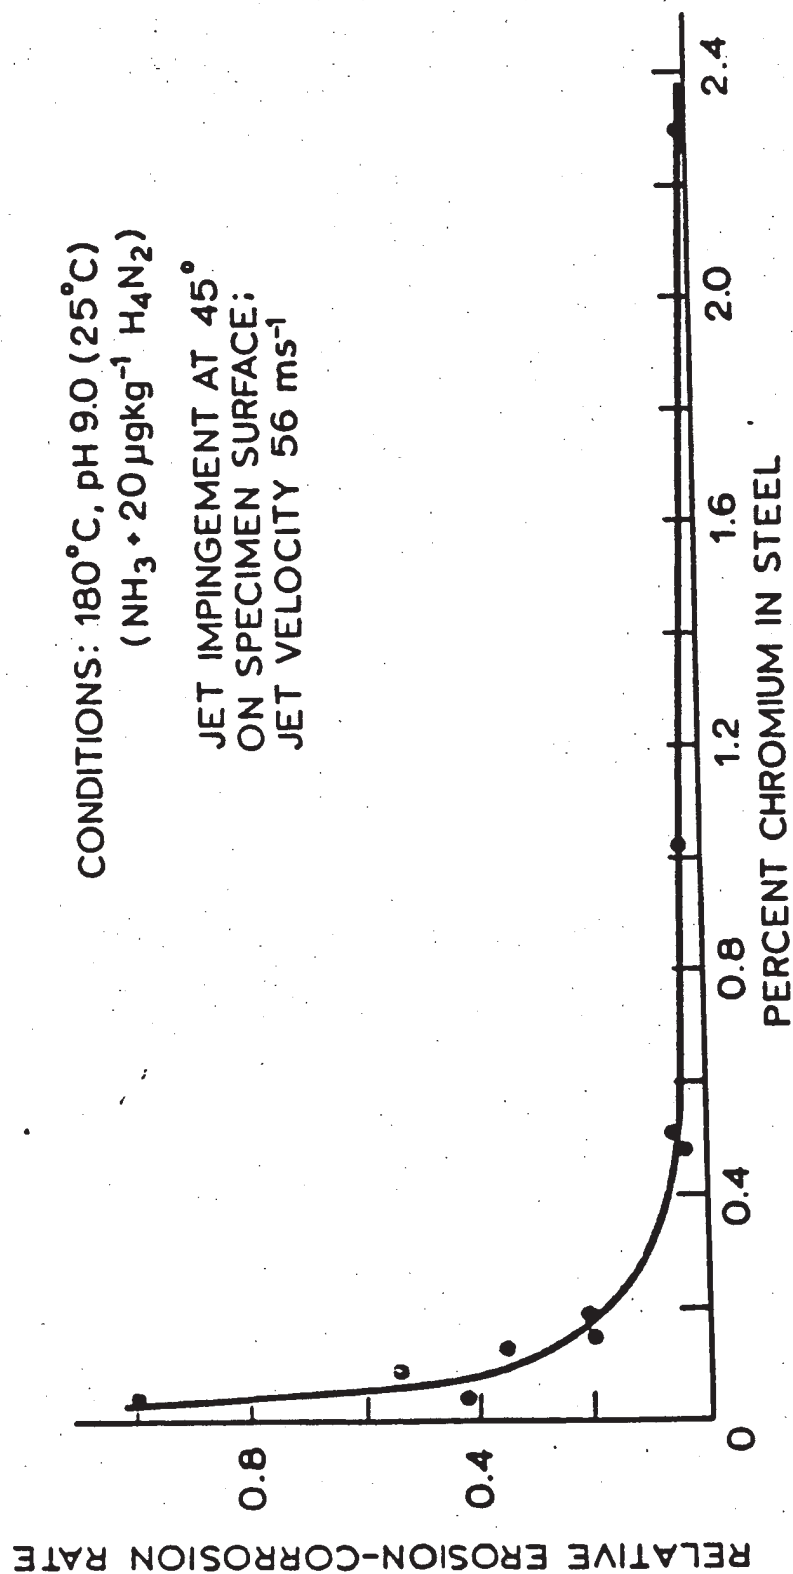
FIG.4 EFFECT OF CHROMIUM CONTENT ON EROSION-CORROSION  
RATE OF MILD AND LOW CHROMIUM ALLOY STEELS (DUCREUX, 1982)

The effect of the erosion-corrosion rate as a function of chromium content in steel is shown in the attachment from the EPRI Workshop on Erosion-Corrosion of Carbon Steel Piping - Nuclear and Fossil Plants, April 1987.
