Calc No.: F10503-R-001
Title: Transformer Internal Pressure
Evaluation

The photographic report ST02/11 summarizes Trench's and Siemens' investigation on the failed bushing serial number 05F9080-04 originally installed in phase B of TR#21 at Indian Point Nuclear station.

Problem Statement (object/deviation format): 21 Main Transformer Failed

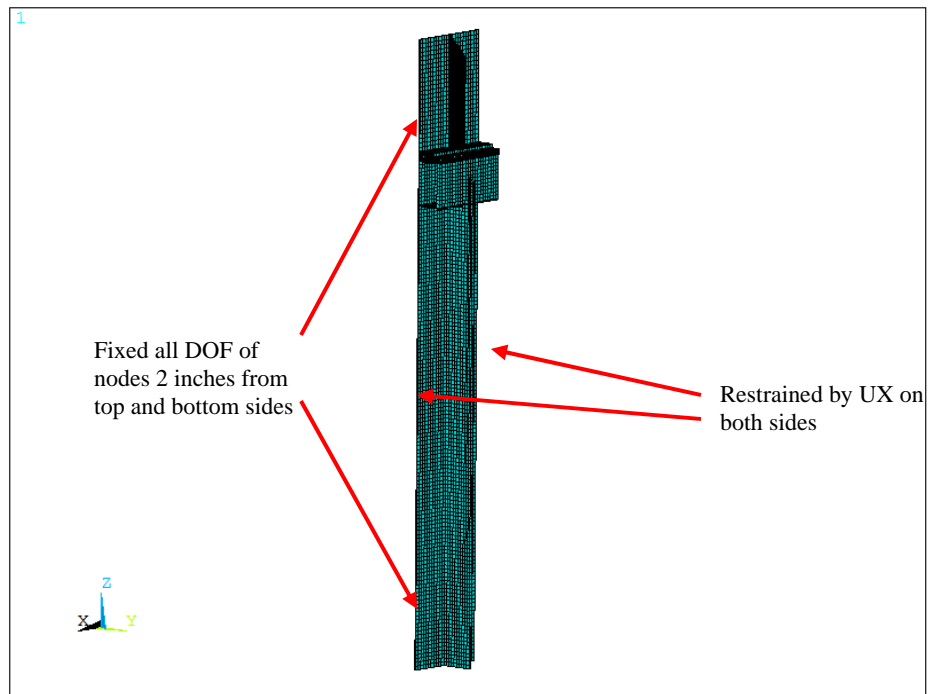
Fig. B.1: Sketch of the representative transformer model.

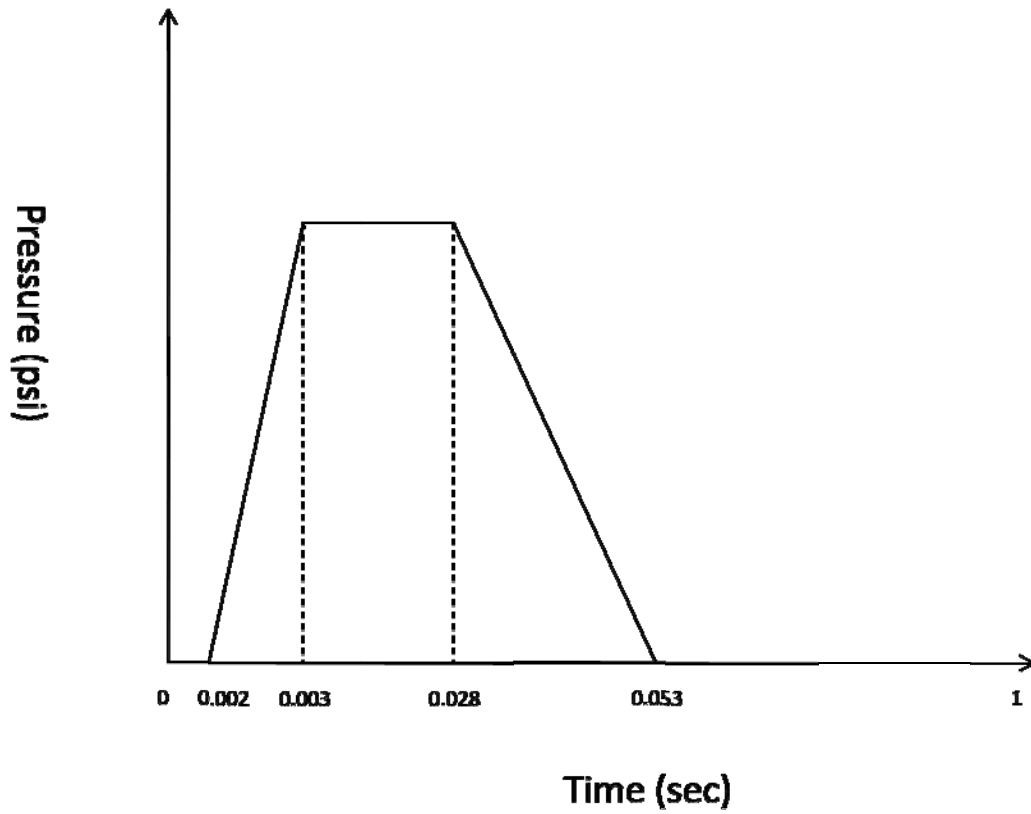
Fig. B.3: Graph of the loading conditions selected for the analyses.

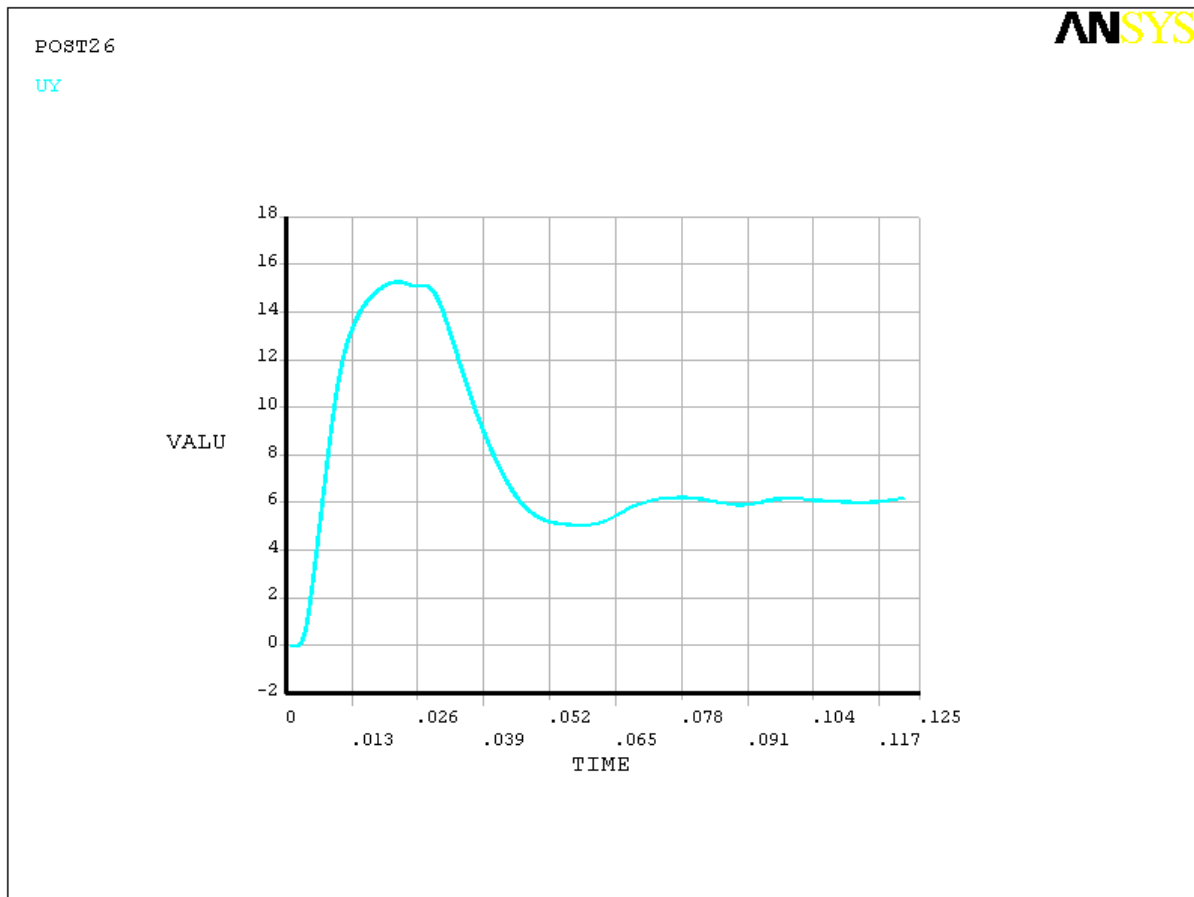
Various pressure pulse simulations at peak dynamic pressure values of 700 psi and 800 psi were analyzed. As Fig. B.4 shows, the maximum out-of-plane deflection at a peak pressure of 700 psi was found to be around 15 inches (38 cm). The residual out-of-plane deflection after the pressure pulse is around 6 in., which was approximately the deflection observed in the 21MT while on-site for the external visual inspection. For the simulation run at a peak dynamic pressure of 800 psi, the maximum out-of-plane deflection was found to be slightly greater than 16 inches (41 cm). These values are within the range of dynamic pressures calculated in Appendix A.

Fig. B.4: Maximum out-of-plane deflection and residual deflection for a 700 psi peak dynamic pressure.

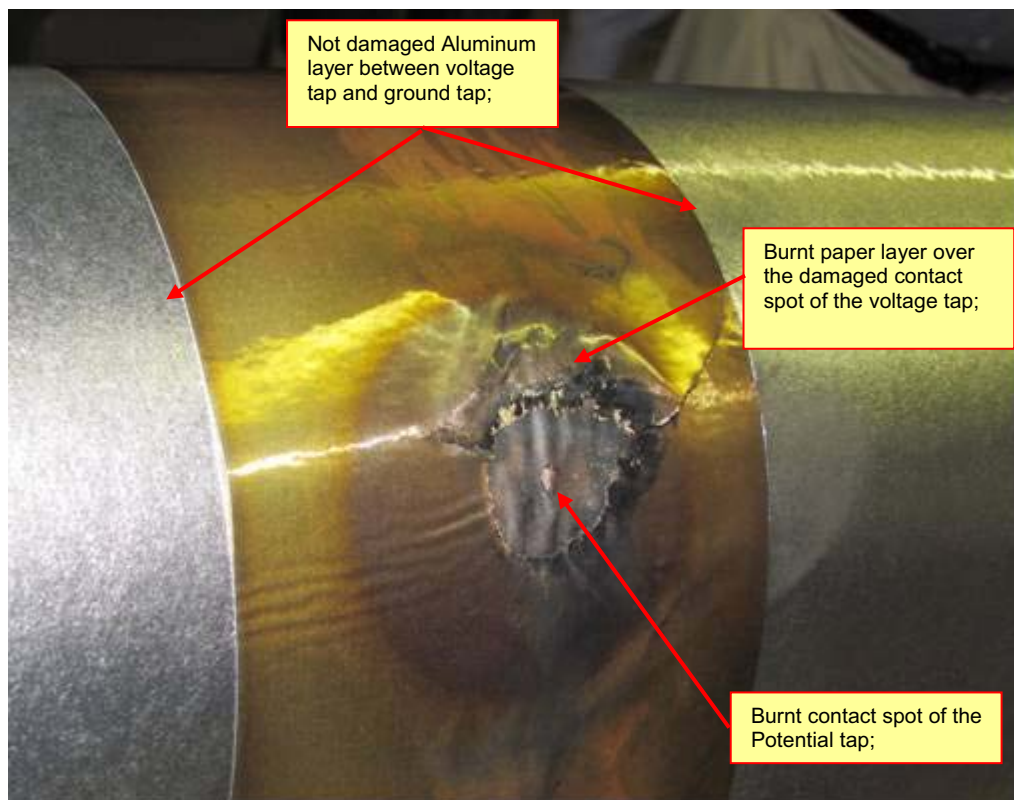
Picture 10: H2 bushing: Further Aluminum layer after Test tap and the burnt voltage tap.

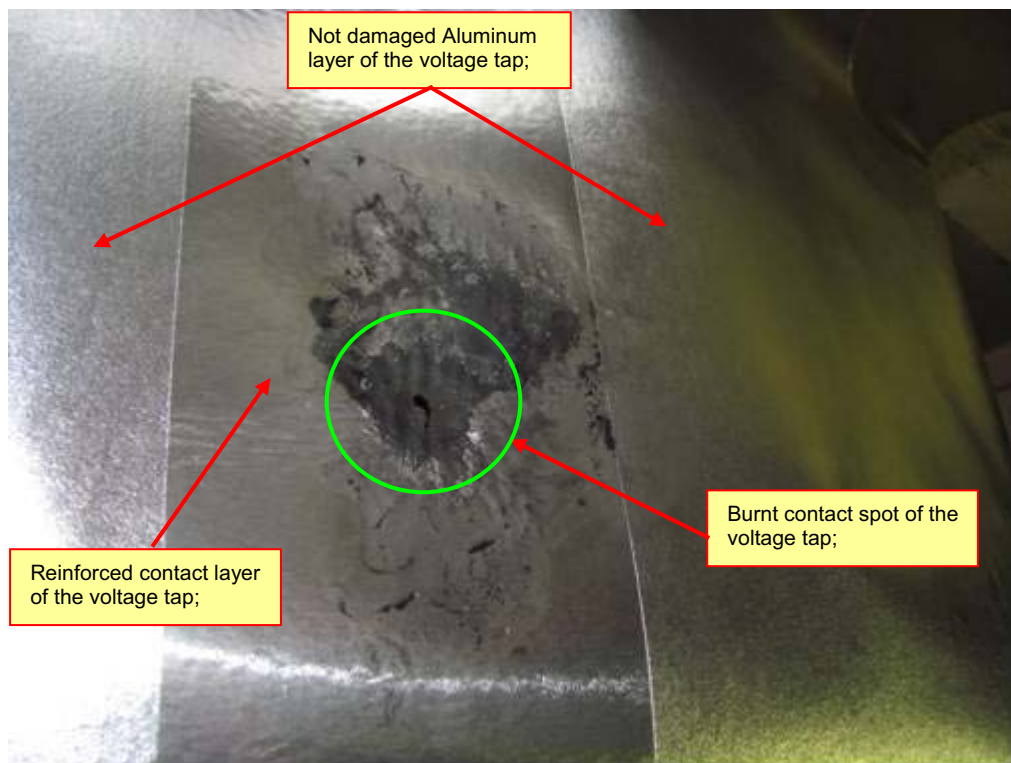
Picture 11: H2 bushing: burnt contact layer of the voltage tap.

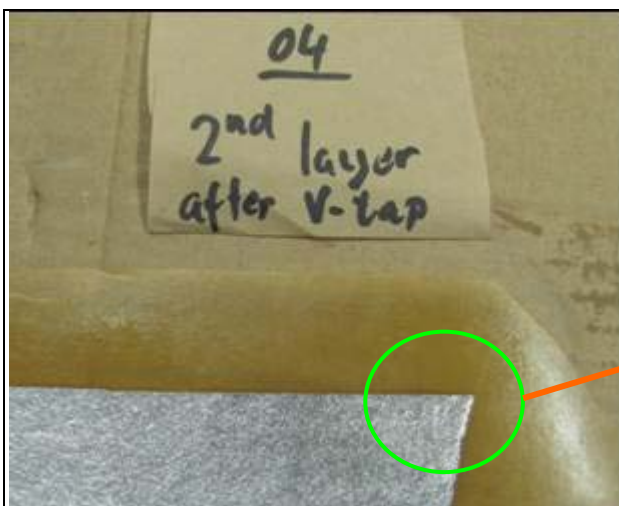
Picture 12: **H2 bushing:** Detail of the 2nd layer beneath (inwards) the voltage tap layer with "treeing" traces on the edge.

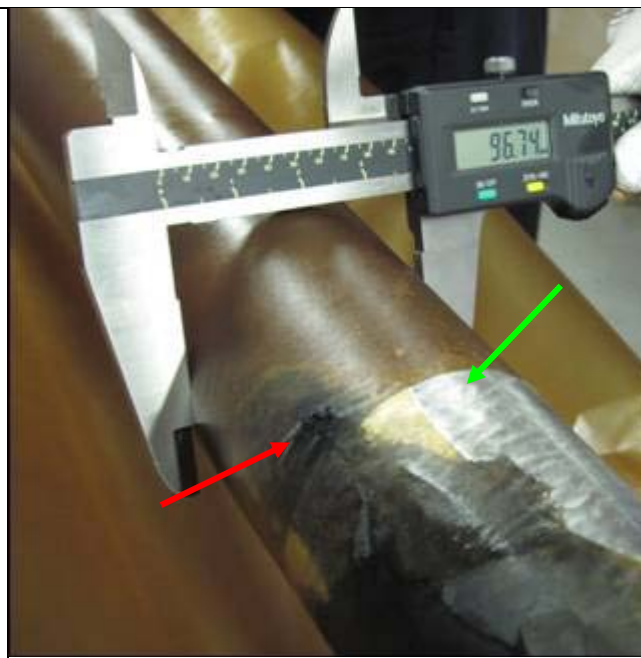
Picture 32: H2 bushing:

The innermost 18 foil layers at the lower part of the bushing were not damaged during the failure (see picture 32), allowing the inspection of the bottom portion of the condenser core. Similar treeing traces were found at these locations.

Green circle: discharge path also visible by mechanical & burnt marks on the 18th layer.

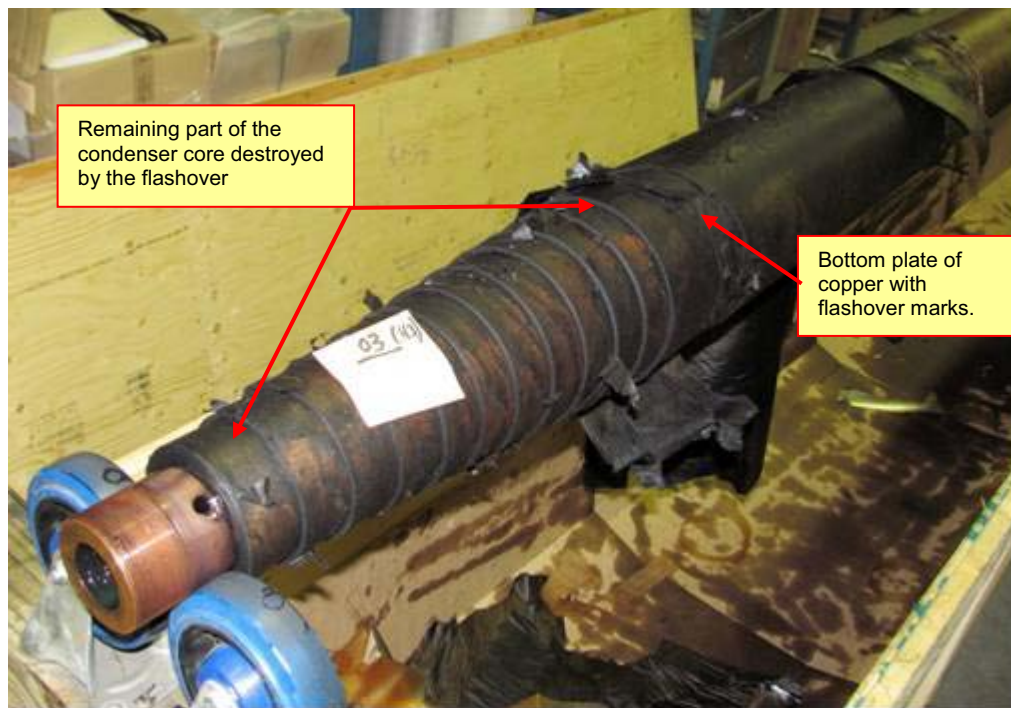
Picture 39: General view of the **H3** bushing showing the bottom part; all layers of the condenser core are complete, only few external paper turns are slightly burnt when the epoxy envelope of the oil side was broken and thrown away due to the mechanical impact caused by the flashover at the bushing H2 on the central phase.

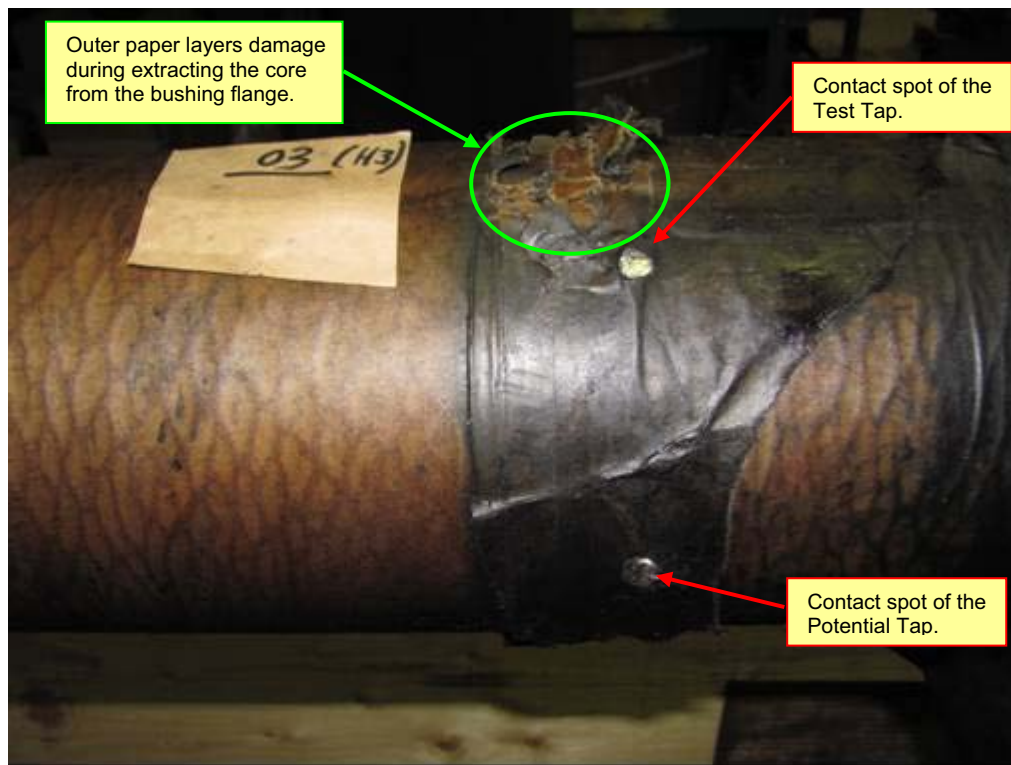
Picture 42: Bushing H3: detail view of the flange region, showing the contact spots of the Test & Potential taps without damage.

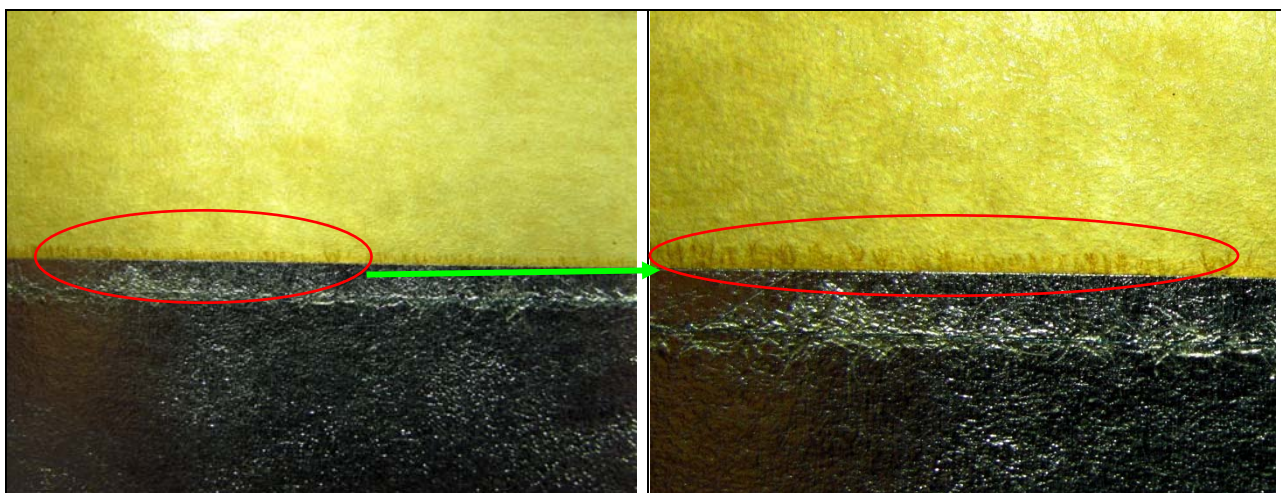
After taken away the grounded layers corresponding to the voltage and ground taps, the first layer below the voltage tap layer showed intense traces at its lower edge, as shown in the pictures below:

Picture 43: **H3 bushing:**
: 1st layer beneath the voltage tap layer;
Red circle: region enlarged (**Green arrow**) on photo #44, with clear "treeing" traces at the bottom edge of the 1st layer beneath the voltage tap.

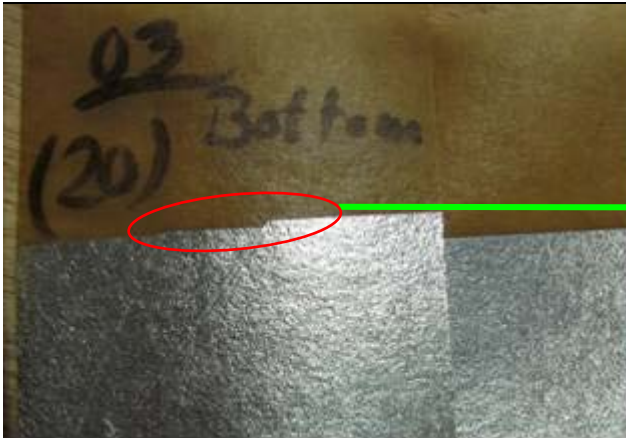
Picture 49: H3 bushing: detail of an intermediate layer halfway between the voltage tap layer and the central conductor, bottom edge of the lower foil:
Red circle: region enlarged on photo #50 (**Green arrow**) lighter "treeing" traces observed than traces observed on the layer just beneath the voltage tap.

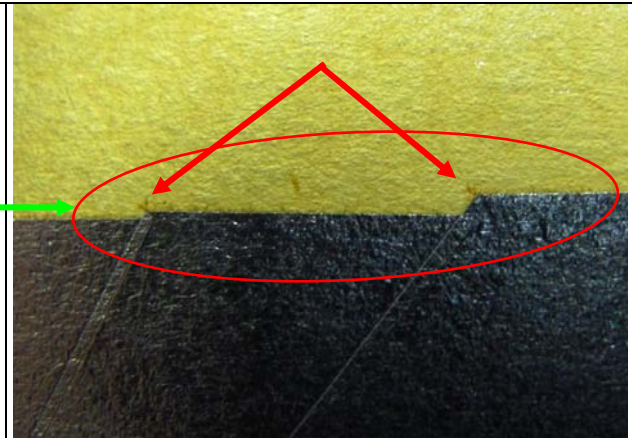
Picture 50: H3 bushing: detail view of the bottom edge of the lower foil of the intermediate layer
Red circle: detail of the clear but slighter "treeing" traces, where it is visible that the traces are more intense at the corners created by small folding of the aluminum foils (**red arrows**).

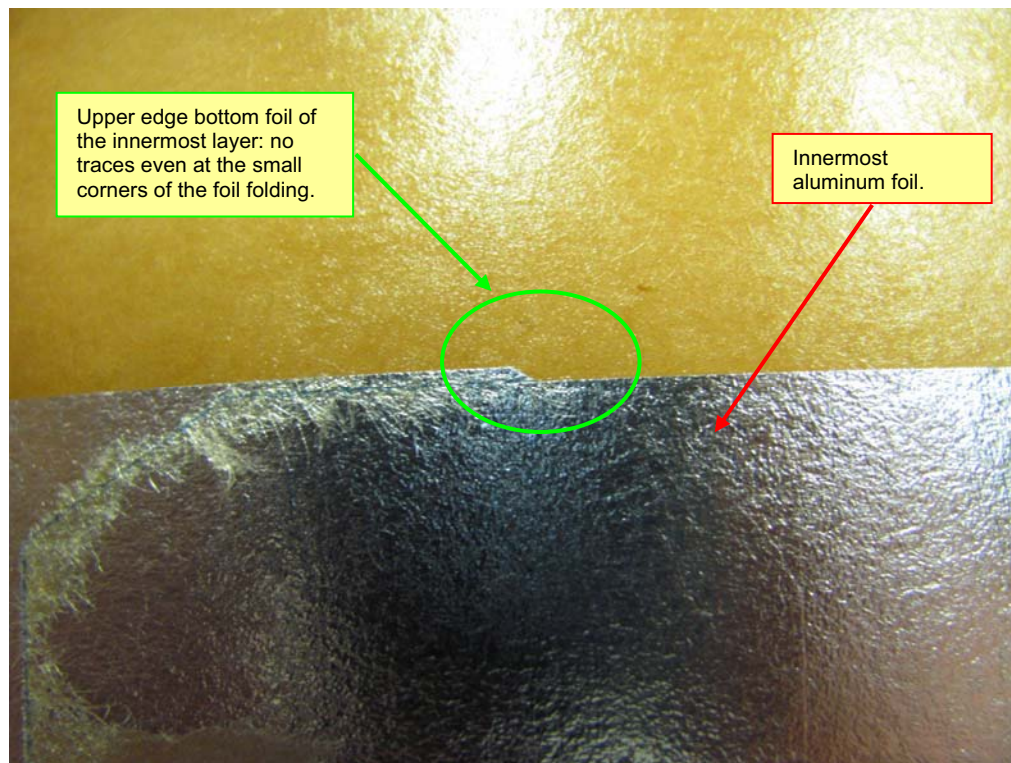
Picture 53: Bushing H3: detail view of the innermost aluminum foil (1st layer over the central conductor),
No "treeing" traces are visible at the internal (upper edge) of the lower foil.

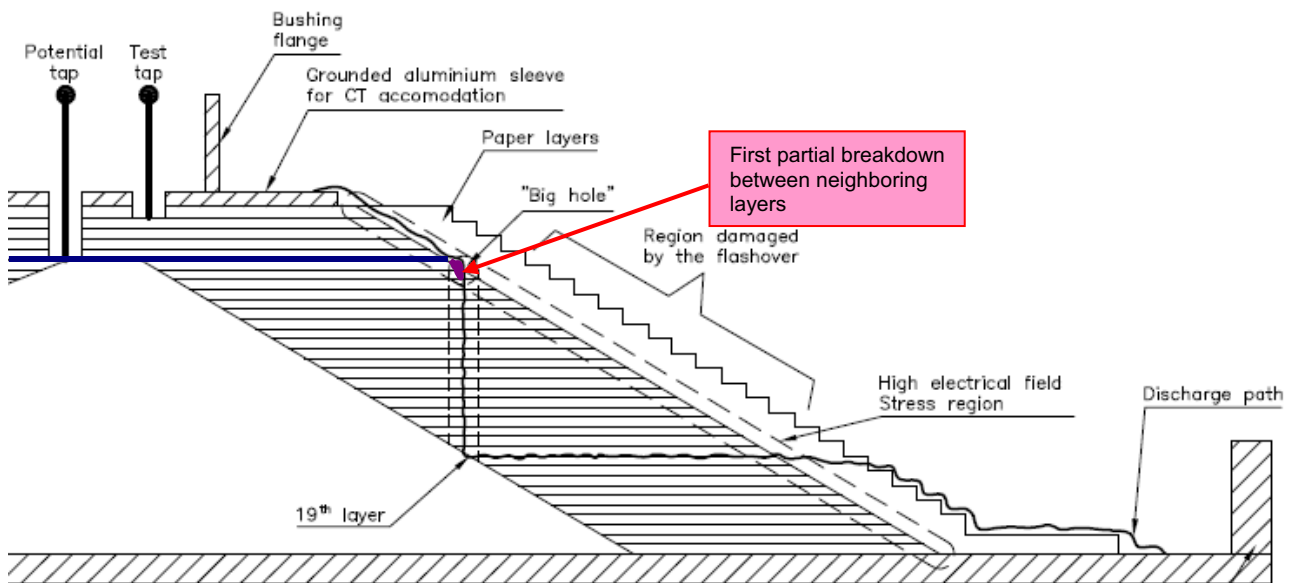
Sketch 3. The highest electrical field stress at the edge of each layer is radially inward (e.g. in direction of the next inner layer) Therefore, the partial breakdown between two layers tends to grow inwards.

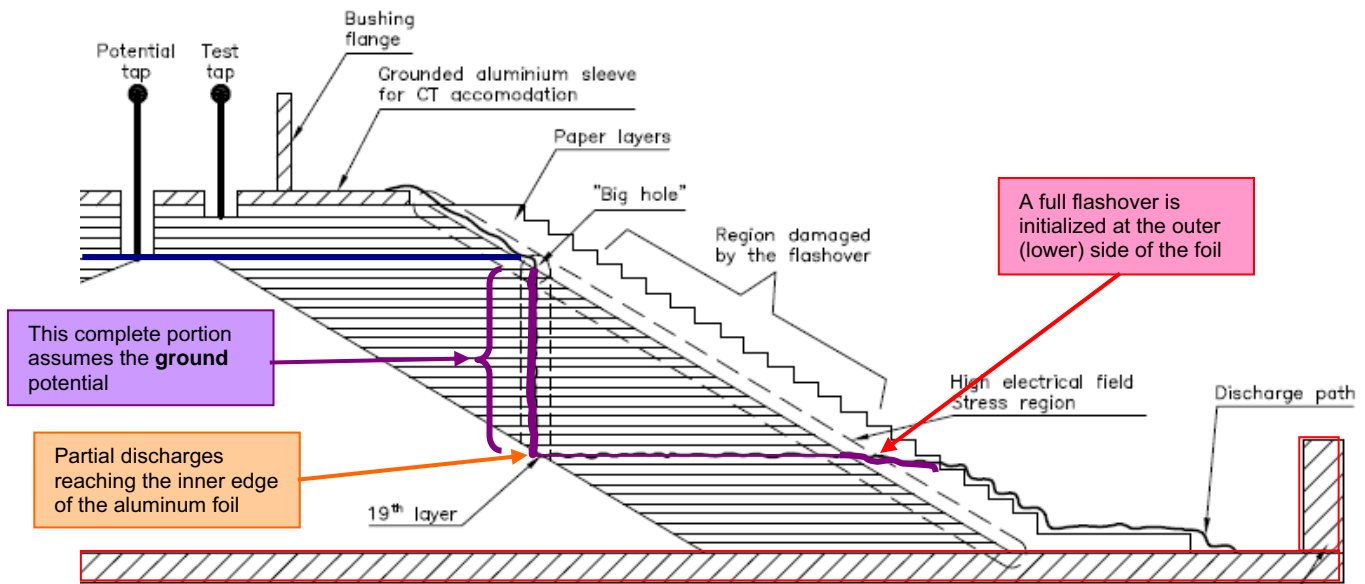
5.10 The progression of the partial discharge activity continues inwards and stops when the inner edge of the aluminum layers is touched. At this point a critical condition is reached at the outer (bottom) edge of the foil at the lower part of the bushing, where the field stress gets so high that a pre-breakdown in the oil is generated.

5.11 This pre-breakdown activity rapidly escalates to a discharge toward the central conductor, which is at the 100% potential.

Sketch 5. When the partial discharges reach the inner edge of one foil, there is no further radial breakdown between layers which can be established. But the electrical field stress at the lower edge on the outer side of this foil is now extremely high, initializing a full flashover to the central conductor.

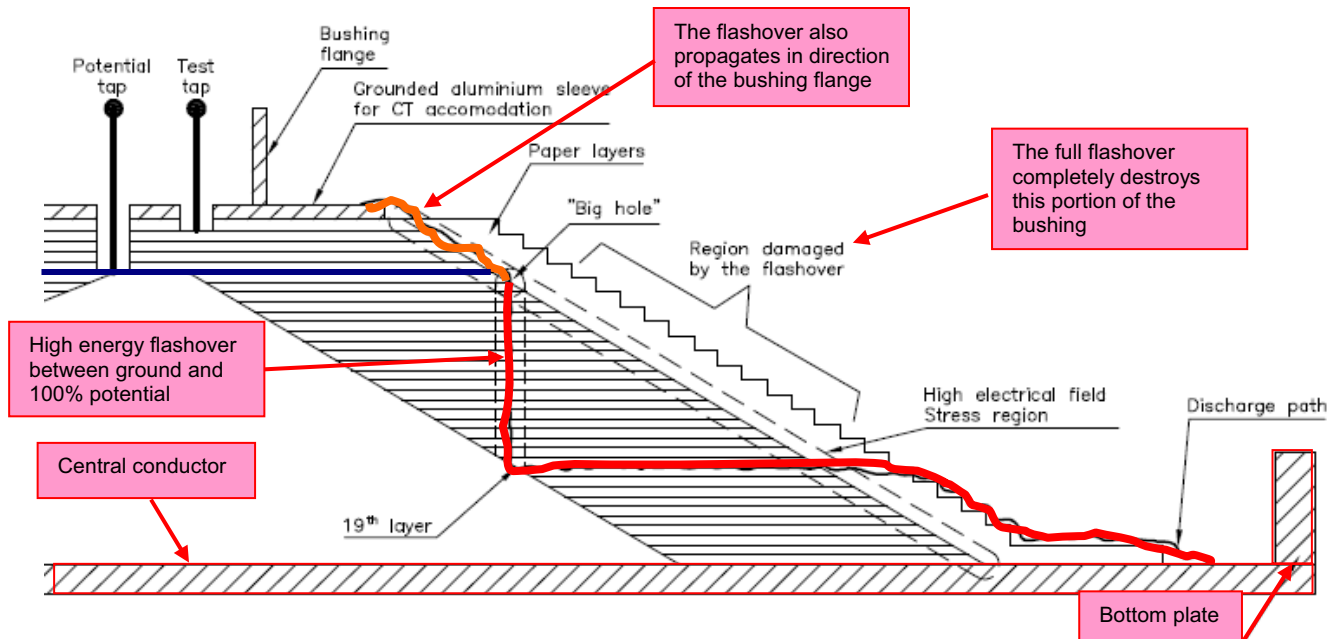
The most likely failure path was identified as starting on or around the outer edge of the first layer following the layer of the potential tap, passing through the “big hole” and reaching the 100% potential at the central conductor near the bottom terminal. The failure path also expanded to the bushing flange at the zero potential side (refer to the **sketch 6 – section 5**).

5.12 Finally, the discharge expands until it reaches the grounded flange. This establishes a high energy flashover between the central conductor and the bushing flange. The pathway travels axially through the 19th layer, rupturing the external paper layers and causing the explosion of the oil side of the bushing. This final high energy discharge results in external electrical failure.

Sketch 6. The flashover reaches the central conductor and establishes the high energy discharge between 100% potential and ground. An explosive thermal oil expansion occurs, making the lower part (oil side) of the bushing to rupture.

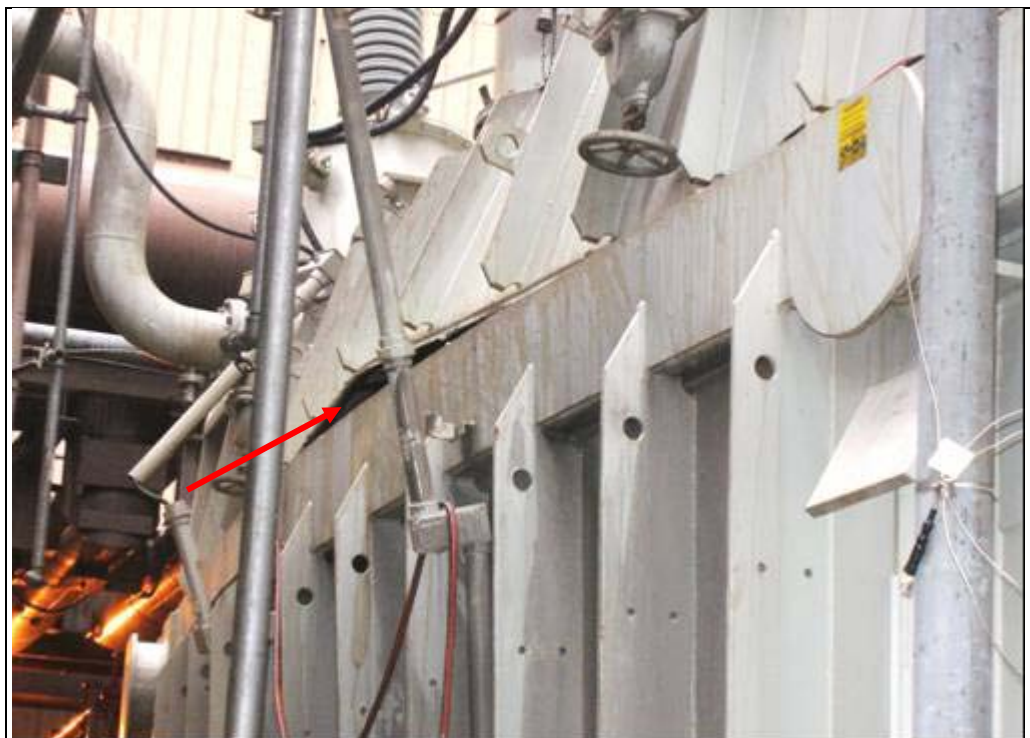
Picture 2: Damaged tank of the Unit #21 after the occurrence:

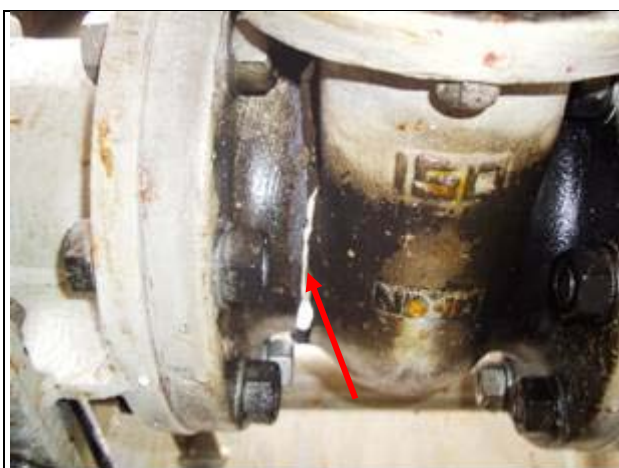
Picture 3: **Red arrow:** ruptured cooling system 12" valve

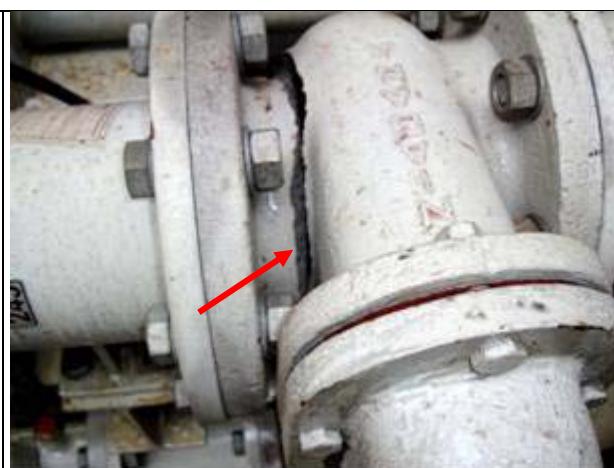
Picture 4: **Red arrow:** ruptured cooling system 12" valve

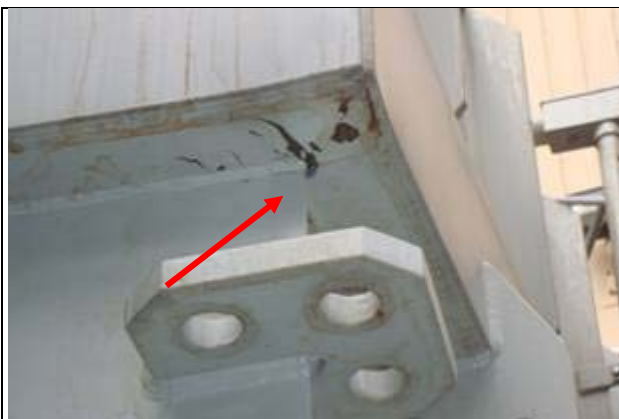
Picture 5: **Red arrow:** mechanical stress marks on the corner of the tank frame;

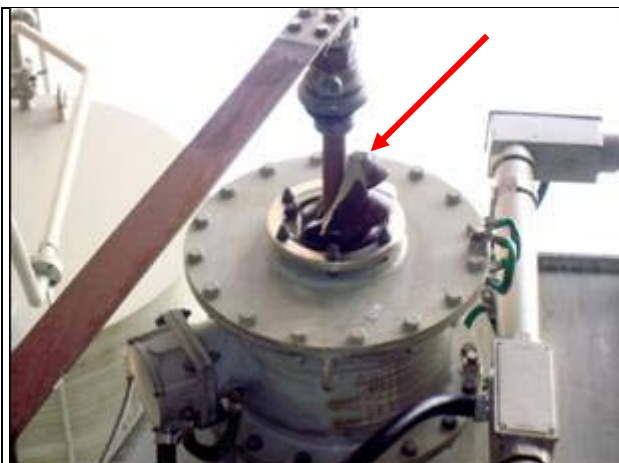
Also the porcelain of the neutral bushing installed at the tank wall was broken by the shock wave (**Picture 7**).

Picture 7: **Arrow:** Neutral bushing (H0) broken porcelain;

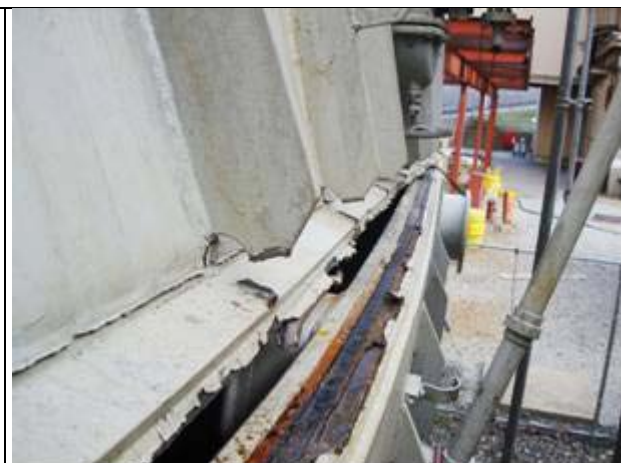
Picture 8: Detail of the ruptured tank & cover weld;

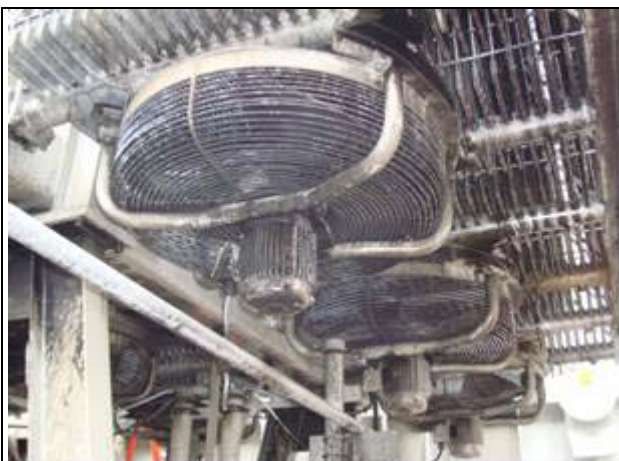
Picture 9: Radiators and fans were involved by the fire;

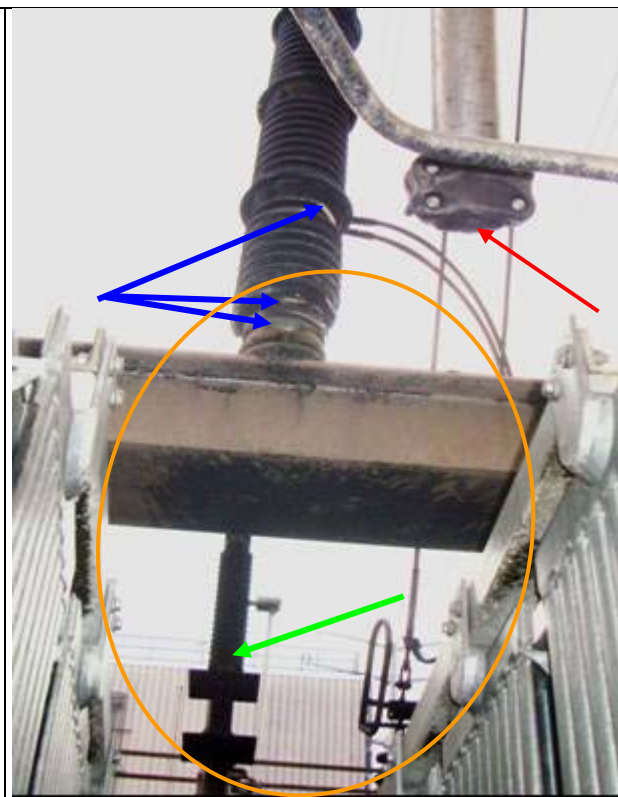
Picture 12: **Red arrow:** Broken connector of 345 kV bus;
Blue arrows: Damaged porcelain of the insulating post for the 345 kV bus;
Orange circle: Space between the radiator banks in front of the phase "B" bushing, allowing the propagation of the expelled fire ball until the surge arrester installed on the top of the fire wall (**Green arrow**)

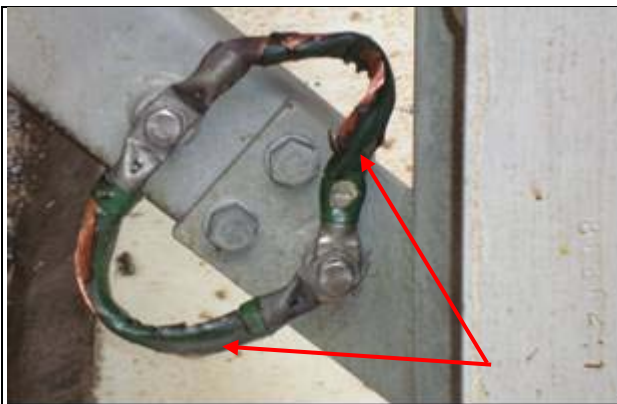
Picture 13: **Red arrows:** The grounding lead insulation was melted by the fire, rather than by a short circuit current to ground: the plastic covering of the grounding strips is melted only at a single side;

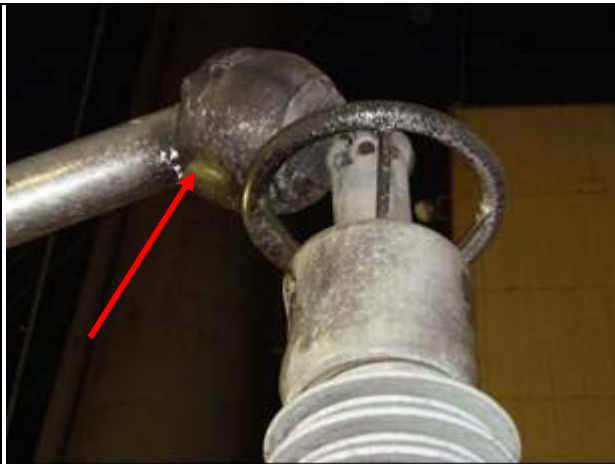
Picture 15: Red arrow. Damaged top connector of the H2 Bushing (Phase "B")

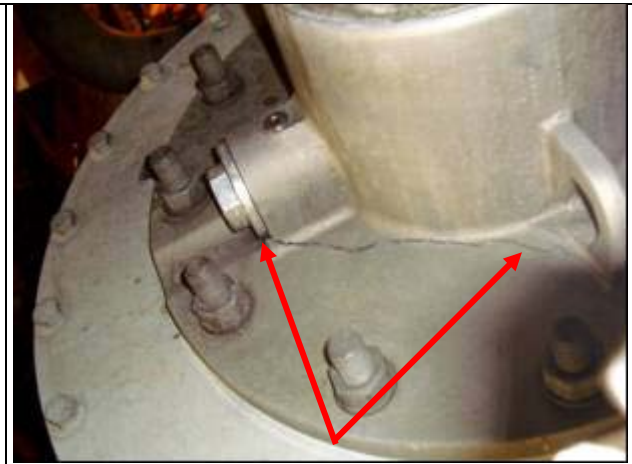
Picture 16: Red arrows: Crack on the flange of the H3 Bushing (Phase "C") caused by the shock wave.

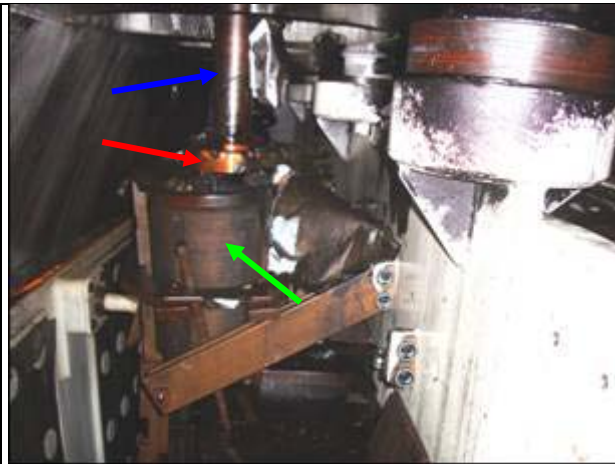
Picture 17: **Red arrow:** Bottom plate of the H2 Bushing;
Blue arrow: remaining insulation its condenser core;
Green arrow: Shielding electrode forced downwards;

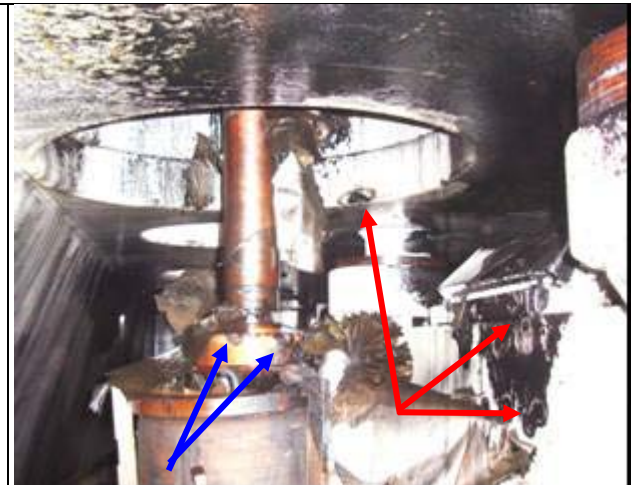
Picture 18: **Red arrows:** Flashover marks on the grounded parts around H2 bushing (on frame and turret);
Blue arrows: Arcing marks on the bushing bottom plate;

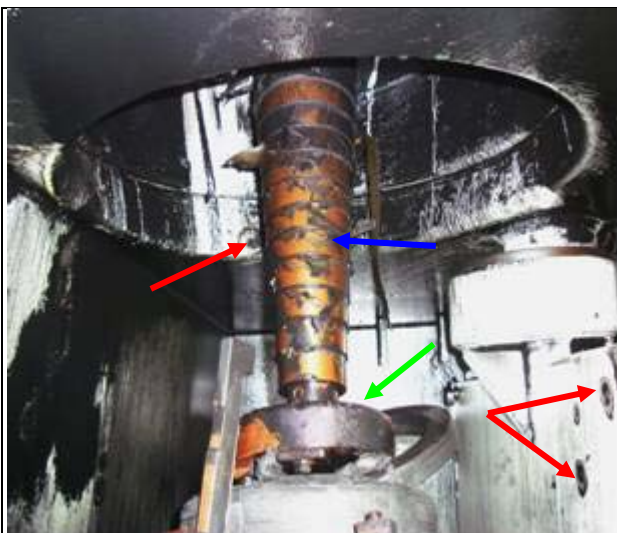
Picture 19: H3 (Phase "C") H3 Bushing:
Red arrows: Flashover marks on grounded parts;
Blue arrow: Condenser core without its epoxy shell;
Green arrow: Shielding electrode dropped downwards;

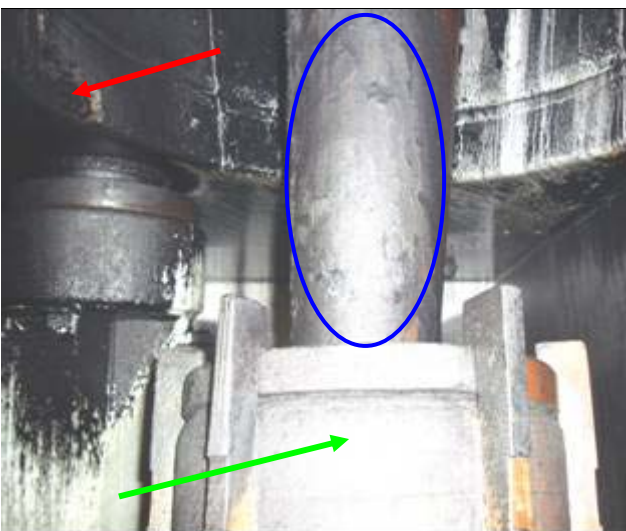
Picture 21: H1 (Phase "A") H1 Bushing:
Red arrow: Flashover marks on grounded parts (turret);
Blue circle: Epoxy shell at the oil side heavily burned;
Green arrow: Shielding electrode still in place;

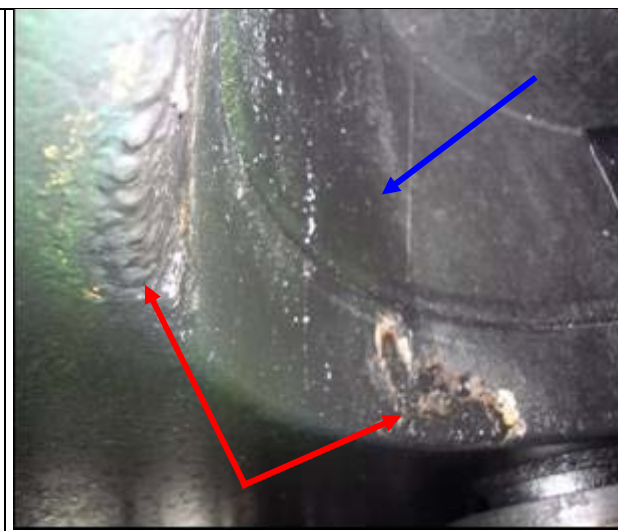
Picture 22: H1 (Phase "A") H1 Bushing:
Red arrows: Flashover marks on the grounded parts of the H1 bushing turret;
Blue arrow: Inner part of the phase "A" turret;

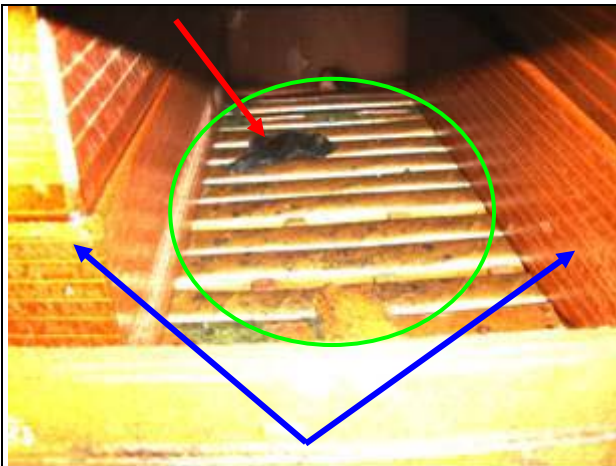
Picture 25: Top of the HV winding:
Red arrow: Debris of burned paper coming from the bushing flashover;
Blue arrow: Pressboard spacers on the top of the HV winding;
Green circle: Showing carbonized debris resulting from the flashover; no bending of the HV conductors was detected, demonstrating that no remarkable short circuit forces occurred during the flashover event;

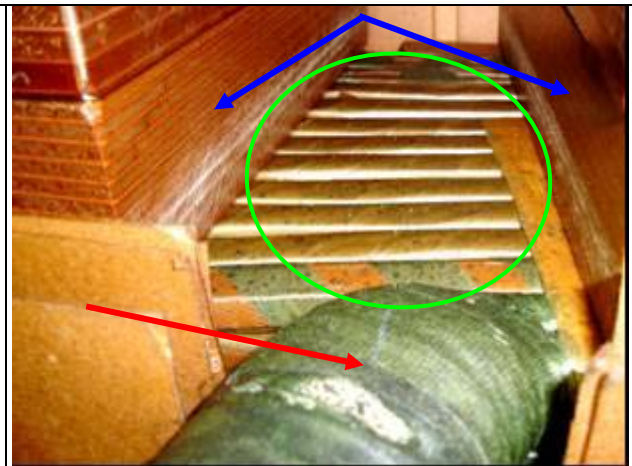
Picture 26: Top of the HV winding:
Green circles: ; No bending of the HV winding conductors was detected, demonstrating that no remarkable short circuit forces occurred during the flashover event;
Blue arrow: Pressboard spacers on the top of the HV winding;
Red arrow: HV winding outlead on the uppermost disk connecting to the neutral point (H0 Terminal);

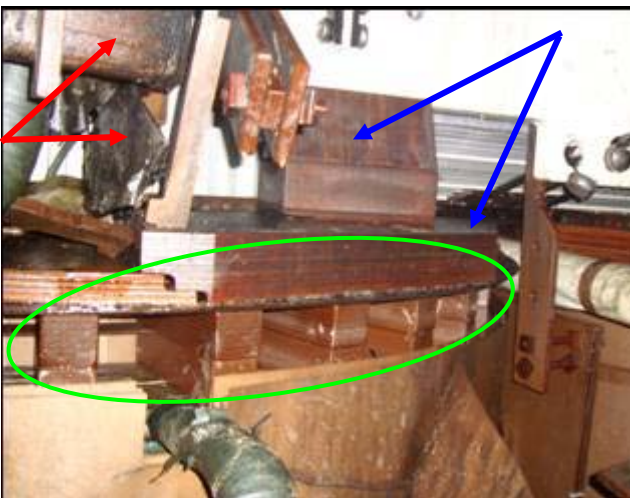
Picture 27: Top of the HV winding Phase "B":
Red arrow: Shielding electrode of the H2 bushing as well as some paper debris of burned paper coming from the bushing flashover;
Blue arrows: Winding pressing elements showing no displacement or misalignment;
Green circle: Pressboard spacers right in place on the top of the HV winding, no displacement or misalignment was detected;

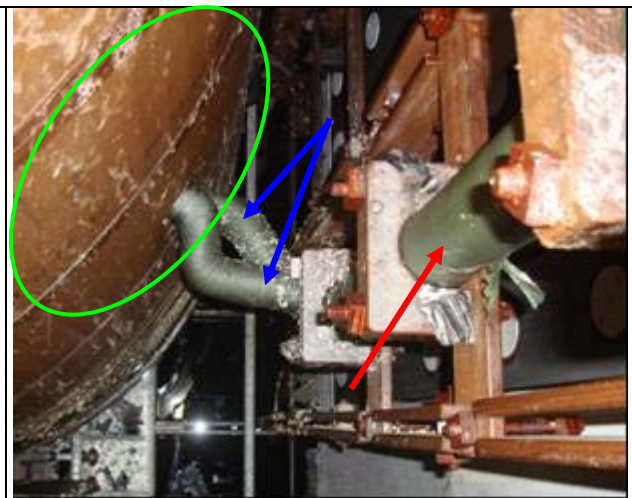
Picture 28: External part of the HV winding:
Green circle: Pressboard cylinder involving the HV winding; no damage was observed;
Blue arrows: Outleads from each half (upper and lower part) of the HV winding;
Red arrow: HV winding central outlead connecting to the HV phase terminal;

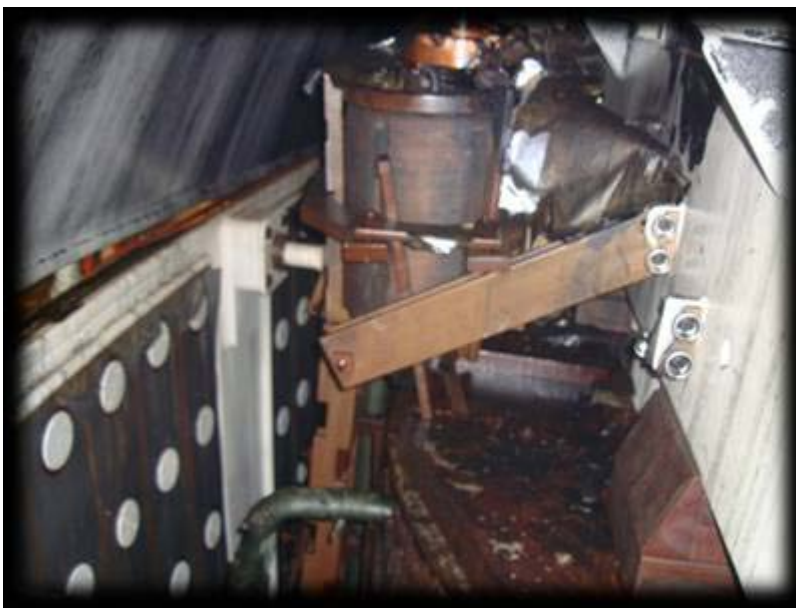
Picture 06 – View of Phase 2 after the flashover event, showing the Shielding Electrode and the supporting pressboard arms damaged by the explosion.

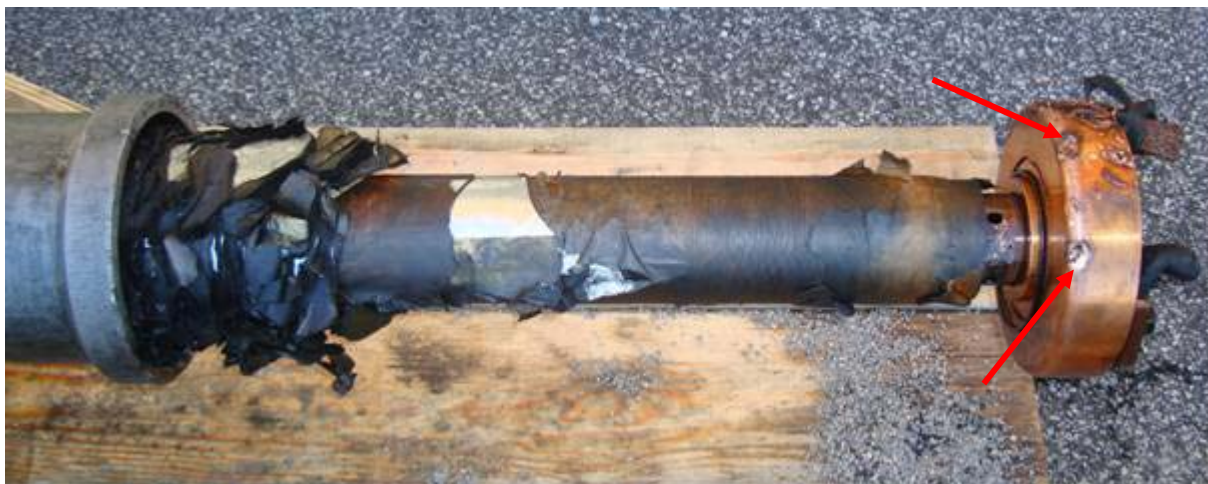
Picture 07 – Detail view of failed bushing H2:
Red Arrows: indicates the arcing marks on the bottom plate.

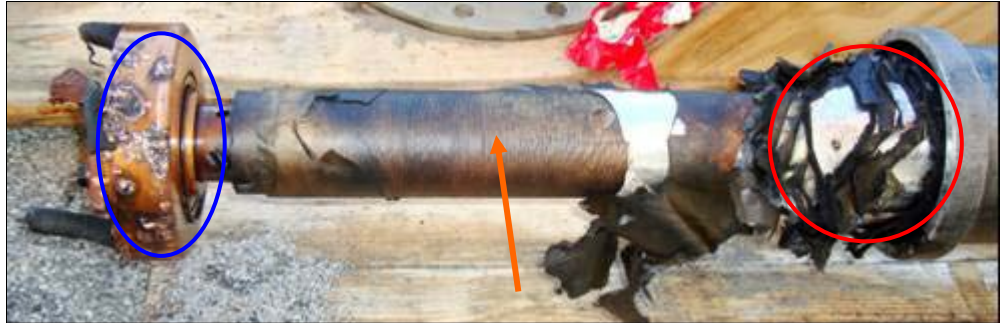
Picture 4: General view of the bushing H2:
Red circle: Area with the puncture to inner layers;
Orange arrow: Remaining layers of the condenser body;
Blue circle: Flashover foot points on the bottom plate;

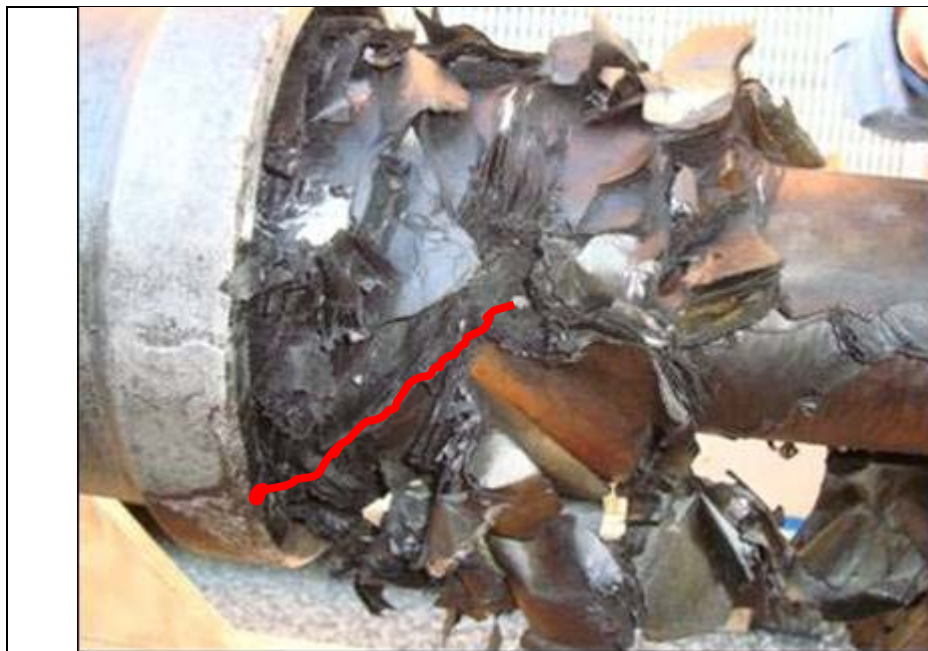
Picture 5: Detail view of failed bushing H2:
Red Line: indicates the arcing trace puncturing the condenser body and hitting the grounded flange extension.

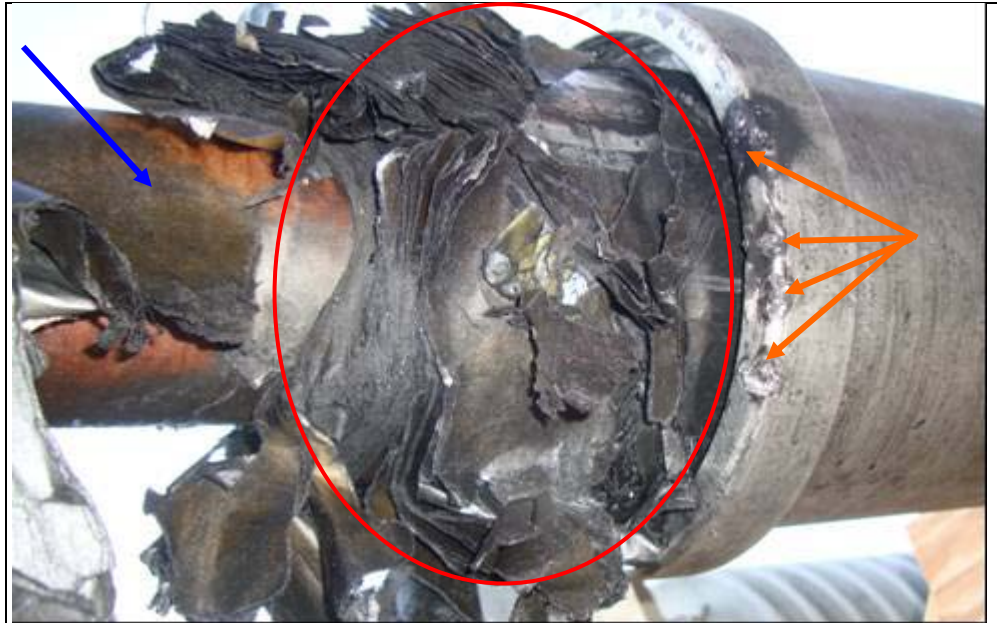
Picture 6: Further view of the bushing H2:
Red circle: Area of the layers destroyed by the flashover;
Orange arrows: Further flashover foot points on the bushing flange extension;
Blue arrow: Remaining layers of the condenser body;
