Calc No.: F10503-R-001
Title: Transformer Internal Pressure
Evaluation

The photographic report ST02/11 summarizes Trench's and Siemens' investigation on the failed bushing serial number 05F9080-04 originally installed in phase B of TR#21 at Indian Point Nuclear station.

Problem Statement (object/deviation format): 21 Main Transformer Failed

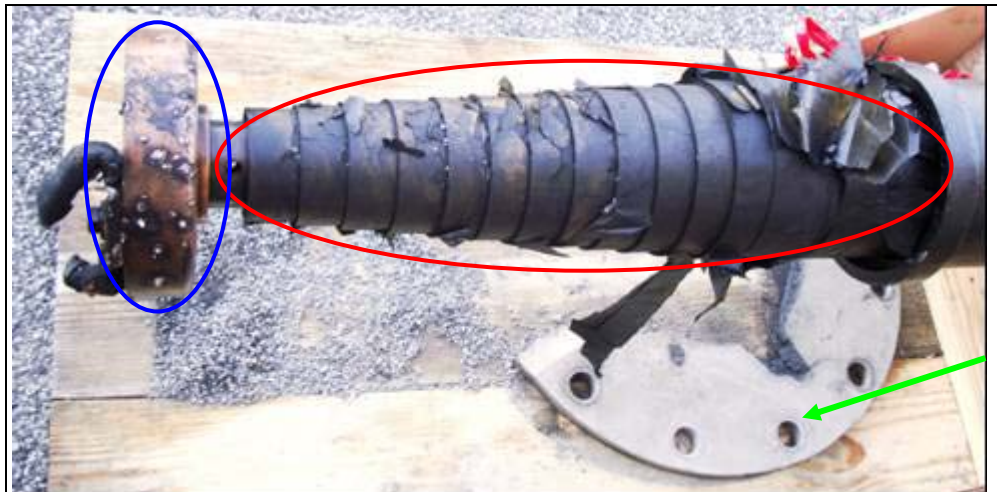
Picture 8: View of the H3 bushing:
Red circle: Condenser body partially damaged, without the epoxy shell destroyed by the flashover on the H2 bushing;
Blue circle: Flashover foot points between bottom plate and surrounding grounded parts;
Green arrow: Part of the bushing flange that was broken by the mechanical impact of the pressure surge inside the tank;

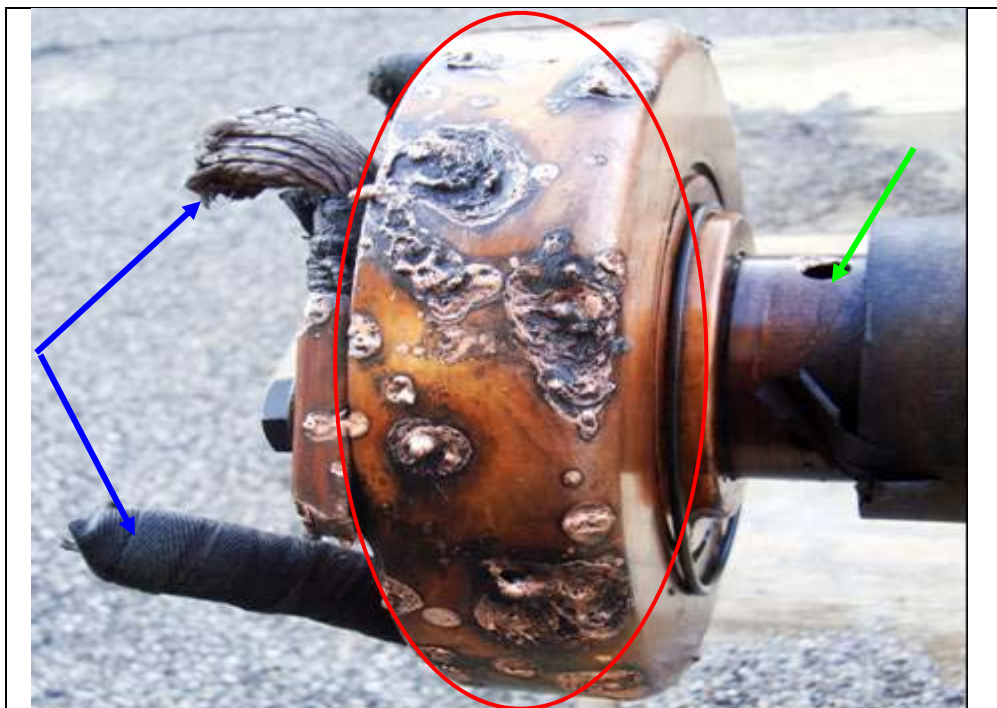
Picture 9: View of the H3 bushing bottom plate:
Red circle: Foot points caused by several flashover strikes occurred after the H2 event;
Blue arrows: Flexible connection leads cut away during the dismantling of the bushing;
Green arrow: Oil circulation hole on the central conductor;

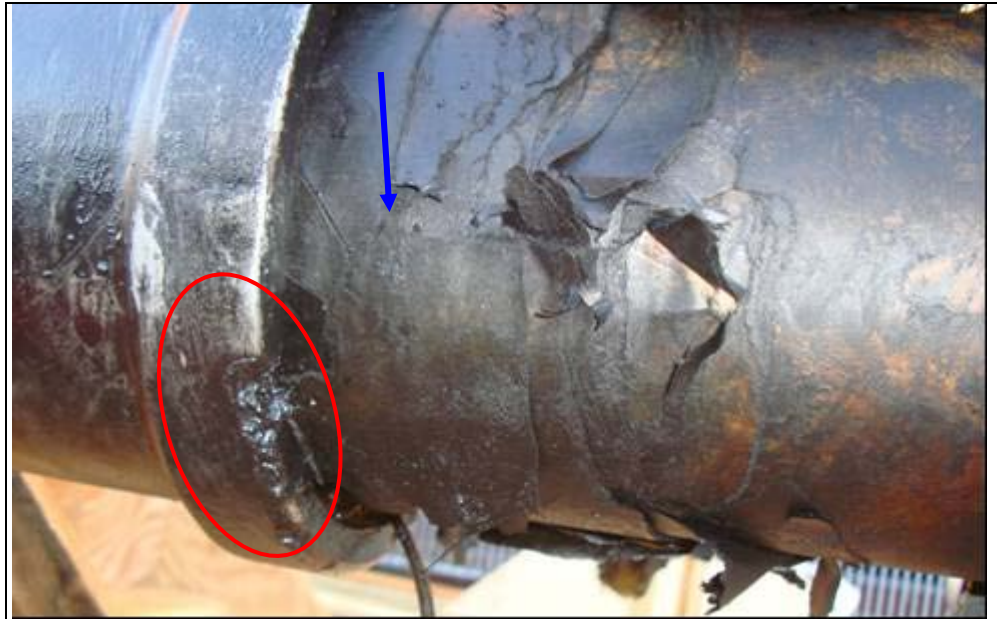
Picture 10: View of the H3 flange extension region:
Red circle: Foot points on the grounded flange extension caused by flashover events occurred on the condenser body ;
Blue arrow: Discharge traces on the condenser body;

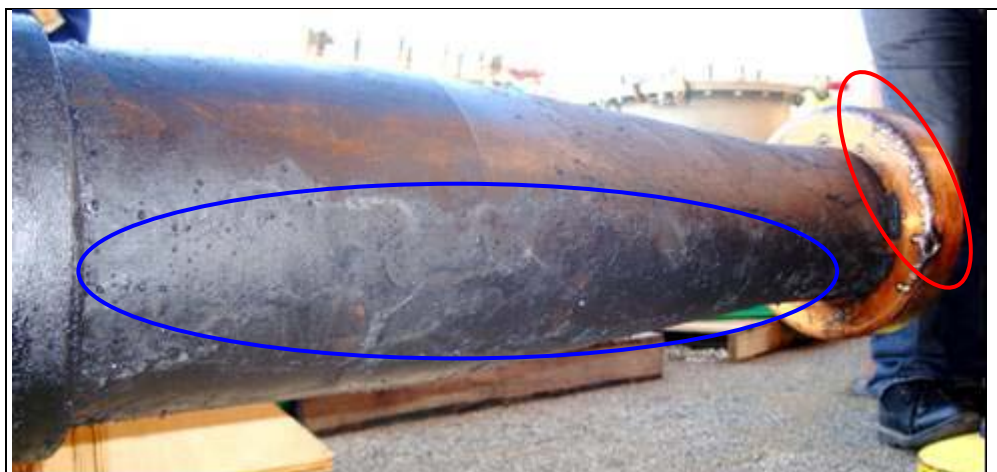
Picture 11: View of the H1 bushing oil side area:
Red circle: Foot points on the bushing bottom plate caused by flashover events to surrounding grounded parts after the H2 bushing explosion;
Blue circle: Heavy burning marks on the external surface of the epoxy shell;

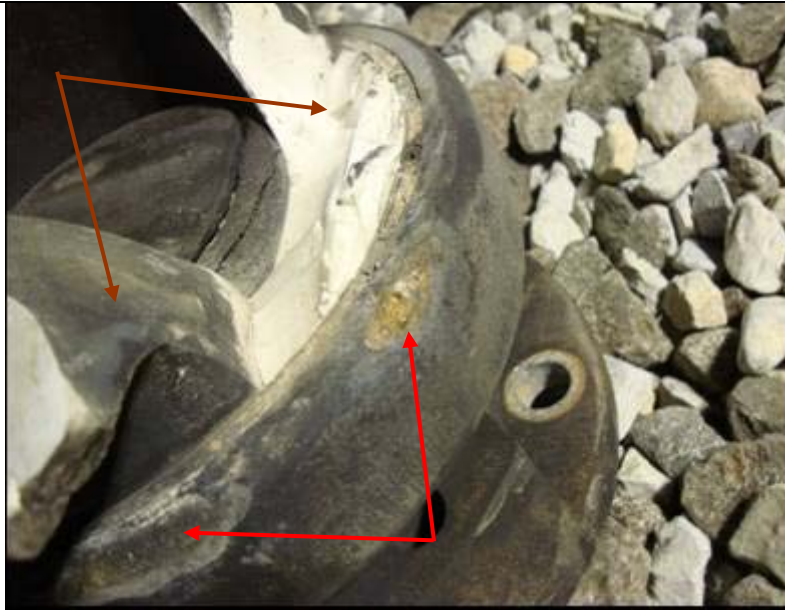
Picture 10: Further detail view of the fixing base of the Post Insulator phase "B",:
Red arrows: Foot points of the flashover which occurred on the post Insulator, **before they were wetted by rain**;
Brown arrows: Fracture surface of the broken porcelain.

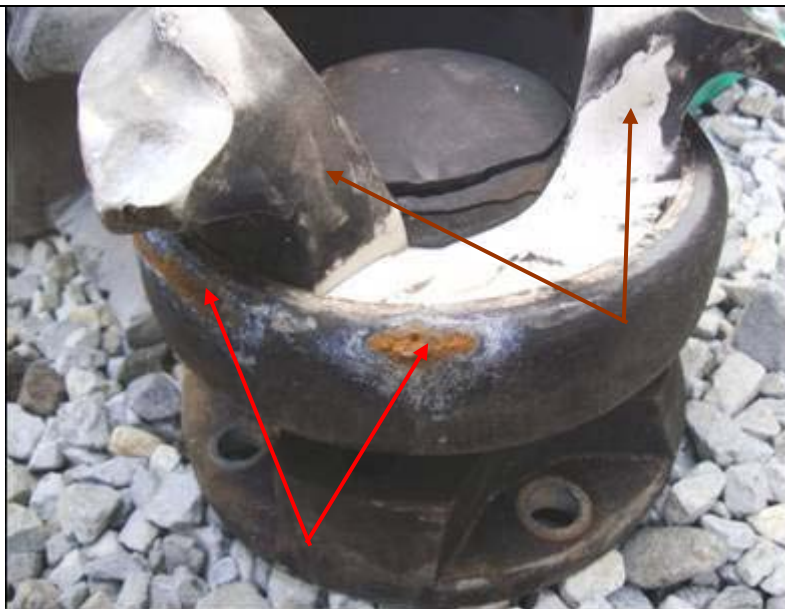
Picture 11: Detail view of the fixing base of the Post Insulator phase "B",:
Red arrows: Rusty foot points of the flashover which occurred on the post Insulator, **after the occurrence of rain**;
Brown arrows: Fracture surface of the broken porcelain.

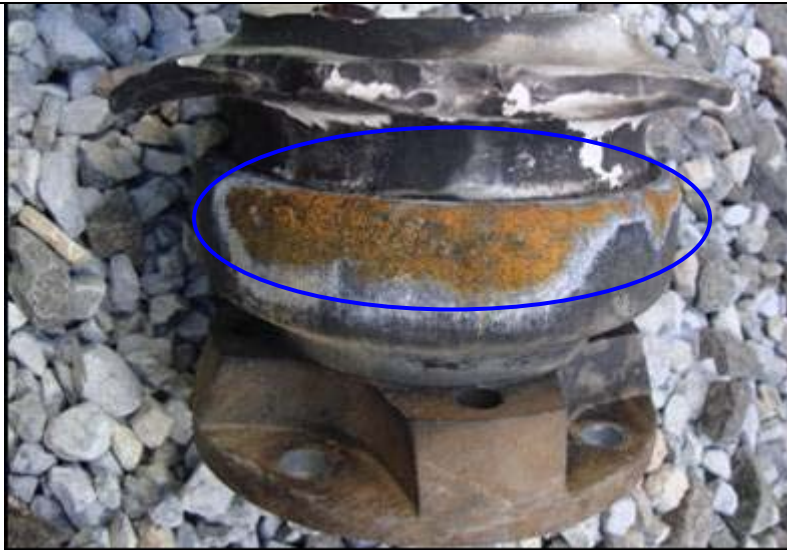
Picture 12: Detail view of the fixing base of the Post Insulator phase "B":
Blue circle: Rusty foot points of the flashover which occurred on the post insulator, after the occurrence of rain;

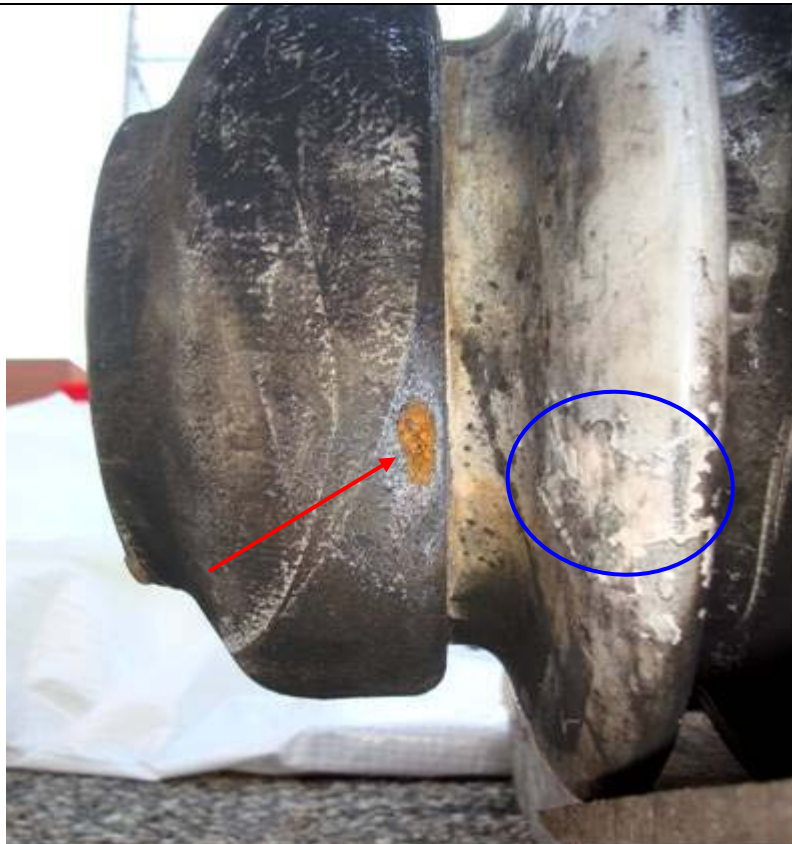
Picture 13: Detail view of the top of the Post Insulator phase "B":
Red arrows: Rusty foot point of the top armature after the occurrence of rain;

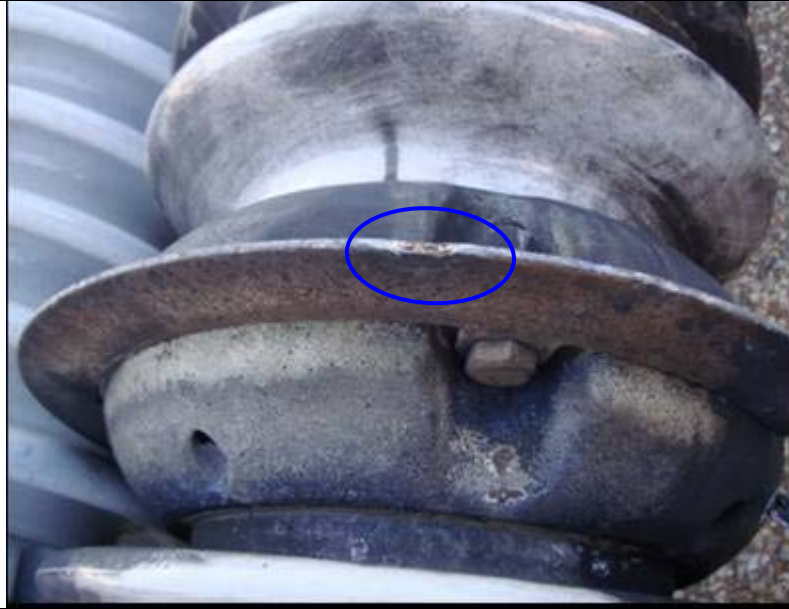
Picture 14: Detail view of the intermediate sections of the Post Insulator phase "B":
Blue circle: Flashover traces on the upper metallic piece installed between porcelain sections;
