Davis-Besse Nuclear Power Station, Unit 1
Docket Number 50-346, License Number NPF-3
Submittal of Revision 1 of Shield Building Root Cause Evaluation

"Concrete Crack within Shield Building
Temporary Access Opening"

Condition Report 2011-03346, dated 10/10/2011

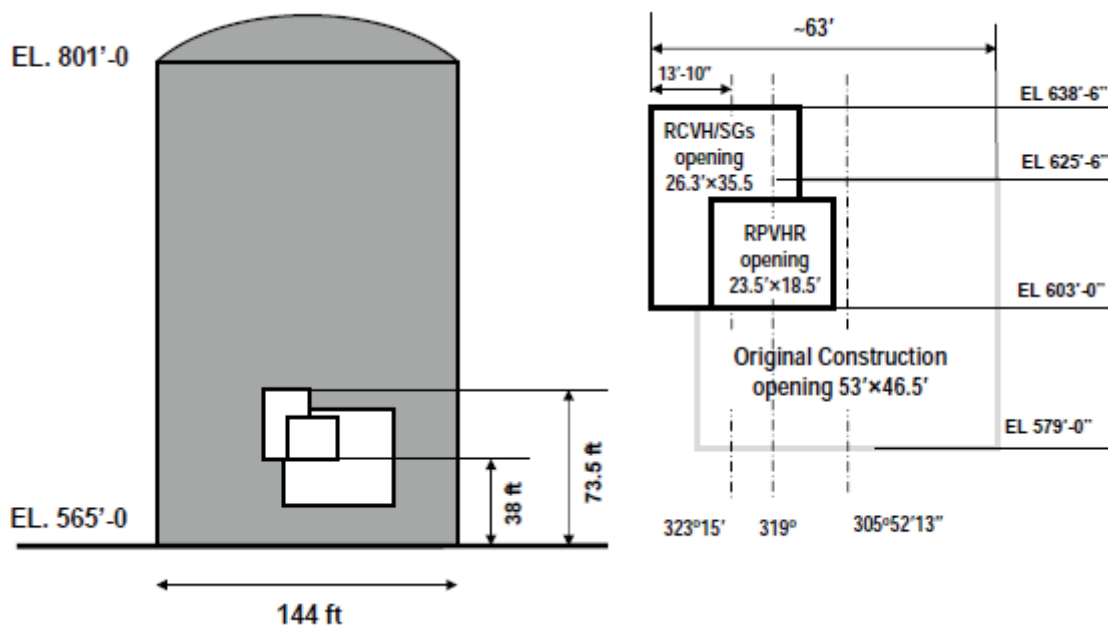
Elevation View of Shield Building / Construction Opening & Temporary Access Openings

American Hydro personnel performing the hydrodemolition of the shield building temporary access opening noted that towards the left side, between the architectural flute reinforcing steel and the outer face of structural reinforcing steel, the concrete removed consisted of larger chunks that sheared through the aggregate leaving a smooth flat surface. The concrete past (inward of) the outer face of structural reinforcing steel, and also on the right side of the temporary access opening placed during the 2002, was more difficult to remove and the larger chunks were not present [Reference 10.1.6]. The American Hydro personnel observed these conditions while using consistent parameters for the hydrodemolition equipment (water pressure, cut angle, nozzle stand-off, traverse speed, step distance). Therefore, the only variable was determined to be the condition of the shield building concrete.

The known extent of condition at the time of problem discovery was a concrete crack in the shield building wall that was visible on the entire 35 feet height of the temporary access opening left face. The crack was adjacent to the outer face of structural reinforcing steel, and it extended approximately eight feet into the left-top and approximately four feet into the left-bottom region of the temporary access opening progressing from the outer face of structural reinforcing steel towards the architectural flute reinforcing steel. The crack at the left-top of the temporary access opening continued to the exterior surface at the edge of the opening and extended about two and a half feet vertically upwards on the exterior surface of the shield building concrete [Reference 10.1.7]. The crack width was initially indeterminate, due to the effect of the hydrodemolition process, resulting in disintegrating the concrete aggregate and cement paste at the crack location. The hydrodemolition process was incomplete at the time of crack discovery and had been stopped to allow removal of the outer face of structural reinforcing steel.
