FUKUSHIMA DAI-ICHI INITIATING EVENT SIGNIFICANCE

FUKUSHIMA DAI-ICHI FLOODING DAMAGE

FUKUSHIMA DAI-ICHI HYDROGEN GENERATION

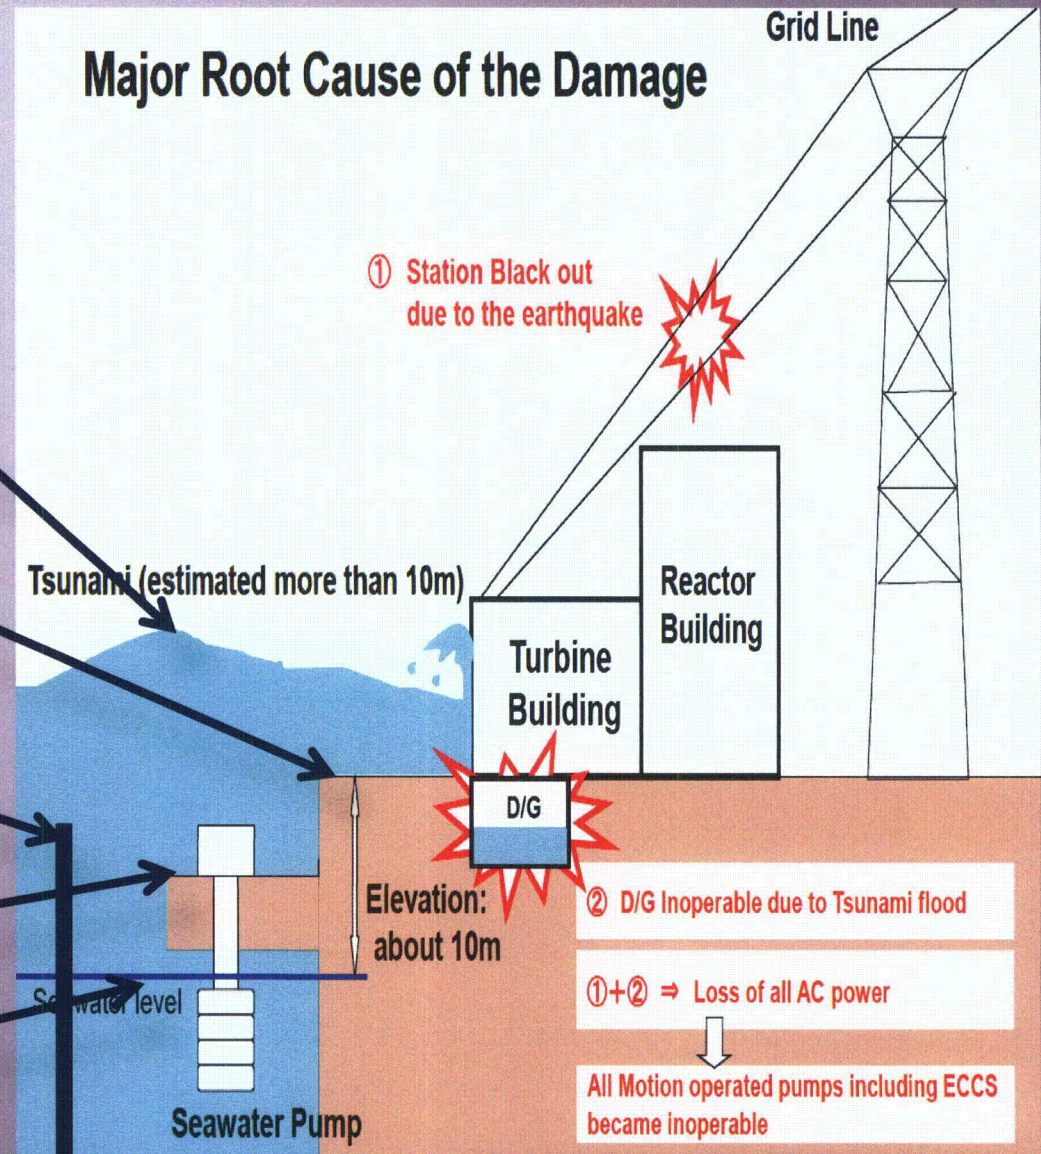
- 46 feet. Tsunami Peak Elevation
- 42.5 feet Ground elevation of Units 5-6 TB/RB
- 33 feet Ground elevation of Units 1-4 TB/RB
- 17 feet Assumed highest tsunami and elevation of break wall
- 13 feet Ground elevation of intake structure
- 0 Feet Sea level

Major Root Cause of the Damage

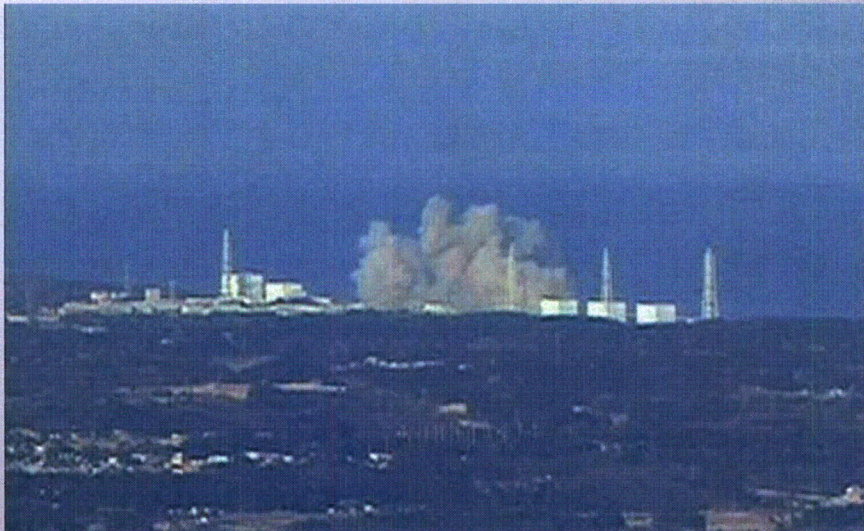
UNIT 1

FUKUSHIMA DAI-ICHI HYDROGEN EXPLOSIONS

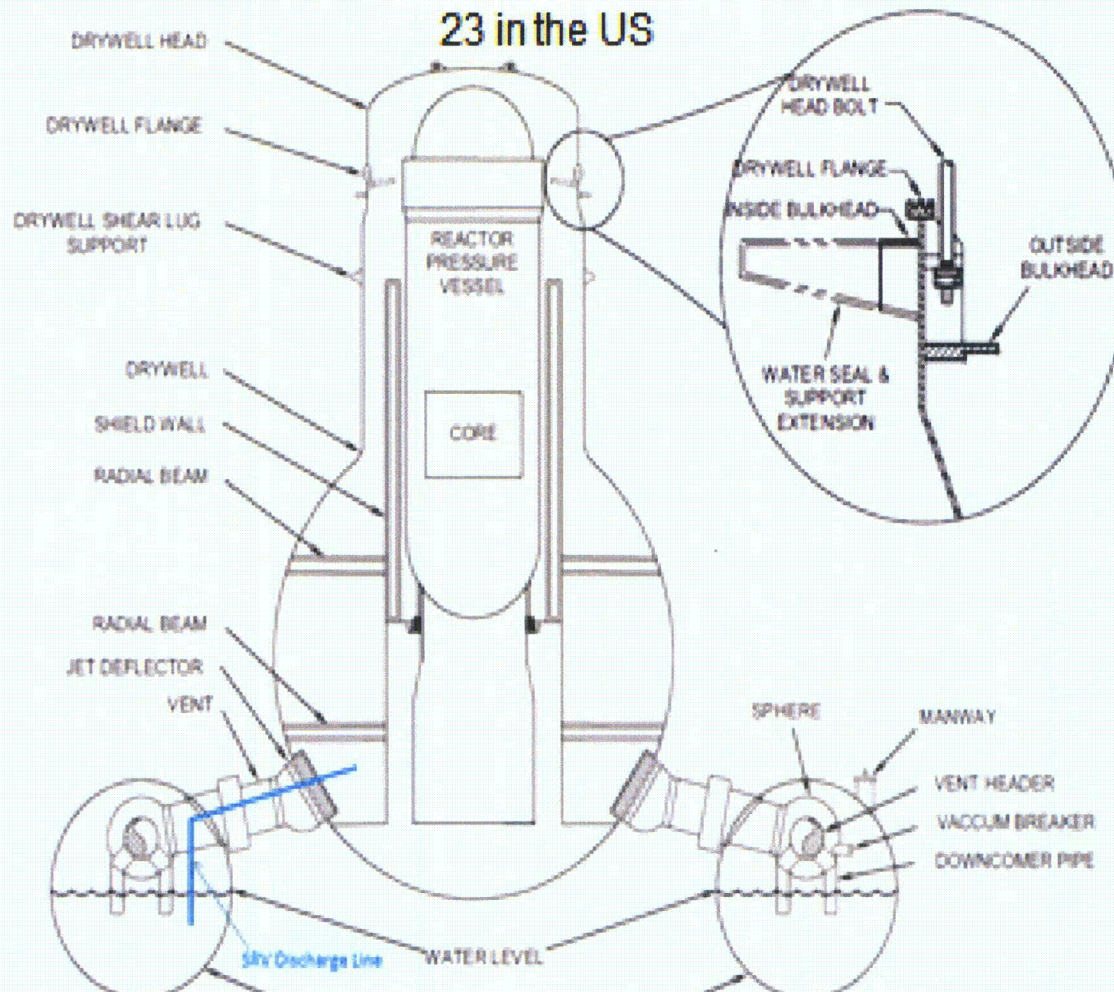
**TYPICAL
BWR MARK 1 CONTAINMENT**
23 in the US

- SRV operation vents RPV internals to Suppression Pool
- Hydrogen accumulates in Suppression Chamber
- Hydrogen vents to Drywell atmosphere
- Containment failure or intentional venting passes hydrogen to the Reactor Building atmosphere
- 4-78% hydrogen in air is flammable/explosive

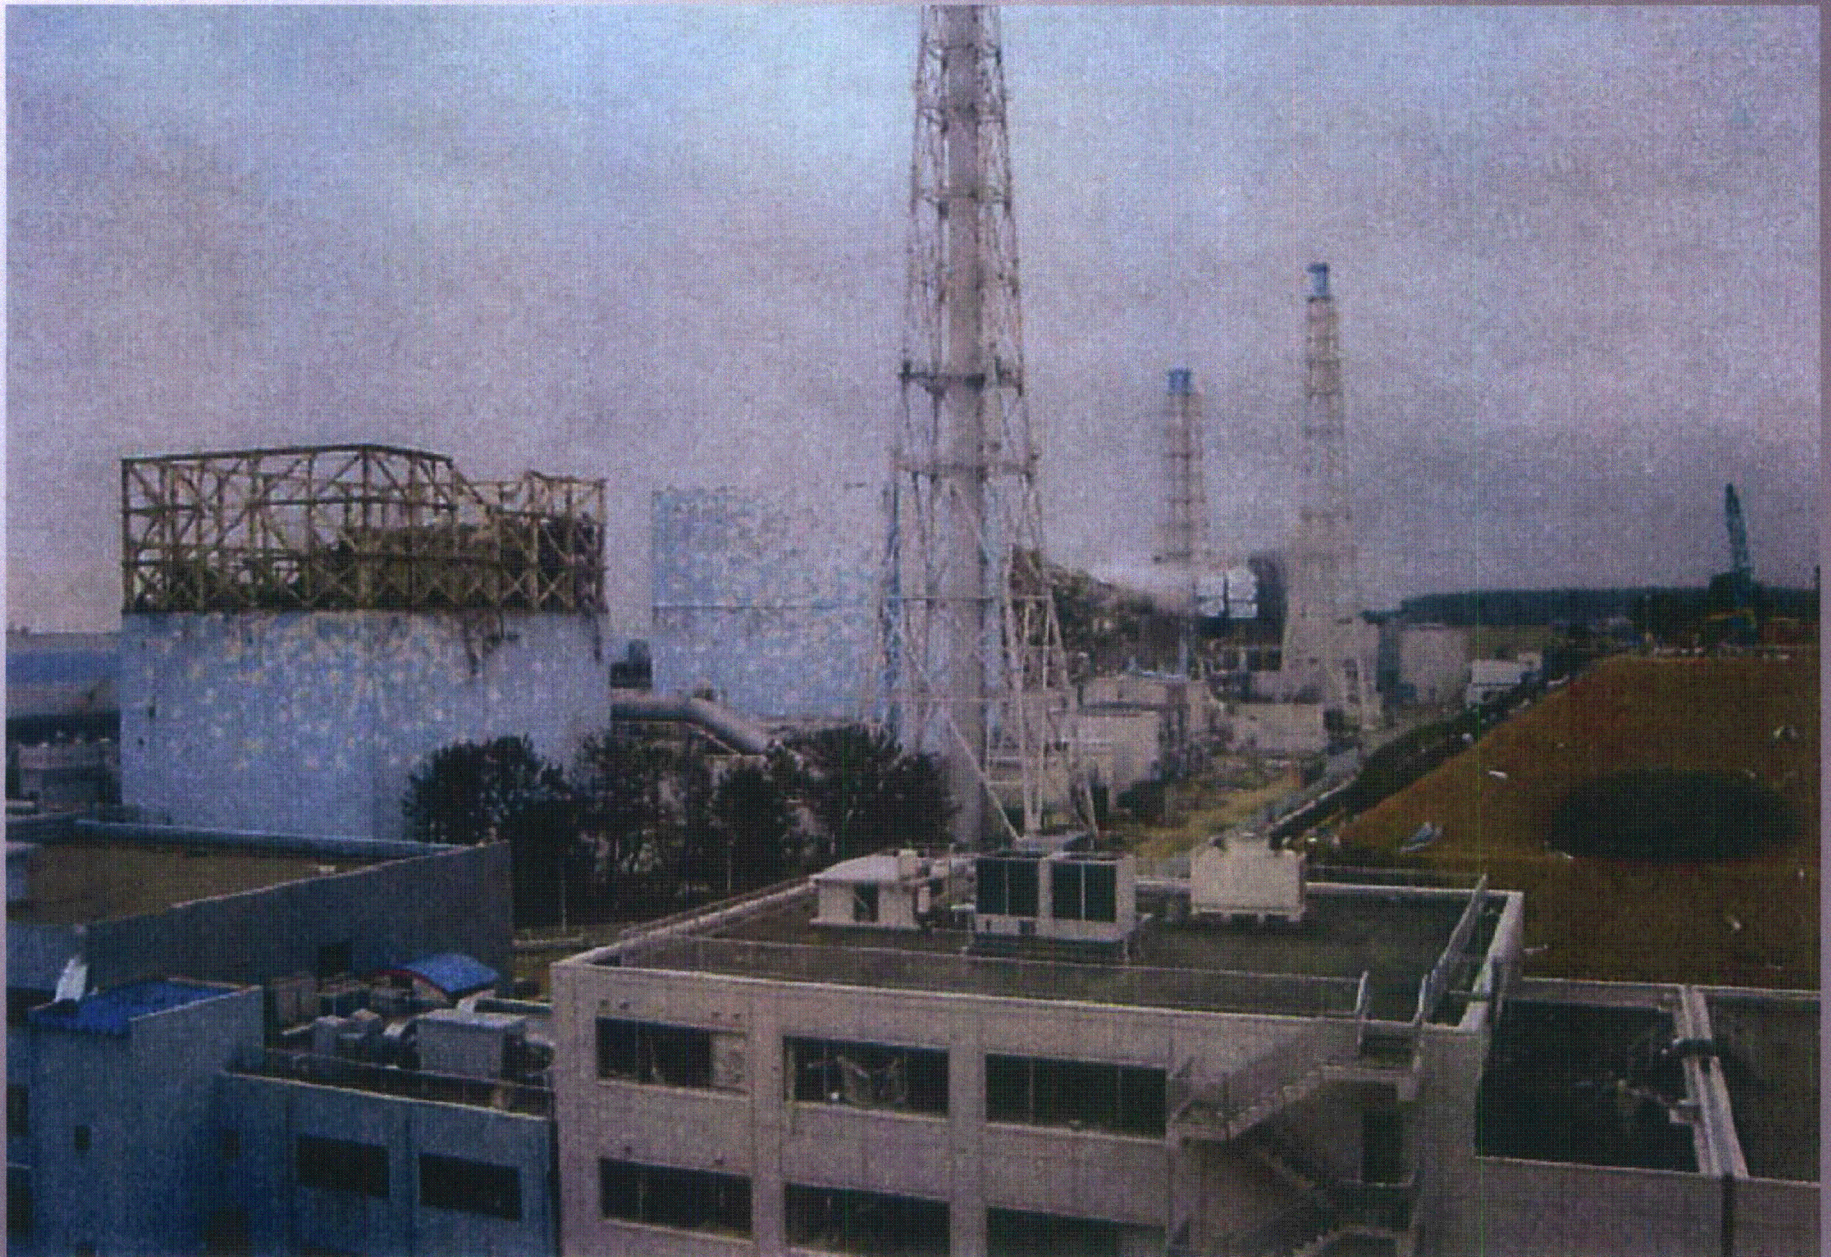
Fukushima Dai-ichi Unit 1 (airborne picture: TEPCO)

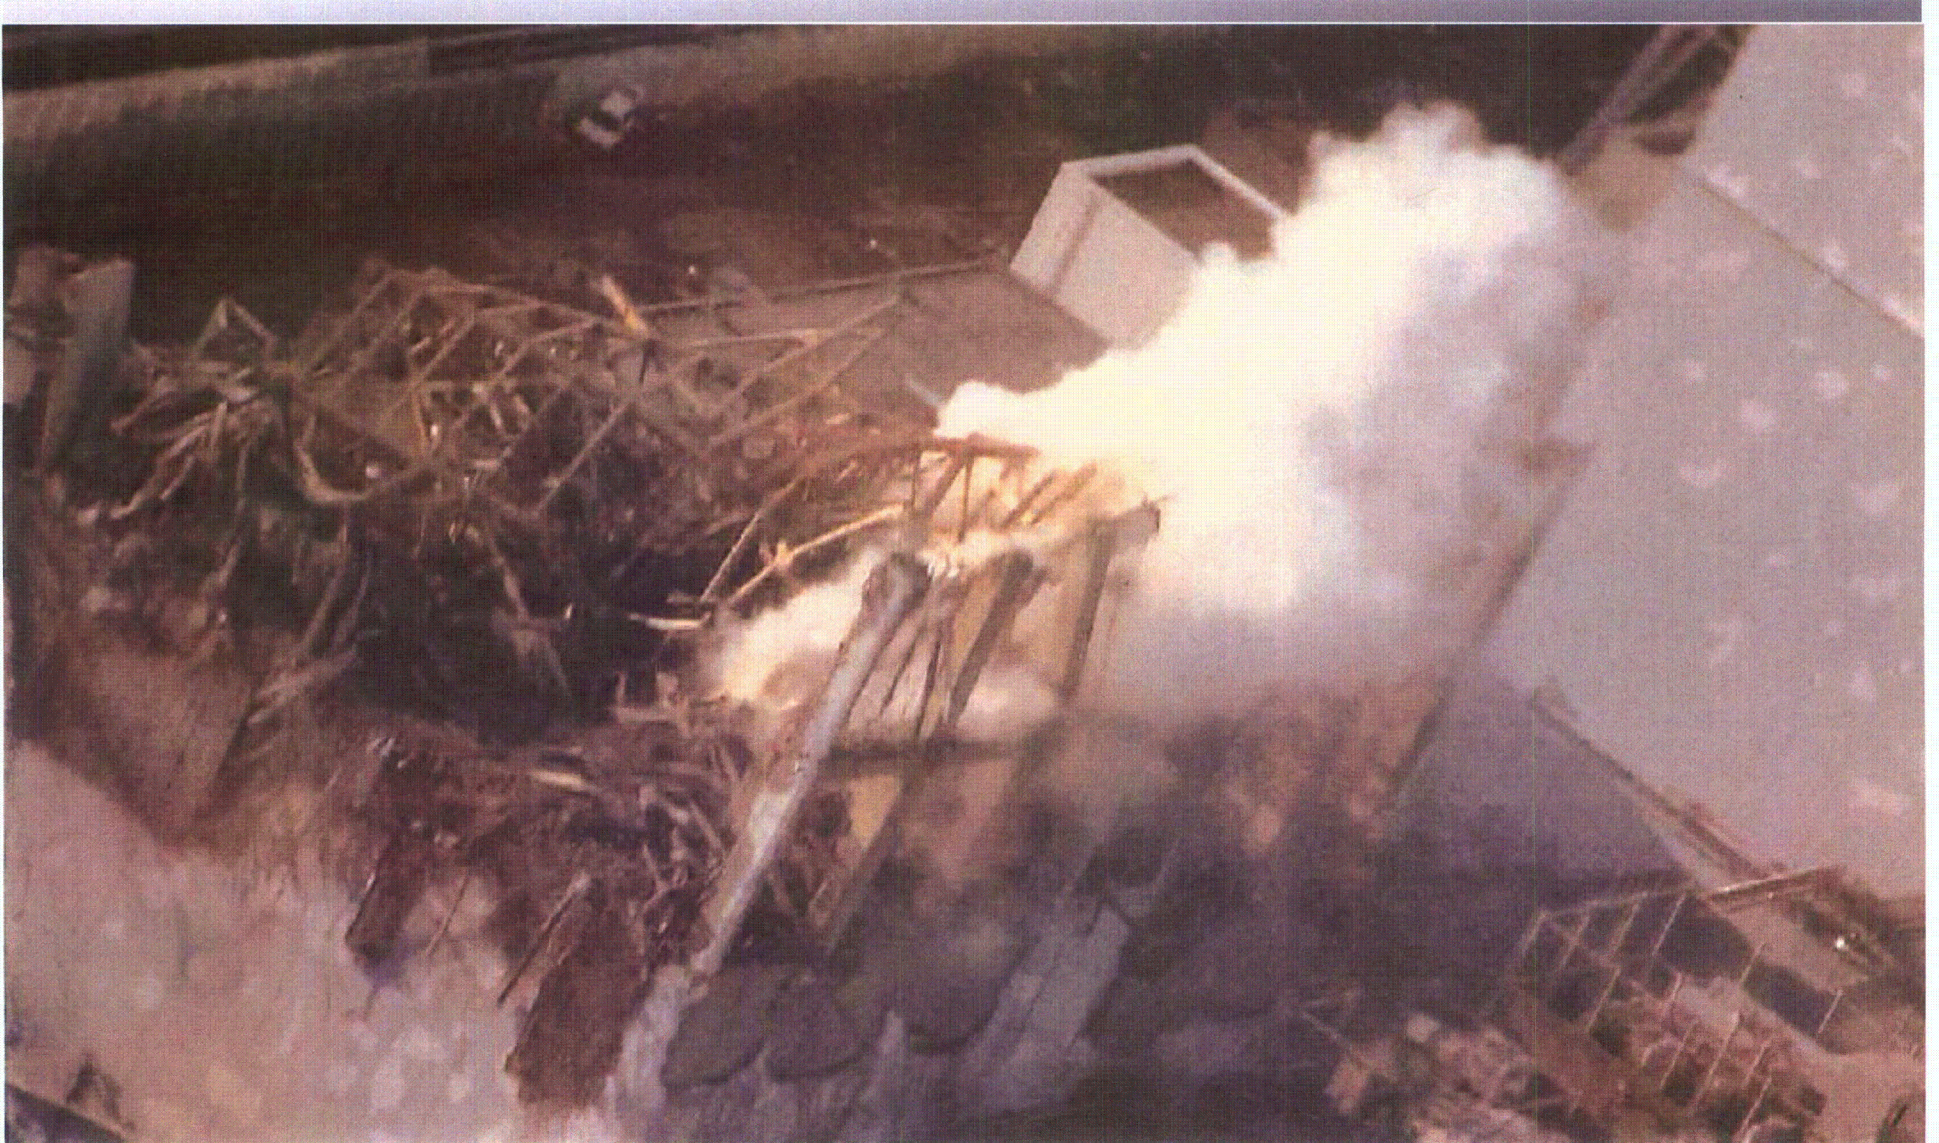
Fukushima Dai-ichi Unit 3 (airborne imagery: TEPCO)
