ENTERGY NUCLEAR VERMONT YANKEE, LLC
and ENTERGY NUCLEAR OPERATIONS, INC.

(Vermont Yankee Nuclear Power Station)

Docket No. 50-271-LR
ASLBP No. 06-849-03-LR

**Assessment of Proposed Program to Manage Aging of the Vermont
Yankee Steam Dryer Due to Flow-Induced Vibrations**

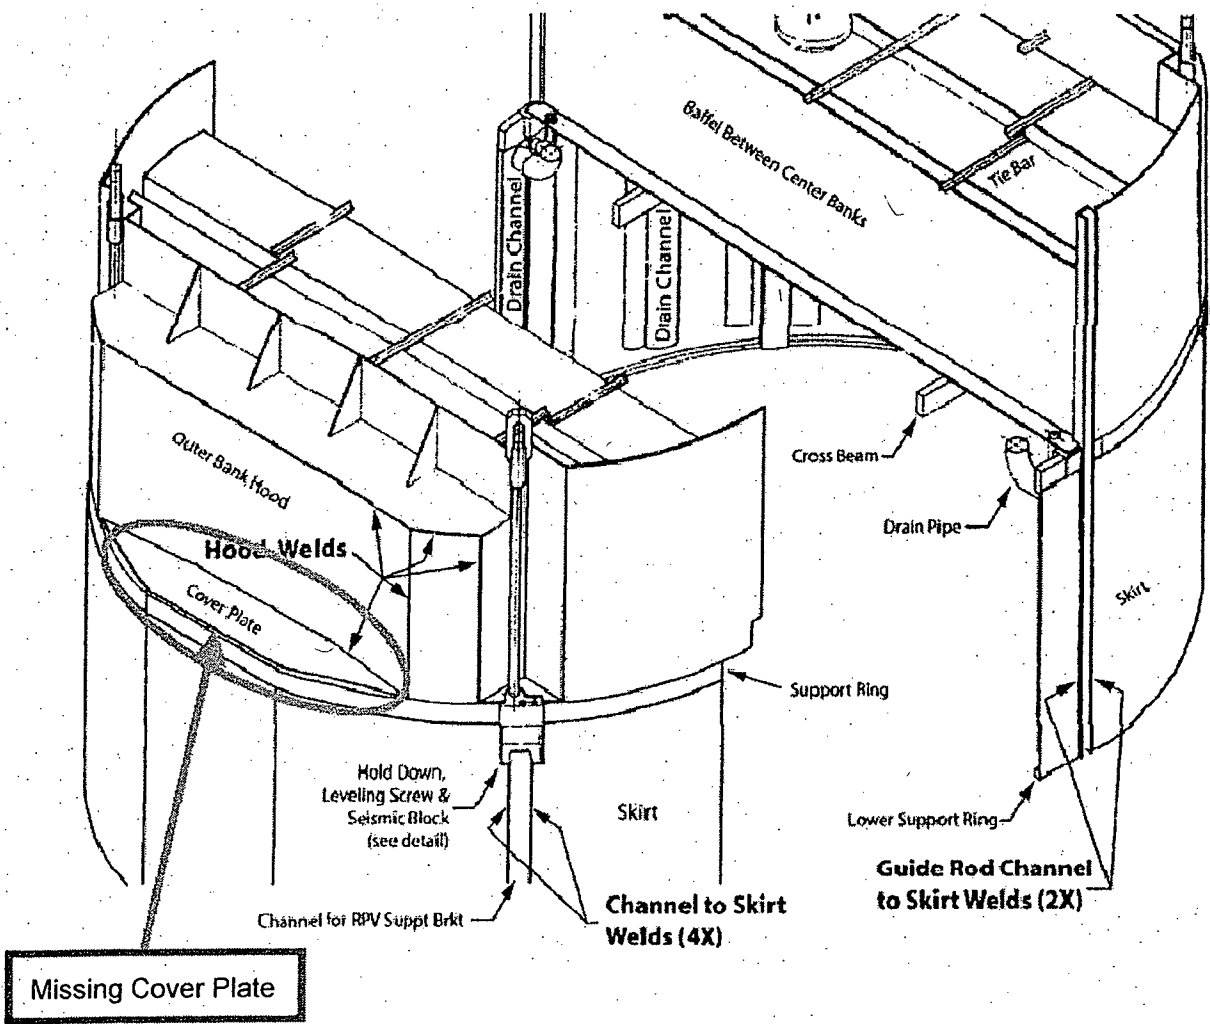
Lower horizontal cover plate failure occurred in a BWR/3 in 2002. In this failure, almost the entire lower horizontal cover plate came completely loose, with some large pieces falling down onto the steam separators and one piece being ingested into the main steamline and lodging in the flow restrictor. This failure was accompanied by a significant increase in moisture content, along with changes in other monitored reactor parameters. The cause of this failure was attributed to the higher fluctuating pressure loads at extended power uprate (EPU) operation. In particular, there may have been a potential resonance condition between a high frequency fluctuating pressure loading (in the 120-230 Hz range) and the natural frequency of the cover plate. Appendix A provides a more detailed description of this event.

Figure A-1: Location of the 2002 Lower Cover Plate Failure

The cover plates on both sides of the dryer have been replaced with 1/2-inch continuous plates (this eliminates two intermediate welds on the original plates). The fillet weld connecting the plate to the support ring was increased to 3/8-inch and the weld to the vertical face of the dryer hood was increased to 1/2-inch. The plant has been returned to service with interim, enhanced monitoring of moisture content, reactor steam dome pressure, MSL flow rates and reactor water level. As an additional measure, the plant has implemented dynamic response monitoring of the MSLs to determine if higher flow induced vibration occurs as the steam flow is increased.

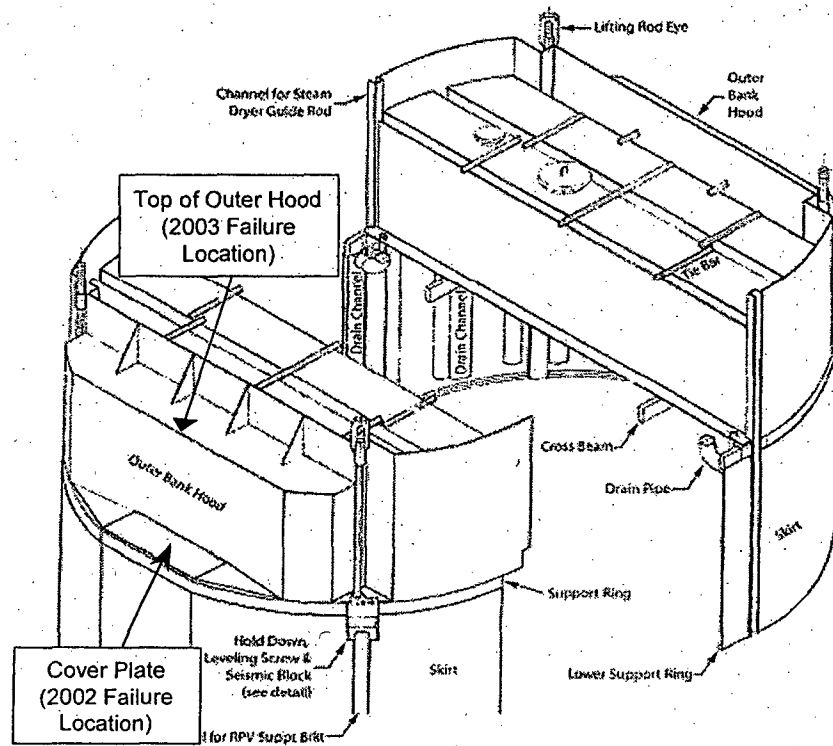
The same BWR/3 experienced extensive through-wall cracking in the outer bank hood on

the 90° side in May 2003. On the opposite side of the steam dryer (270° side), incipient cracking was observed on the inside of the outer hood cover plate. Several internal braces were detached and found on top of the steam separators. No damage was found on the inner banks of the dryer. Again, the failure was accompanied by a significant increase in moisture content. Of the other monitored reactor parameters, only the flow distribution between the individual steamlines was affected. The cause of this failure was attributed to high cycle fatigue resulting from low frequency oscillating pressure loads (<50 Hz) of higher amplitude at EPU operation and the local stress concentration introduced by the internal brackets that anchor the diagonal internal braces to the dryer hoods. Appendix B provides a more detailed description of this event.

Figure B-1: Location of the 2003 Outer Hood Failure

The combined effect of these modifications was to increase the natural frequency of the outer hood, reduce the maximum stress by at least a factor of two, and reduce the pressure loading by reducing the magnitude of vortices in the steam flow near the MSLs.

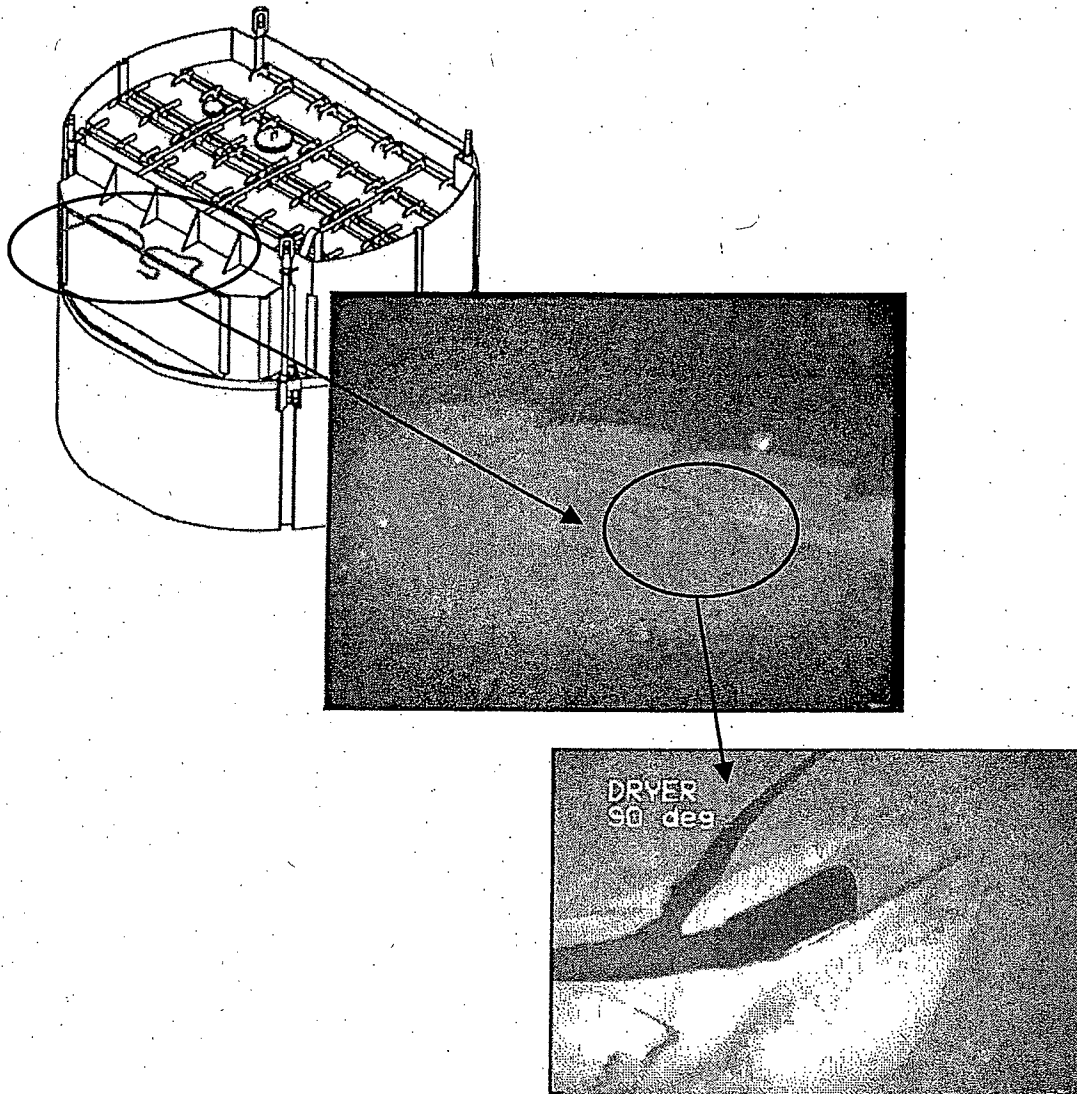
Figure B-2: Steam Dryer Damage 90 Degree Side

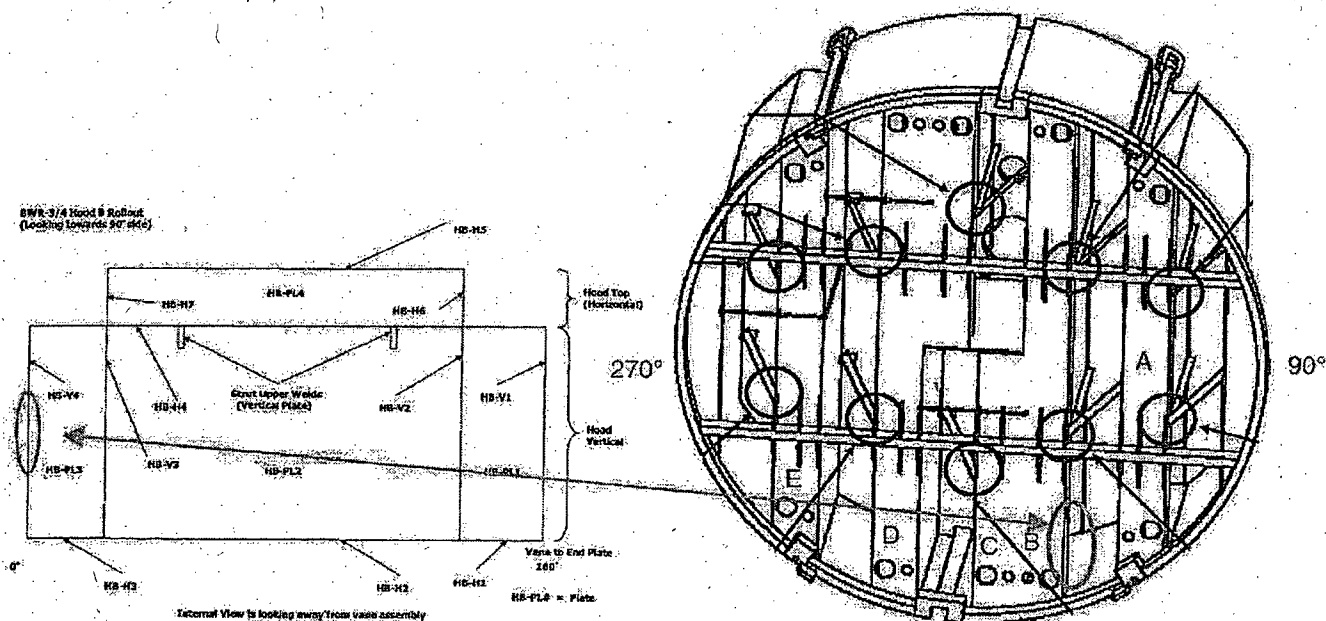
During the Vermont Yankee 2007 refueling outage, in accordance with the Vermont Yankee VT-VMY-204V10 Rev 2 Procedure, the Steam Dryer was inspected. The dryer inspection included inspection of the Steam Dryer interior welds and components. These inspections were done with GE's Fire-Fly ROV with color camera. During the inspection of the HB-V04 weld (Dryer Unit Hood End Panel to HB-PL3 Plate weld), relevant linear indications were observed in the heat-affected zone on the Dryer Unit side of the weld. Most of these linear indications were previously seen in RFO-25, Reference: INF # 002. When comparing this outage with last outage, one new relevant indication is seen (3rd indication) of similar appearance, orientation and size as those previously seen; one indication was not seen (RFO25: 3th indication). No discernible change was noted in those indications which correlates to those of RFO26. See attached 2007 photos and sketches.

Sketch on the left shows the weld map rollout. The sketch on the right shows a bottom view of the dryer.

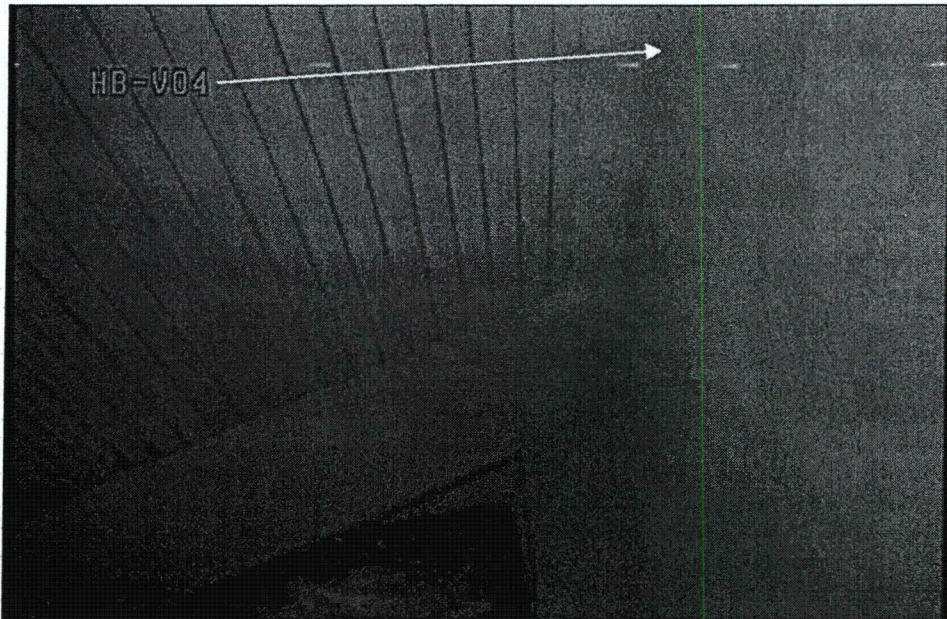
INR-IVVI-VYR26-07-10- Steam Dryer Interior HB-V04

This 2007 photo shows the interior of the dryer and the location of HB-V04 vertical weld.

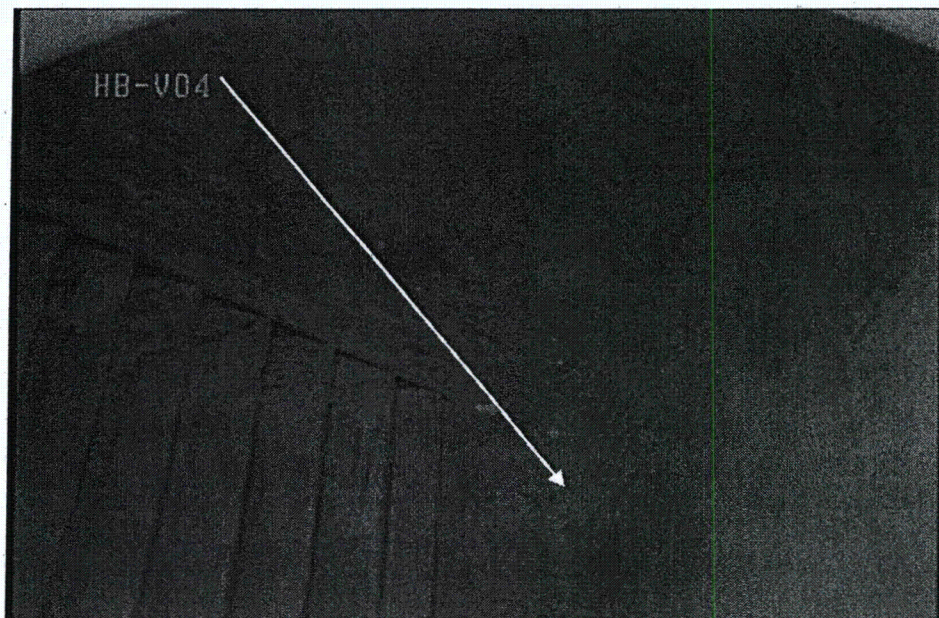
This 2007 photo shows the top of the vane bank (on the left) and the end panel (on the right) and the vertical weld in the center

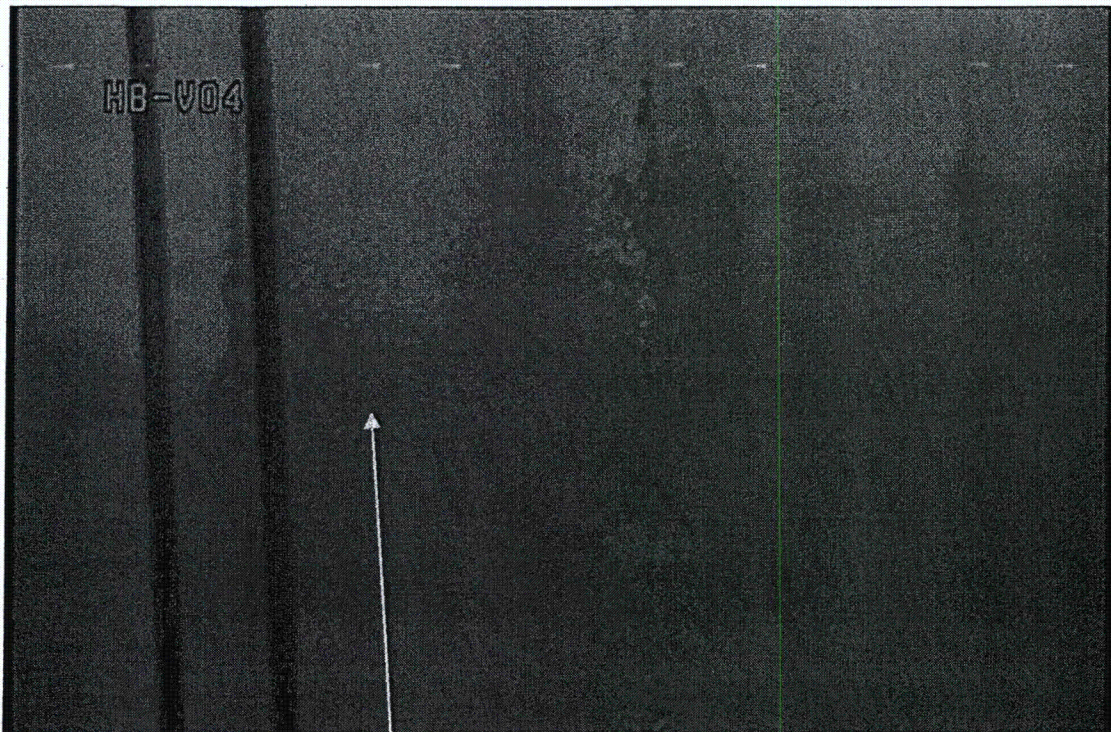
INR-IVVI-VYR26-07-10- Steam Dryer Interior HB-V04

This 2007 photo is of the 1st indication from top down (Correlates to RFO25: 1st indication).

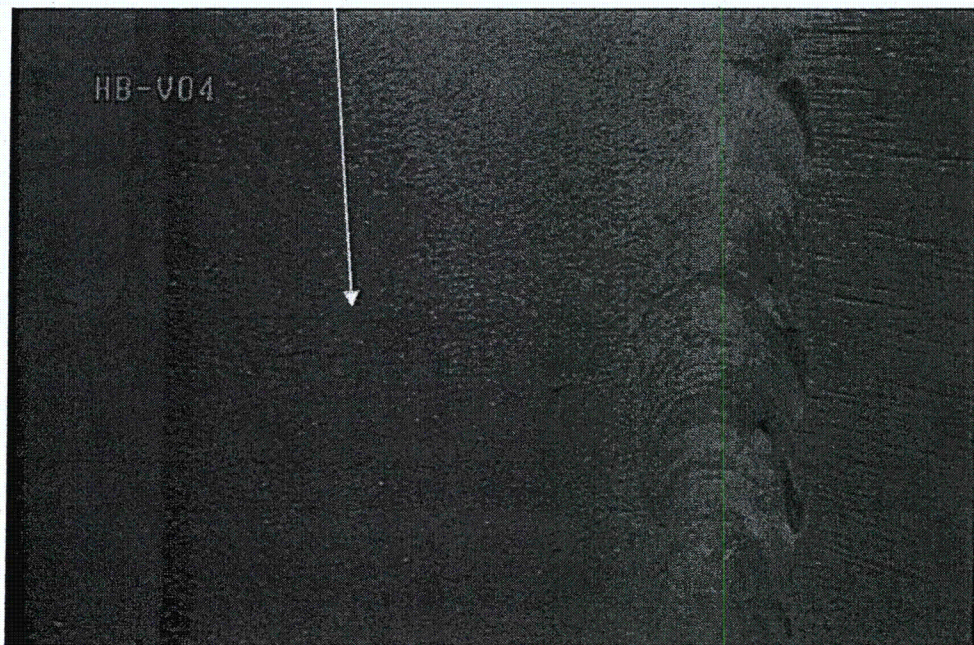
This 2007 photo is a close-up of the 1st indication (Correlates to RFO25: 1st indication).

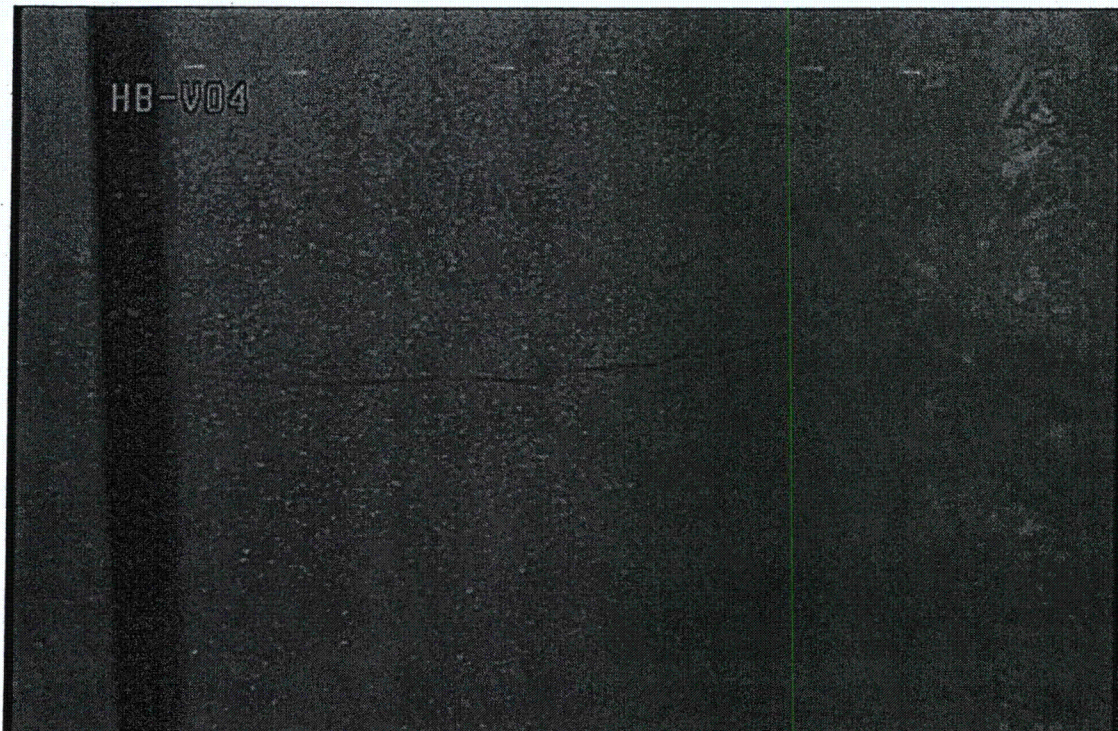
INR-IVVI-VYR26-07-10- Steam Dryer Interior HB-V04

This 2007 photo is the 2nd indication (Correlates to RFO25: 2nd indication).

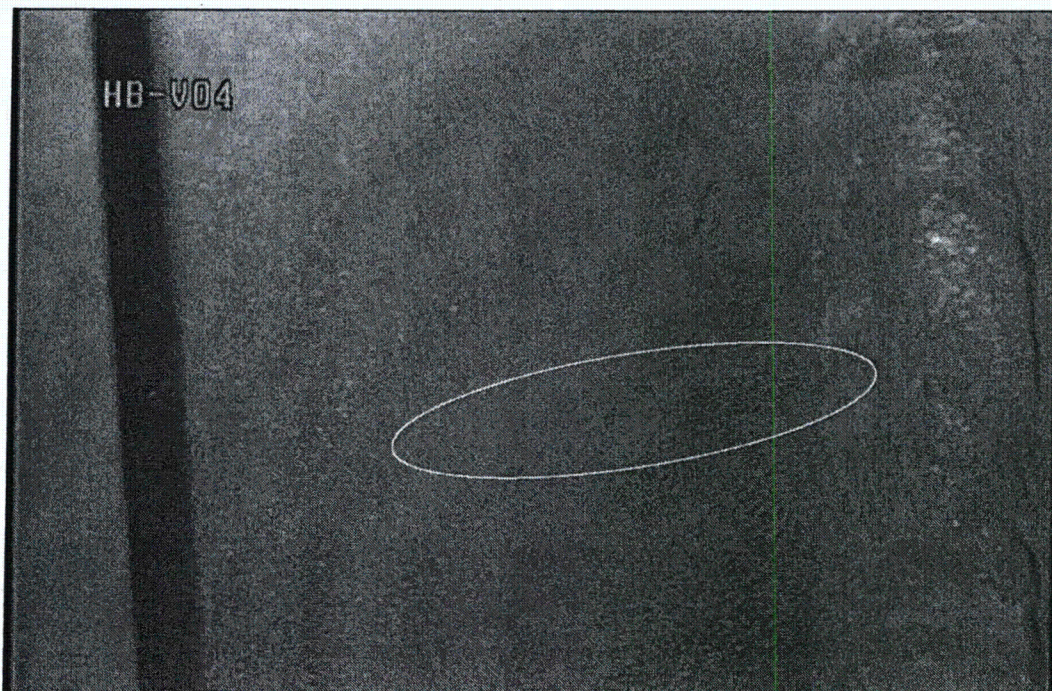
This is a 2007 photo of the 3rd indication and is a new RFO26 indication.

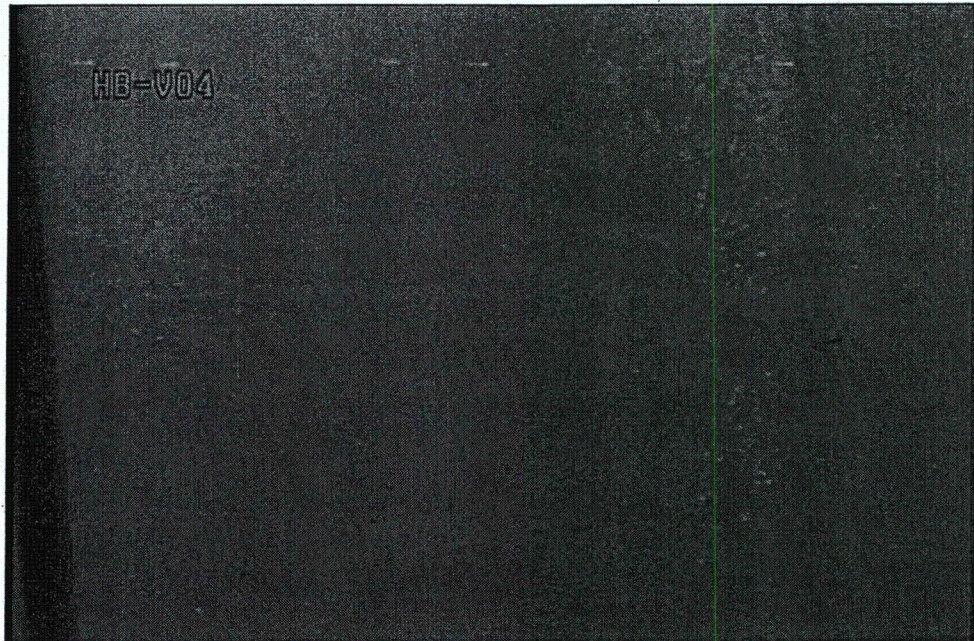
INR-IVVI-VYR26-07-10- Steam Dryer Interior HB-V04

This is a 2007 photo of the 4th indication (Correlates to RFO25: 3rd indication)

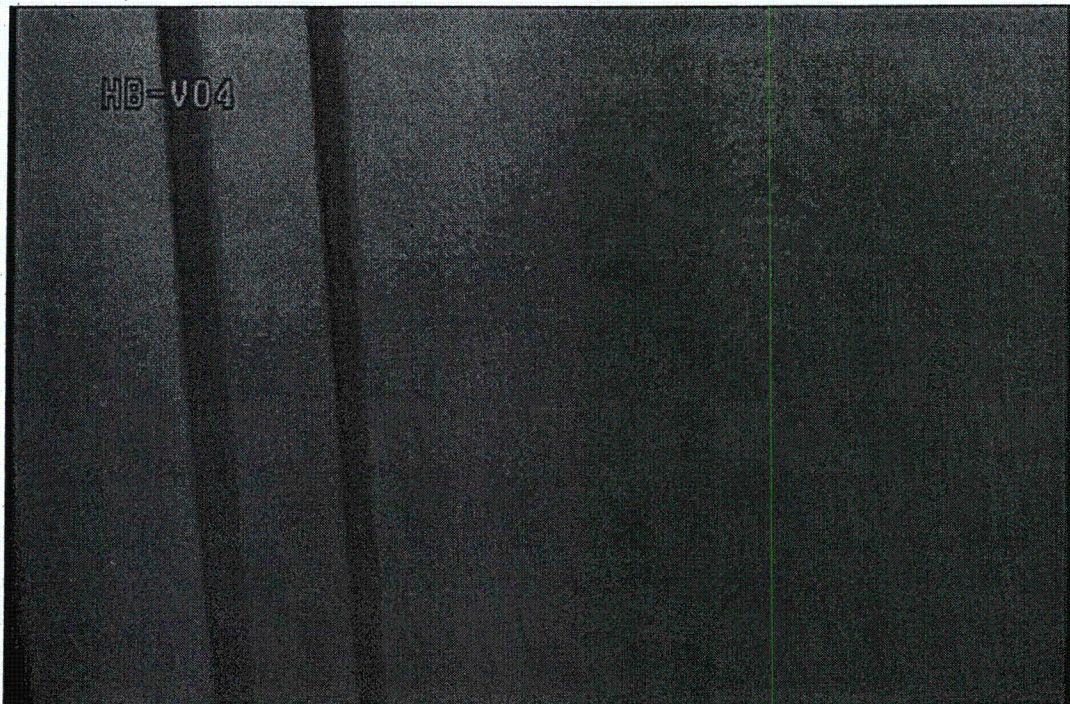
This is a 2007 photo of the 5th indication (Correlates to RFO25: 4th indication).

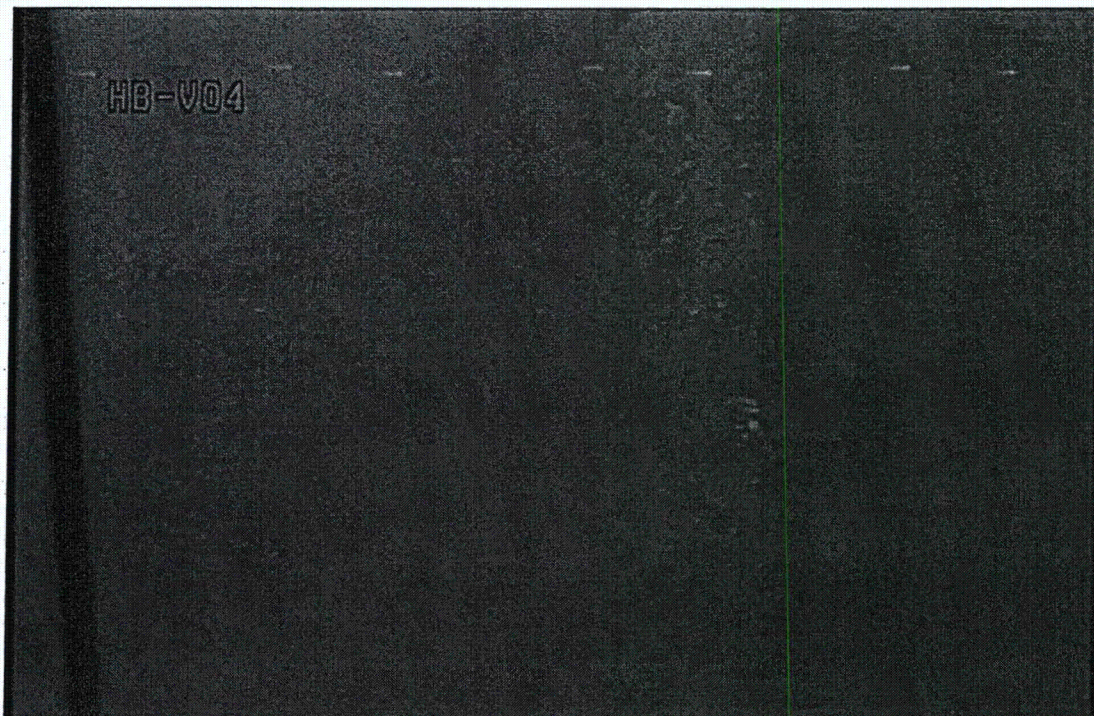
INR-IVVI-VYR26-07-10- Steam Dryer Interior HB-V04

This is a 2007 photo of the 6th indication (Correlates to RFO25: 5th indication).

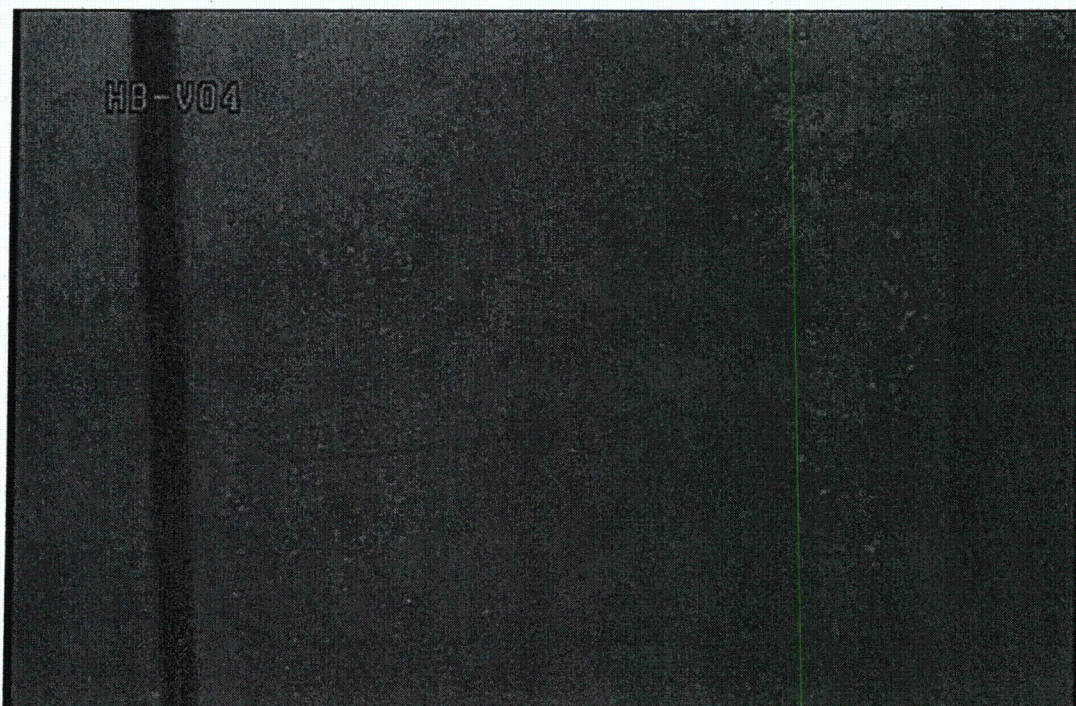
This is a 2007 photo of the 7th indication (Correlates to RFO25: 6th indication).

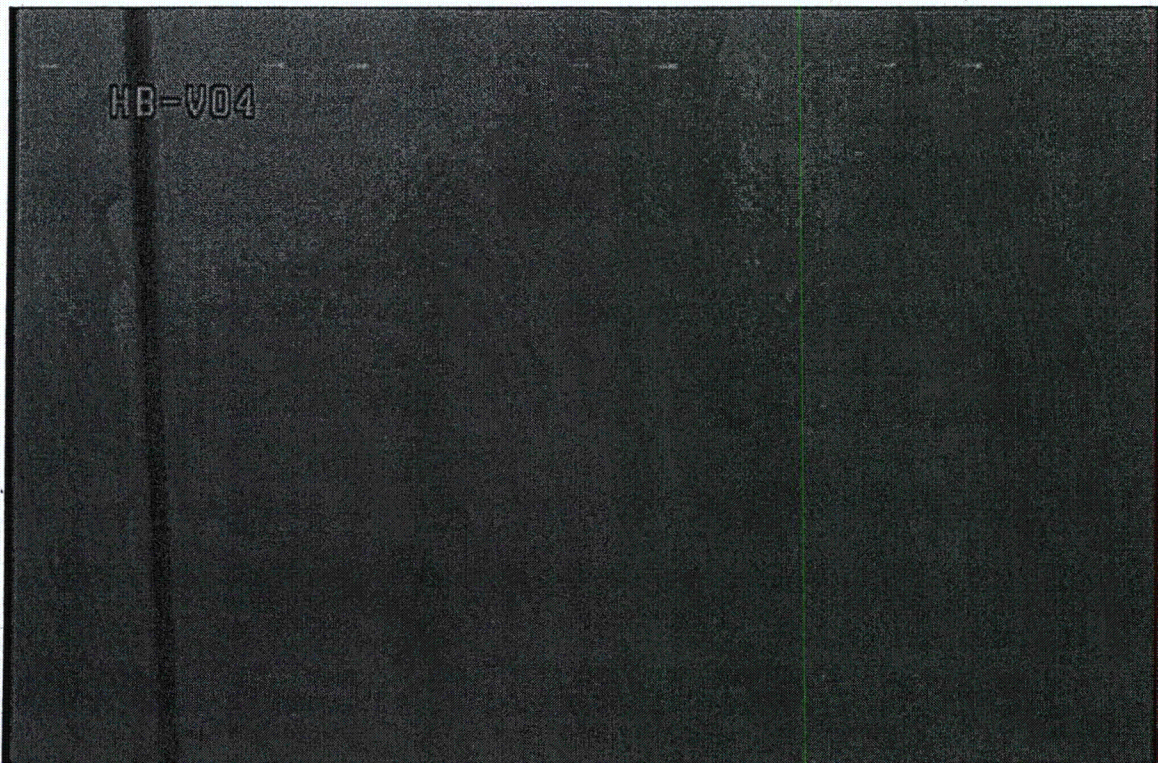
INR-IVVI-VYR26-07-10- Steam Dryer Interior HB-V04

This is a 2007 photo of the 8th indication (Correlates to RFO25: 7th indication).

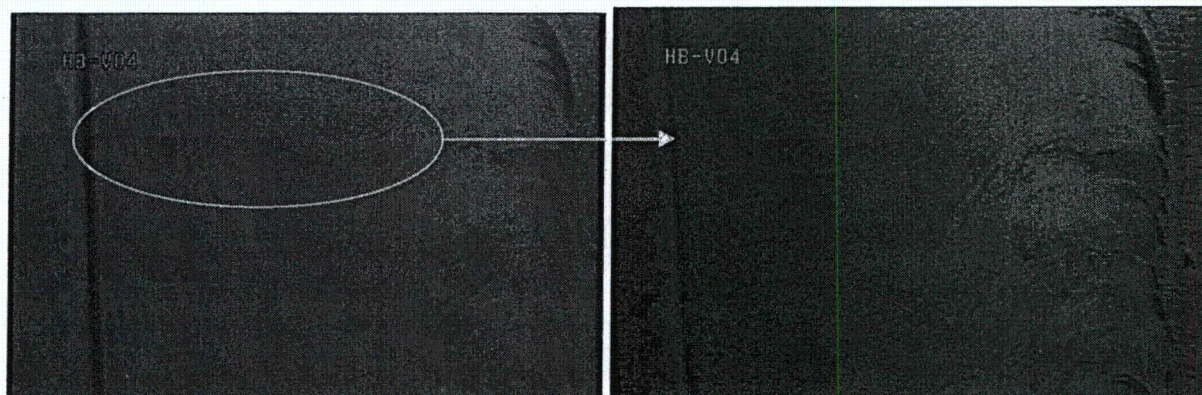
These 2007 photos show a linear indication and change of lighting and show a non-relevant indication (Correlates to RFO25: 9th indication).

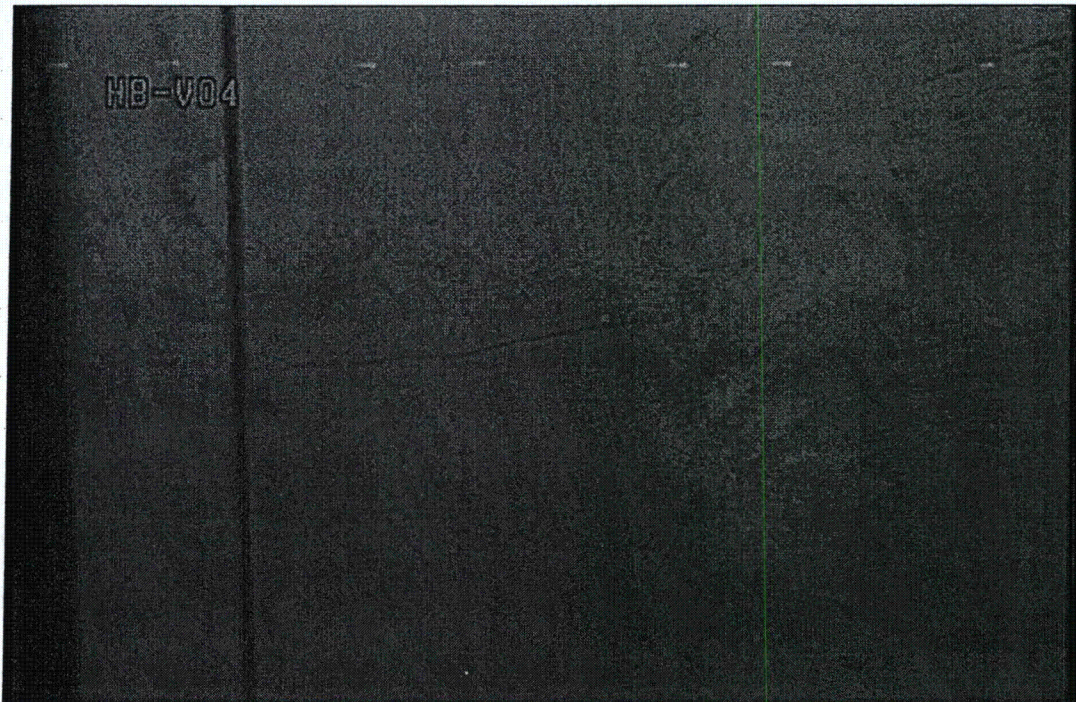
INR-IVVI-VYR26-07-10- Steam Dryer Interior HB-V04

This is a 2007 photo of the 9th indication (Correlates to RFO25: 10th indication).

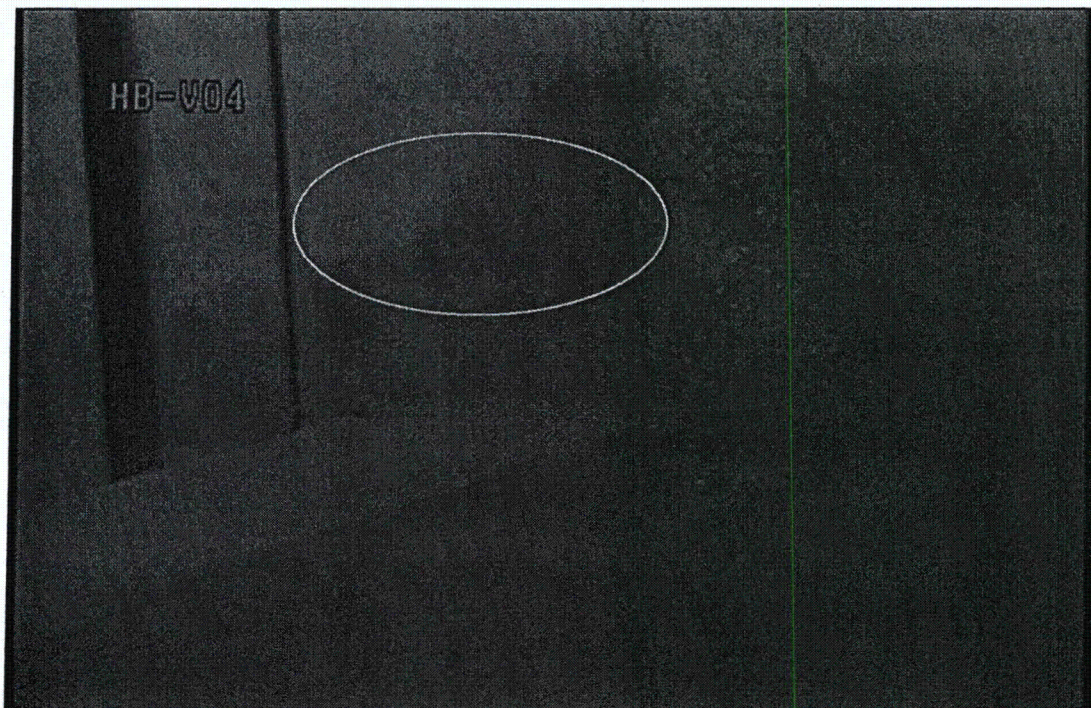
This is a 2007 photo of the bottom weld area and crud line.
