CONCISE REPORT

REPORT OF PETROGRAPHIC EXAMINATION

Re: Petrographic Examination of Concrete Curb and Gutter Samples

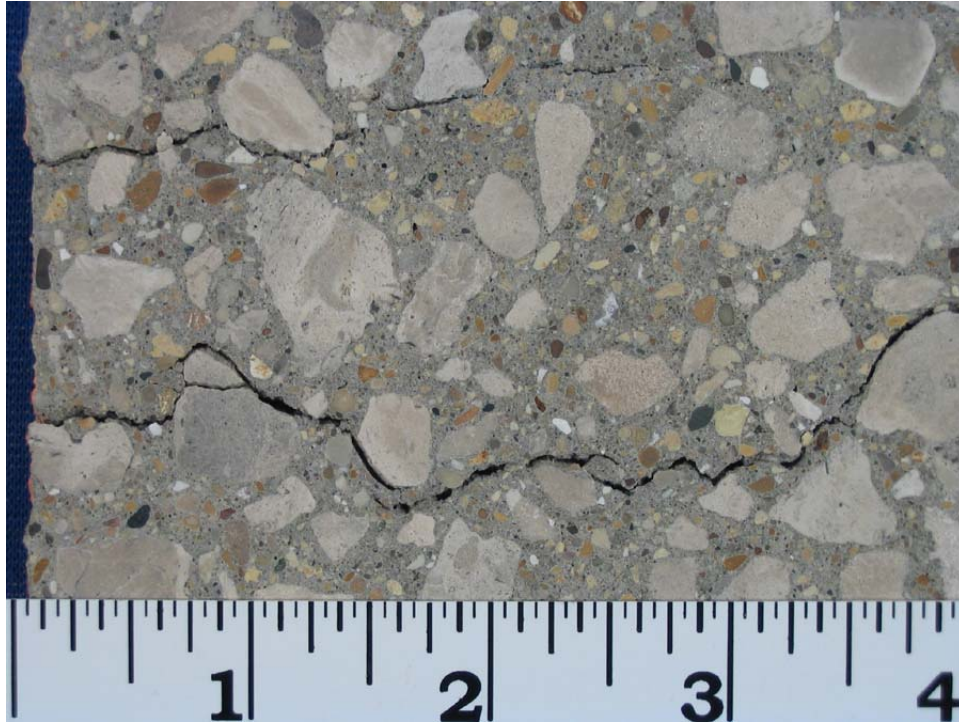
3a. Lapped surface.

Based on petrographic findings, the general nature and characteristics of the cracks strongly suggests they occurred while the concrete was still plastic. The cracks (Fig. 3) are discontinuous, pass around aggregate particles and do not extend full gutter thickness (9.7-in. depth). The cracks are not straight or sharp, as would be expected if cracking occurred at a later age (while the concrete was in the hardened state). A definitive cause for the observed cracks is not determined, although the cracks do not appear to be materials related. A site visit by an engineer is recommended to confirm joint spacing and establish a map of the overall crack pattern to assist in determining a definitive cause for the early-age cracking.

Fig. 3 Photomicrograph of near-surface concrete showing the crack(s).

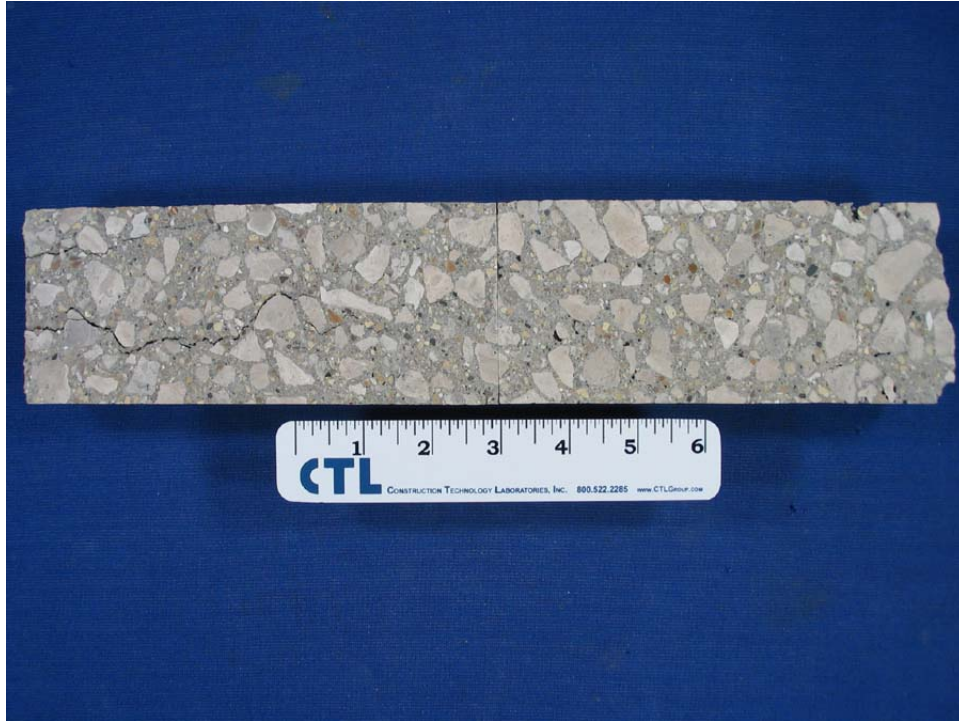
The concrete was produced using a relatively well-graded, ¾-in. top size, crushed limestone coarse aggregate and a natural sand fine aggregate dispersed fairly uniformly (Fig. 4) in a air-entrained, portland-cement paste. No supplementary cementitious materials, such as fly ash, are observed in the hardened paste matrix. The concrete is well consolidated.

Fig. 4 Lapped cross-section of the core sample showing the general appearance and condition of the concrete. Top surface is to the left.
