**Subject: April 2012 Inspection Report
Cameco Resources, Permits 603 & 633**

APRIL 2012 INSPECTION REPORT

PERMITS 603 & 633

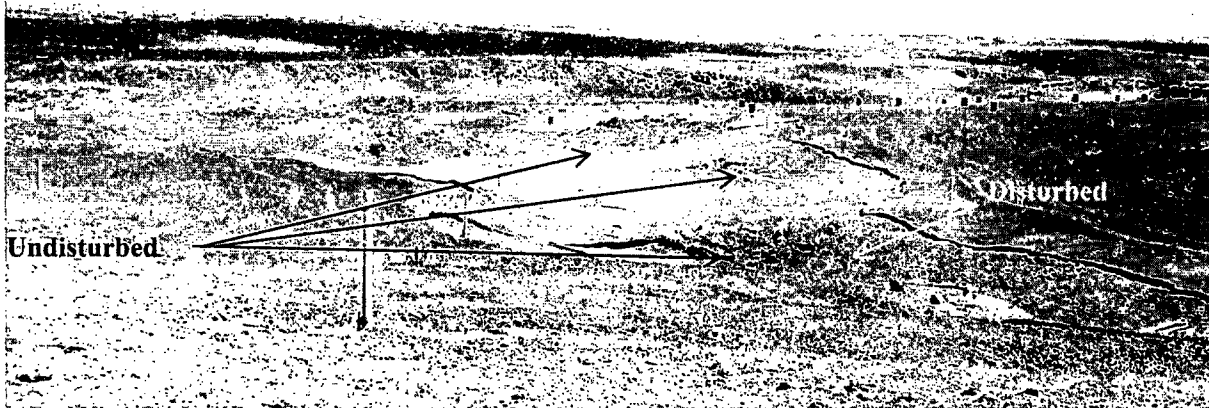
During the well completions inspection, it was noted that the surface disturbance to ephemeral drainages during well construction is significant. Although the drainages may not require designs for reconstruction (as when mining occurs through a drainage under surface mining of other resources i.e., coal, hard rock mines, etc., a large area of disturbance results from well installation (**Figure 1- 3**).

Figure 1 Disturbance to ephemeral drainage during well construction

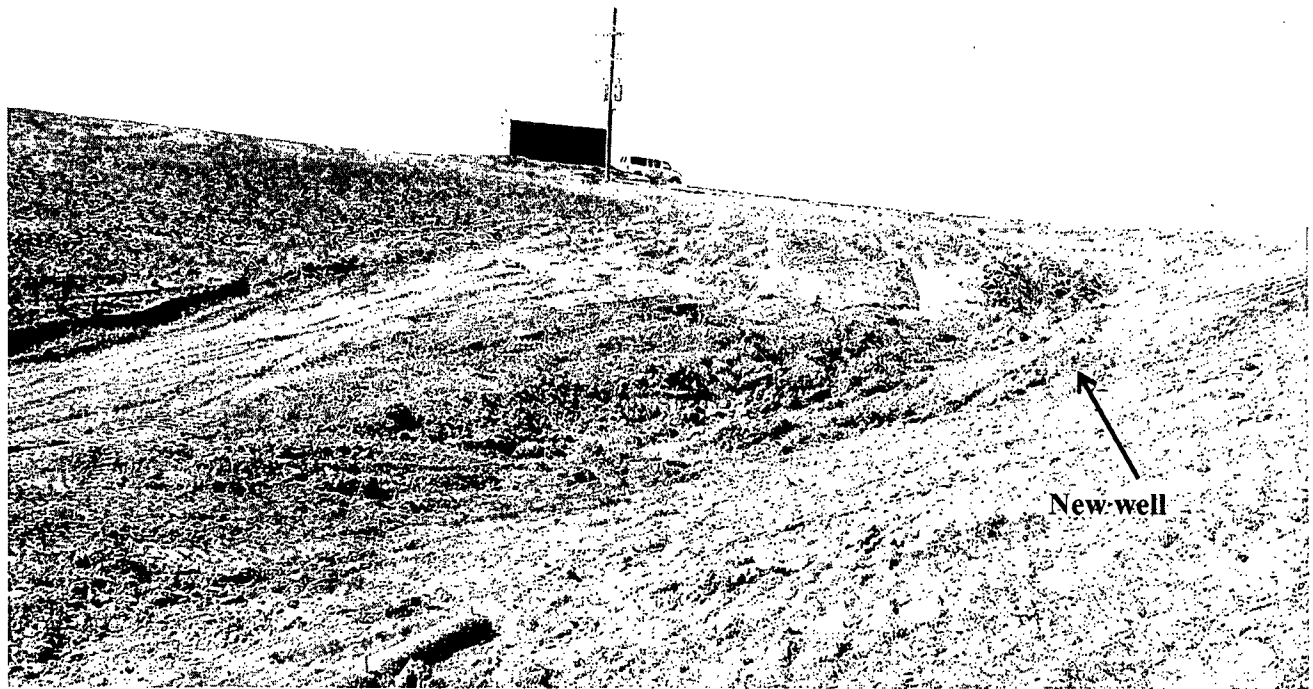
Figure 2 Top of ephemeral drainage with well construction disturbance

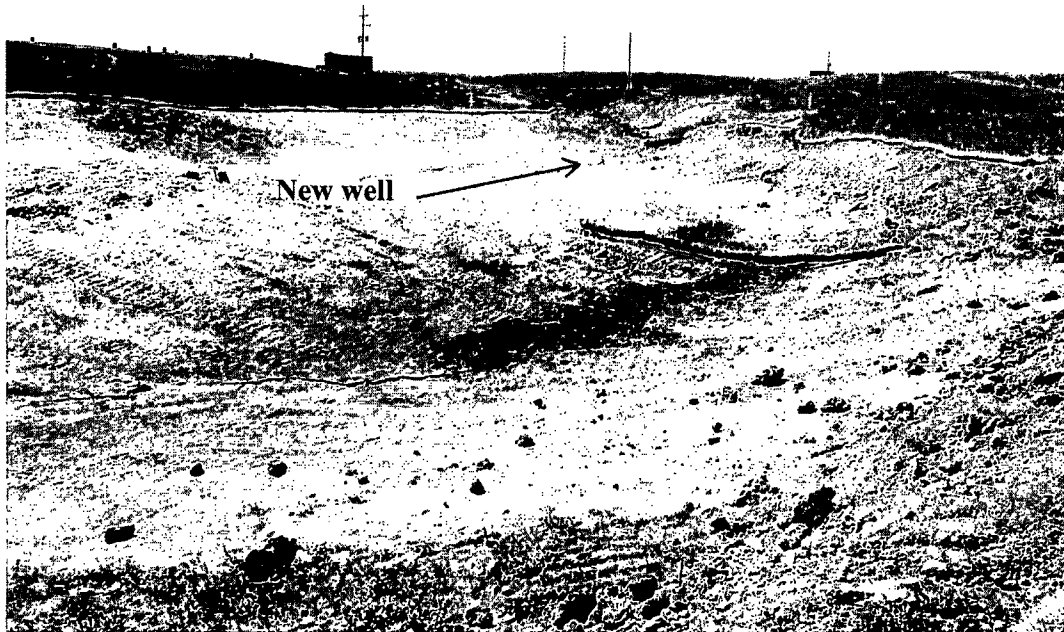
Figure 3 Disturbance to drainage following well construction

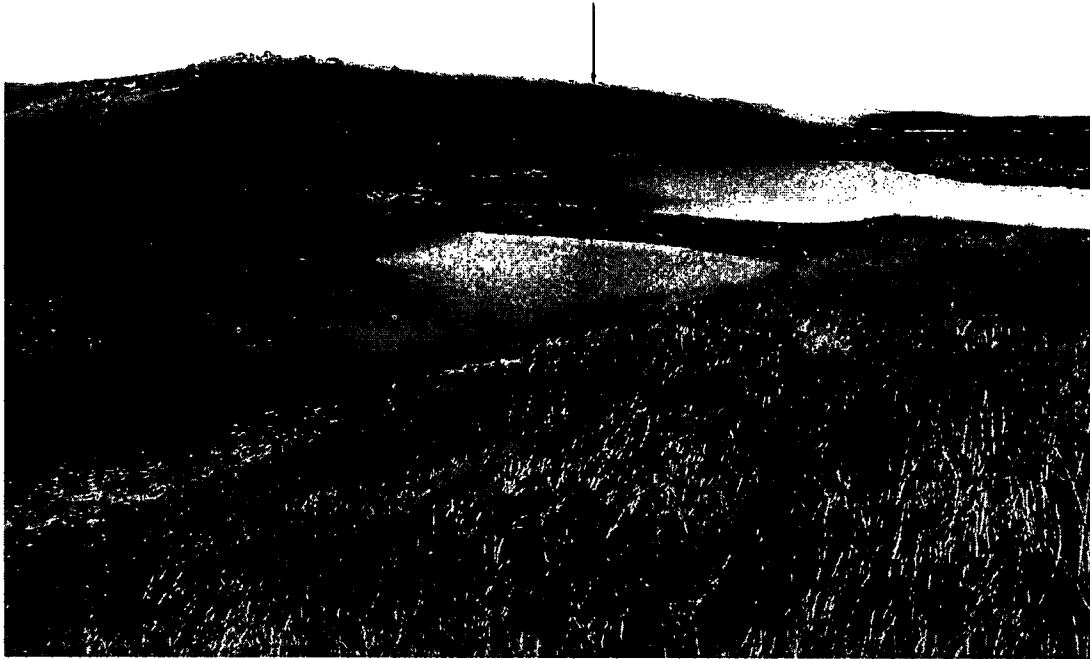
A water supply pond outside the permit boundary is in violation of:

- WEQA § 35-11-405(a) for construction activities related to mining outside the permit,
- LQD Noncoal Rules and Regulations, Chapter 11, Section 4(a)(iv) for lack of approved plan and design for the pond in the permit and,
- WEQA § 35-11-406(b)(xiv) for unapproved use of water in mining related activities.

Figure 7 View of water supply pond

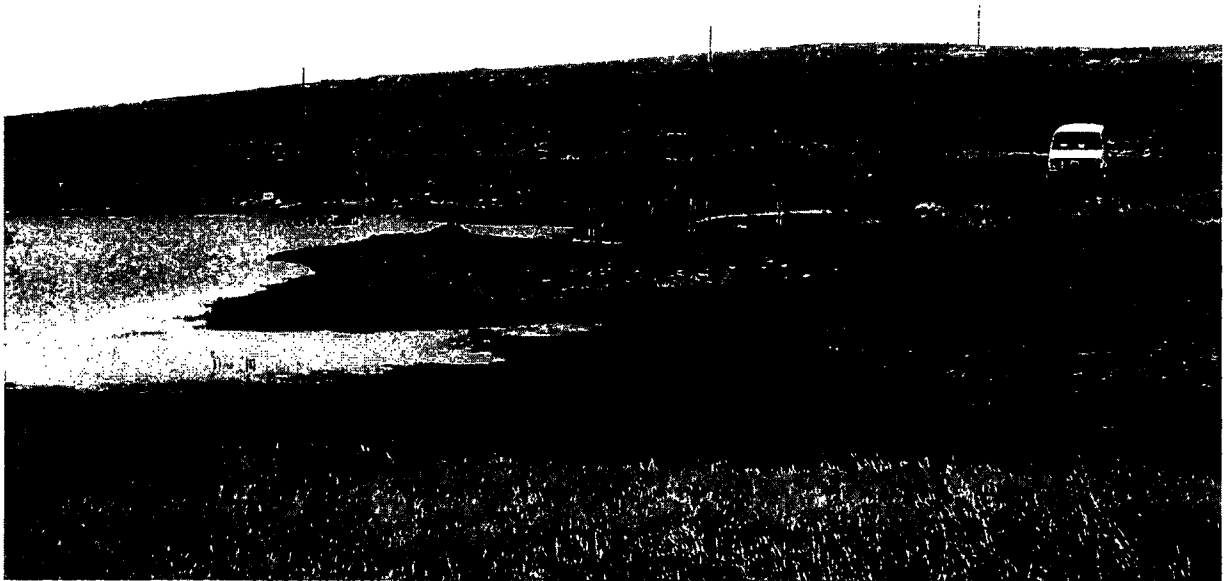
Figure 8 View of water supply access with sump hoses lying on the ground

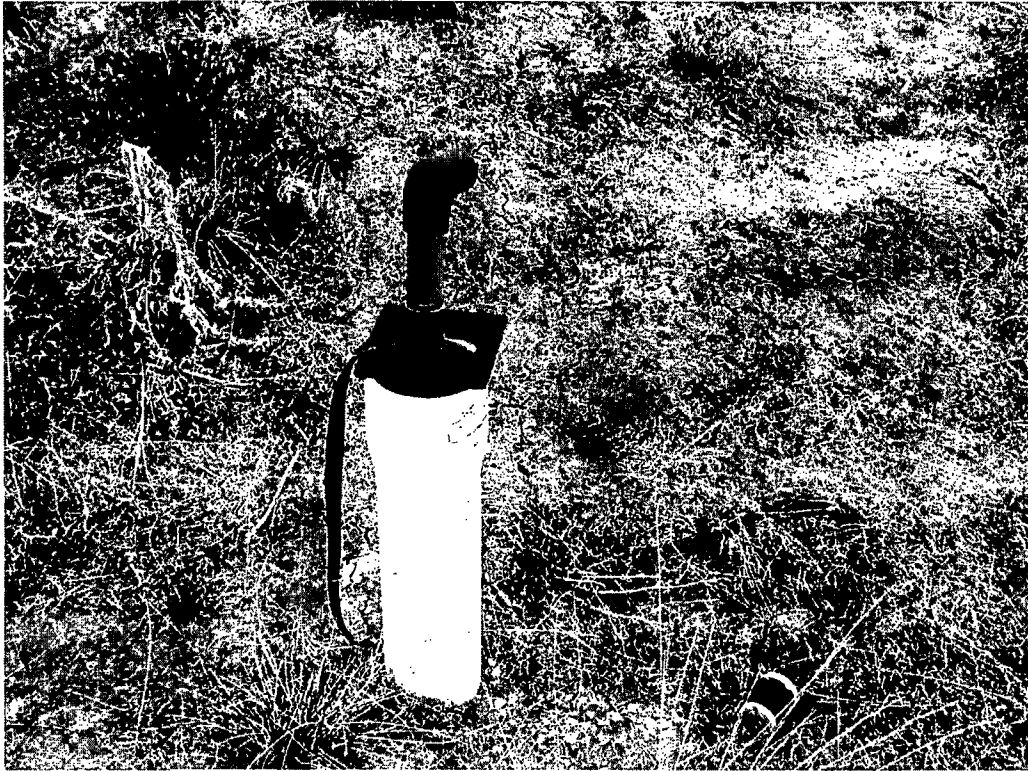
Pattern Area for HH-1 included many wells installed, however, due to proximity to the permit boundary CR needs to amend lands to complete the pattern. This has not happened due to stalled land acquisition issues to propose an amendment. An improved access road has been constructed which is used to access a water supply pond located outside the permit boundary (**Figures 6, 7 & 8**). In addition, two monitor wells and a third well of unknown usage that had inadequate capping were discovered outside the permit boundary (**Figures 9, 10 & 11**). CR stated the monitor wells were used to establish baseline for Wellfield-9.

- 3 Violations in the area of Wellfield-9 header house #1 were identified related to:
 - Monitor wells 901 and 949 are in violation of:
 - Wyoming Environmental Quality Act (WEQA) § 35-11-405(a) for construction activities related to mining outside the permit and,

- LQD Noncoal Rules and Regulations, Chapter 11, Section 6(b)(ii) for insufficient cover of the wells
 - An improved road to the water supply pond is in violation of:

Figure 9 Monitor well outside the permit boundary, M-901

- 2 CR will need to provide a summary of the complete history for the three wells identified during the inspection located outside the permit boundary and any other wells that are located outside the permit boundary under Permits 603 or 633. The information should include dates drilled and completed, MIT dates, pump test and/or sampling dates with results, use of the wells, SEO permits, etc. **Please provide the information within 10 days of receipt of this report.**

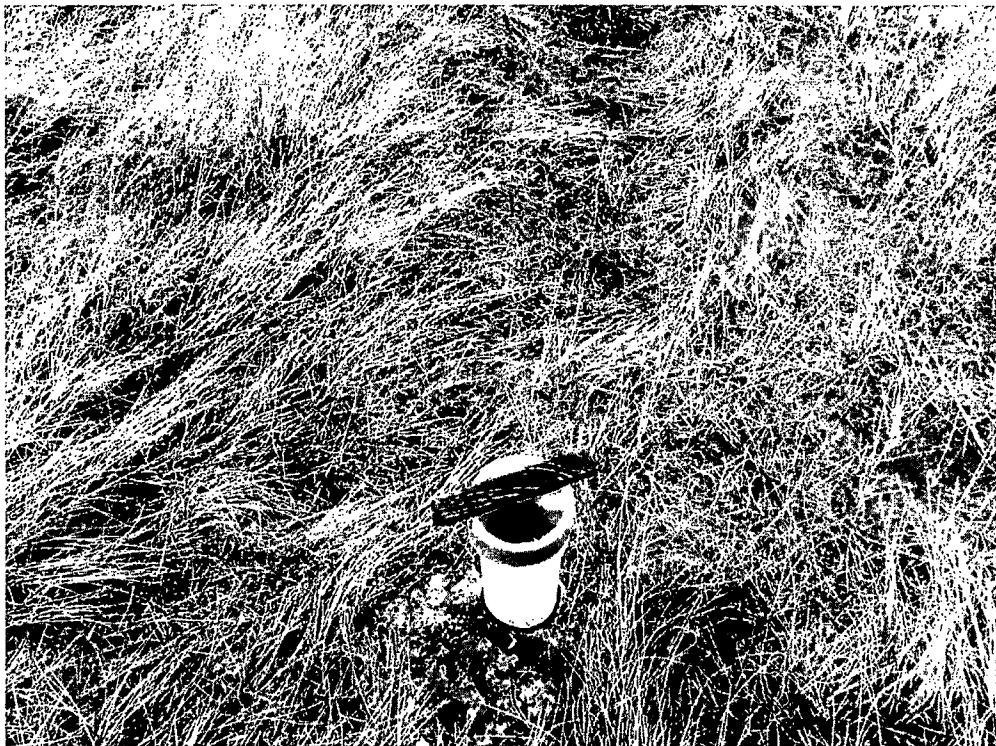
Figure 10 Unknown well with broken cap; located outside the permit boundary

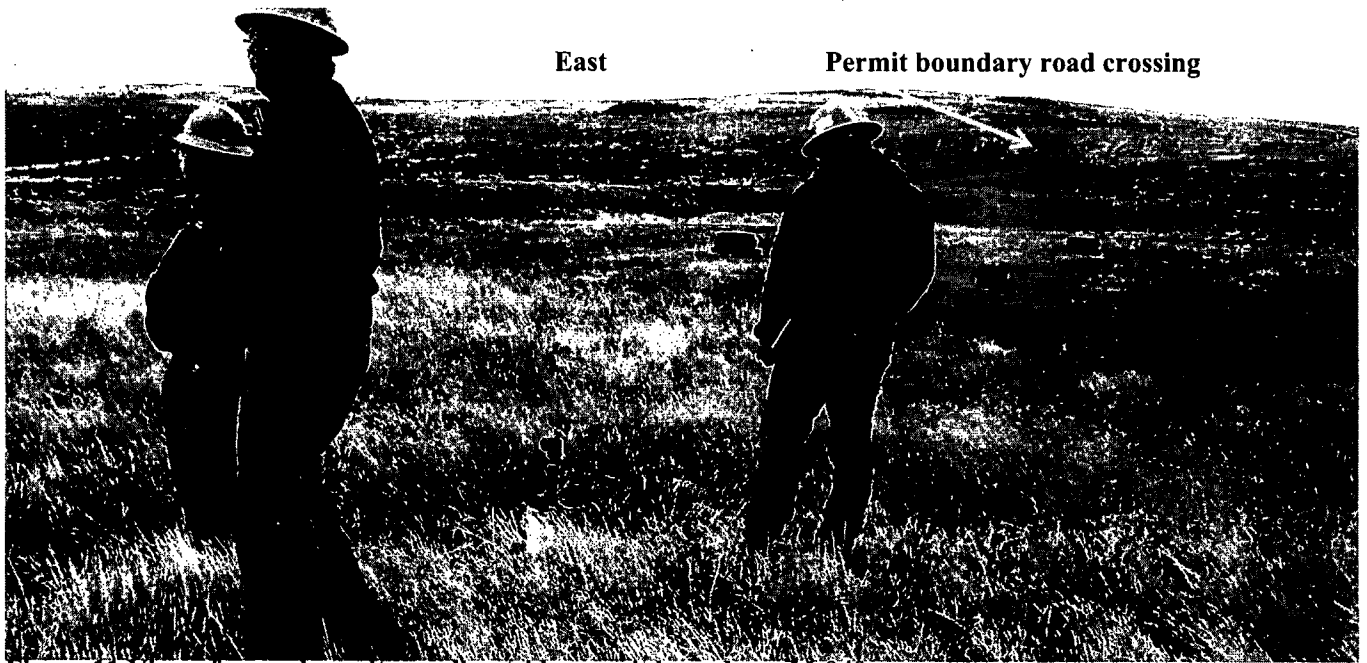
Figure 11 View of second monitor well outside permit boundary; M-949
