The Plutonium Spill at NIST- Boulder, June 2008

Richard E. Toohey, Ph.D., CHP
Sr. Scientific Advisor

Radiation Emergency Assistance Center / Training Site
Oak Ridge Institute for Science and Education (ORISE)

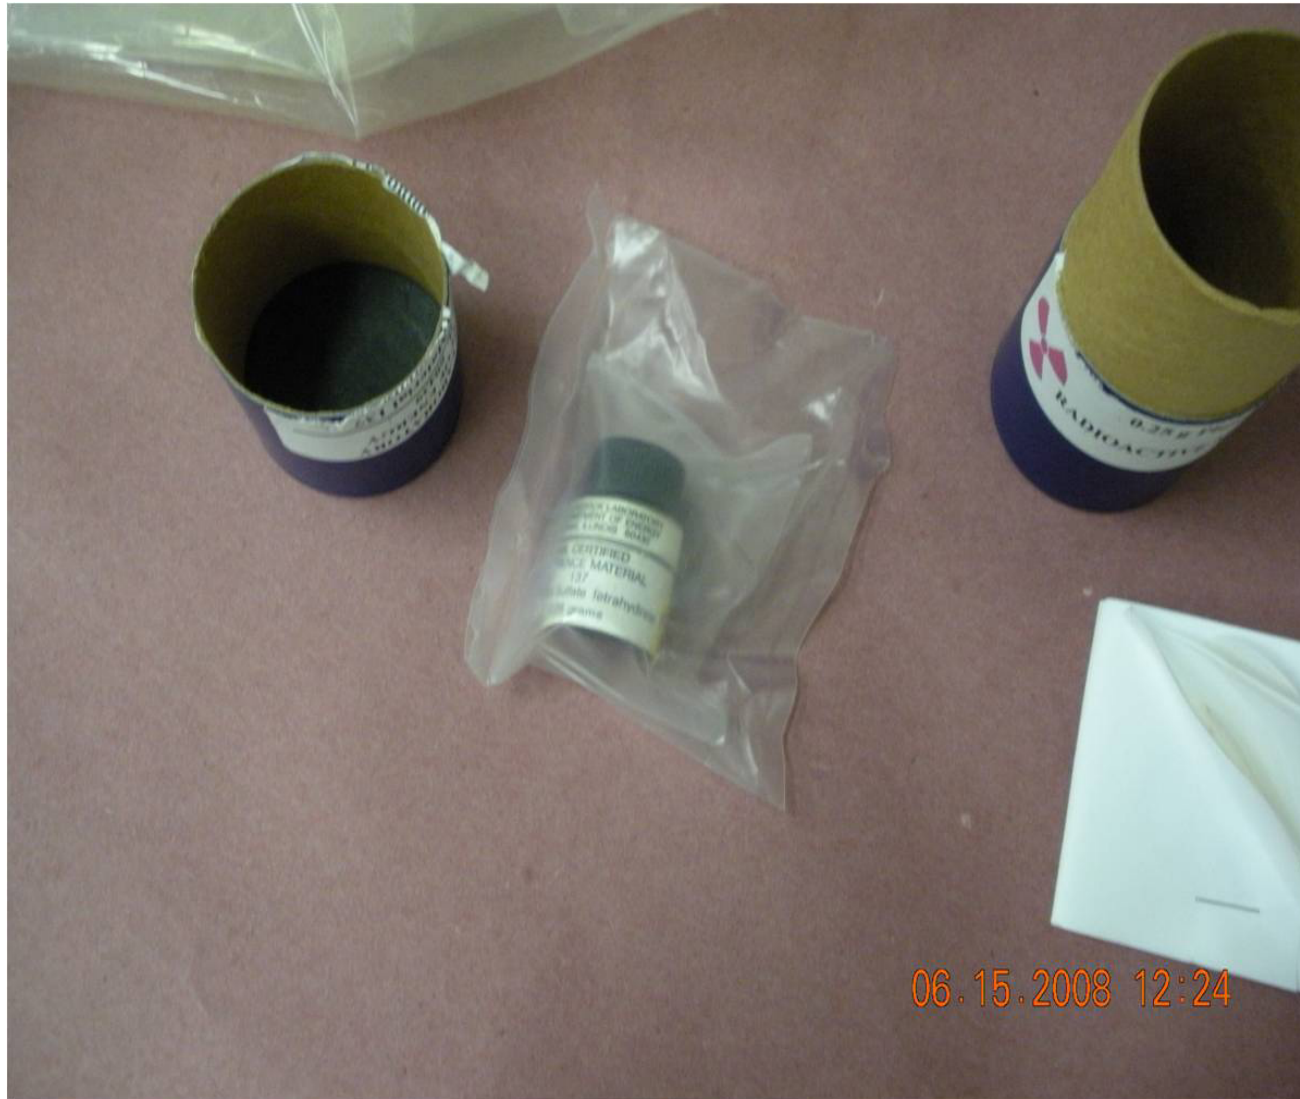
Source Configuration

- The source was 250 mg of $^{239,240}\text{Pu}$ sulfate tetrahydrate in a glass vial, about the size of a liquid scintillation vial, with a rubber O-ring seal under the screw-on cap; activity ~ 0.6 GBq
- Sample was prepared as Standard Reference Material about 20 years ago by the DOE New Brunswick Laboratory at Argonne East

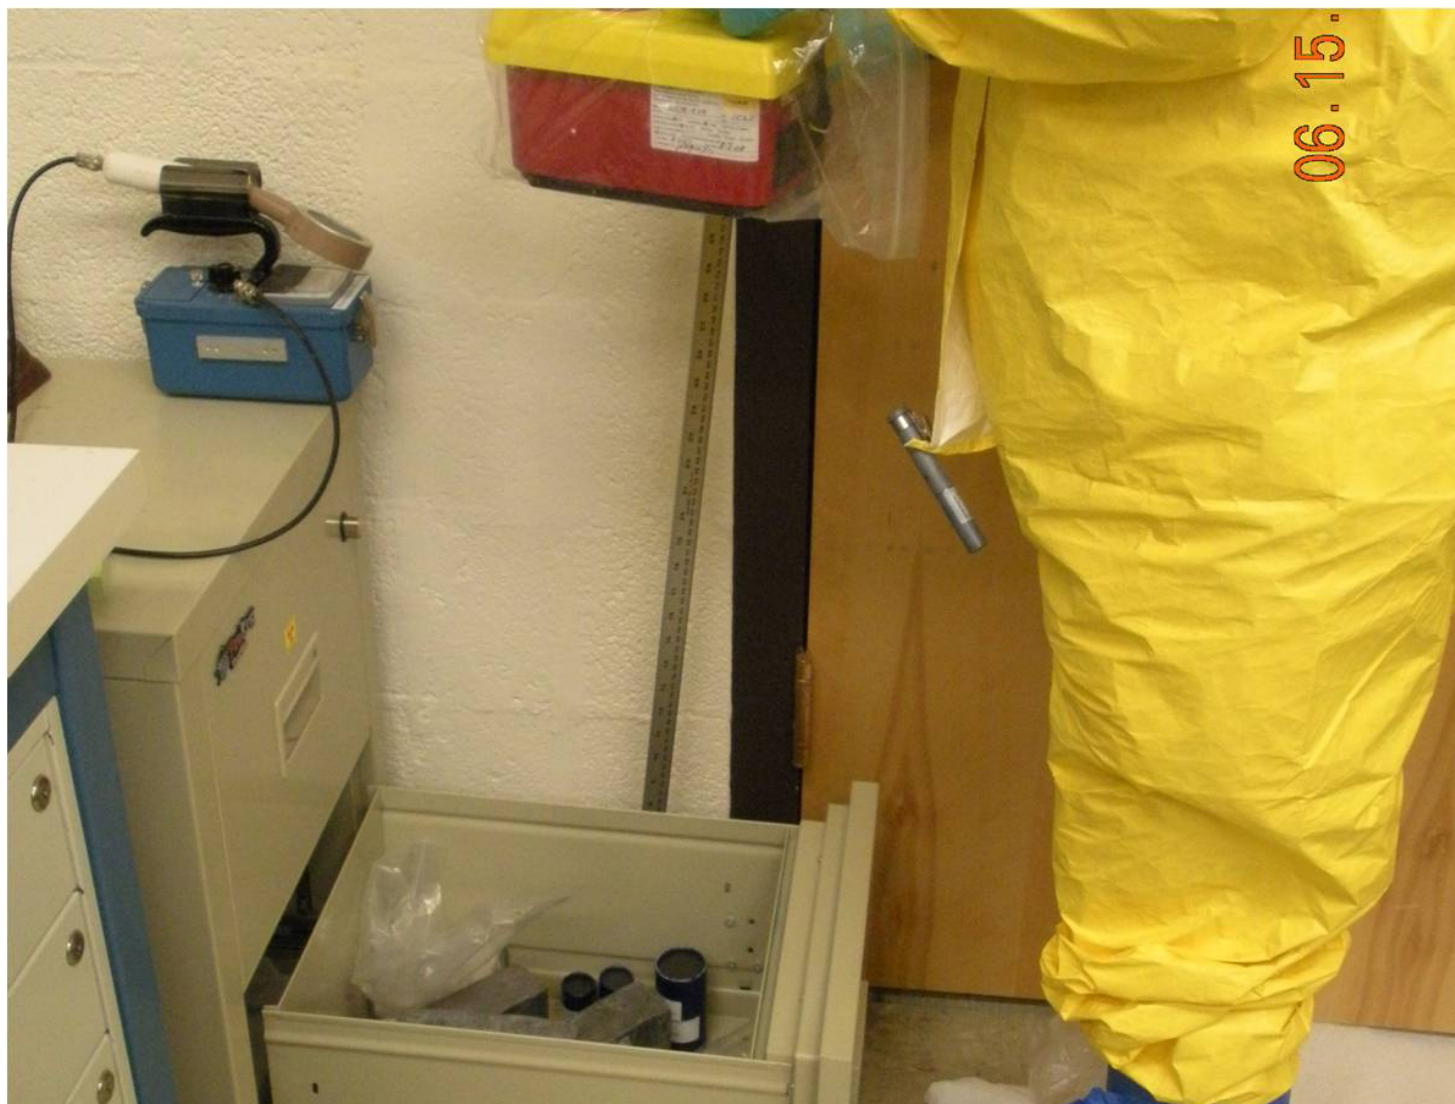
Source Storage

- Detector being calibrated occupied one corner of a multi-use laboratory routinely occupied or occasionally used by about 20+ individuals, most of whom were not radiation workers
- Sources stored in a locked 2-drawer file cabinet near entrance, some distance from detector

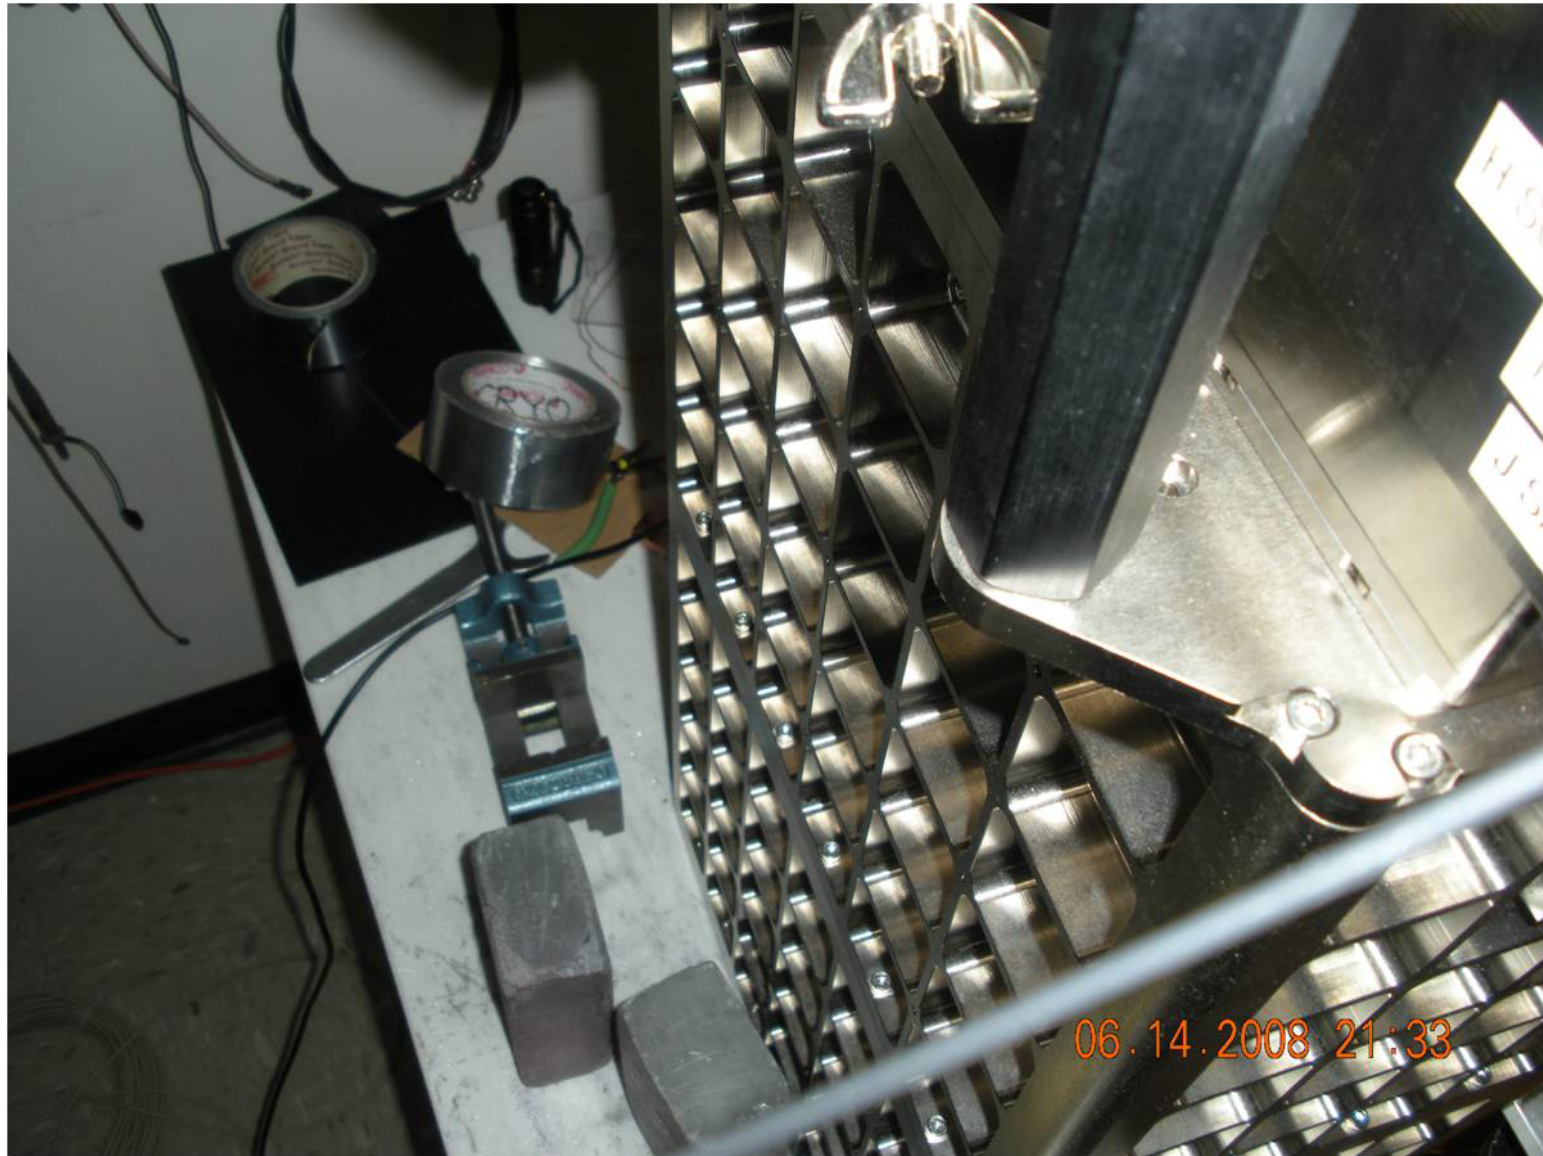
Detector Face

- On Friday 6 June Worker #1 and #2 (who had been trained) set up a long weekend run; they noticed varying count rate with source position, so tapped vial on marble bench top to settle powder in one corner
- Worker #1 also set up Pb bricks to shield computer from source to prevent failure from dropped bits he thought were caused by radiation.

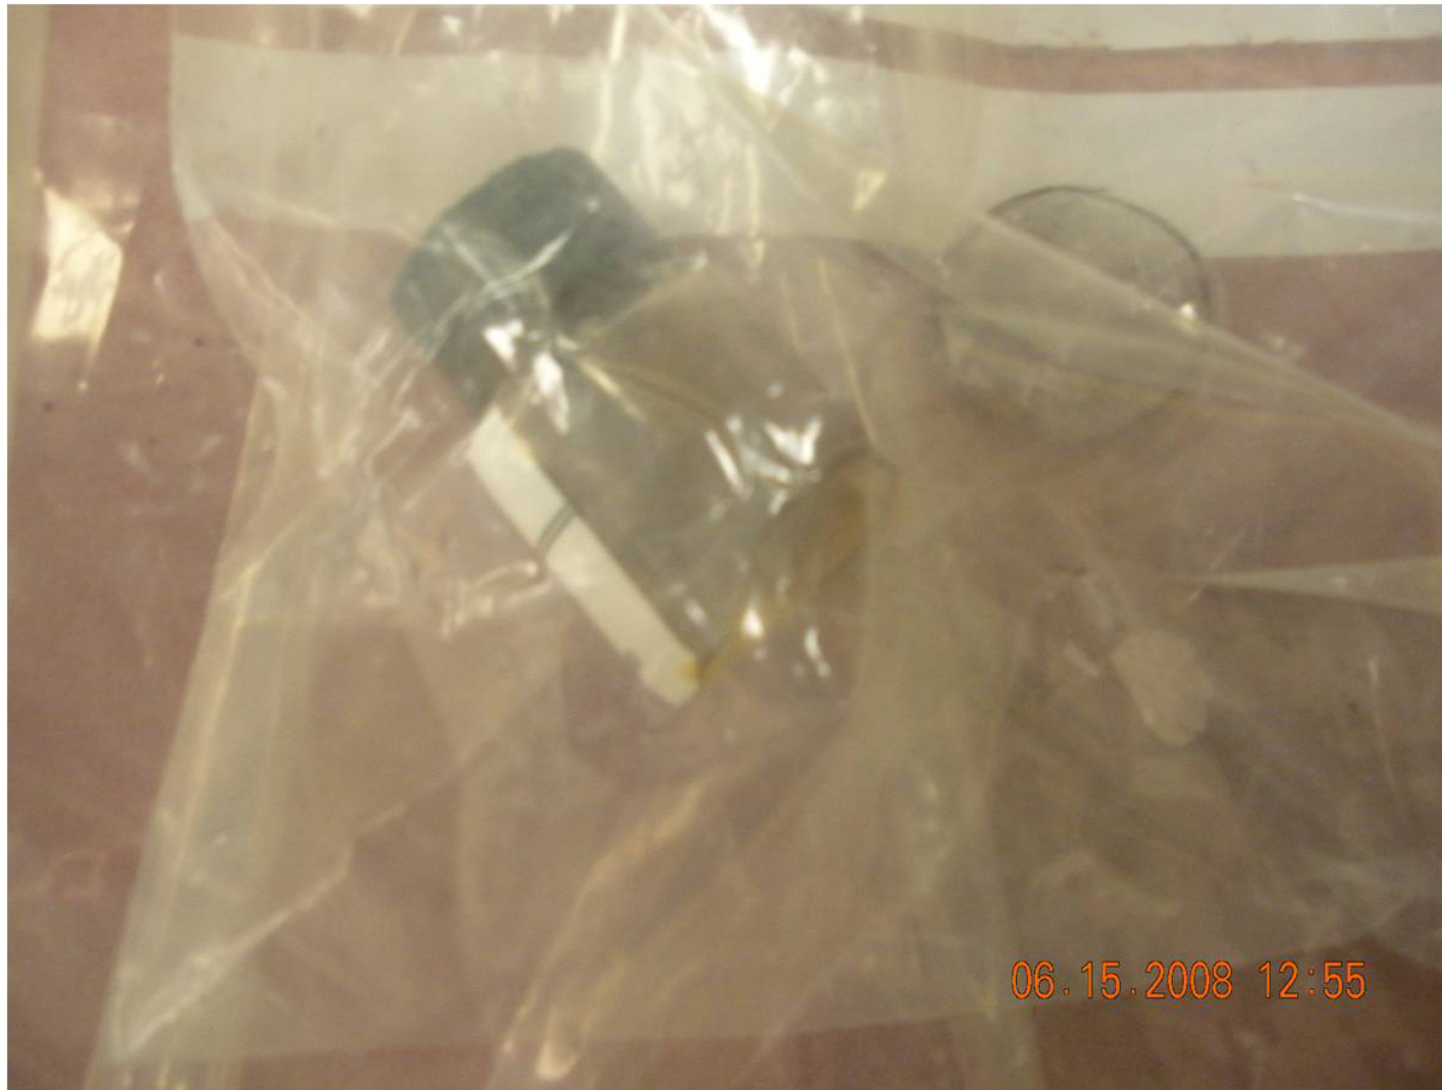
Ruptured Source

- On Monday June 9, worker #1 was setting up another run and moving source by hand in front of detector while observing count rate on computer and stated he may have tapped the source bottle against one of the Pb bricks.
- Worker #1 stated he then noticed what appeared to be a crack in the bottle, so replaced it in outer plastic bag and source safe, washed his hands, took his notebook to his office, then notified P.I. about 1 hr later

- P.I. was not made aware of potential seriousness of incident, so went to lab ~30 minutes later
- P.I. looked in source storage drawer and saw a second source that was obviously intact
- Worker # 1 then showed him the “cracked” source bottle

- P.I. observed “brown powder” inside source bag and also on bench top, and ordered the lab to be evacuated, but workers were told to wait in the hallway for further instructions.
- P.I. notified Group Leader, who came to lab, and advised workers to remove their shoes to avoid spread of contamination

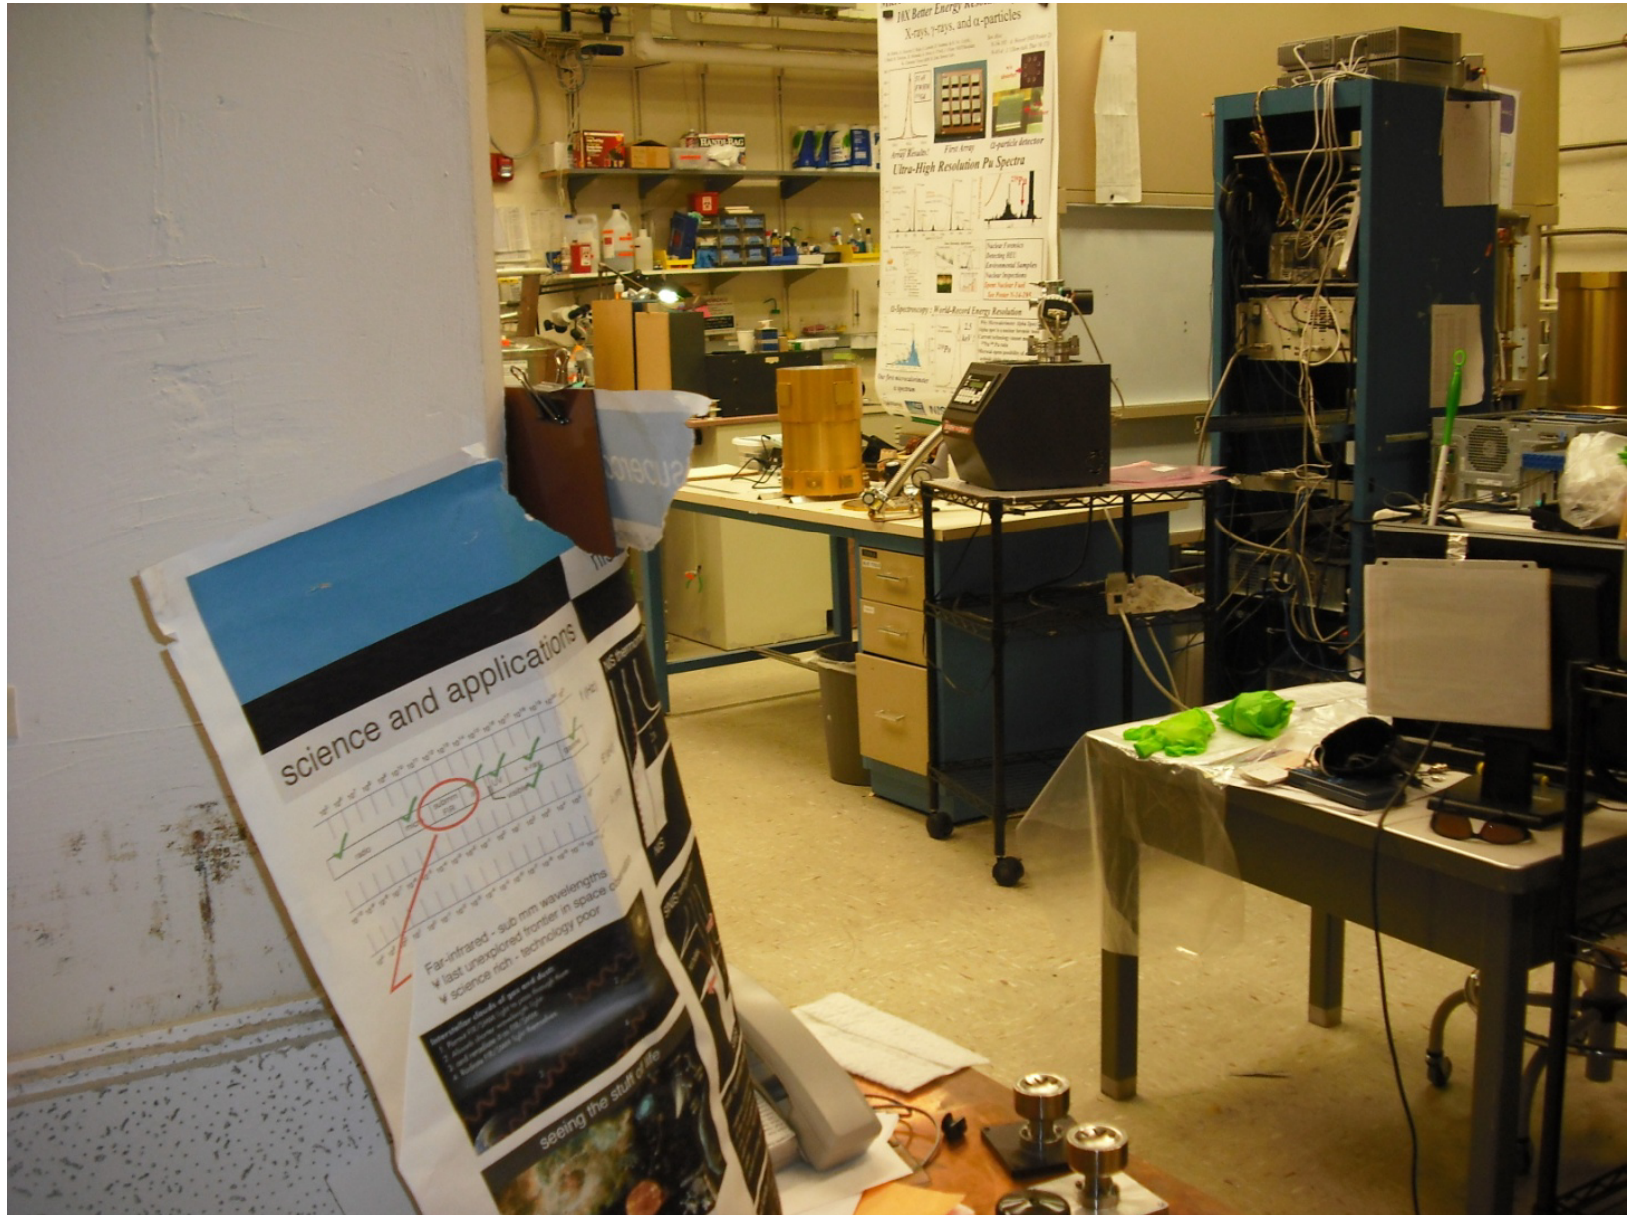
Cleanup (before)

- On 12 June, NIST-B requested assistance from DOE for additional survey and decon work; Radiological Assistance Program (RAP) Teams from Los Alamos and Livermore arrived on site the next day
- High level of contamination found in lab sink, which discharged directly to municipal sewer line
