## PART 21 REPORT - FAILURE OF CRD COLLET RETAINER TUBE/OUTER TUBE WELD

June 6, 2012  
MFN 12-006 R1

**Subject: Part 21 60-Day Interim Report Notification - Closure:  
Failure of CRD Collet Retainer Tube/Outer Tube Weld**

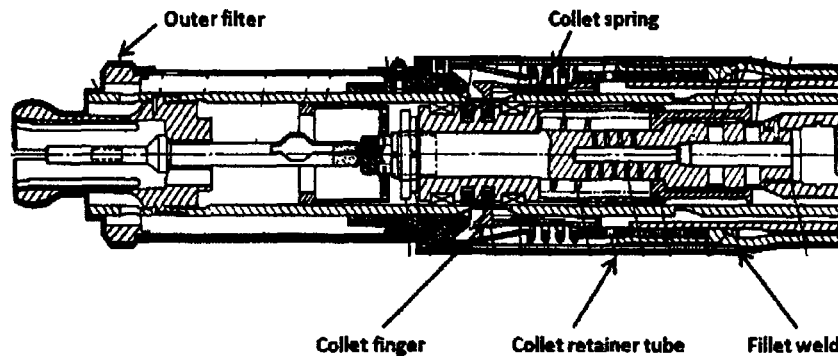
The fillet weld design in question is applicable to all 919D258G002 and G003 Cylinder, Tube and Flange assemblies since the collet retainer tube material, configuration and fillet weld design are the same for both groups. This fillet weld is located on the Outer Tube Assembly and is part of the Cylinder, Tube and Flange (CTF) assembly of the CRD mechanism.

The G003 CTF containing the failed fillet weld was removed from service in 2011. The collet retainer tube axial displacement was observed to be 0.15 inches. The observed displacement is bounded by two dimensions for potential movement of the collet retainer tube:

1. Per drawing dimensions, after separation, the collet retainer tube could displace a nominal axial distance of ~1.3 inches, before the top of the CRD outer filter would stop against the bottom of the control rod guide tube base.
2. After separation, an axial displacement of ~1 inch would result in the collet spring, which is maintained in a compressed state per design requirements, returning to its free-length state. The collet spring in its free-length state would restrict the collet fingers from deflecting outward and clearing of the index tube notches.

CRD index tube movement would likely begin to be inhibited if the collet retainer tube was to separate and displace approximately 1 inch or more. This degree of separation could potentially result in a stuck control rod (no insert, withdraw or scram capability).
