**UNITED STATES
NUCLEAR REGULATORY COMMISSION**

**SUBJECT: DAVIS-BESSE NUCLEAR POWER STATION - INSPECTION TO EVALUATE
THE ROOT CAUSE EVALUATION AND CORRECTIVE ACTIONS FOR
CRACKING IN THE REINFORCED CONCRETE SHIELD BUILDING OF THE
CONTAINMENT SYSTEM 05000346/2012009(DRS)**

IR 05000346/2012-009(DRS); 12/01/2011 - 5/09/2012, Davis-Besse Nuclear Power Station; Inspection to Evaluate the Root Cause and Corrective Actions for Cracking in the Reinforced Concrete Shield Building of the Containment System.

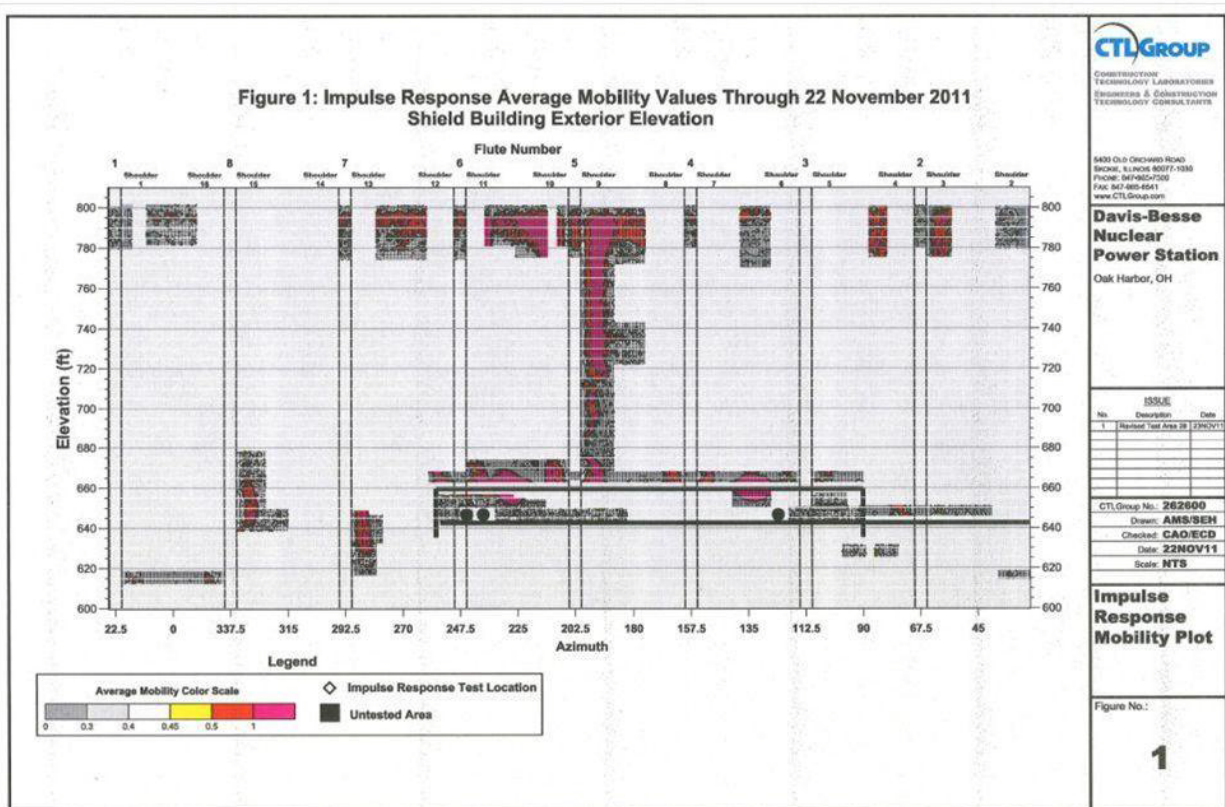
Picture No. 4 – Davis-Besse Shield Building Impulse Response Testing Mobility Plot

- The NRC team reviewed the IR mapping results (Attachment 2, Pictures 4 and 5) and SB drawings identifying the location and configuration of structural reinforcement (e.g., rebar) to determine if the extent of laminar cracking identified was consistent with the RCT conclusions that SB reinforcement design features contributed to the extent of cracking observed. The NRC team confirmed that the extent of cracking identified by IR testing results was consistent with the RCT identified Contributing Causes. However, the NRC team identified areas of laminar crack indications between SB shoulders 6 and 7 and above the mainstream line penetrations which did not include sufficient IR test locations to link this area directly with cracked areas in the adjacent SB shoulder regions. The NRC team's observation related to a lack of IR coverage did not invalidate the theory for the Direct Cause of the cracking or the Contributing Causes because the extensive computer modeling and vendor CBS testing provided a sufficient basis to validate these causes. Specifically, five analyses were completed in support of the SB laminar cracking causes Freezing Failure and Rebar Spacing Sensitivity Study, Structural and Thermal Analysis Investigation, Stress State During 1978 and 1977 Blizzards, Stress Analysis Due to 105 mph Wind Load, and Laminar Cracking Due to 1978 Blizzard. Therefore, the NRC team concluded that the RCT had developed a sufficient basis for the Contributing Causes.

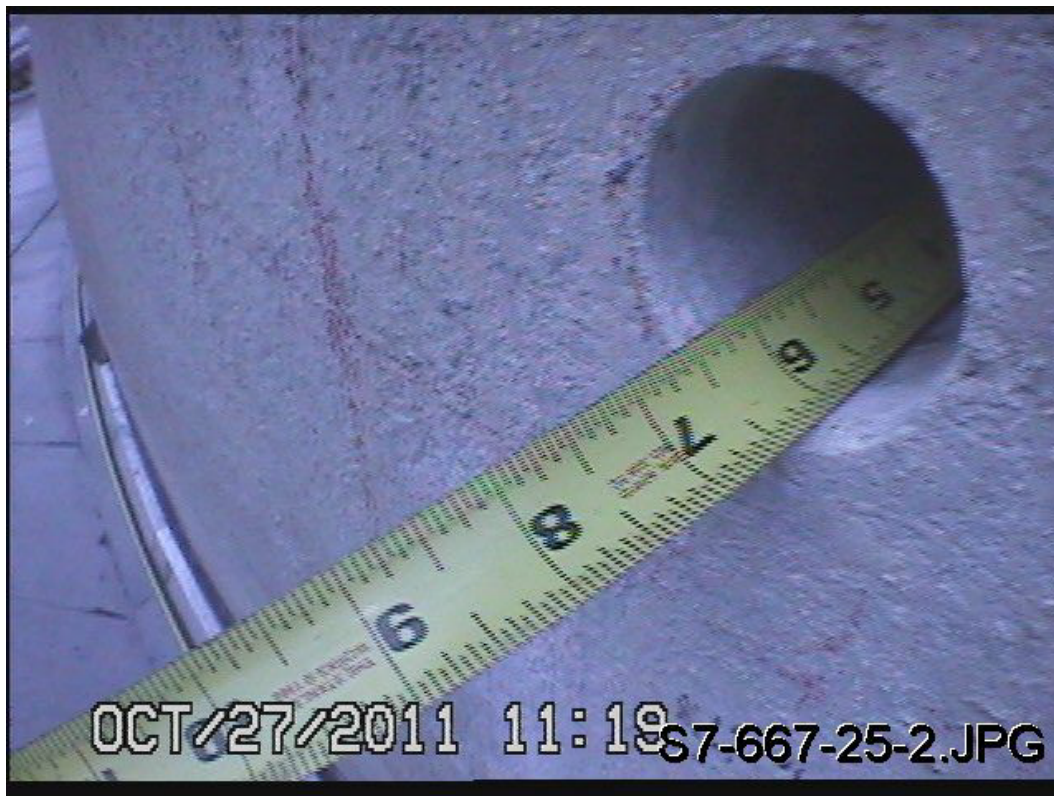
Picture No. 6 – Davis-Besse Shield Building Core Bore Location S7-667-25-2

The NRC team identified a brown deposit located near the bottom of a core bore at location S7-667.0-25, which had not been recorded on a licensee CR. The licensee staff believed this deposit was rust related stain and documented this condition in CR-2012-03889. The NRC team reviewed photographs from other SB core bore locations and noted a similar condition in the first core bore location (S15-645.5-3). The licensee staff believed this stain/deposit could be the results of minor rebar corrosion caused by water introduced during the core bore drilling operation. The licensee's corrective action associated with the identified corrosion is subject to future NRC inspection.

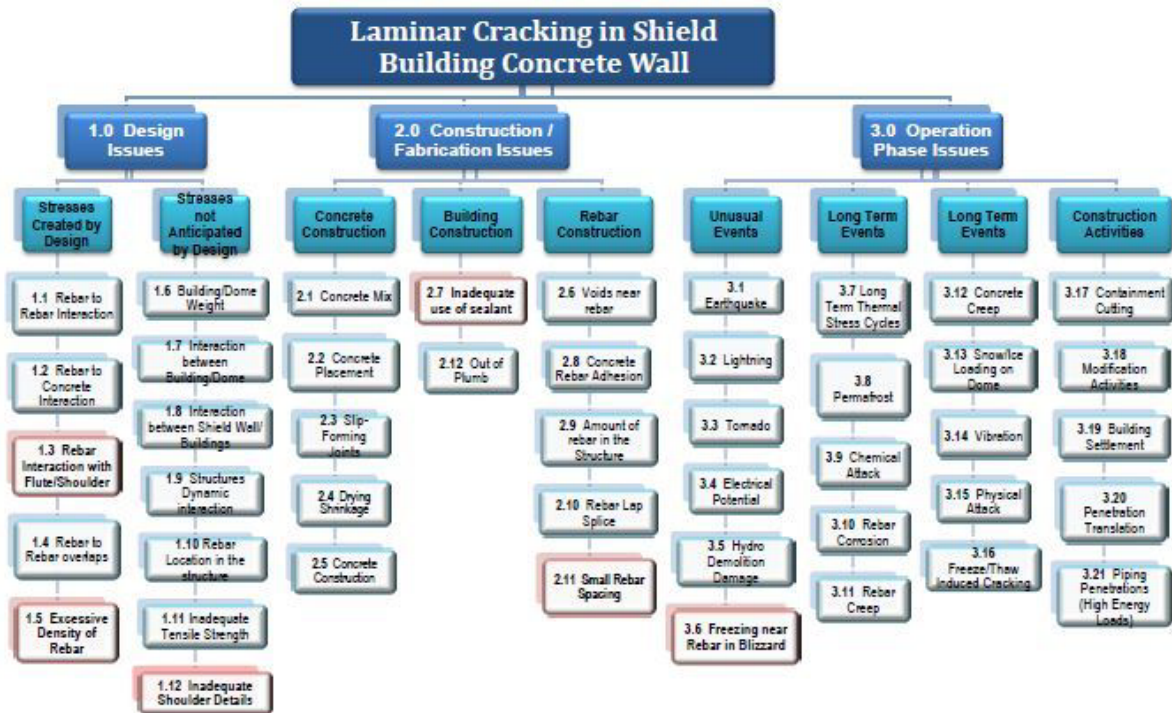
Picture No. 9 – Davis-Besse Shield Building Root Cause Analysis Report – Fault Tree

The RCT developed a fault tree of 45 possible failure modes that could potentially contribute to the laminar cracking, either individually or in concert based upon characteristics of the SB laminar cracking and other OEs with concrete issues. The 45 failure modes were grouped into three major categories consisting of Design, Construction and Fabrication, and Operational (Attachment 2, Picture 9) and each of these failure modes was evaluated during the root cause investigation. In general, each failure mode was either refuted or supported by laboratory tests and examinations or analysis. Some failure modes were refuted by deductive reasoning based on existing evidence to either support or refute their mode of failure. Potential failure modes were not eliminated without evidence to refute the postulated failure mode.

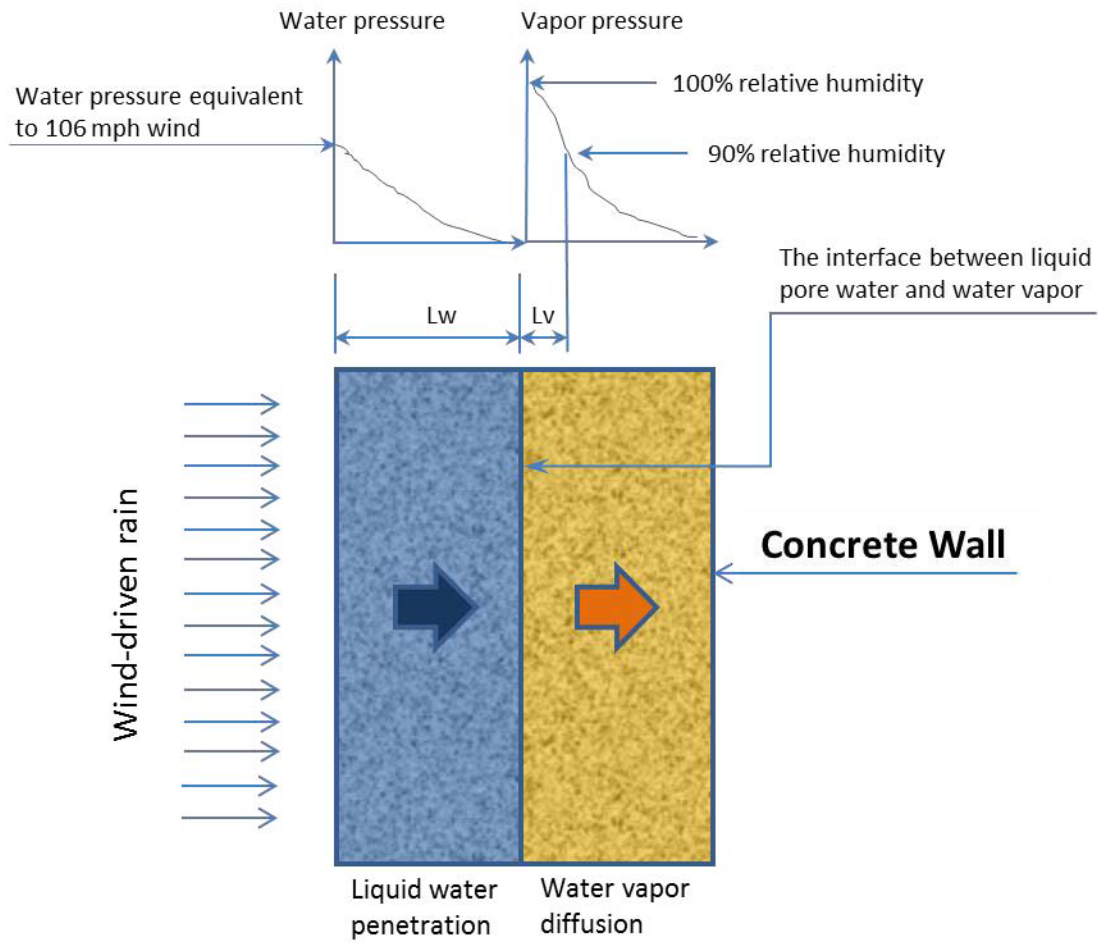
Picture No. 10 – Davis-Besse Shield Building – Water Migration

- The NRC team confirmed that weather records existed which supported the Direct Cause related to the extreme environmental conditions associated with the blizzard of 1978. This blizzard occurred from January 25 – 27, 1978, and produced rain with sustained winds, followed by rapid temperature drop and significant snowfall. Specifically, snowfall amounts ranging from 12 inches in Toledo to 22 inches at Saginaw, Michigan were recorded with wind speeds of 45 miles per hour (mph) and gusts to 105 mph west of Toledo, Ohio. This blizzard was preceded by a rapid drop in temperature beginning at 12 noon on January 25, 1978, and ending at midnight January 27, 1978. The vendor report included temperature maps that record a temperature drop from 40 degrees Fahrenheit (°F) at about 6:00 pm on January 25, 1978, to about -5° F by midnight. Daily temperatures were below 20° F by noon on January 26, 1978, and surface temperature continued to drop to near 0° F by midnight on January 27, 1978. These environmental conditions enabled moisture to penetrate the SB concrete, freeze and expand, which created a radial stress that exceeded the tensile strength of the concrete triggering the subsurface laminar cracking (Attachment 2, Pictures 10, 11 and 12).

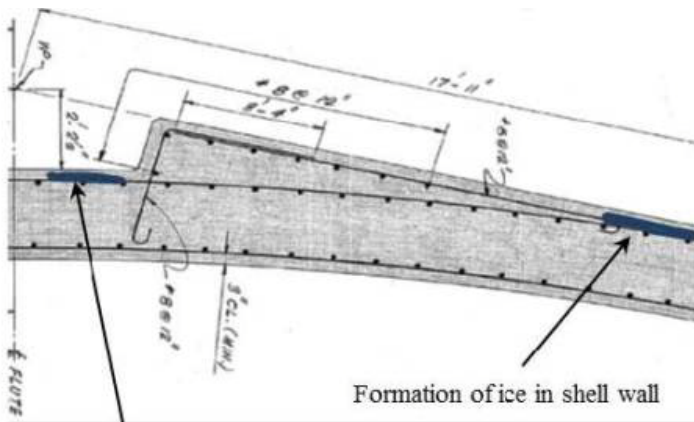
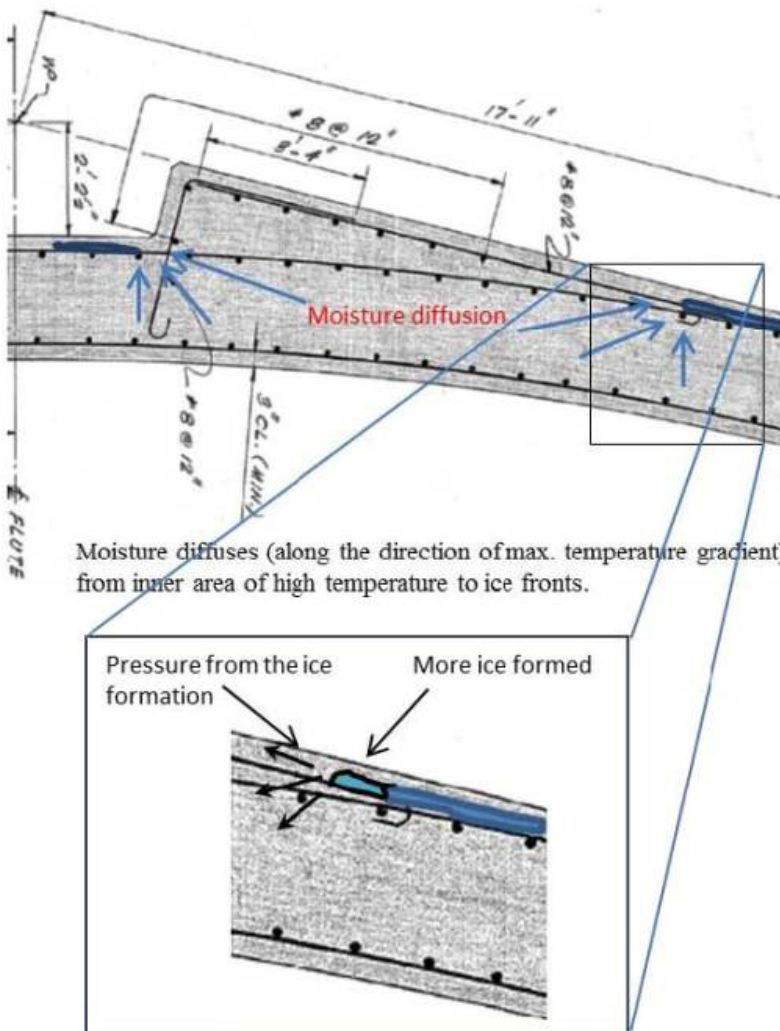
Picture No. 11 – Davis-Besse Shield Building – Location/Progression of Ice Formation

The RCT concluded that the Direct Cause for the SB concrete laminar cracking was the integrated affect of moisture content, wind speed, temperature, and the duration of these conditions created during the blizzard of 1978. The environmental conditions created by the blizzard of 1978 enabled moisture to penetrate the SB concrete, freeze and expand, which created radial stresses that exceeded the tensile strength of the concrete and initiated the subsurface laminar cracking (Attachment 2, Picture 11).

Formation of ice in flute

Progressive delamination of concrete cover near outer rebar mat due to ice formation
