UNITED STATES
NUCLEAR REGULATORY COMMISSION
OFFICE OF NUCLEAR REACTOR REGULATION
OFFICE OF NEW REACTORS
OFFICE OF NUCLEAR MATERIAL SAFETY AND SAFEGUARDS
WASHINGTON, DC 20555-0001

August 9, 2012

NRC INFORMATION NOTICE 2012-15: USE OF SEAL CAP ENCLOSURES TO MITIGATE
LEAKAGE FROM JOINTS THAT USE A-286
BOLTS

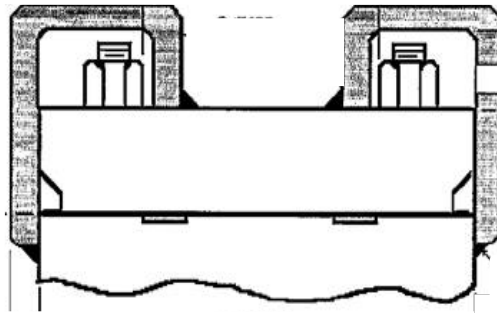
In February 1997, South Texas Project Nuclear Operating Company (STPNOC) discovered steam wisping from the body-to-bonnet gasket of a swing check valve located in the 8-inch nominal diameter safety injection piping at South Texas Project, Unit 2 (STP-2). This valve is constructed from an austenitic stainless steel body (SA182, Type 316) and bonnet (SA240, Type 316) joined using type A-286 bolts. As a corrective action, the licensee welded a metal enclosure over the bonnet and the studs of the check valve to mitigate the leakage (Figure 1). This enclosure is designed to contain leakage only; it is welded to, but not part of, the reactor coolant system pressure boundary.

Figure 1: Diagram of the enclosure

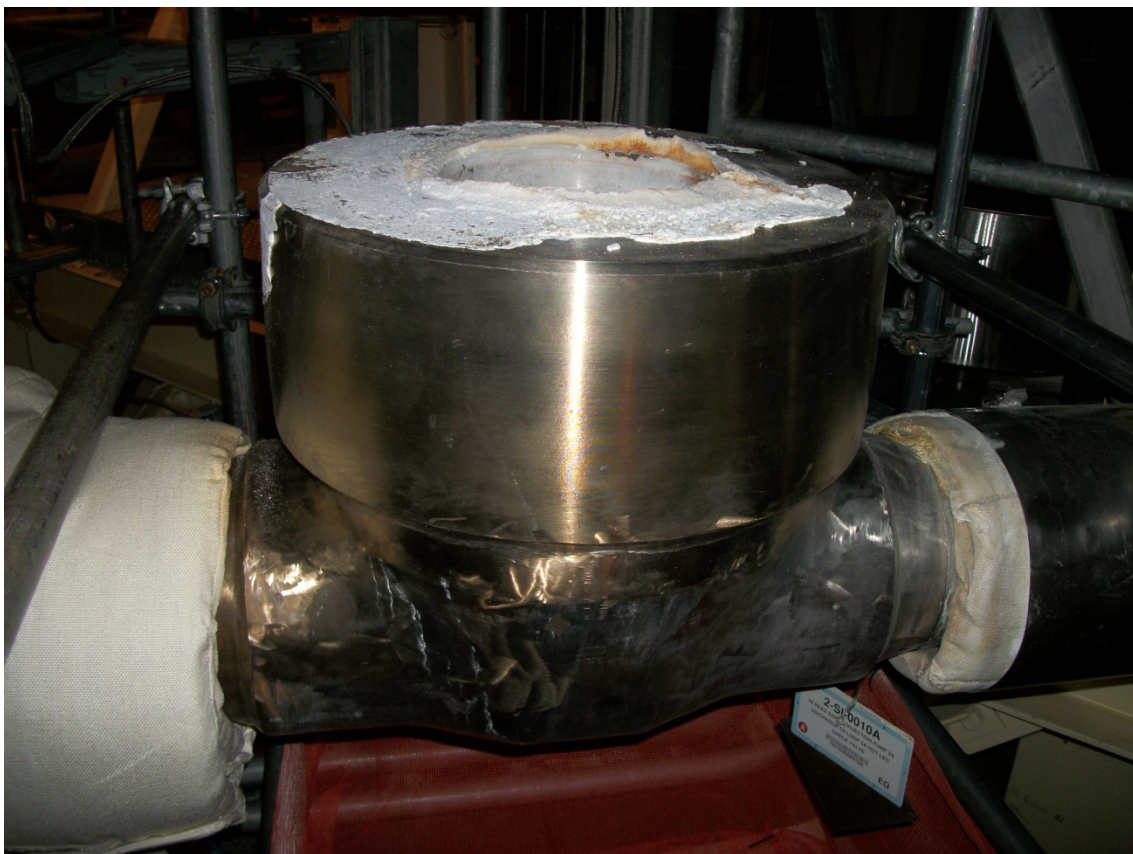
During the October 2011 refueling outage, the licensee identified water and boric acid crystals on the outside surface of the enclosure and on the valve bonnet (Figure 2). The licensee performed liquid penetrant testing and identified flaws on the weld joining the enclosure to the bonnet. Subsequently, the licensee repaired the fillet weld.

In April 2012, the licensee again found boric acid crystals in the weld joining the enclosure to the bonnet. Subsequently, the licensee removed the enclosure on the check valve and performed ultrasonic and visual examinations of the bolts. It did not find any degradation on the bolts. The enclosure was subsequently reinstalled. Permanent repair of the valve and removal of the enclosure are currently scheduled for the next refueling outage planned in 2013.

Figure 2: Photo of the enclosure
