**TECHNICAL EVALUATION REPORT
CHRISTENSEN RANCH MINE UNITS 2 THROUGH 6 RESTORATION REPORT
URANIUM ONE USA, INC., WILLOW CREEK ISR FACILITY**

DATE: October 23, 2012

DOCKET NO.: 040-08502

SITE: Willow Creek Christensen Ranch, Wyoming

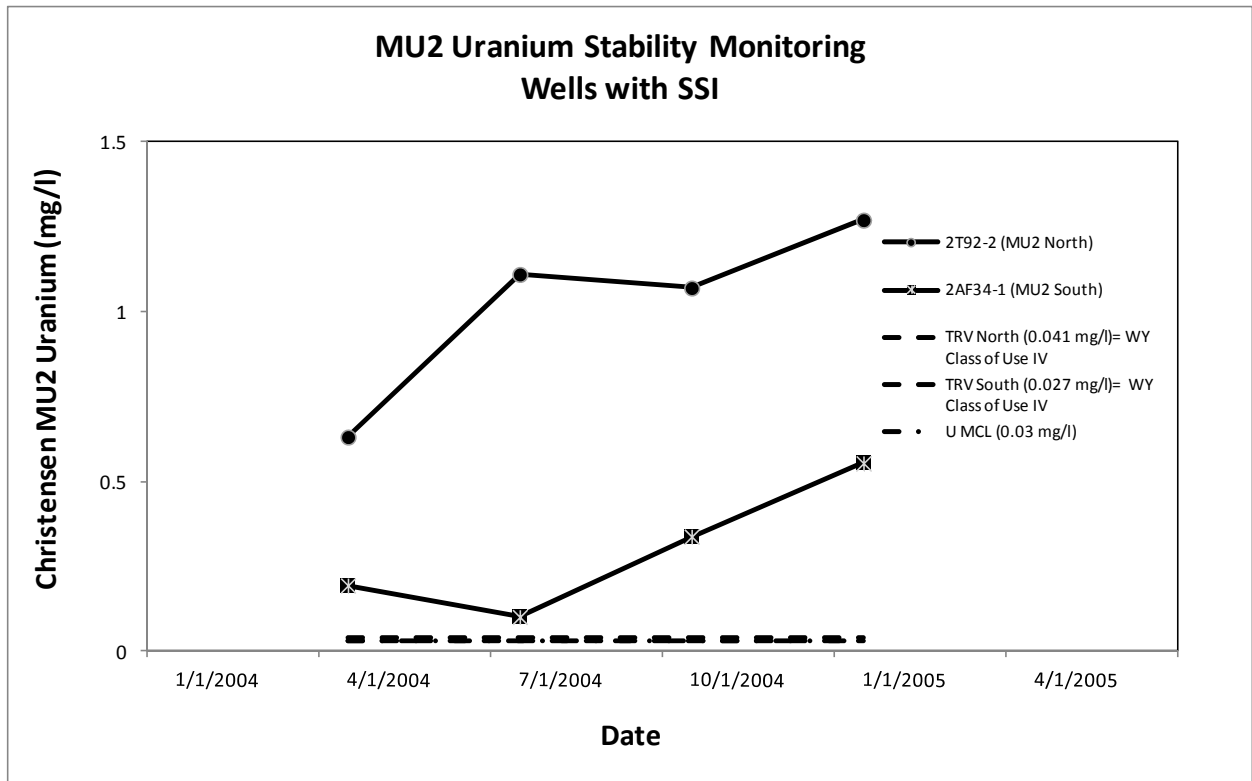
Figure 3b. MU2 North and South Uranium Stability Monitoring Trend Analysis

Based on the staff's stability analysis, a SSI trend was noted in the stability data for the following wells:

- (1) The licensee demonstrates the overlying and production aquifers between MU-2 South and MU-3 are not impacted; and
- (2) The licensee demonstrates the SSI trend noted in the uranium concentrations at well 2AF34-1 is reversed and stable.

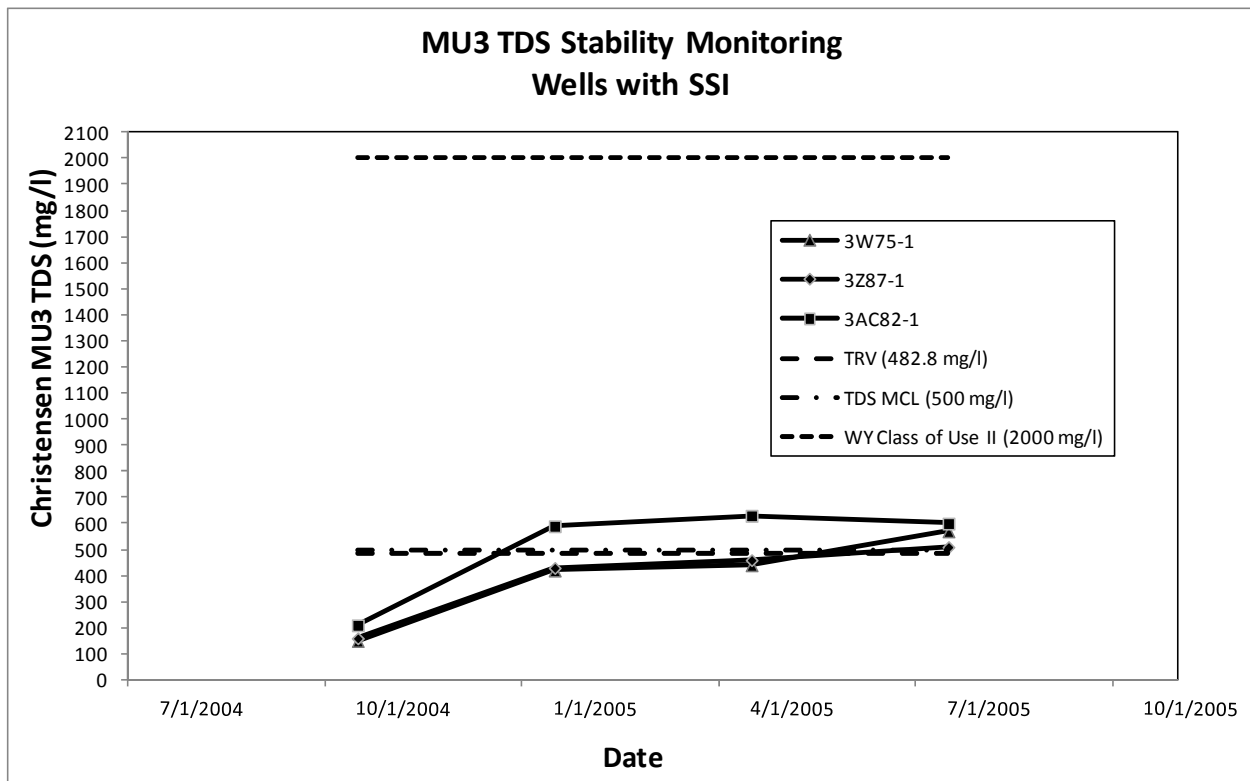
Figure 4a. MU3 TDS Stability Monitoring Trend Analysis

The SSI trends for wells in MU-3 w/o expansion and MU-3 w/ expansion (module 4A) for TDS, uranium and radium-226 are shown in Figures 4a, b, and c respectively. Based on the stability analysis, a SSI trend was noted in the stability data for the following wells in MU-3 w/o expansion:
