POEF-2086  
ORNL/TM-11988

## Investigation of Breached Depleted UF<sub>6</sub> Cylinders

Date Published: September 1991

Prepared by the  
OAK RIDGE NATIONAL LABORATORY  
and  
URANIUM ENRICHMENT  
Oak Ridge, Tennessee 37831-6285  
managed by  
MARTIN MARIETTA ENERGY SYSTEMS, INC.  
for the  
U.S. DEPARTMENT OF ENERGY  
under contract DE-AC05-84OR21400 and  
DE-AC05-76OR00001

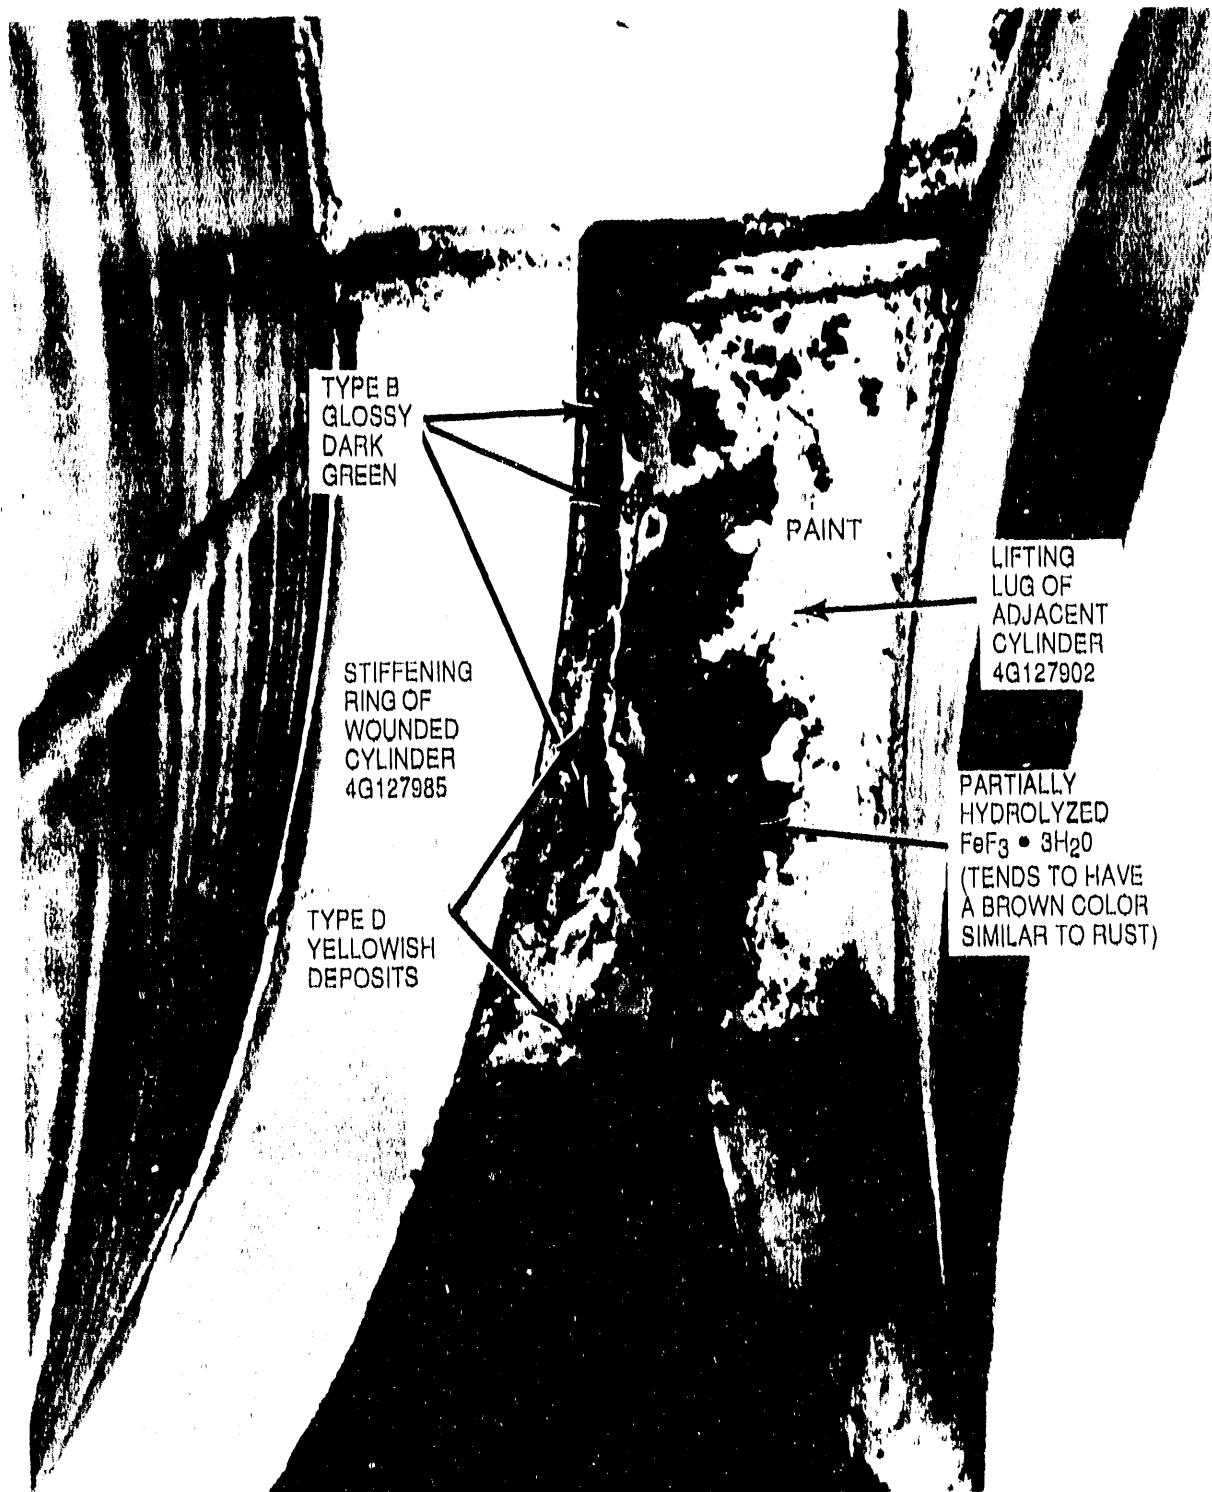
PHOTO NO. K/PH-91-3193

Fig. B1.1. Location of materials taken from surface of stiffening ring of cylinder 4G127985 and lifting lug of cylinder 4G127902. Photograph taken before separation of the cylinders. The hole is just above the longitudinal weld and on the other side of the stiffening ring.

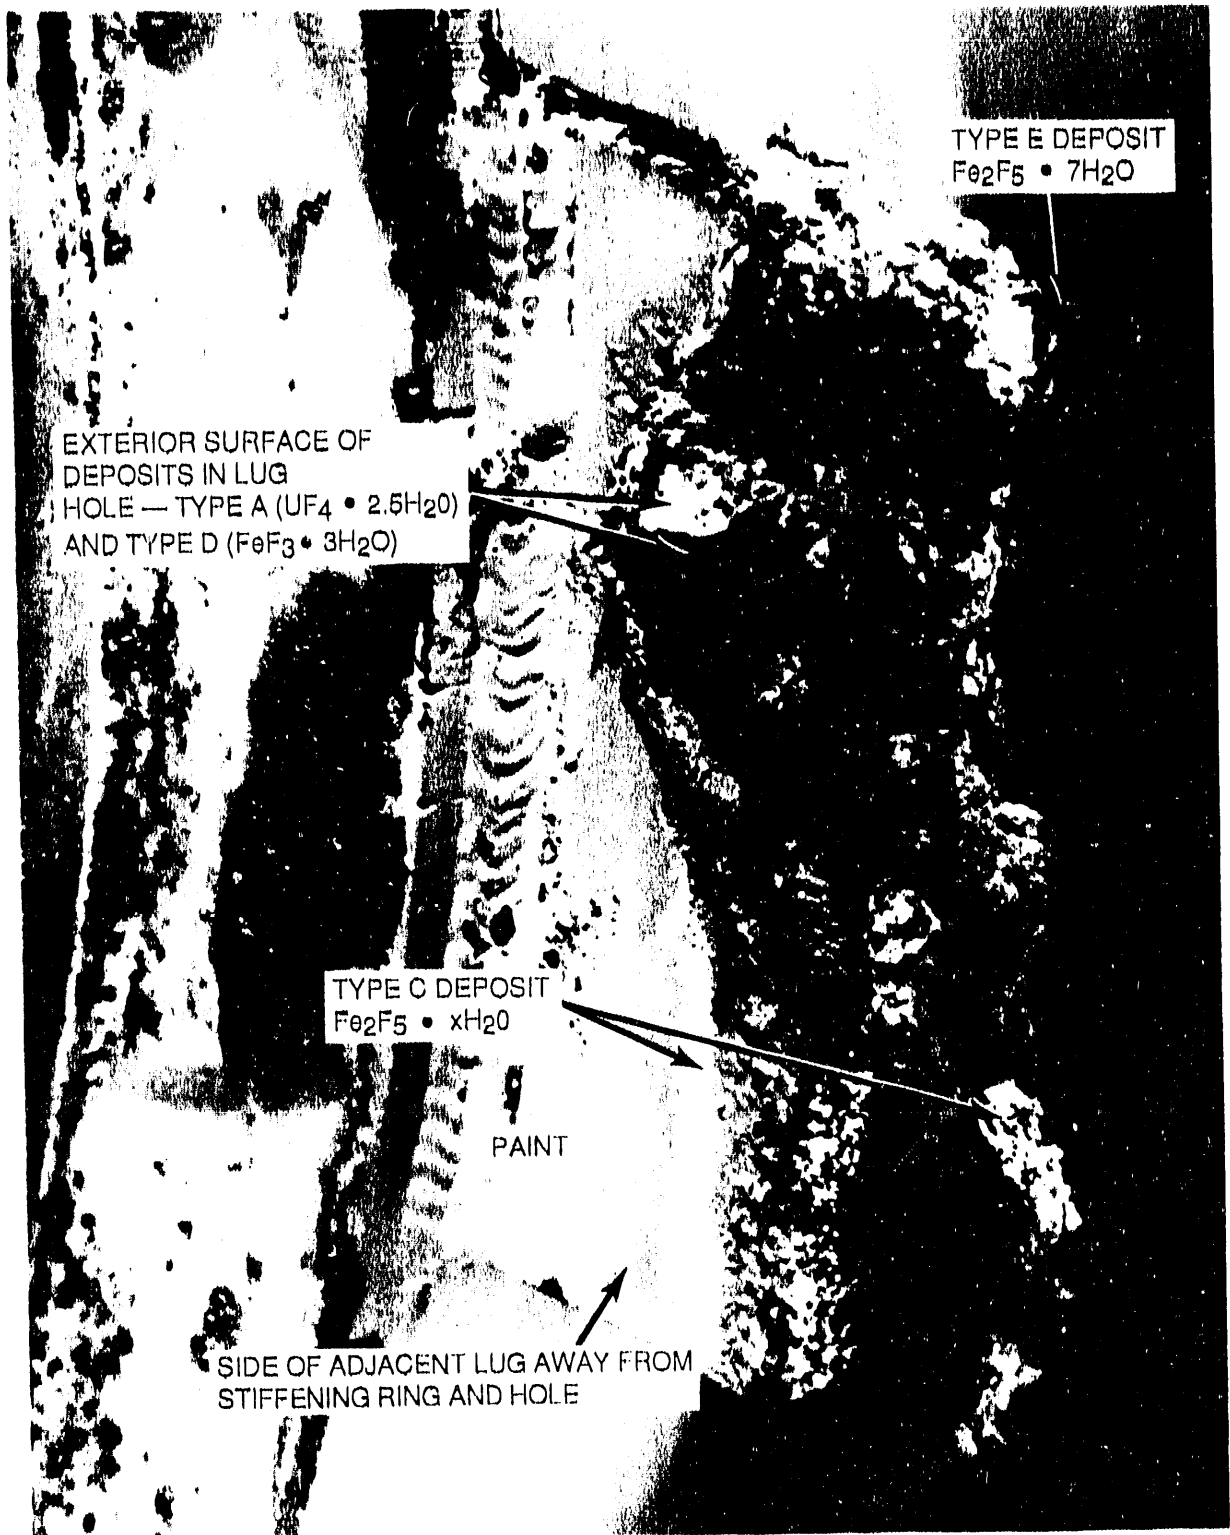
Fig. B1.2. Location of various materials in the lifting lug of cylinder 4G127902 as seen from the side away from the stiffening ring of cylinder 4G127985 after separation from cylinder 4G127985.

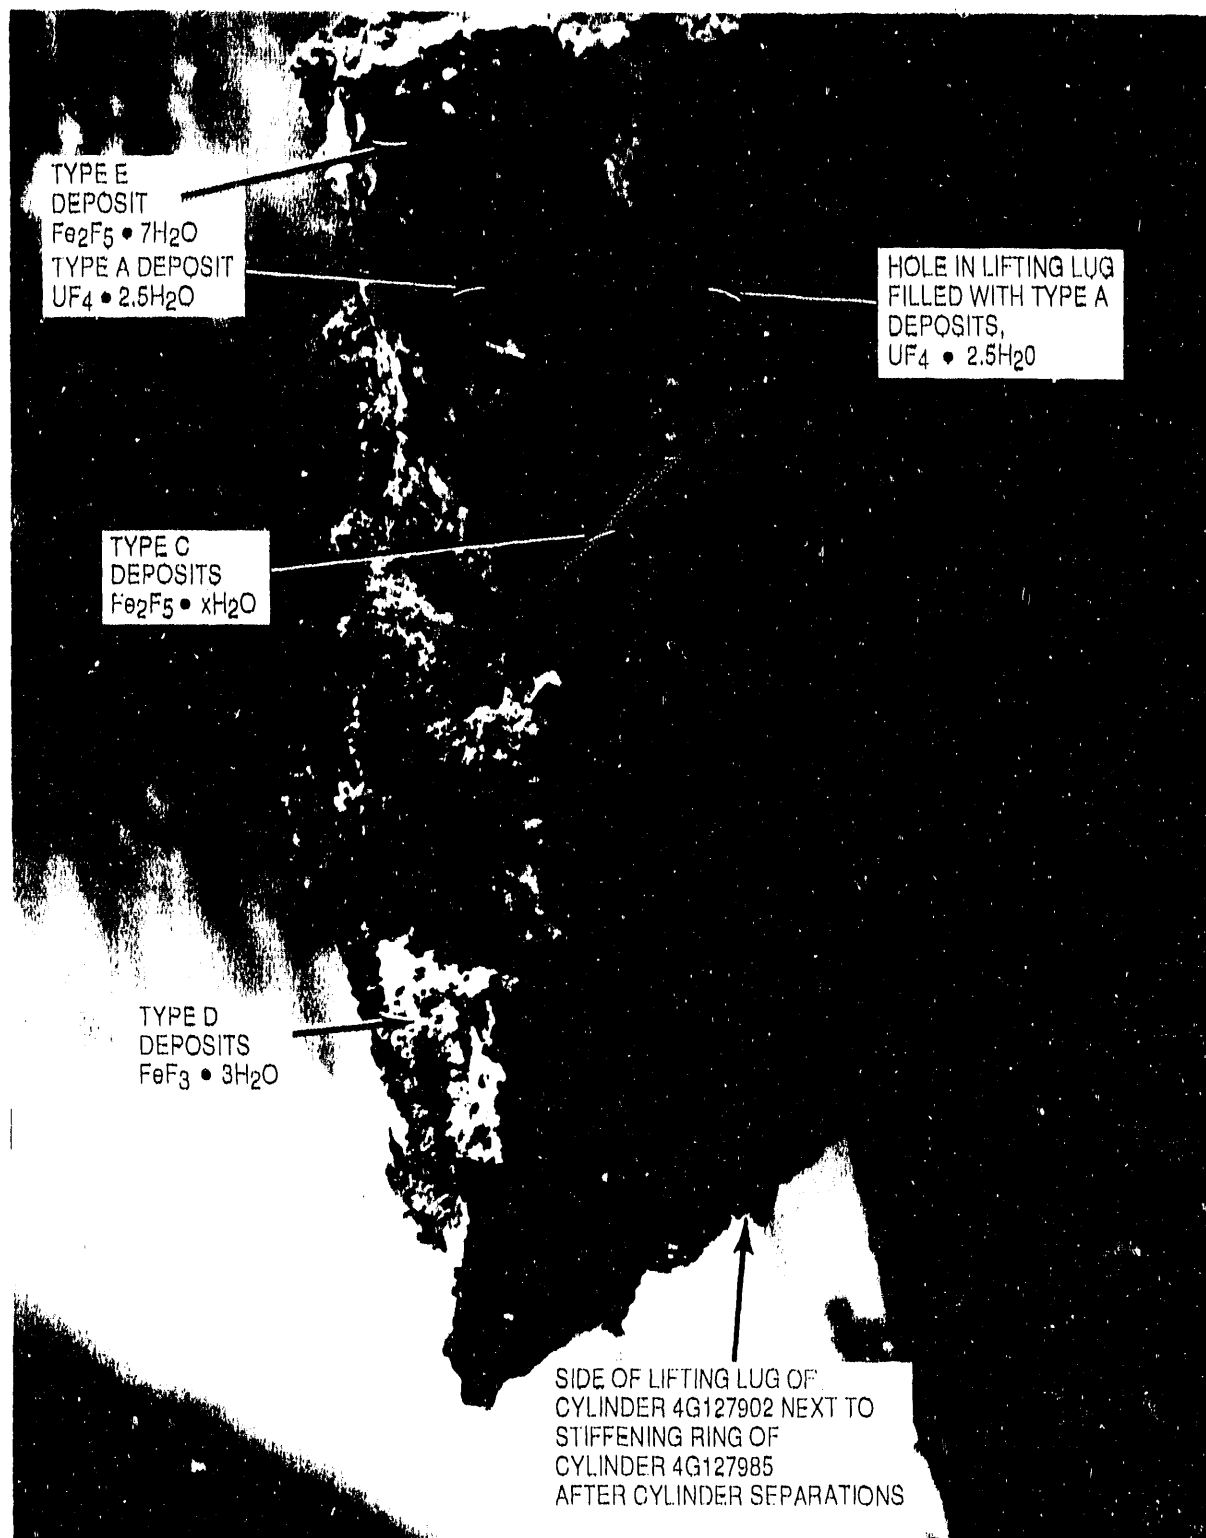
Fig. B1.3. Location of various materials on the lifting lug cylinder 4G127902 as seen from the side adjacent to the stiffening ring of cylinder 4G127985 after separation.

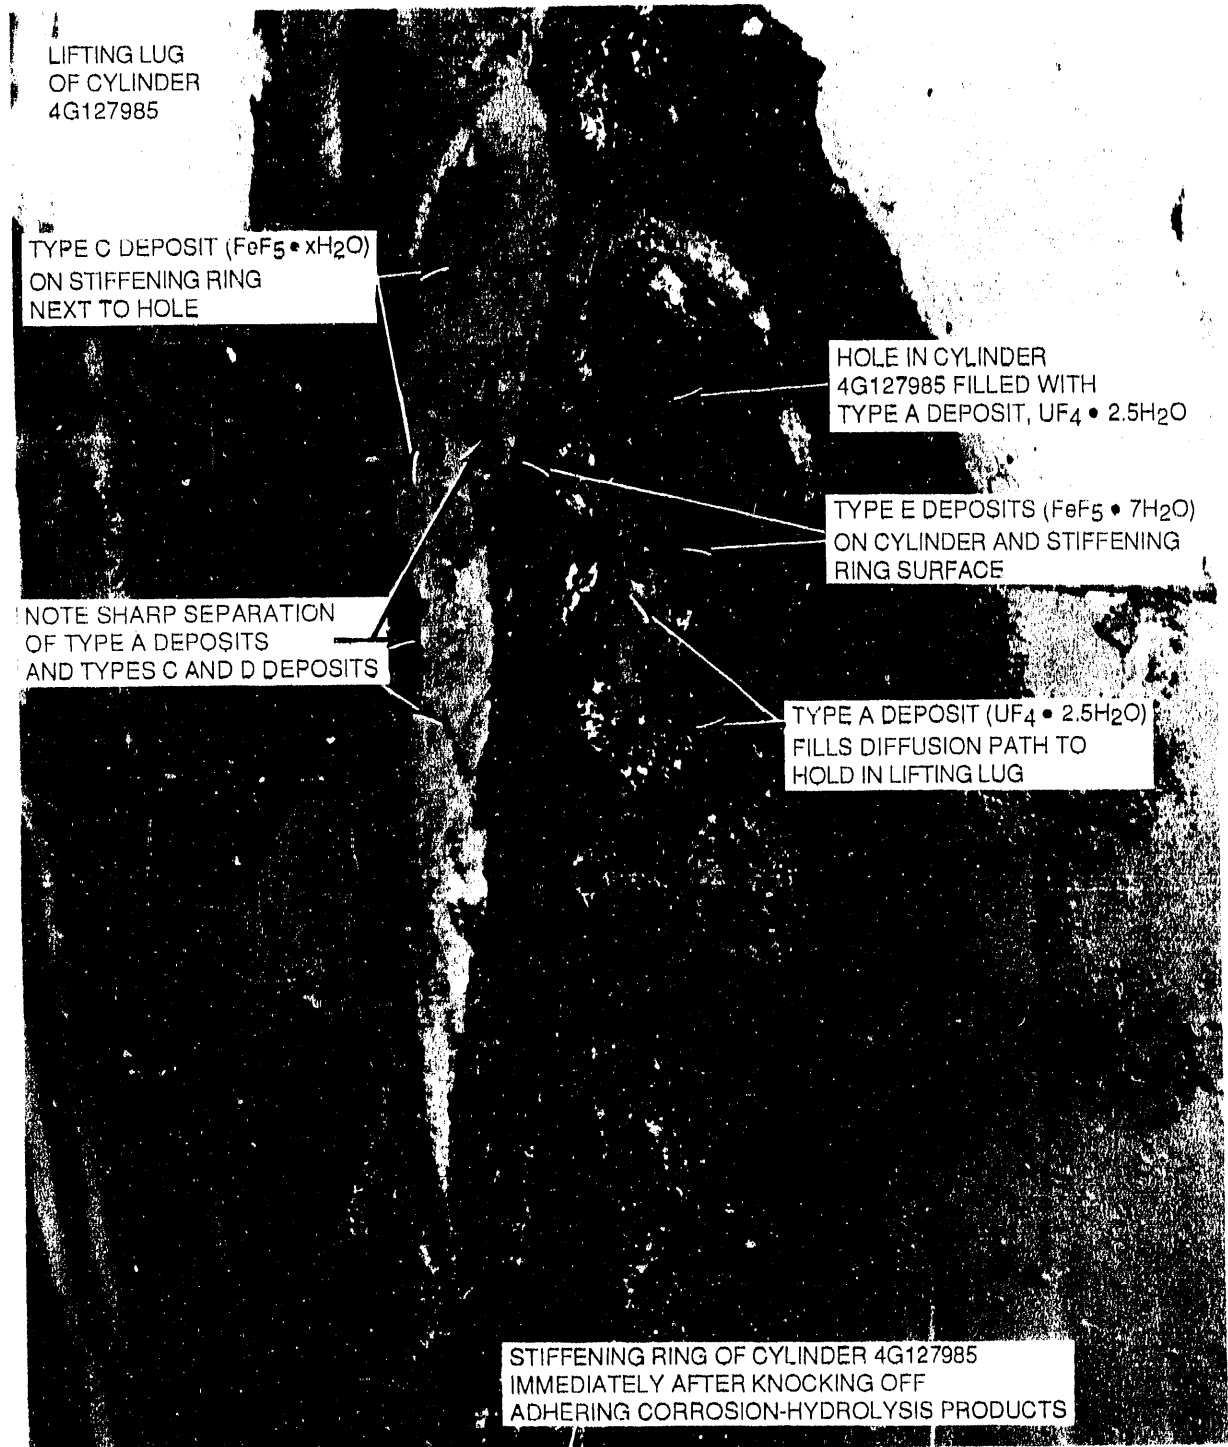
PHOTO NO. K/PH-91-3187

Fig. B1.5. Similar view as in Fig. B1.4 after the corrosion deposit was knocked off revealing the hole.

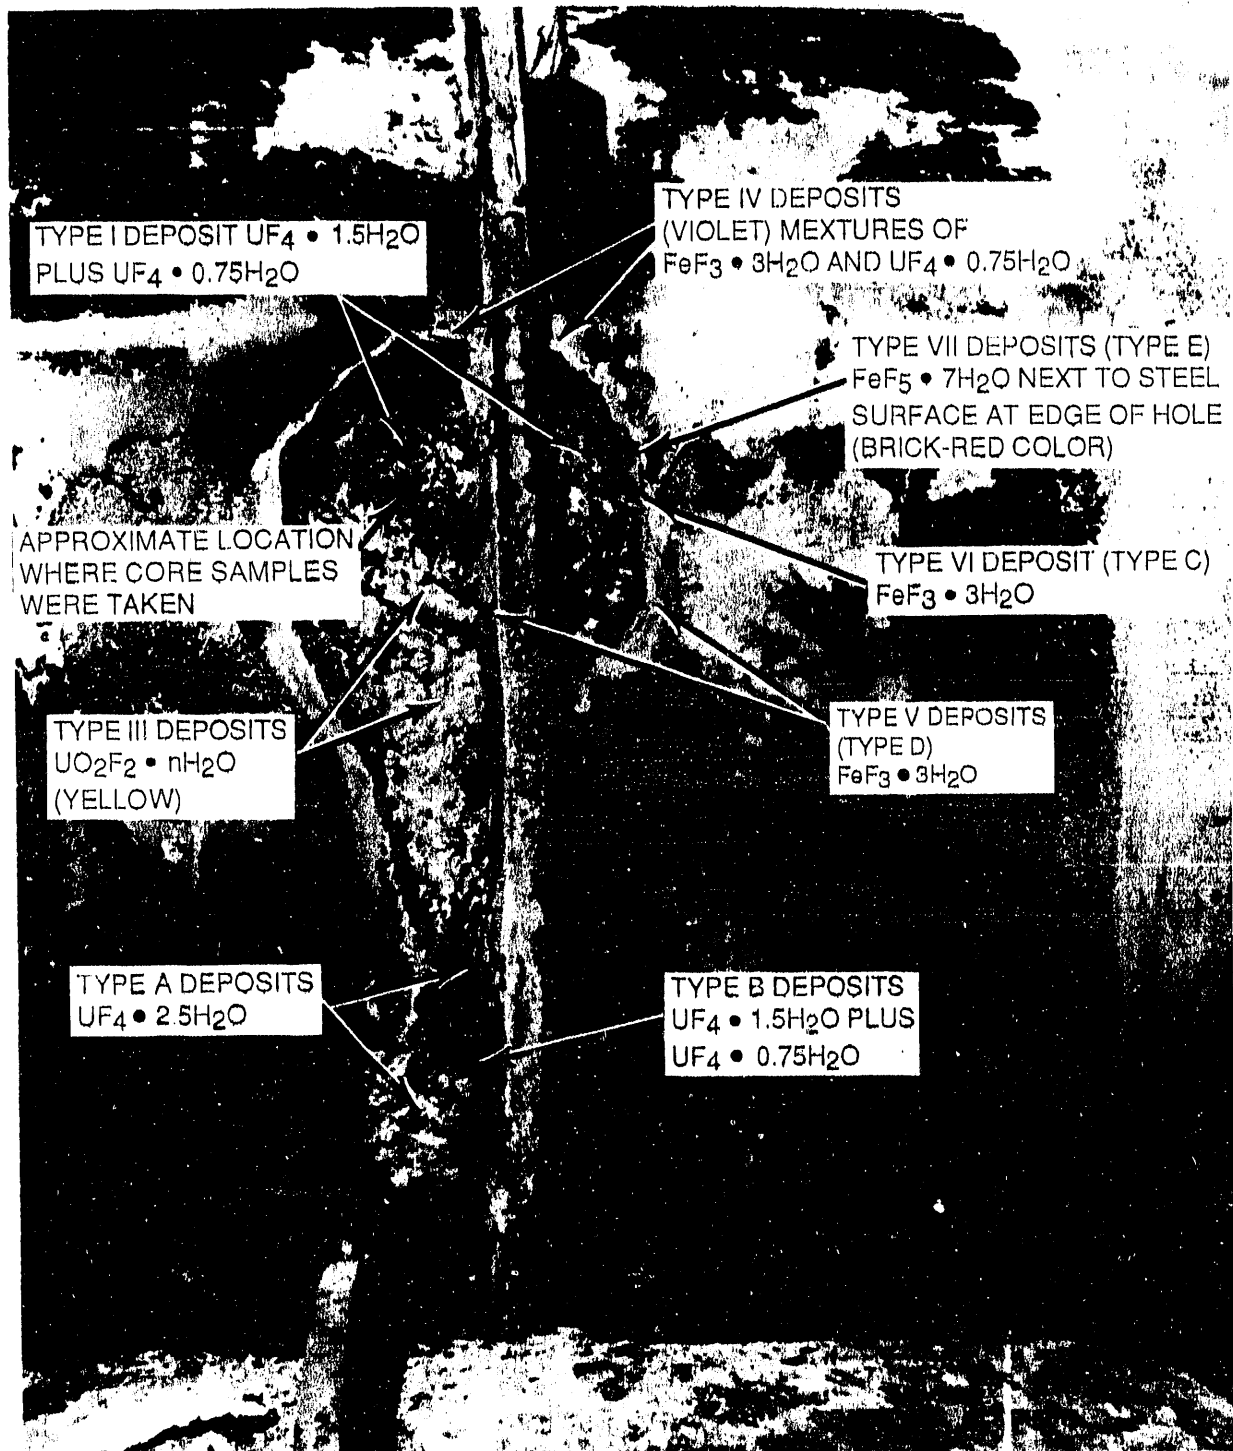
PHOTO NO. K/PH-91-3184

The locations from which the various materials associated with the deposits within the hole of cylinder 4G115688 were taken are shown in Fig. B1.6.

Fig. B1.6. Location of materials in and around the hole in cylinder 4G115688 like those examined by chemical analyses.
