# A Review of Criticality Accidents

2000 Revision

**LA-13638**

**Issued: May 2000**

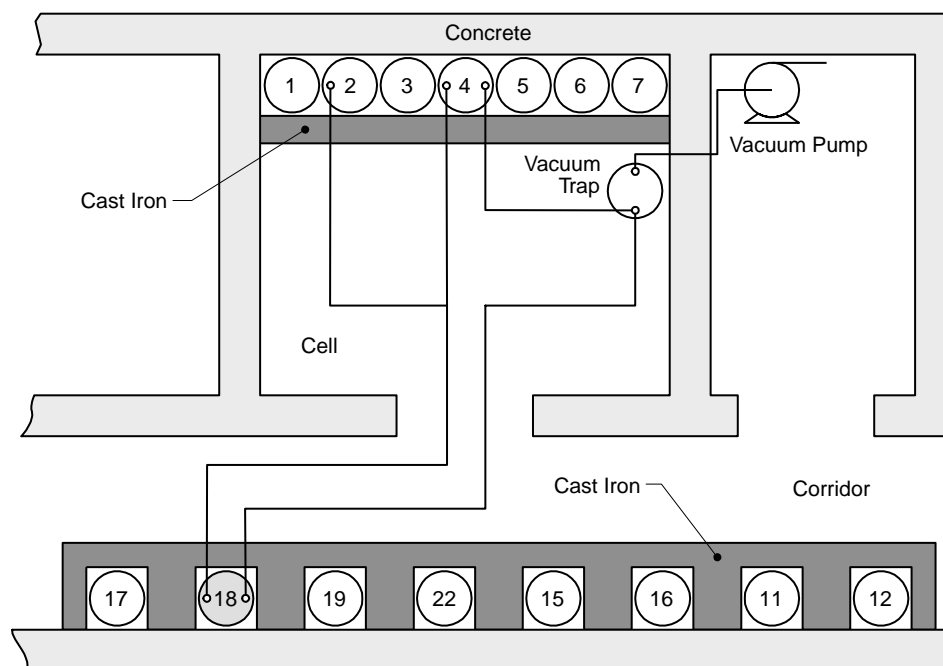
Figure 6. Layout of vessels and equipment in the staging area.

Following purification, the plutonium nitrate solution was routed through a staging area before being sent on for further processing. Operations performed within the staging area included mixing, dilution, volume measurement, sampling for plutonium concentration and purity, and interim storage. Plutonium solution that failed purity requirements was returned for further purification. The staging area consisted of a concrete cell and adjacent space located in the corridor outside of the cell. Figure 6 shows the layout of the concrete cell and corridor.

The staging area contained 15 identical short right circular cylindrical stainless steel vessels, each with a unique identification number. The vessels were 400 mm in diameter and 320 mm high with the cylindrical axis oriented vertically. The staging area was not equipped with radiation monitoring instruments. Criticality control was implemented by a 500 gram plutonium mass limit per vessel. Criticality

As part of the investigation, both experiments and calculations were performed to estimate the conditions for criticality in vessel 18. The results determined that 30 ℓ of solution containing 825 g of plutonium (27.5 g/ℓ) would be required for criticality. These values agree closely with the best estimate of the contents of vessel 18 at the time of the accident, 31 ℓ of solution with  $848 \pm 45$  g of plutonium (27.4 g/ℓ). One contributing cause of the accident was the unrecorded transfer of 5 ℓ of solution from vessel 1 to vessel 18.

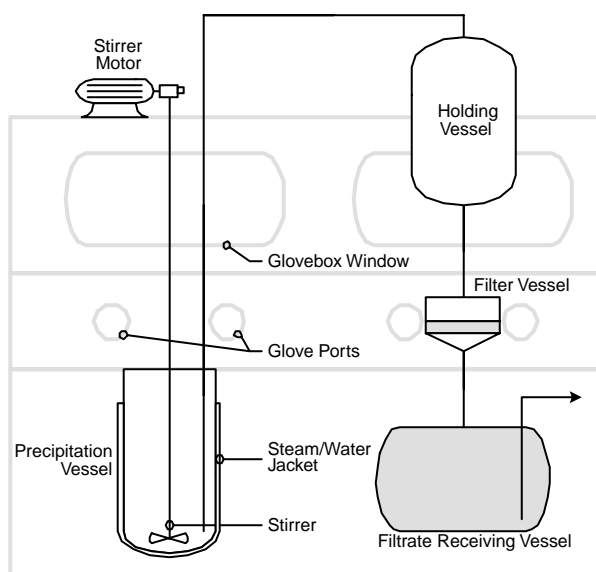
Figure 7. Equipment layout for the oxalate precipitation and filtration process.

- While not known for sure, it was suspected that minor defects in the filter fabric might also have contributed to an increased rate of precipitate accumulation in the filtrate vessel. Procedures called for the filter fabric to be replaced based on either visual evidence of defects or unusually high flow rates through the filter.

After dismantling the glovebox and cleaning the various pieces of equipment, a total of 3.06 kg of  $^{235}\text{U}$  was discovered in the filtrate receiving vessel. This material was primarily in two forms: a thin, hard crust, due to long-term buildup, and a flocculent precipitate, the concentration of which decreased with height in the vessel. The accident caused no mechanical damage to this vessel, and the room was not contaminated. The glovebox was taken apart, cleaned, and reassembled with essentially the original equipment. The operation was resumed after just a few days. During the downtime, a radiation meter was installed on the glovebox, operating instructions were revised, and enhanced operator training was implemented.

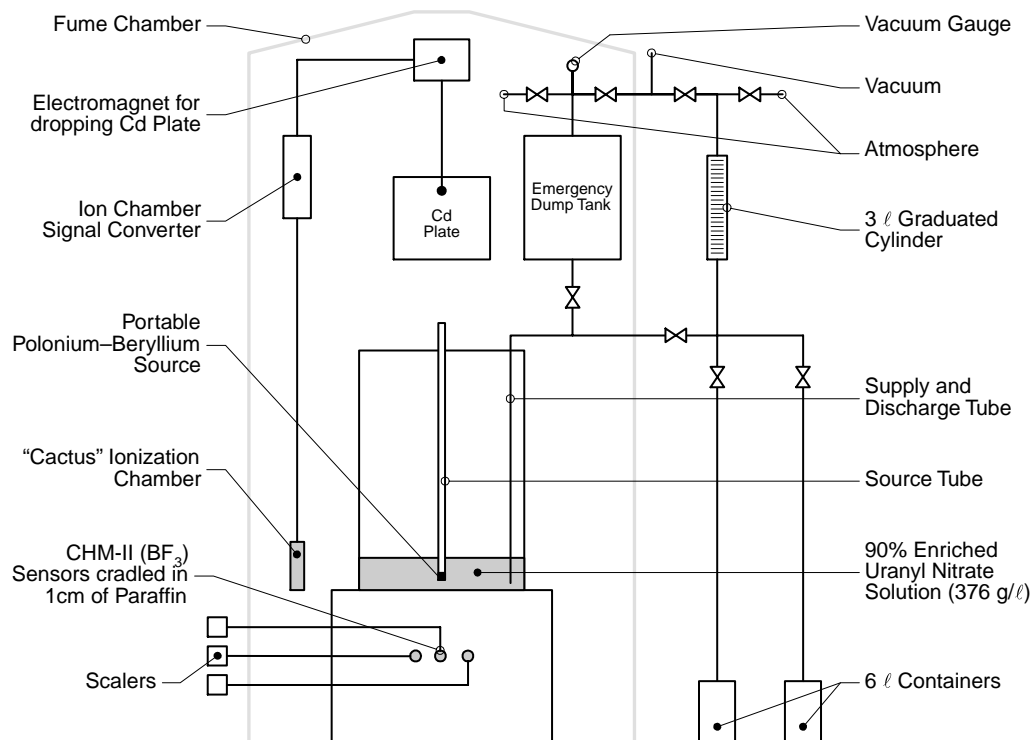
Figure 8. Layout of the experimental equipment.

They immediately noticed a flash (due to Cherenkov radiation), and simultaneously, fissile solution was violently ejected, reaching the ceiling about 5 m above. The three experimenters dropped the vessel and, along with a fourth experimenter who was located about 2.5 m away from the excursion, went immediately to the change room, showered, and were transported to the hospital. The combination of additional reflection from the three experimenters and the change in the geometry of the solution volume was sufficient to cause the system to exceed prompt critical. The small neutron background, estimated at only 100 neutrons per second, apparently also contributed to delayed initiation and thus to increased excursion energetics.

- Violation of the procedure that stipulated the complete draining of the experiment solution into 6 liter bottles.
- Unbolting and removing the experiment vessel when it contained solution. This was not specifically permitted in the operating procedure.

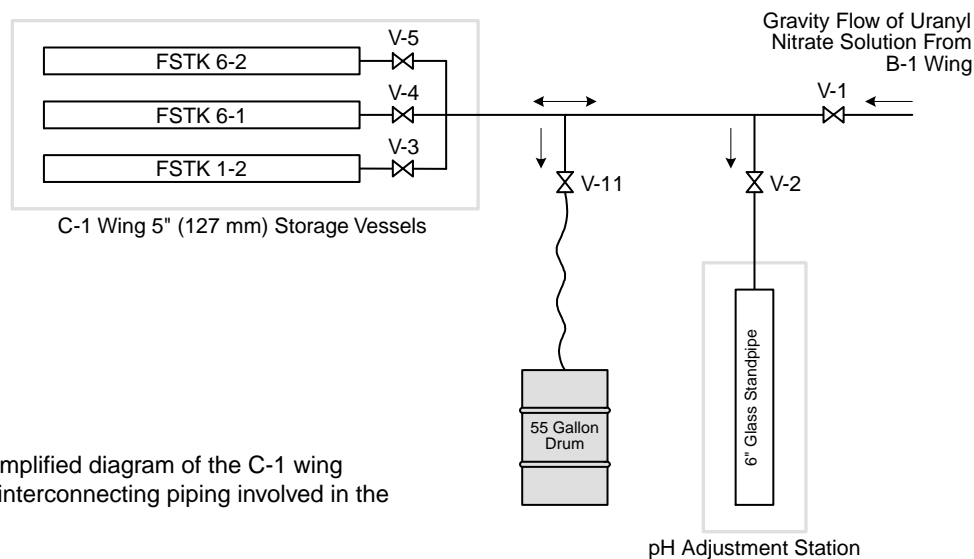
Figure 9. Simplified diagram of the C-1 wing vessels and interconnecting piping involved in the accident.

Figure 9 is a simplified diagram of the C-1 Wing vessels and equipment involved in the accident. The inventory required the disassembly and cleaning of the three, 5 inch (127 mm) diameter vessels\* (FSTK 1-2, FSTK 6-1, FSTK 6-2) used to store uranyl nitrate solution. Before resumption of operations, it was necessary to reassemble and to leak test the vessels. This entire process usually required several, 8-hour shifts to complete.

At ~01:00 during the shift preceding the accident (23:00 Sunday, 15 June, to 07:00 Monday, 16 June), the C-1 Wing supervisor noted that uranyl nitrate solution was present in a 6 inch (152 mm) diameter glass standpipe that was part of the pH adjustment station (Figure 9). He instructed an operator to drain the standpipe. At 05:00, the supervisor again noted uranyl nitrate in the standpipe and questioned the operator as to whether it had been drained earlier. The operator confirmed that it had been, and upon further

investigation, they determined that solution was leaking into the standpipe through valve V-2. The valve was closed, and the standpipe was again drained.

Unknown to anyone at the time, uranyl nitrate had been leaking from the B-1 Wing through valve V-1 from the early hours of the previous shift until about 13:30, when one of the operators checked it (and by applying pressure completely closed the valve), as instructed by the supervisor. Before this, the uranyl nitrate had been collecting in vessel FSTK 1-2, because valve V-3 had also been open.

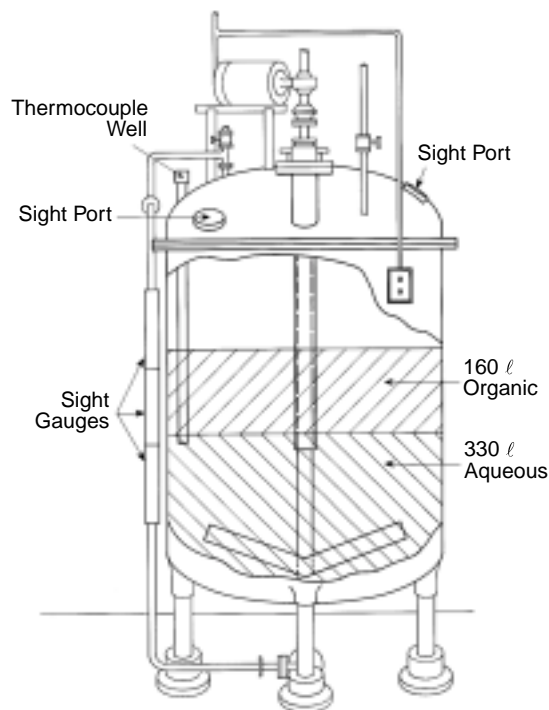
Figure 11. Configuration of solutions (aqueous and organic) in the vessel before the accident.

From these time intervals and the estimate that initially the system was 5 \$ subcritical, the reactivity insertion rate would have been about 5 \$/s. Using coefficients appropriate for the solution, this insertion rate leads to a spike yield of  $2.2 \times 10^{17}$  fissions with the spike completed in 1.65 seconds, that is, 0.45 seconds after prompt criticality was reached. To obtain the observed yield ( $1.5 \times 10^{17}$  fissions) in a single spike, the reactivity insertion rate would have to be reduced to about 2 \$/s. Because this is inconsistent with the time involved (about 3 seconds before complete mixing), the only alternative is to assume that the rate was somewhat less than 5 \$/s and that the excursion was terminated in about 3 seconds by the stirring action. One can surmise that the initial action was thickening of the upper layer at the same time reflection was added by the aqueous liquid. This was followed almost immediately by distortion into a less critical, vortex-like shape by the action of the stirring blades and then permanent shutdown due to a uniform concentration of less than 7 g/ℓ.

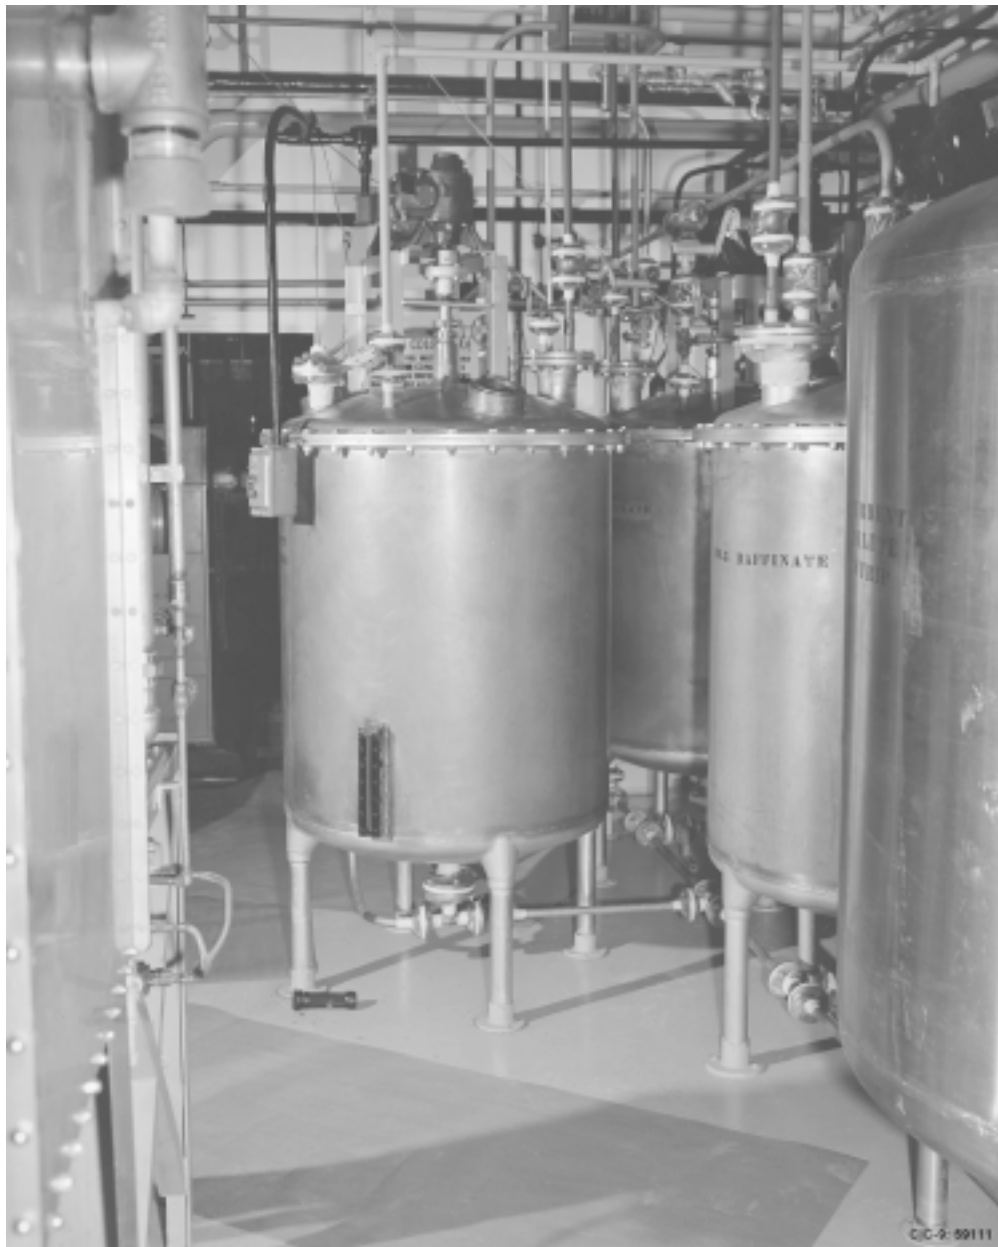
Figure 12. Vessel in which the 1958 Los Alamos process criticality accident occurred.

The accident resulted in the death, 36 hours later, of the operator who was looking into a sight glass when the motor was turned on. The dose to his upper torso was estimated to have been  $12,000 \pm 50\%$  rem. Two other persons apparently suffered no ill effects after receiving radiation doses of 134 and 53 rem. No equipment was contaminated or damaged even though the shock associated with off-axis bubble generation displaced the tank about 10 mm at its supports.

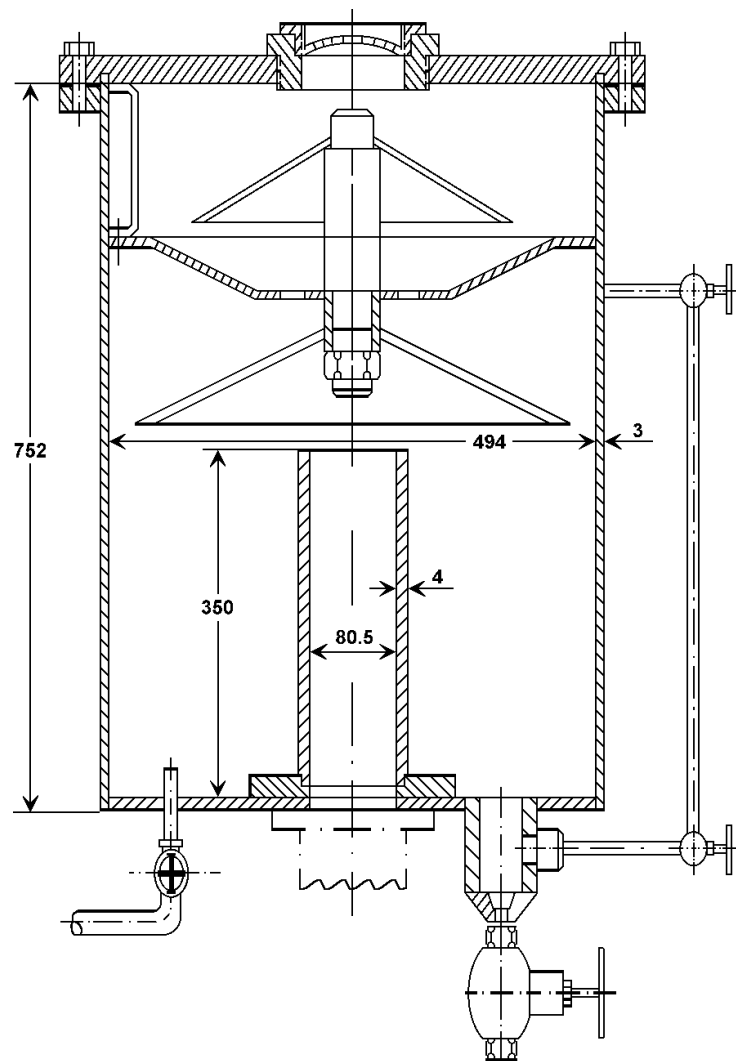
Figure 16. Oil reservoir (Dimensions are in mm).

When the pump was turned on at 07:30, the oil in the pump's cavities was forced out into the central pipe of the oil reservoir. This sudden injection of oil containing uranium led to the second and much larger excursion. The shutdown of this excursion was due to a combination of temperature rise and radiolytic gas generation, which caused ejection of the oil from this central pipe back into the pump's cavities and the gas purification equipment. As with the first excursion, the

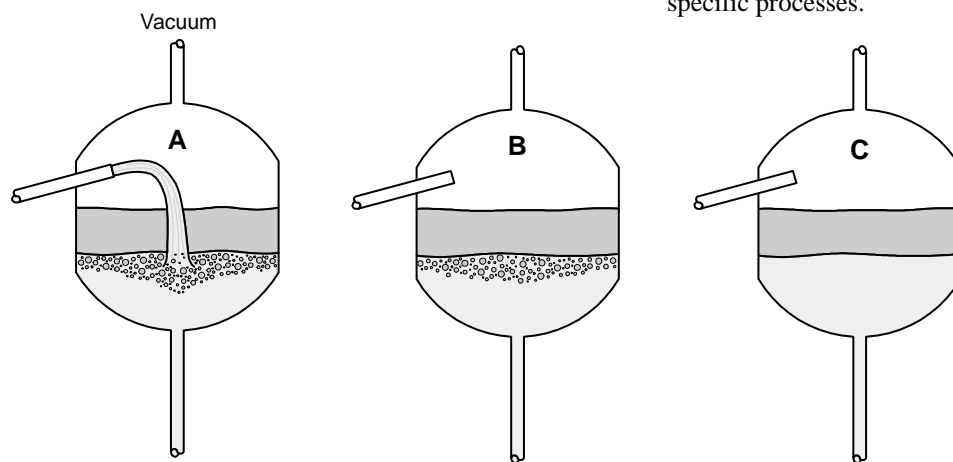
Figure 26. Solution transfer as reconstructed from the transparent plastic mockup of the transfer vessel. Configuration (B) is the postulated state at the time of the accident.

This excursion illustrates the subtle ways in which accidents can occur during solution processing. Although the deep trap was considered a safety feature for the control of contamination, it contributed directly to the criticality accident. The difficulty of understanding what had happened, even after it was known in which vessel the excursion occurred, is an excellent example of the impracticability inherent in attempting to calculate criticality accident probabilities for specific processes.

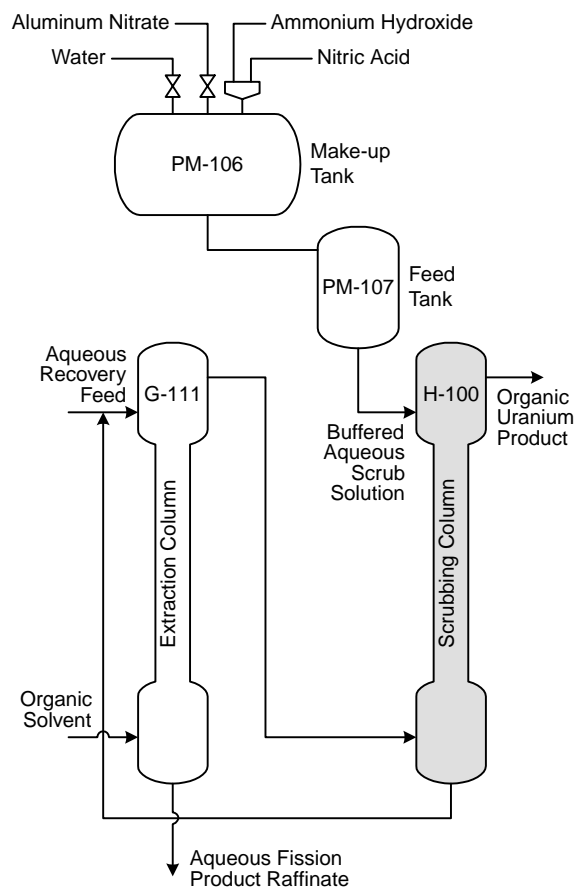
Figure 27. First cycle extraction line equipment. The accident occurred in the lower disengagement section of the H-100 column.

for the scrubbing column, H-100, had been leaking for about a month prior to the accident. Over time, this leak caused a dilution of the feed solution from 0.75 M to 0.08 M. The 13,400 ℓ make-up tank was equipped with a density alarm that would have indicated the discrepancy, but the alarm was inoperable. A density alarm was scheduled to be installed on the 3,000 ℓ process feed tank (PM-107) that was filled, as necessary, from the make-up tank, but this had not been done. The make-up tank was instrumented with a strip-chart recorder showing the solution level in the tank. However, the leak into the tank was so slow that the change in level would have not have been discernible unless several days worth of the chart was analyzed. To complicate matters, the chart recorder had run out of paper on 29 September and it was not replaced until after the accident. Furthermore, procedures that required the taking of samples from the feed tank, PM-107, to confirm the density, were not being followed.
