| Entergy | CONDITION REPORT | CR-IP3-2011-02393 |

Condition Description:

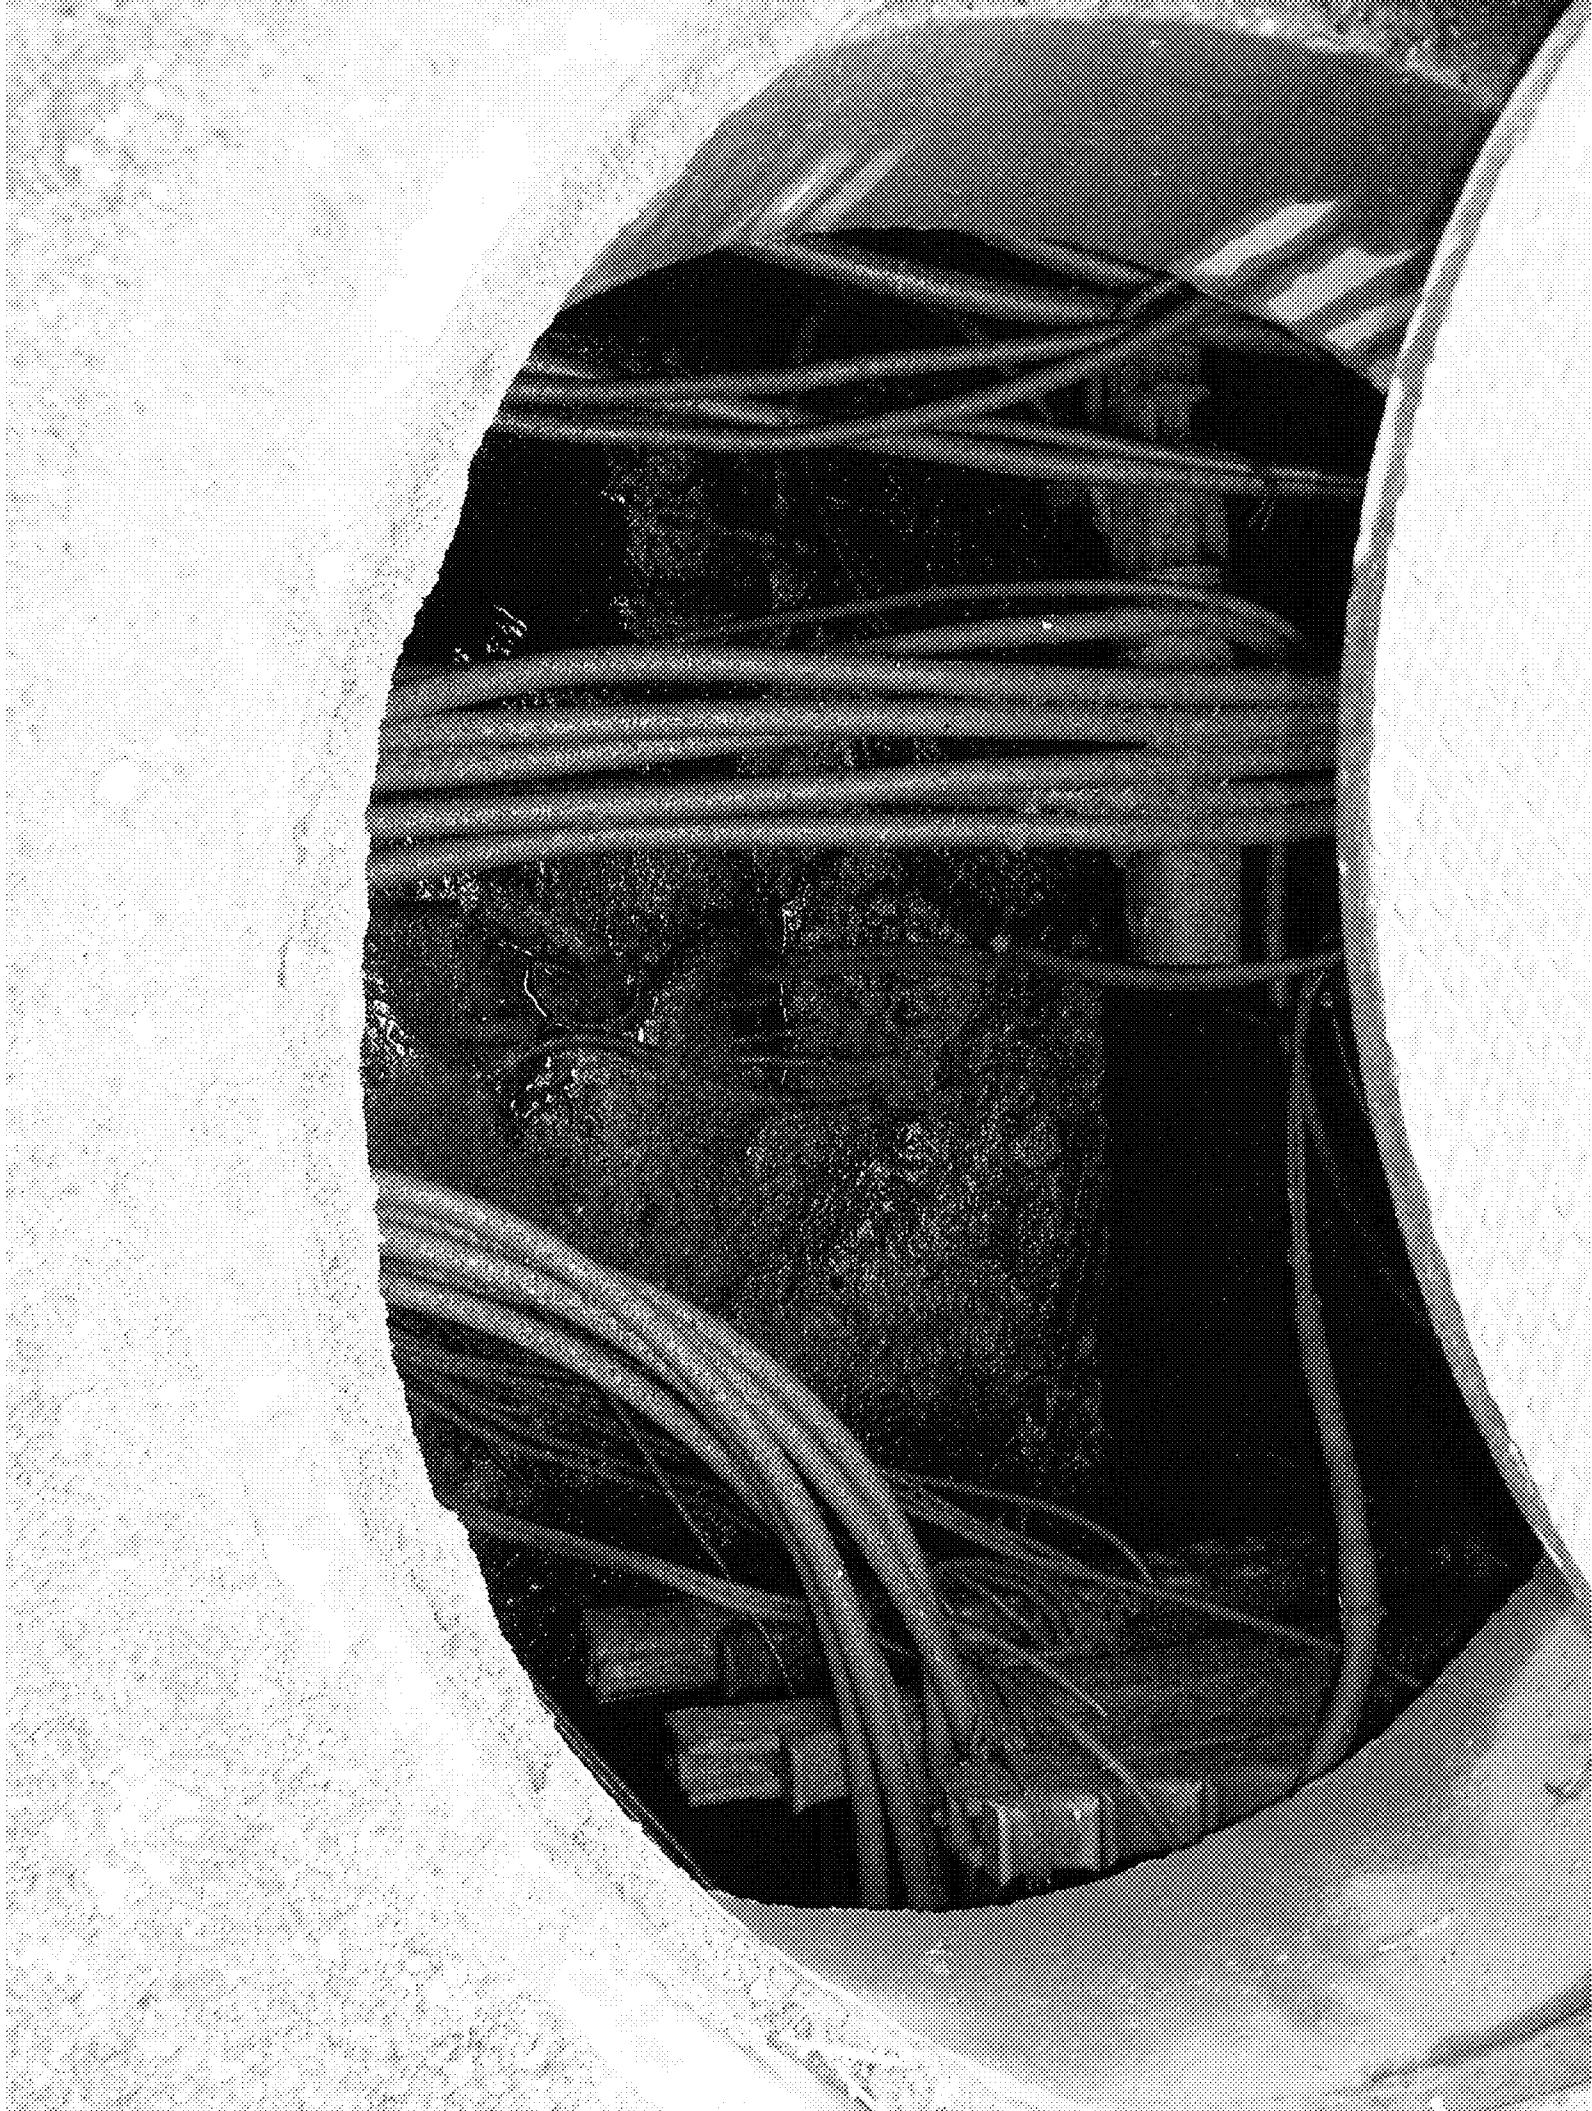
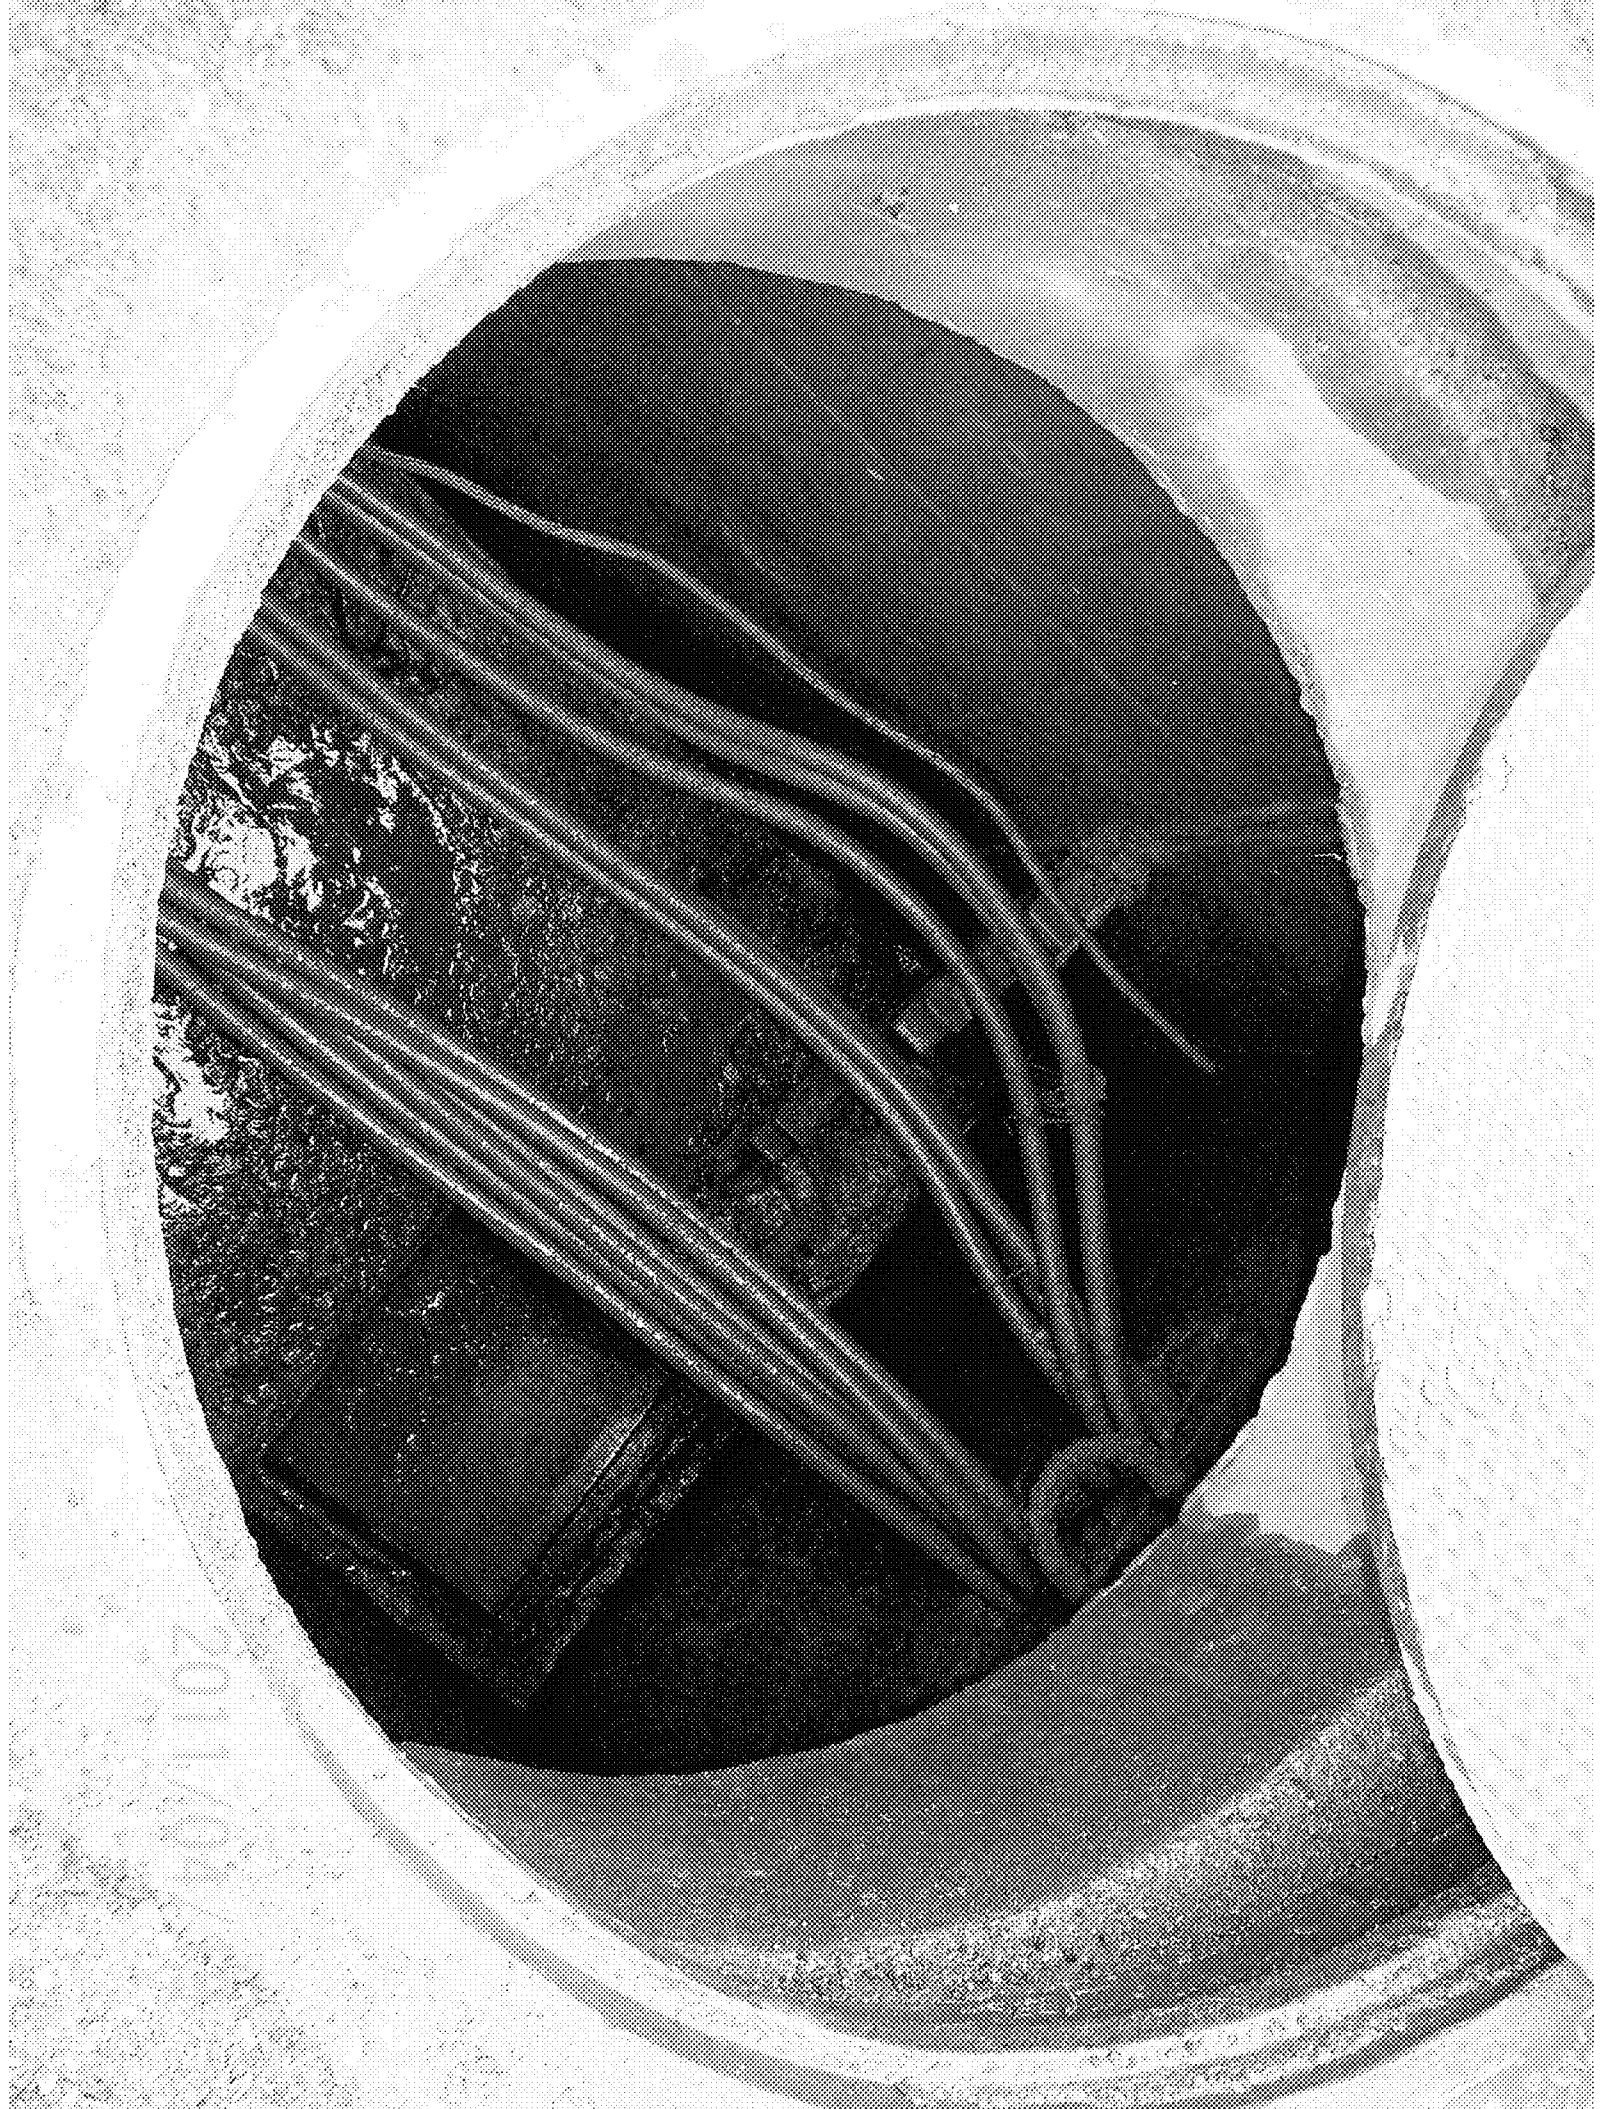
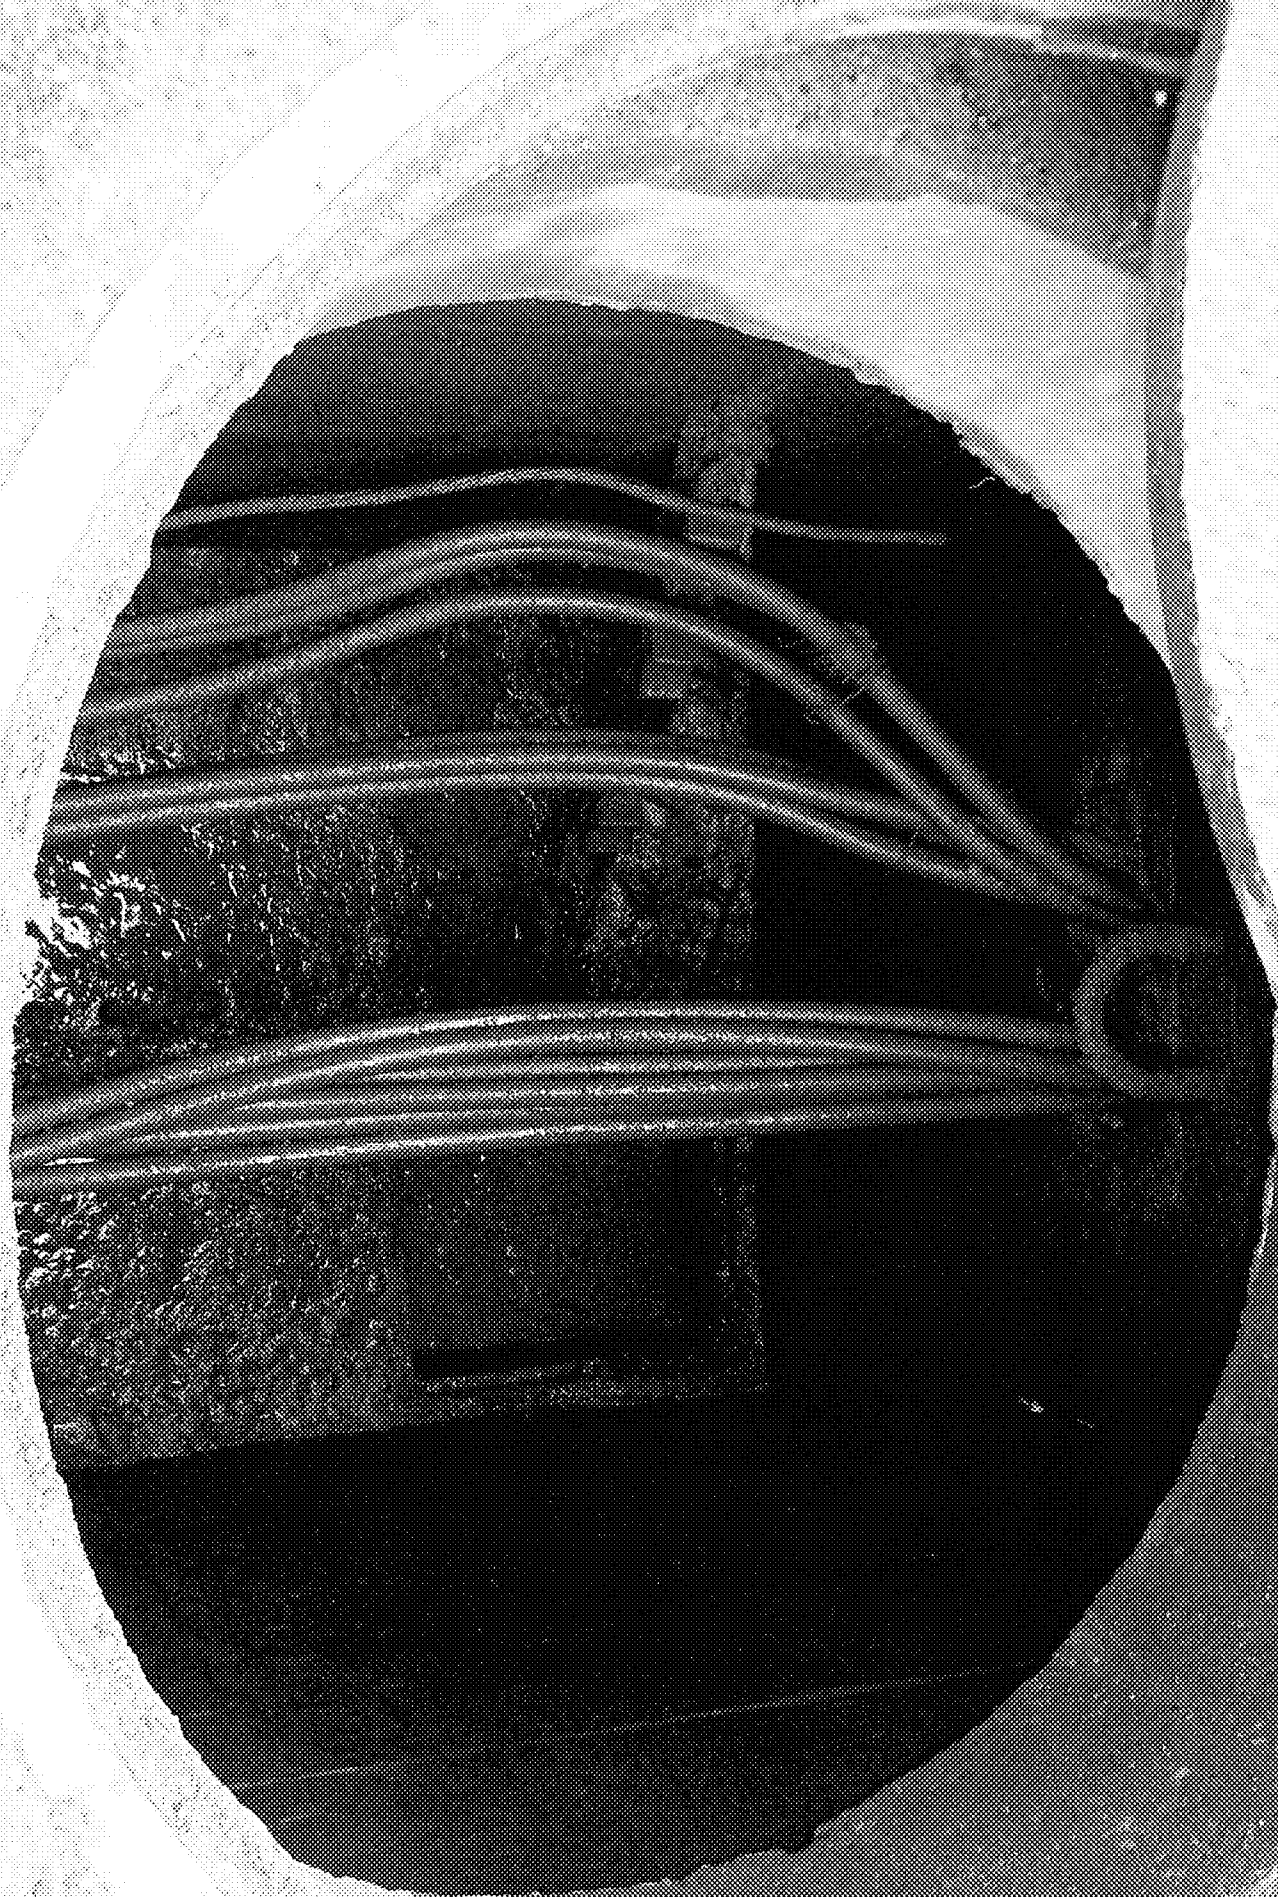
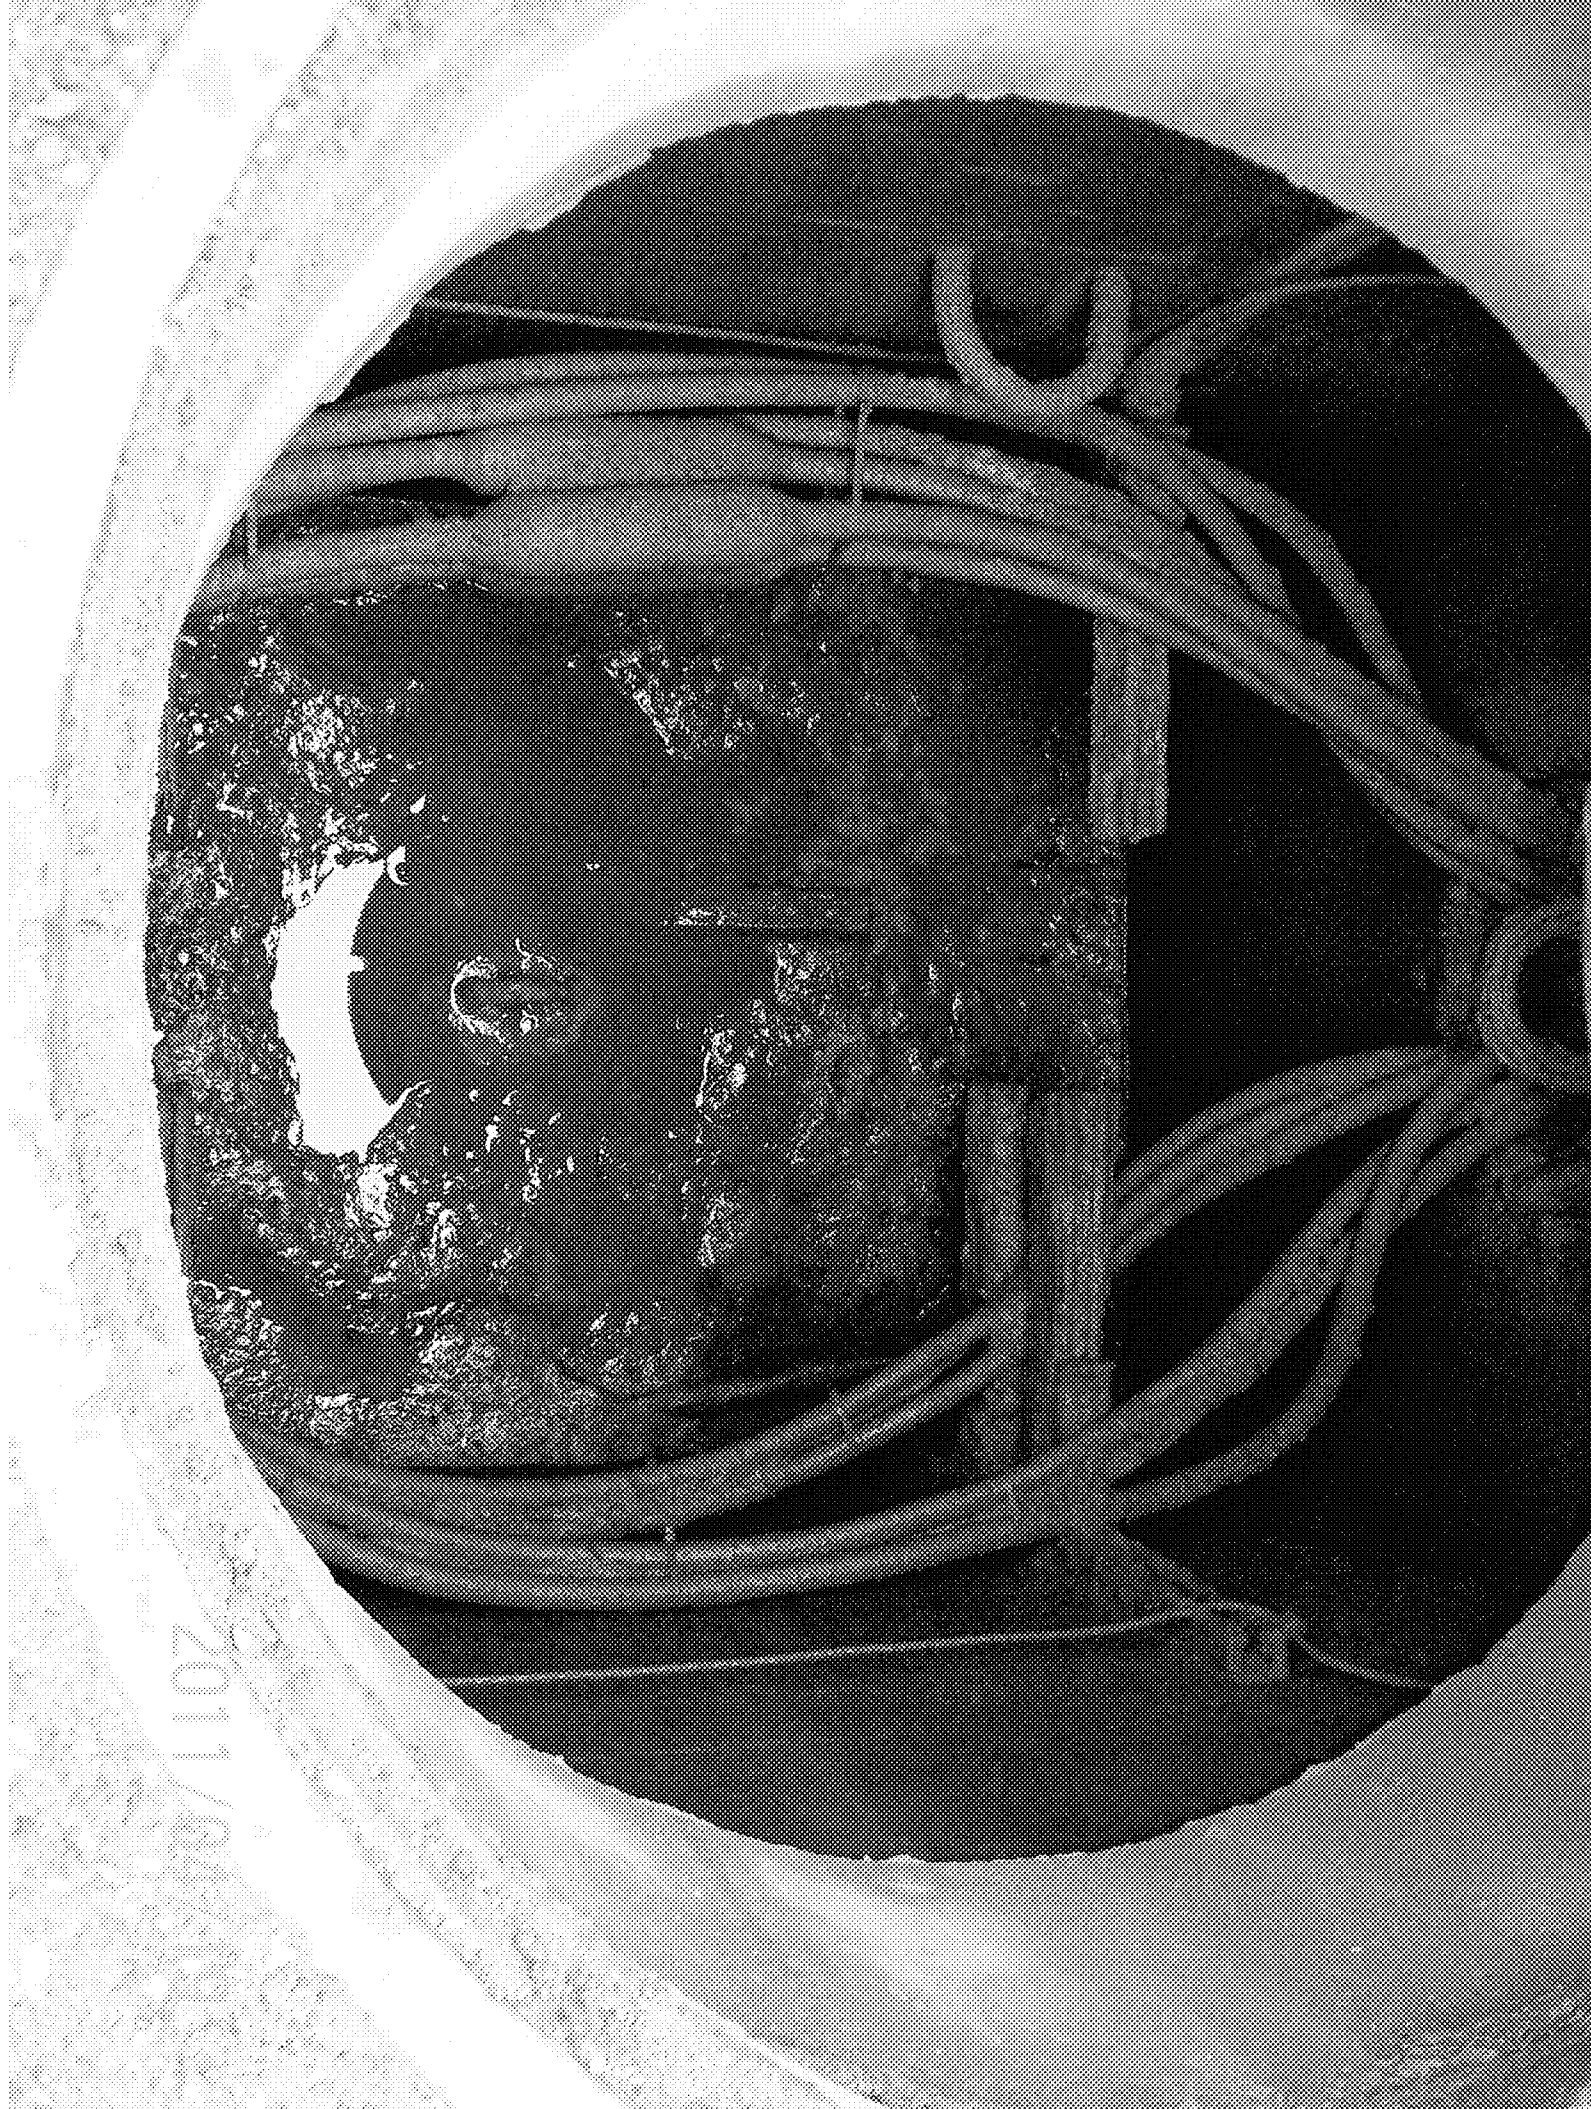
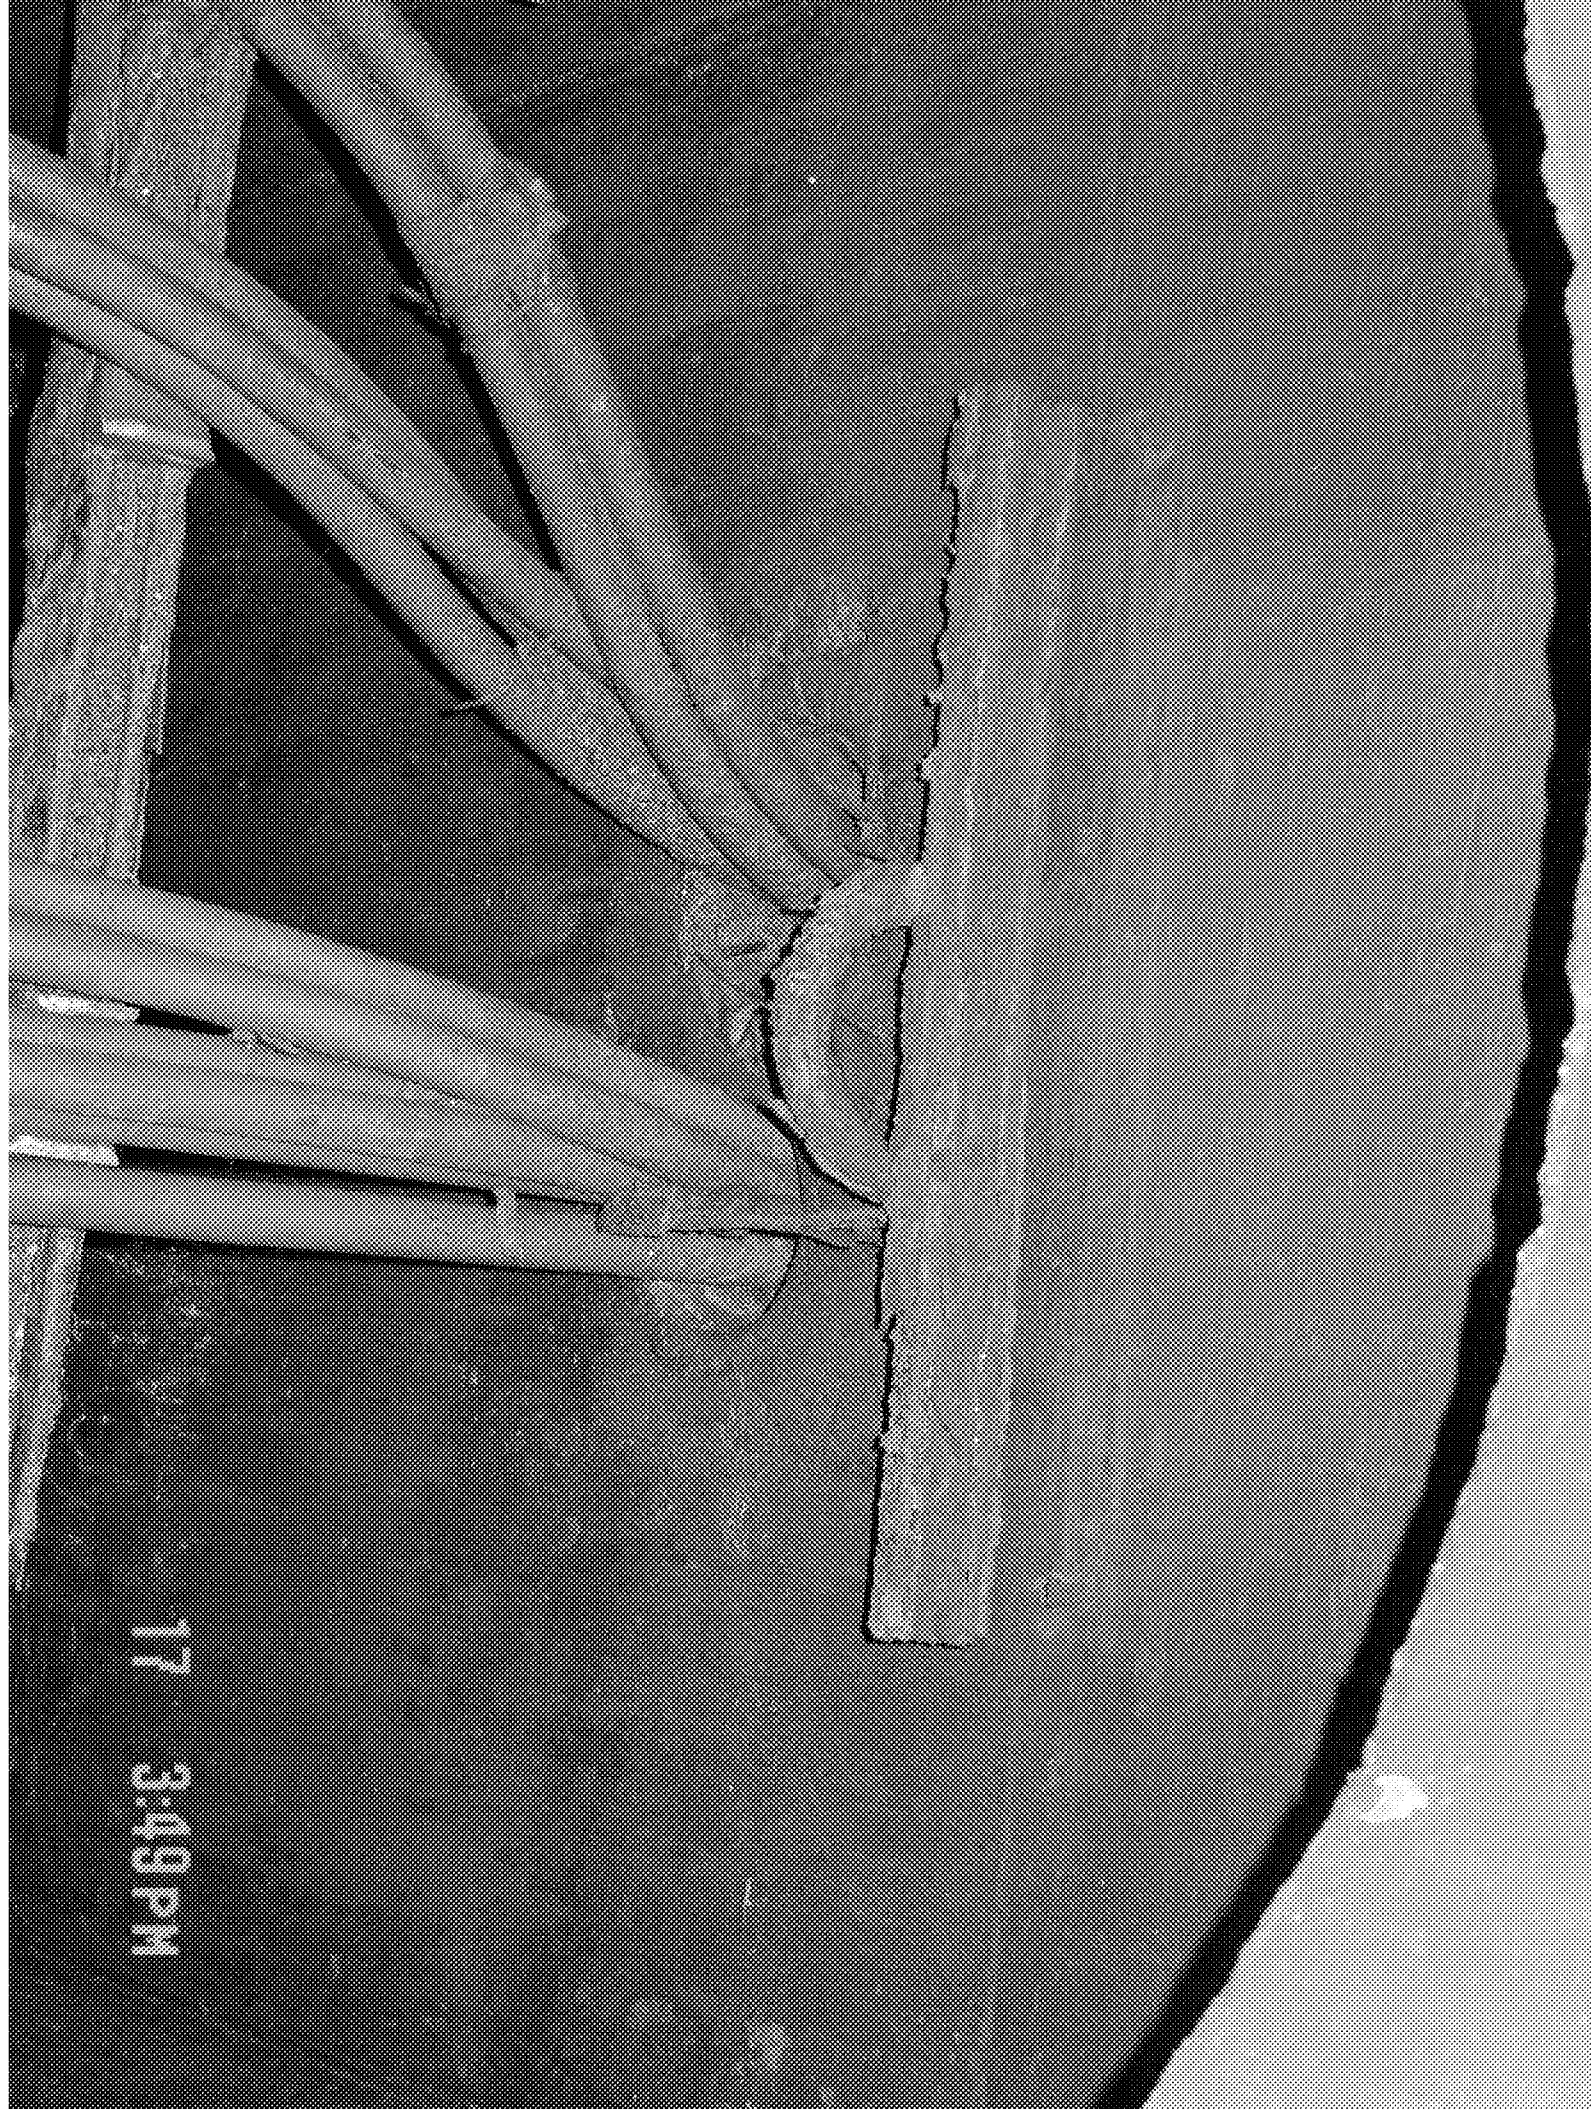
During the 3 month PM inspection of 31, 31A, and 31B manholes under work orders 52316417, 52316418, and 52316412 respectively, the following was noted: All three manholes were filled to the top with water. 31 Manhole does not have any broken supports, but there appears to be cable lying in the bottom of the hole. It also looks like some of the cable has been cut off. 31A Manhole has a support that appears to have broken and is not supporting the cables in the center of the pit. 31B Manhole appears to have all the supports intact, but they are heavily corroded. There appears to be a piece of channel lying in the bottom of the pit. Photos were taken and placed on the R Drive in the Manhole 31A Photos folder. There are previous photos in that folder depicting the same discrepancies as noted in this CR.

| <i>Entergy</i> | | CORRECTIVE ACTION | CR-IP3-2011-02393 |
|--|--|---|---|
| <p>There has been previous documentations of the noted conditions in the manholes as found in past PMs. The responses to the past CRs include some repairs to the existing supports and pumping out of water. However, dewatering PM frequencies were never adjusted and the degraded supports have not been replaced. In the current conditions, there is no challenge to cable integrity since the cable is in supported condition. The following corrective actions have been performed / are recommended to achieve acceptable conditions:</p> | | | |

| <i>Entergy</i> | | CORRECTIVE ACTION | CR-IP3-2011-02393 |
|--|--|---|---|
| 1. Dewatering PM frequencies have been adjusted to accommodate water levels according to history: | | | |
| <p>Manhole 31 PM frequency adjusted to 1 month Manhole 31A PM frequency adjusted to 2 month Manhole 31B PM frequency adjusted to 2 month</p> | | | |
| 2. The following work orders have been generated to correct / repair degraded conditions found in the manholes: | | | |
| <p>Manhole 31 - 274954 Manhole 31A - 274955 Manhole 31B - 274958</p> | | | |
