Exelon Generation Company, LLC
Byron Station
4450 North German Church Road
Byron, IL 61010-9794

Subject: Licensee Event Report 2012-001-00, "Unit 2 Loss of Normal Offsite Power and Reactor Trip and Unit 1 Loss of Normal Offsite Power Due to Failure of System Auxiliary Transformer Inverted Insulators"

1. FACILITY NAME Byron Station, Unit 1				2. DOCKET NUMBER 05000454		3. PAGE 1 OF 12			
4. TITLE Unit 2 Loss of Normal Offsite Power and Reactor Trip and Unit 1 Loss of Normal Offsite Power Due to Failure of System Auxiliary Transformer Inverted Insulators

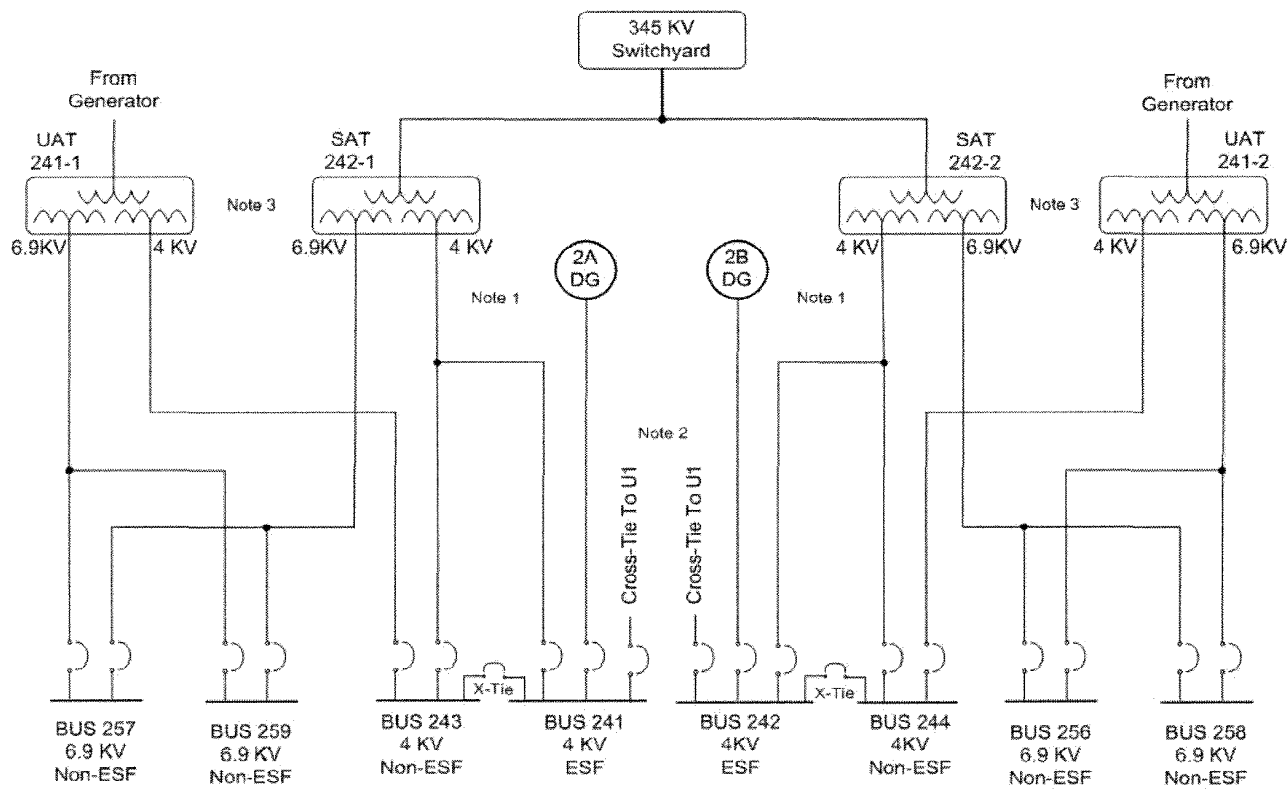
Figure 1

Unit 1 and Unit 2 AC Electrical Power Design Summary (see figure 1)
