SUBJECT: NRC INSPECTION REPORT 040-00299/12-001

Report: 040-00299/12-001

Facility: Gas Hills facility

Umetco Minerals Corporation Gas Hills Facility NRC Inspection Report 040-00299/12-001

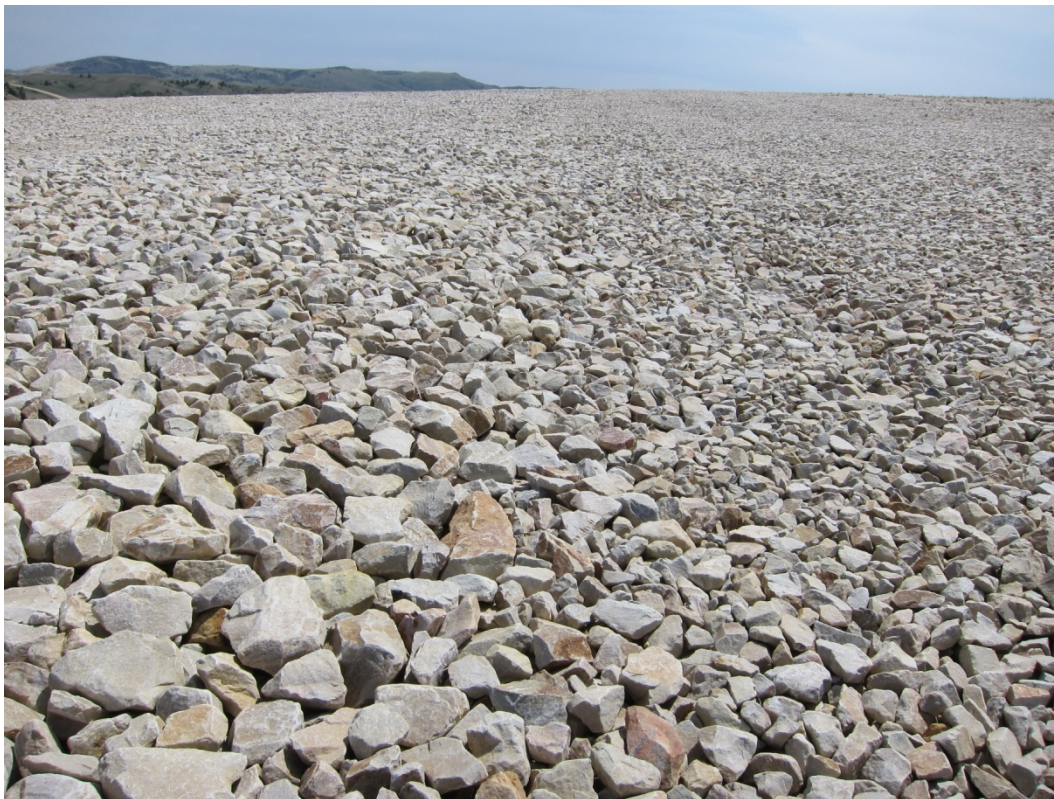
AGTI erosion protection cover – Type C rock on left side, Type B rock on right side

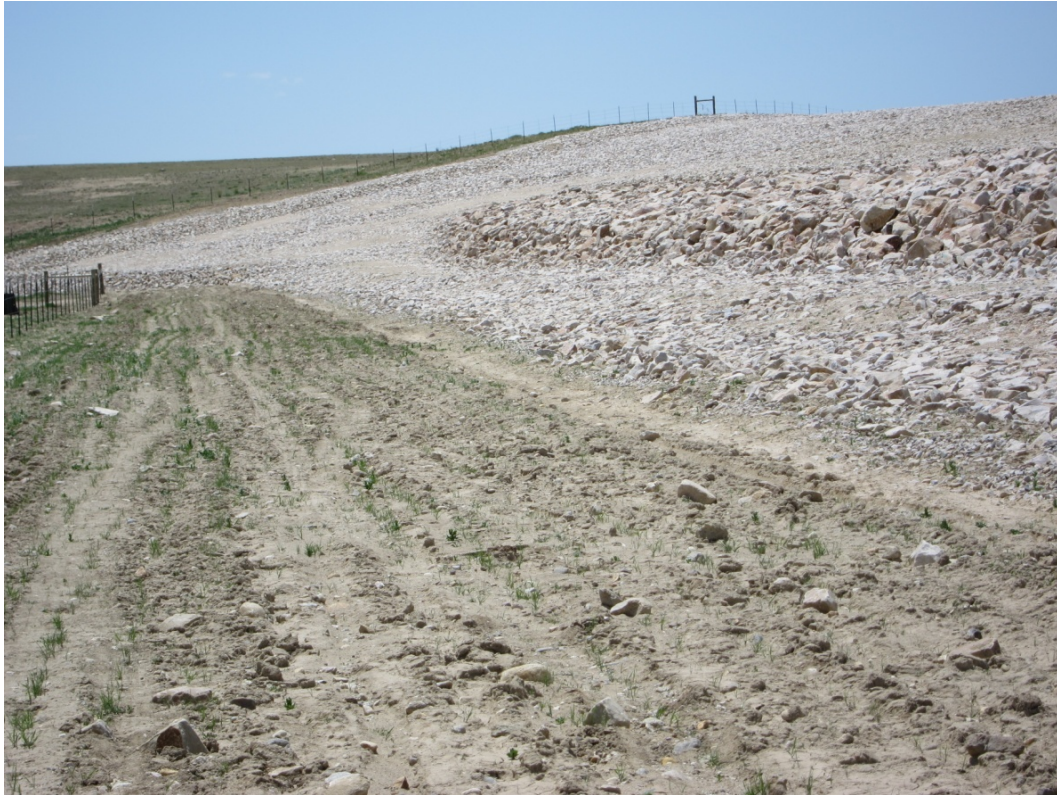
Apron channel located southeast of the AGTI area

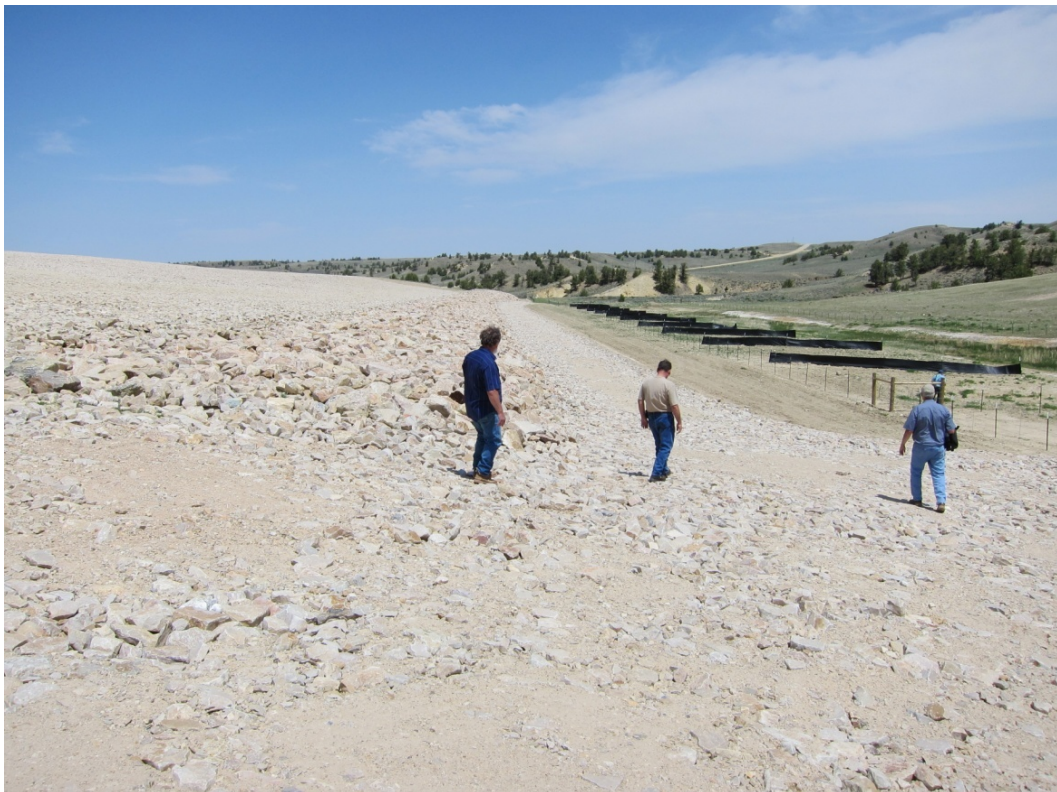
Launch rock structure located due east of the AGTI area

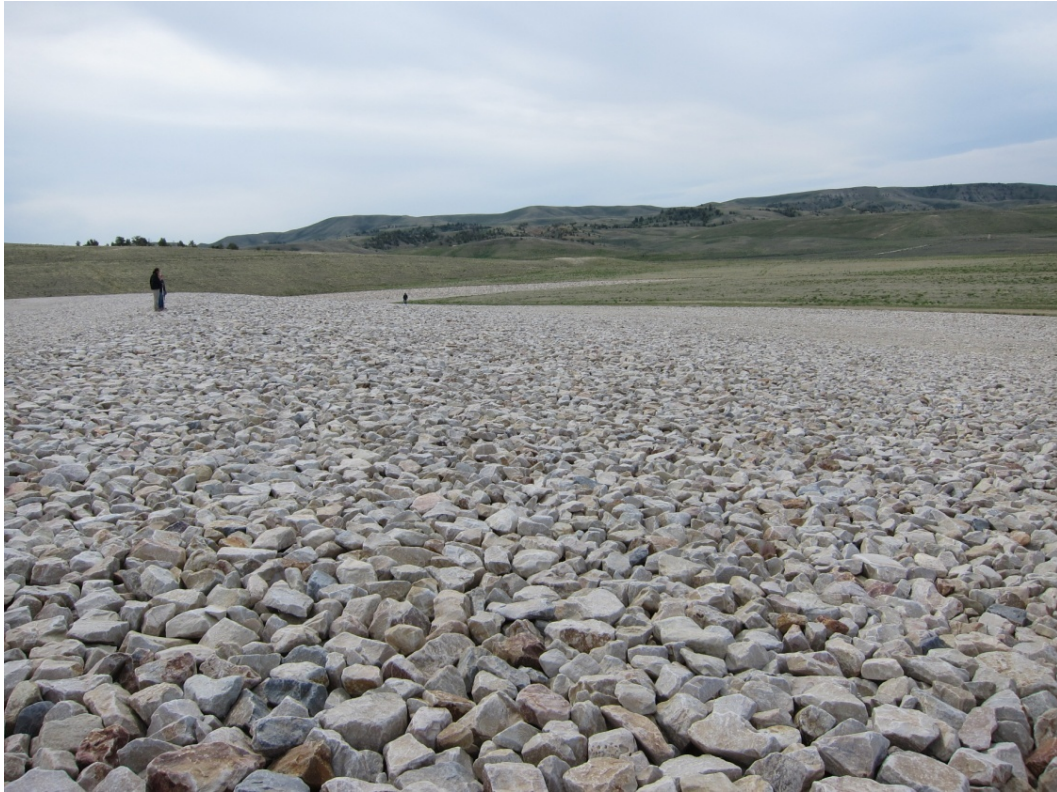
Area A-9 erosion cover, after repairs have been completed

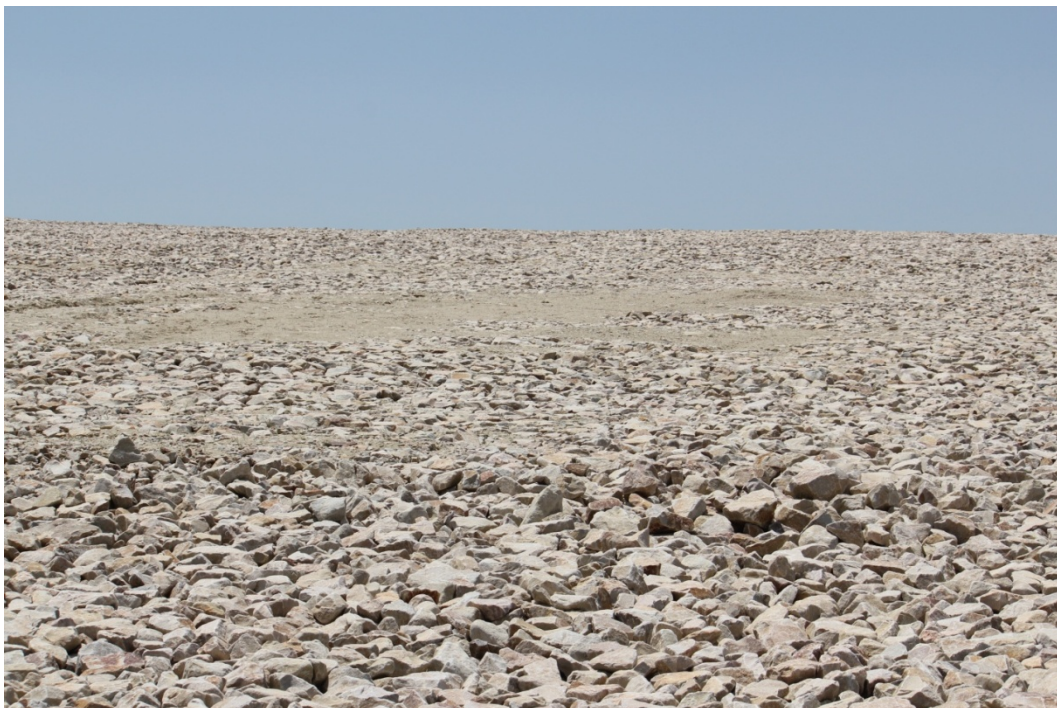
- In certain areas on the AGTI where the first method was used, the licensee replaced the erosion protection rock layer using alternating lateral bands of Type C and Type B rock. Due to the different sizes of the rock types and different settling characteristics of the two types due to compaction, the Type C rock bands were about one-half to one foot higher than the Type B rock bands. This construction technique was not expected to adversely affect the erosion protection layer of the tailings pile as the bedding layer was present beneath the bands, and because the direction of the run-off flow is perpendicular to the bands.

Layered bands of rock (rippled rock) layers due to compaction of different sized rocks

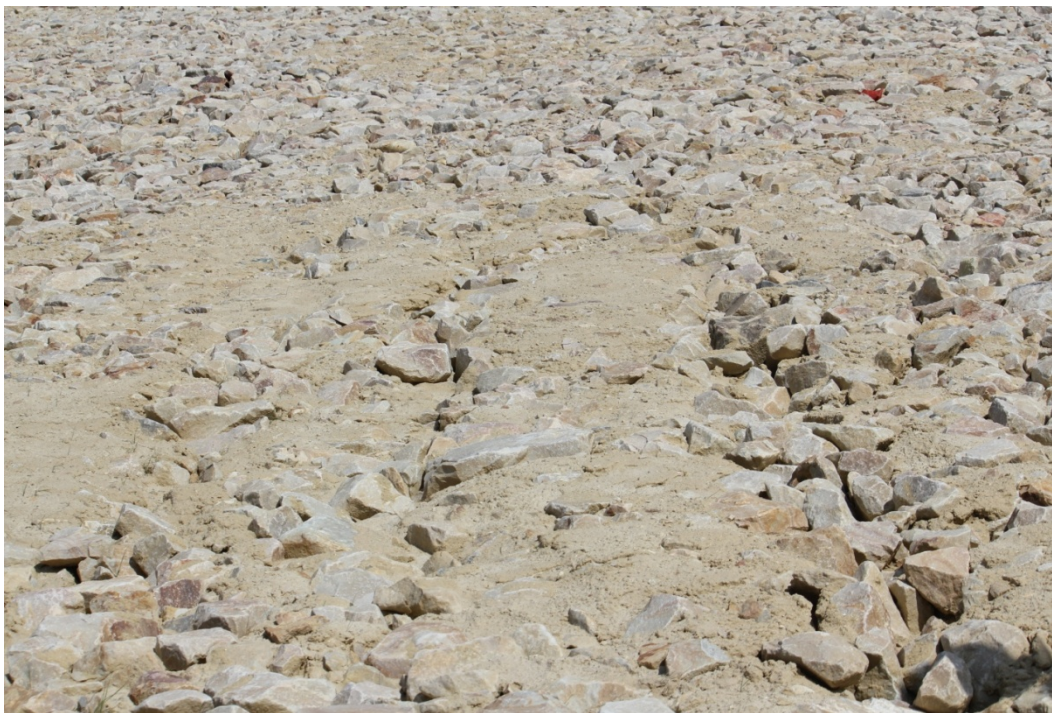
- In areas where the first method was used, soil was observed to have been deposited in numerous discreet areas on the surface of the erosion protection layer. Licensee representatives explained that, when the rock was removed to allow emplacement of the bedding layer, some soil was also removed along with the rock. The licensee's representatives referred to these areas as "dirty rock." When the rock was replaced, this soil was placed on the surface of the tailings pile. This construction technique was not expected to impact the erosion protection layer as the soil is expected to wash down through the erosion protection layer during future rain events. In addition, the licensee conducted independent quality assurance/quality control checks at various locations to verify that the rock layers met the construction specifications. The licensee conducted approximately 4-5 quality assurance/quality control checks per acre.

Soil on surface of erosion rock ("dirty rock")

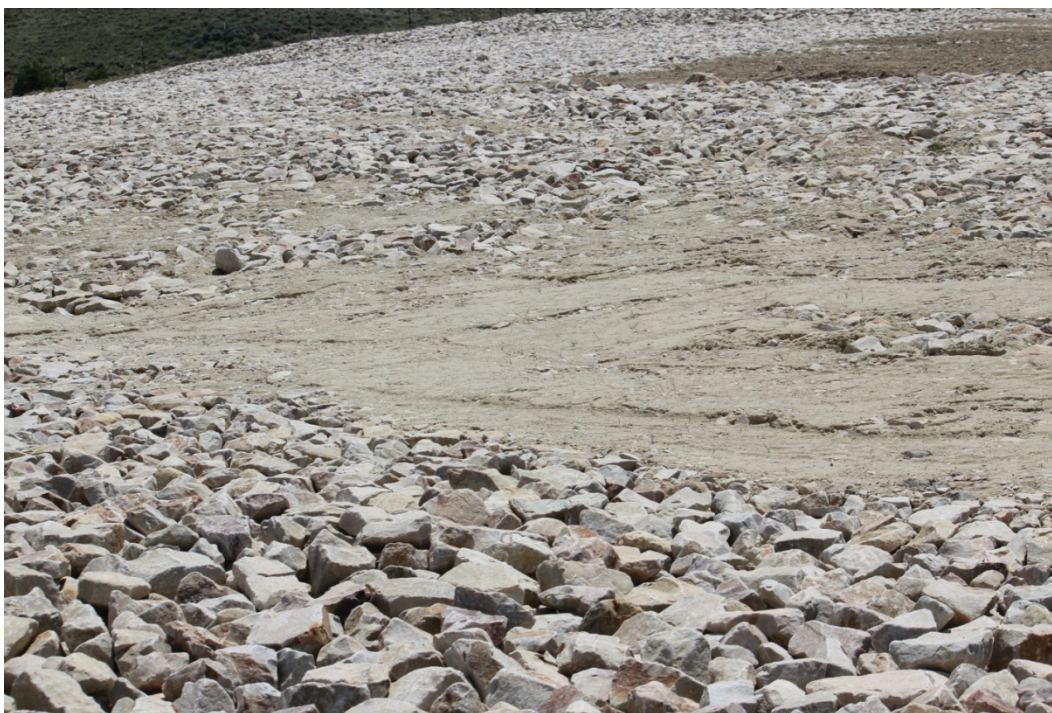
- The NRC staff observed several equipment tracks/ruts on the northeastern portion of the AGTI. Licensee representatives explained that this area had been extensively reworked to emplace the bedding layer and that the tracks remaining were from the last construction vehicles to leave the site. This finding was not expected to affect the erosion protection layer or the bedding layer because the erosion protection and bedding layers' thicknesses were confirmed to be adequate during independent quality assurance/quality control checks.

Wheel ruts from heavy equipment on the AGTI erosion rock cover
