Region III Fire Protection Utilities Group Meeting

Dariusz Szwarc
Reactor Inspector, Region III
June 26, 2012

Monticello Sprinkler Piping Blockage

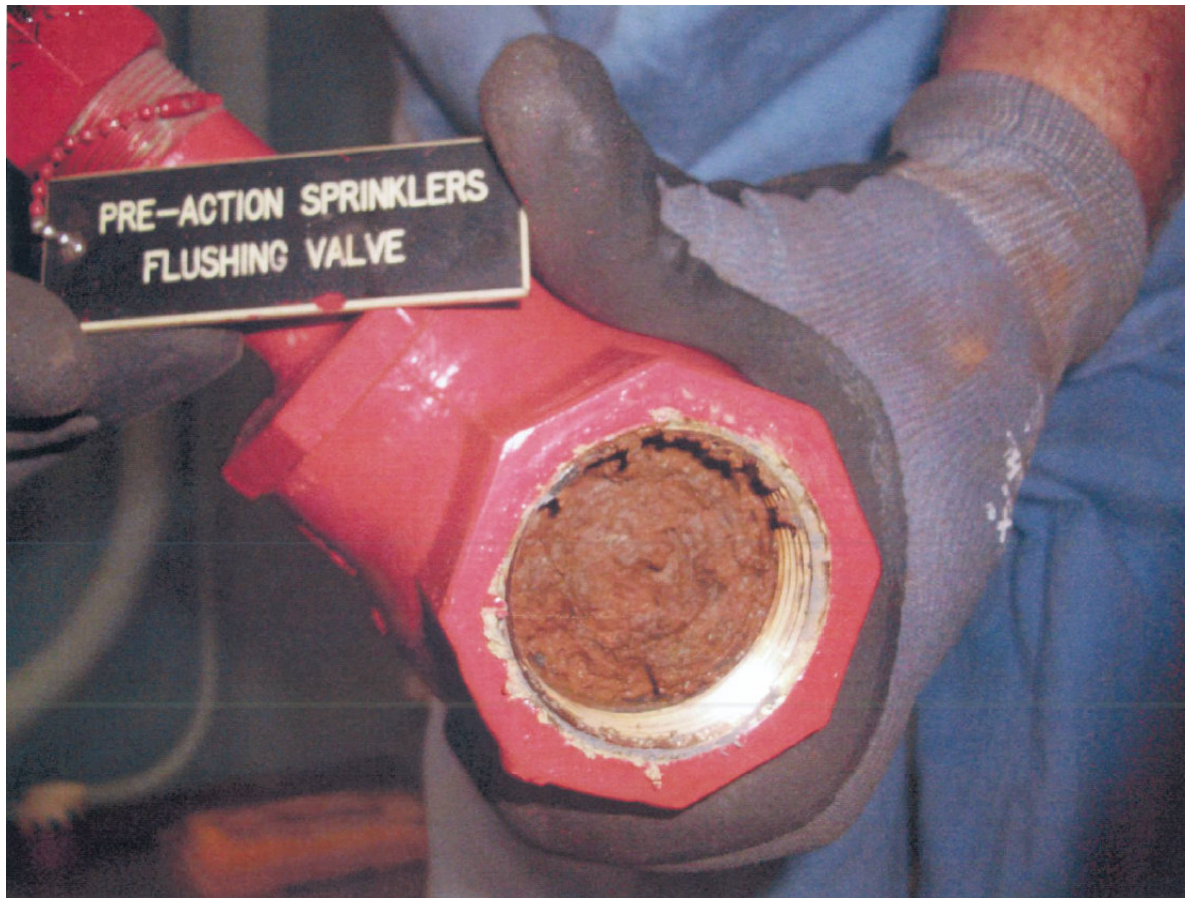
- Blocked Inspector Test Valve
- Blockage Discovered Upstream of Valve
- Reported to NRC Under 10 CFR 50.72 – System Declared Non-Functional

- Blockage
 - Pipe corrosion byproducts
- Causes
 - Inadequate draining
 - Periodic wetting and drying

- Flushed all sprinkler piping in the intake structure
- Replaced segments of pipe
- Replaced sprinklers
- Verification via video boroscope and radiography
- Extent of condition – EDG rooms

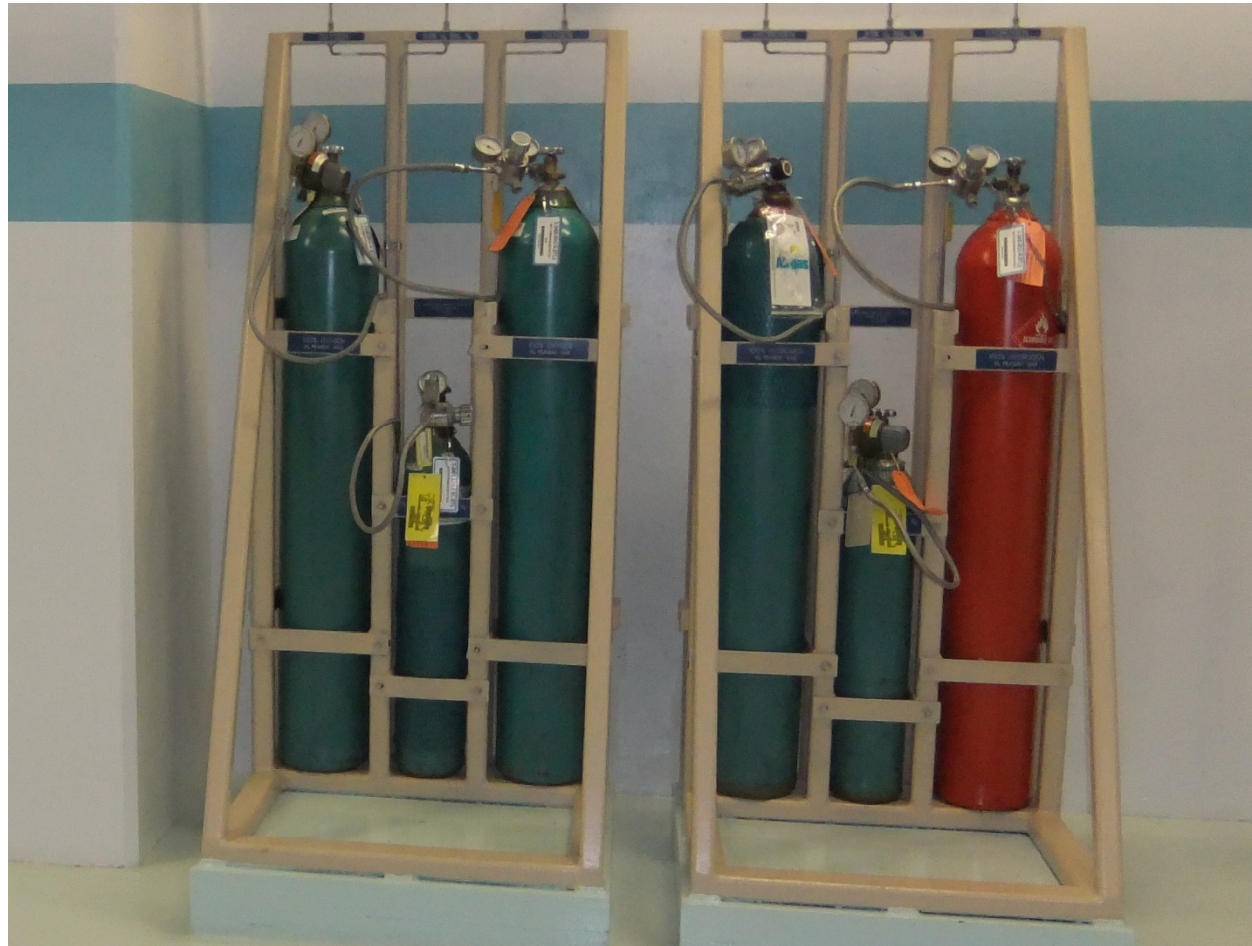
Flammable Gas Bottles
